ARBORICULTURAL IMPACT ASSESSMENT AND PRELIMINARY ARBORICULTURAL METHOD STATEMENT

Site 115 Frognal, London, NW3 6XR

8th October 2016

Project reference: DS23031601

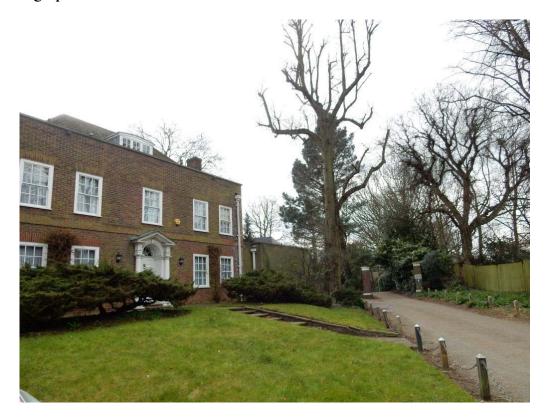
- 5.2.1 This is a highly prominent mature tree with a height of 20 metres, located at a distance of 2.5 metres from the front of the existing building close to the western corner. The tree has been subjected to past heavy crown reduction from which it is re-growing with reasonable vitality. The tree shall be retained with the proposed development. A trial pit has revealed that the existing building has a foundation depth of 1m and on this basis I do not consider it foreseeable that roots of significance will extend beneath the building. I have adjusted the RPA to exclude the footprint of the existing building.

Photograph 1. View of Tree 7

- 5.2.5 There is currently a single low-hanging chain defining the front boundary, with open grass leading directly from the road (see Photograph 1). It is proposed that along the boundary a dwarf wall with a height of 1-2 brick courses shall be constructed with metal railings above. Where the boundary extends into the RPA of the Tree 7 construction of the dwarf wall shall be with great care. Details have not been worked up at this stage; however it is proposed that mini screw piles shall be inserted into the ground (in locations which have previously been assessed for root presence) and that these shall support a lintel entirely above the ground level. If required brick slips could be fixed to the front of the lintel to conceal it. If constructed in this way, with mini piles being the only insertion into the ground in locations previously investigated for tree root presence, I am satisfied that construction of the front boundary wall / railings shall not cause harm to Tree 7.

- 5.2.6 It is proposed that the existing steps leading up the front garden shall be replaced with new steps 1.3m further from Tree 7. Whilst technically still within the tree's RPA the existing steps are likely to act as a partial root barrier, and providing excavation for construction of the new steps is undertaken carefully by hand and does not extend lower than the depth of the existing steps I am satisfied that the tree will not be harmed by this.

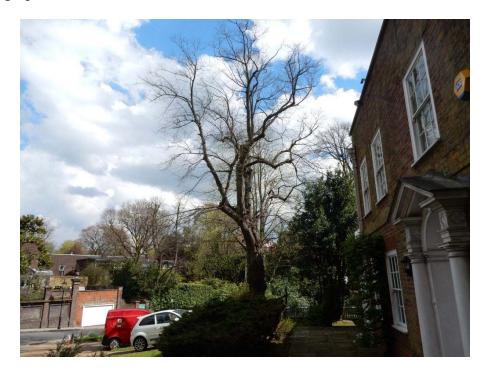
- 5.2.1 This is a highly prominent mature tree with a height of 19 metres, located at a distance of 6 metres from the front of the existing building close to the eastern corner. I have assessed Tree 8 to be in a poor condition and have advised the design team that the tree should be shown for removal.

Photograph 2. View of Tree 8

- 5.2.4 I have recommended that Tree 7 should be shown for removal and that this planning application should be used as an opportunity to secure a high quality, large sized replacement tree in a similar location at the front of the site. An area of soft landscaping is proposed at the front (see the Arboricultural Impact Plan) where it is proposed that a holm oak shall be planted with a height at planting of 7-8 metres and a stem girth of 50-60cm. This is a substantially larger tree than is likely to be secured through a TPO application for the tree's removal.

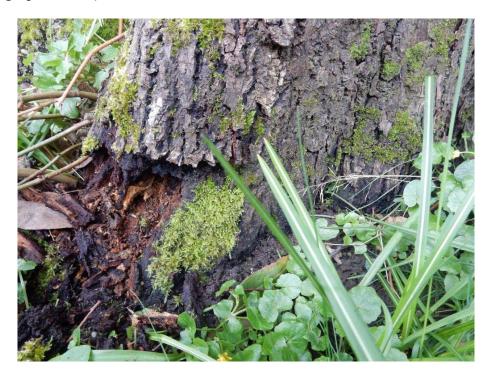
- 5.2.2 My assessment of the tree's poor condition is based primarily on the state of the wood on its western side at the base. In this position there is a major supporting buttress which has become entirely degraded to the point that it provides no strength at all. The bark covering the buttress is dead and the wood behind it is soft and highly degraded. The nature of the decay that I observed is consistent with that caused by the fungus *Kretzschmaria deusta*, though I observed no fruiting bodies of that fungus at the time of my assessment (which doesn't mean that this is not the cause). *Kretzschmaria deusta* is a frequent cause of whole tree failure of limes. In addition to the tree's decayed base, a wide, open cavity is extending downwards from the top of stem where past heavy pruning has caused the onset of decay.

- 5.2.3 I consider that Tree 7 will increasingly be at risk from failure, and could only be retained if topped to a pollard framework to a height of around 7 metres. This work would exceed all recommended good practice and would substantially reduce the tree's amenity value with it looking very poor following the work. Following work of this nature the tree's long-term future would remain doubtful particularly if the causal agent of the decay at the base is *Kretzschmaria deusta* as suspected.

Photograph 3. Decayed buttress at base of Tree 8

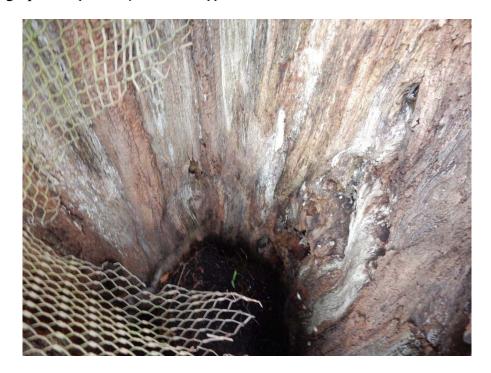
Photograph 4. Open cavity within the upper stem of Tree 8

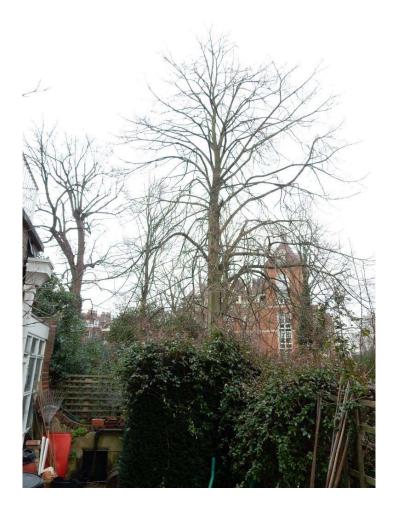
- 5.4.1 This is a good quality early-mature tree located in the verge of the road to the east side of the existing garden, close to the rear elevation of the house. The tree is located beyond the garden's side retaining wall in ground which is 1 metre below the garden level. Given the difference in level and taking account the wall's foundations, I consider that the boundary wall will act as a barrier preventing root growth into the garden, and I have adjusted the RPA shape to reflect this.

Photograph 5. View of Tree 11 from the rear garden
