Heritage Statement

Internal Structural and Roof Fabric Repairs, 27 Russell Square

October 2016

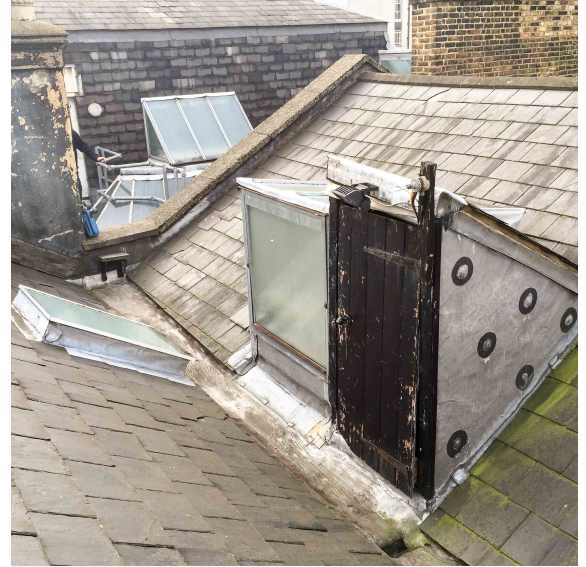
The roof profile comprises slate clad pitched roofs, with ridge lines running parallel to the front facade, and hidden behind low parapet walls at front and rear. There is a central valley that can be accessed via a step over the party wall with 28 Russell Square to the south. The party walls extend upwards on both sides of the house to form long chimney stacks with ornate clay pots, that are probably original, although the faces of both chimney breasts have been rendered with a cement mortar that is in poor condition. Also in poor condition are the asphalt lined valley gutters at front, rear, and centre of the roof.

Image 3, View of Roof.

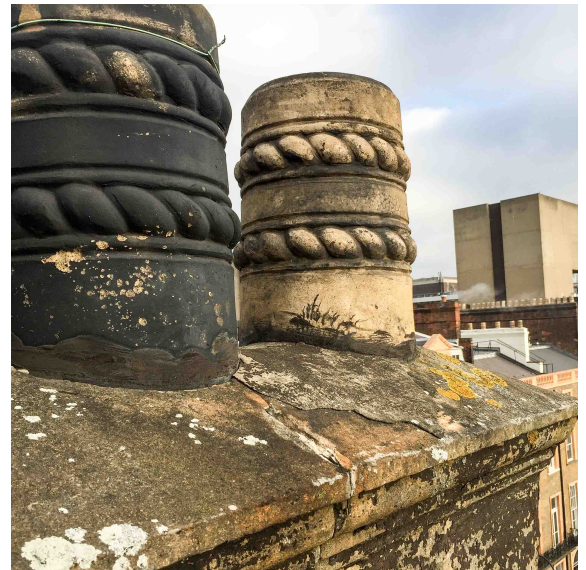
Image 4, View of Chimney Stacks.

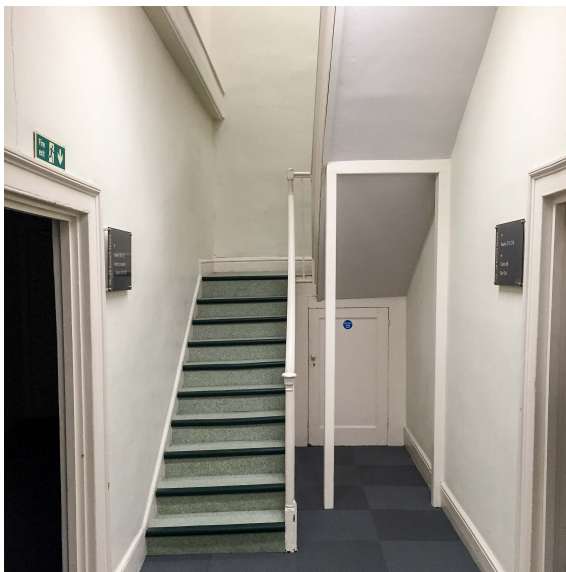
The damage to the internal structure of the upper floors comprises settlements within the third and second floors, and severe deformation of internal walls, also within the third and second floor storeys. A full explanation of the investigations is provided in our structural survey (Barton Engineers, February 2016), although the causes of this damage can be summarised as inappropriate removal of internal structural walls, allowing the roof and upper floors to span clear between party walls, which they were not structurally adequate to do. Also the new second floor was constructed spanning onto the central spine wall that had no structure capable of spanning over the ground floor rooms, and so was supported effectively by floor boards and timber blocking members that eventually failed.

Image 5, View Internal Staircase between Third and Second.

The structural repairs will comprise the insertion of structural support to the upper floors where no effective structure exists at present. The proposed new structure comprises lightweight steel sections inserted within already much modified timber structures, and will be invisible once repairs have been carried out to the wall and floor finishes. The use of an alternative timber framing system was considered; however, the section sizes required would have

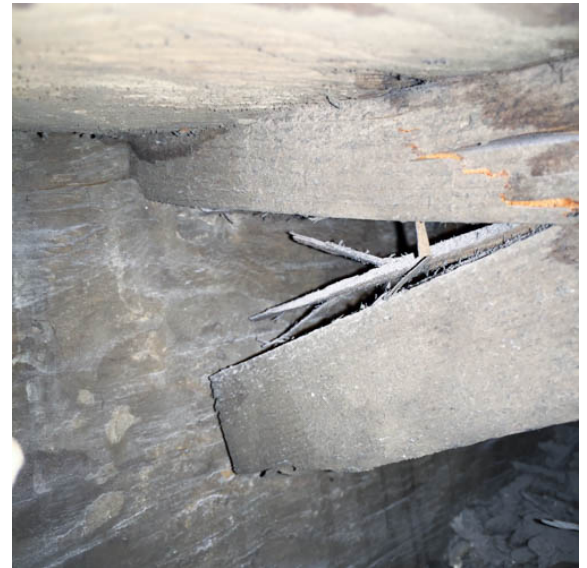
Image 6, View of Failed Blocking Member Within First Floor.

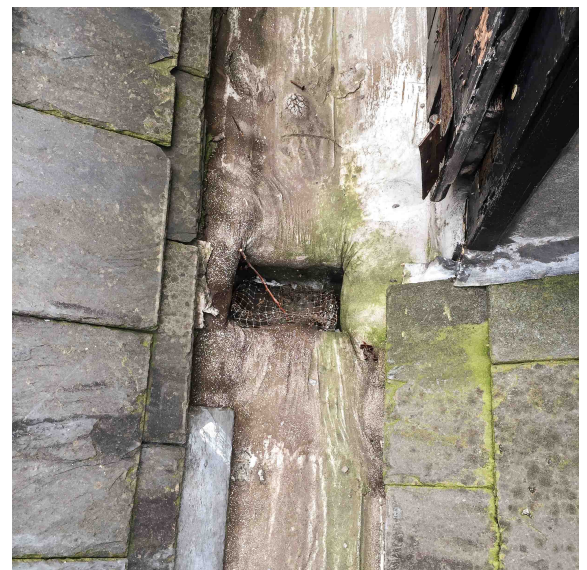
The damage to the roof elements has resulted from short lived and inappropriate materials being used. Specifically a cement render on the chimney breast masonry, and asphalt lining to the gutters.

Image 7, View Central Valley Gutter.

The approach used to the proposed repairs to roof fabric has been to replace the inappropriate materials with more appropriate materials that should allow the structure of the building to behave as intended, and to also provide a much longer design life that is more in keeping with the age of the building and the expected further life of the fabric. Specifically, lead is proposed as the material for the guttering, which should have a design life in excess of 100 years. The lime render proposed as a replacement for the cement mortar to the chimney breasts should also provide a long design life, but just as importantly, should allow the underlying brickwork to become more dimensionally stable by providing reasonable weathering protection and allow drying out through a semipermeable render.

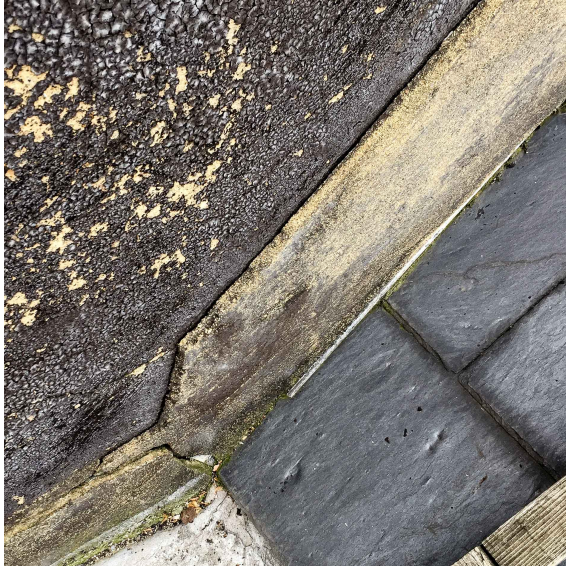
Image 8, View Cement Render to Chimney Breast.
