### Structural Survey

### 27 Russell Square

February 2016

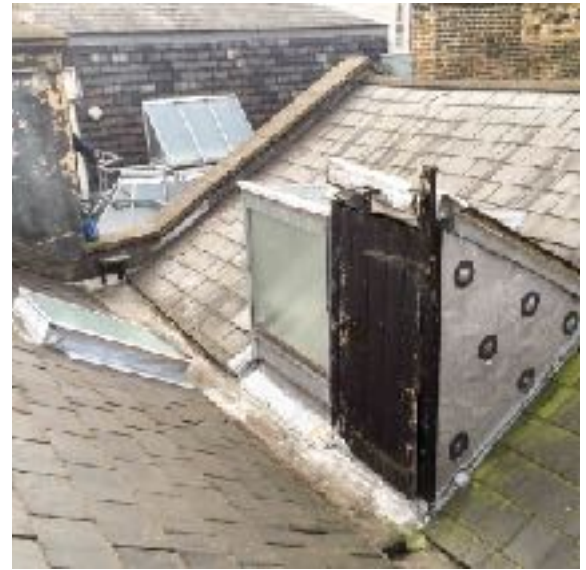
1. View of Roof:

The condition of the roof slates was generally good, although a significant moss build up had occurred on the east slope of the west or rear roof. A number of slates appeared to have been replaced over the years, and it is probable that the roofs have been re-clad at some point within the last thirty years or so. The ridges seemed to be clad in concrete tiles, and again these appeared in good condition. The flashings into the raised chimney stacks appeared to comprise lead that was then clad in a cement render, although lead was only visible at the base of the render. There were significant gaps between the top of the vertical render and the chimney masonry behind in many locations, and it is possible that water ingress has occurred along this joint line in all areas of the roof.

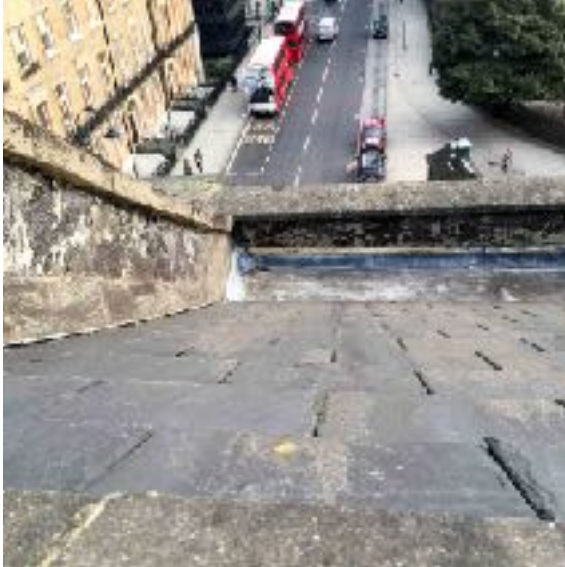
3. View of Front Parapet From Roof Ridge:

The rear of the parapet wall to the front of the building could only be viewed by looking over the ridge of the roof (as described above). It comprised a low wall that was rendered, and with a continuous lead flashing that lapped over the asphalt upstand forming part of the gutter. Concrete or stone coping stones capped the brickwork wall. The parapet appeared in good condition and there were no obvious structural defects visible.

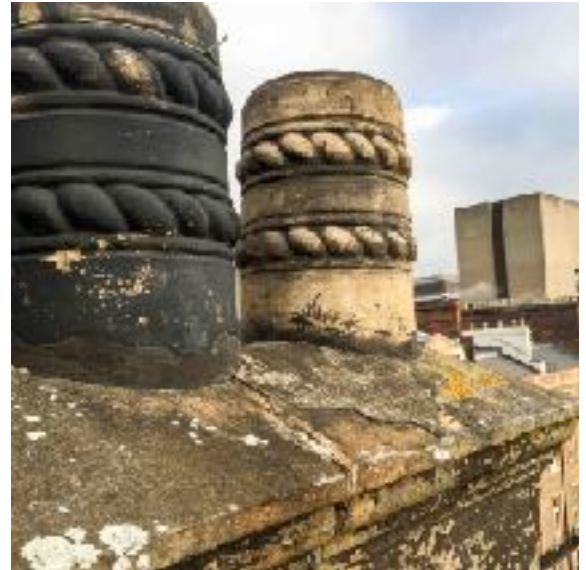
4. View of Chimney Stack and Pots:

The chimney stacks set on top of both the north and south party walls appeared in reasonable condition structurally, and were topped by light cream coloured ceramic chimney pots with highly decorative patterning, suggesting that these elements were part of the early Nineteenth Century construction. However, the render to the chimney stacks was in poor condition in most areas; a bituminous paint on the outer surfaces had flaked away in most areas, and cracking of the render in a crazed pattern, with parts of the render beginning to spall off, seemed to be typical of its general condition. The coping areas of render around the chimney pots were in better condition, and it is likely that this element was still providing the appropriate level of weather protection.

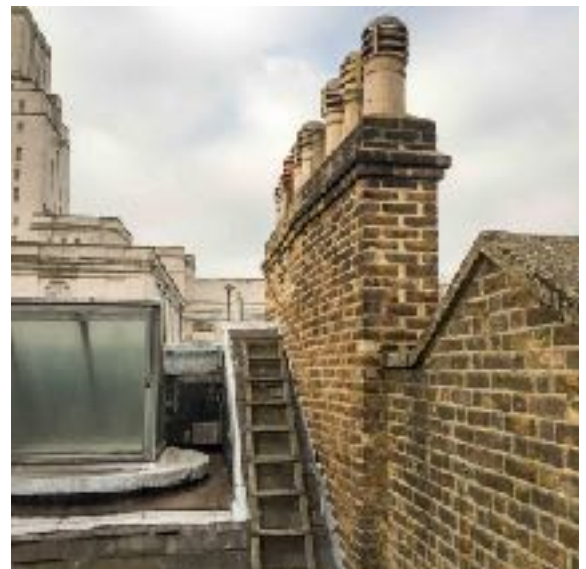
5. View of Rear Chimney Stack.

At the rear of the building the south party wall follows the line of a larger rear extension to Number 28 Russell Square, and contains another chimney stack that is constructed of stock brickwork without any render. The chimney appeared as though it may have been rebuilt at some point in the Twentieth Century, but it also seemed to have been rebuilt with a kink in the plan length, probably caused by rebuilding on the line of the previously deformed chimney stack structure. There were no obvious signs of ongoing defects within this chimney stack.

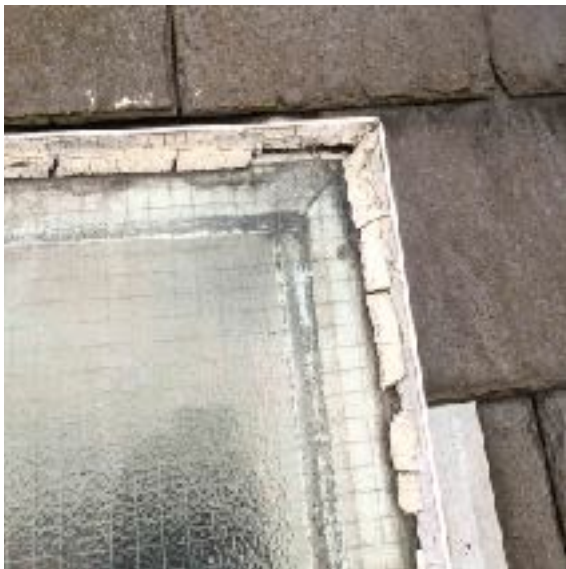
6. View of Rooflight Detail.

The roof lights comprised a combination of timber framing with single panels of glass, some patent glazing, and also some steel W20 type glazing. All of the glass used was of a single glazed Georgian wire type, and the flashings and putty surrounds were in very poor condition generally, suggesting significant water ingress was likely to have occurred through all roof lights. The steel clips holding the glass were also corroded and the roof lights generally were in need of refurbishment. It was noted that asbestos warning stickers had been attached to the glass panels. The access doorway into the west roof space was a timber structure with a timber boarded door panel that fitted badly and was also a probable source of water ingress.

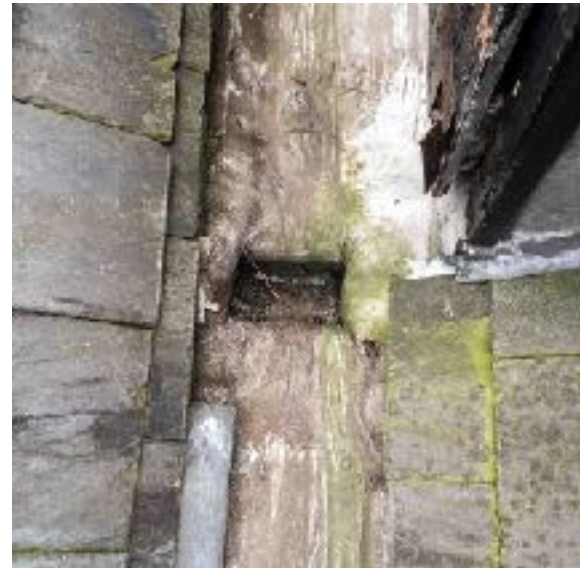
7. View of Gutter.

The valley gutter and front gutter appeared to comprise an asphalt roofing membrane, which also appeared in poor condition with numerous folds and local blisters. It was presumed that the rear gutter was of a similar construction but this could not be confirmed during our visit as no visual access was available to the rear slope of the roof.

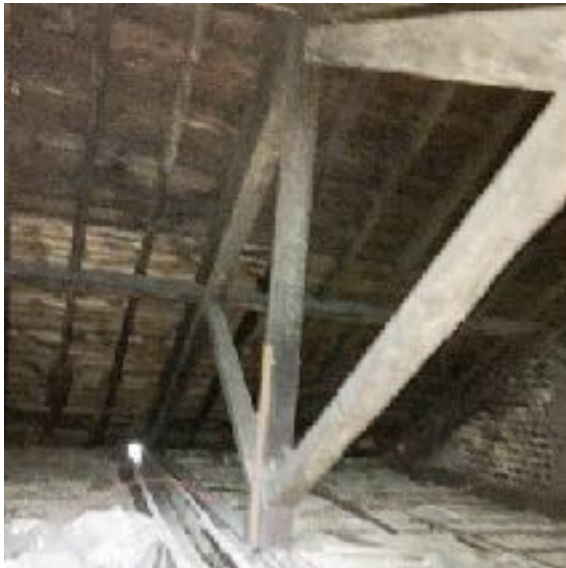
8. View of Roof Truss.

The internal structure of the pitched roofs comprised king post timber trusses supporting purlins and then rafters, with ceiling joists spanning between the trusses. There seemed to be three trusses within each roof; one in the centre and two adjacent to the party walls, all spanning from the external walls onto the central spine wall of the building. All appeared to good condition. Within the rear roof pitch was an open channel lead lined gutter that received stormwater from a central gulley in the valley gutter. This internal gutter then appeared to have a central gulley, with an overflow that fell to the rear of the building. This internal gutter also presumably received stormwater from the front gutter. It was impossible to establish how the inner gulley then distributed stormwater, although it was noted that the rear elevation appeared to have two outlets for stormwater; one at the rear parapet gutter level and another some 450 millimetres below, possibly receiving the inner gulley via another pipe within the third floor ceiling zone.

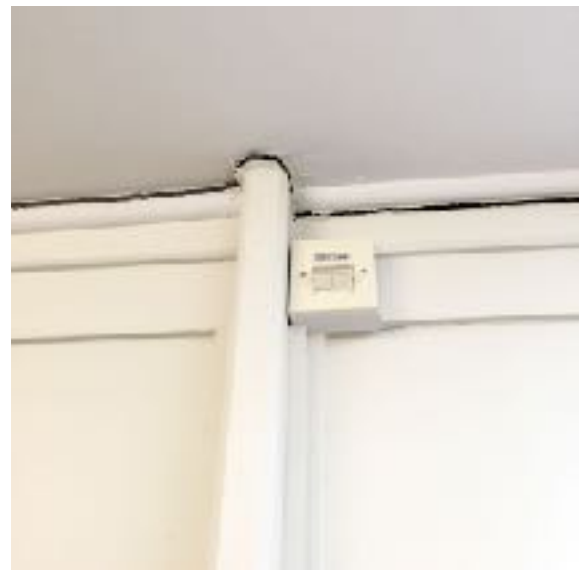
10. View of Corridor Wall Cracking At Third Floor.

Within the central corridor itself, the partition on the east side of the corridor contained a long crack at its junction with the ceiling, that was its widest (5 to 7 millimetres) in the centre of the building, and then narrowing and returning along downstands towards each end of the corridor. As noted above, there was also a pronounced sag in the floor along the length of the corridor, with the lowest point being in the centre of the building. There was also a drag in the wallpaper finish at the north end of the corridor where the west partition joined the party wall for its full height.

1. Install a new steel lintel within the third floor to reduce the span of the floor joists over the second floor corridor. This new steel beam will span onto new timber studs inserted within the second floor partitions, and will need to be carefully installed so as to ensure that the third floor joists are properly bearing onto it. Some jacking upwards of the third floor joists could be undertaken to re-level the third floor corridor.

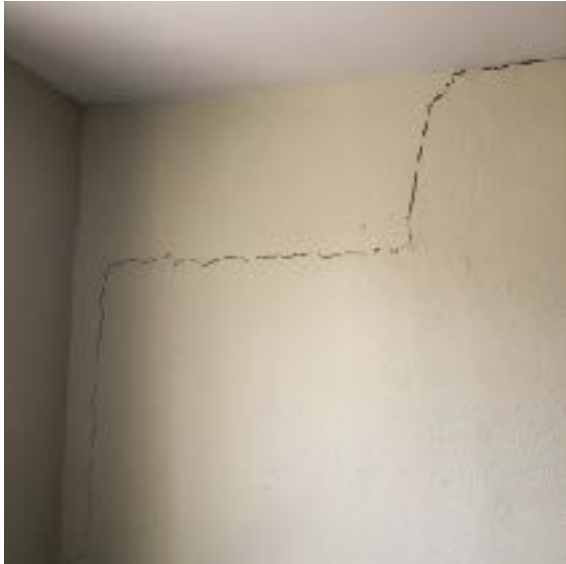
11. Internal Partition Cracking At Third Floor.

All three of the front rooms at third floor level had sloping floors, and all sloped downwards towards the corridor. Also the two dividing partitions between these rooms exhibited severe cracking, with cracks starting at the mid height of the partitions near the front facade and then rising and following the wall to ceiling junction. In some instances these cracks were 10 to 12 millimetres wide. These rooms also showed signs of water ingress having occurred, and damage repairs around the underside of the front parapet wall and the lintels

over the windows. Recent damp penetration appeared to have occurred in the ceiling of the south room, in the corner adjacent to the party wall.

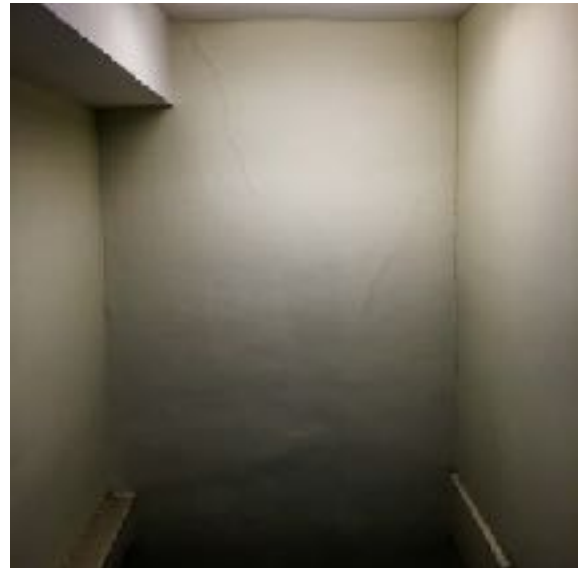
12. View of Cracks In Party Wall At Third Floor.

Within the staircase void to the floor below, the south party wall contained significant cracking with two distinct cracks starting in the centre of the panel and travelling upwards and outwards towards the upper corners of the wall. There were clearly ongoing movements in both party walls at this level.

The other area where structural defects manifested themselves was in the upper parts of both party walls, where diagonal cracking was seen in the third floor storey at the centre of the party walls. It is likely that this diagonal cracking is due to movement in the upper section of wall, and it is possible that some expansion and contraction of the walls has occurred in the area between the main chimney breasts, where the party walls are thinner and braced by the much thicker chimney breasts on either side. The attached sketch shows the locations of the cracks in relation to the party wall elevations and chimney breast locations. The addition of structural stitches in this area may improve the strength of the party wall and reduce the likelihood of further cracking.

4. Concrete stitches are installed within the party walls at the upper levels to prevent further differential movements within the walls.

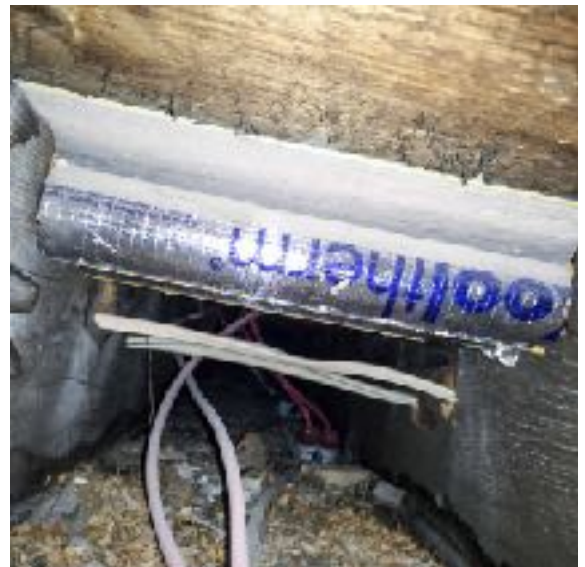
13. View Showing Notched Joists in Third Floor.

Opening up revealed that the floor joists at this level all span in a direction from party wall to party wall. Also that the partitions dividing the rooms at the front of the building sit on the floor boards and so there is no specific structure beneath these partition walls. Extensive notching of floor joists to allow service pipe and cable distribution was also noted, and in some instances 40% of joist depths had been removed.

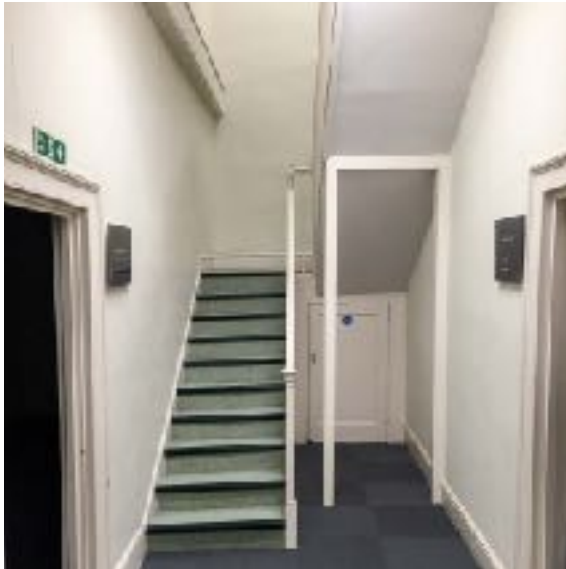
14. View of Staircase And Cracks To Wall.

The timber staircase down from the third floor had clearly suffered deformation, and also significant horizontal cracks existed in the east wall of the stair enclosure at the level of the third floor, with cracks of up to 10 millimetres wide being visible. It appeared that the partition wall of the second floor had come away from that of the third floor level above.

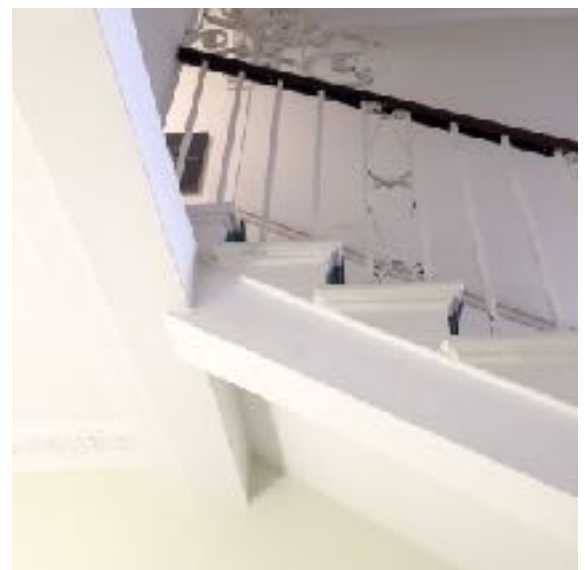
15. View of Staircase.

Access between second, first, and upper ground floor was via a cantilevering stone staircase with iron balustrade. This staircase exhibited local deformations at second floor level, and in other areas, and had been repaired by the addition of a steel structure beneath the stonework comprising a series of carriage beams spanning between walls at landing and floor level, and forming stringers beneath the stone flights. These repairs, whilst somewhat unsympathetic to the appearance and heritage significance of the staircase, appeared effective in providing adequate structural support.

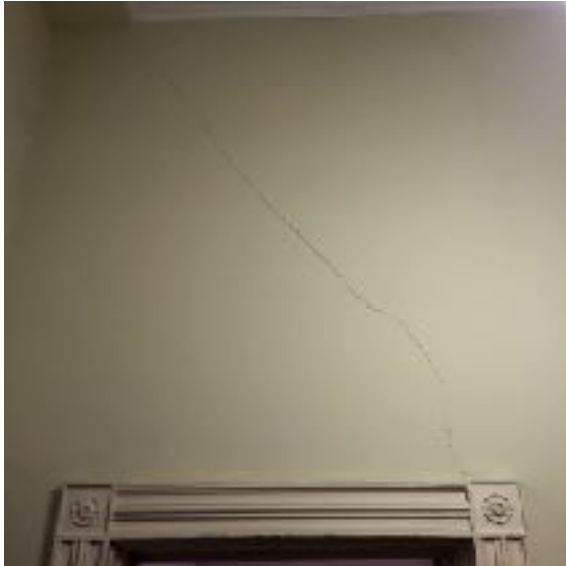
16. View Of Crack In Wall At First Floor.

Within the staircase area at first floor was observed a large diagonal crack above the doorway into the rear main room. This crack appeared recent and corresponded with the central pier moving downwards at this storey level.

The first floor spine wall has been much altered and repaired, and there are still signs of significant deformation within this wall, as well as ongoing minor cracking. The central pier at the north end of the first floor spine wall, is an important structural element. The alterations in the structural load path that would have taken place above this area have probably caused structural movements and damage, and it is likely that the diagonal cracking seen in the first floor wall to the staircase enclosure, the deformation in the ground floor entrance hallway, and the minor cracking in the lower ground floor, are all related to this issue. It is also probable that some settlement has also occurred in this wall due to foundation movements; such movements are very common in this type of property.

3. Install a new column within the central pier at first floor level. The structure of this pier needs to be fully examined and strengthened to ensure that a robust structure is created in this element, and that it is capable of transferring loads down through the building.

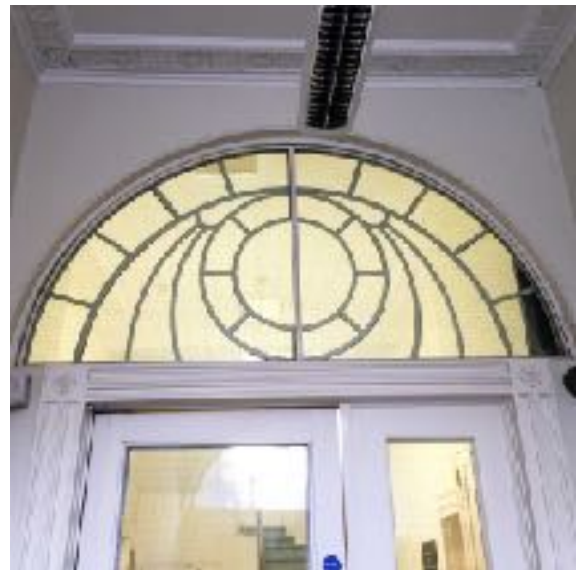
17. Internal View of Fanlight Over Entrance Hallway.

In the entrance hallway there was considerable cracking around the entrance door framing, and also in the ceiling above the entrance door, although the two areas of damage did not seem obviously related. The pattern of ceiling cracking was typical of movements occurring within the floor joists due to dynamic loading, and that has resulted in diagonal cracking of the ceiling where it is effectively stiffened by the cornices, and by being at the corner of the room. The inner entrance corridor displayed signs of historic deformations having occurred, with deformations in the internal dividing wall between the hallway and front main room suggesting that the wall had dropped downwards. There was a fanlight over the inner entrance door that appeared of a late Victorian or early Twentieth Century style, and it appeared that the fan light postdated the historic movements and deformation.

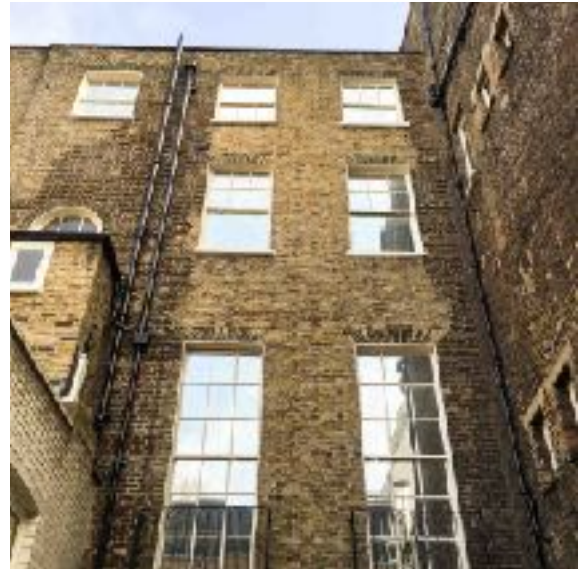
18. View of Rear Facade.

The rear facade of the building comprises simple brickwork construction with gauged brickwork flat arched lintels over all windows, and iron balcony structures at the rear of the first floor windows. The rear elevation, when viewed from the rear ground floor level, showed extensive signs of repairs and rebuilding works, with a considerable range of different brickwork and pointing colours. However, no obvious current or ongoing defects were visible. It was noted that a steel plate and tie bar had been inserted into the third floor level to the north side of the rear wall, suggesting that some movement had occurred previously, although nothing appeared obvious during the survey.

door in the rear facade. This staircase appeared in poor condition, and a tread had been replaced with a timber plank in the lower flight. The rear walls of the yard at the rear of the house appeared in good condition and were free from defects.

- Rear ground floor fire escape; replace with modern steel alternative, or remove if no longer required.

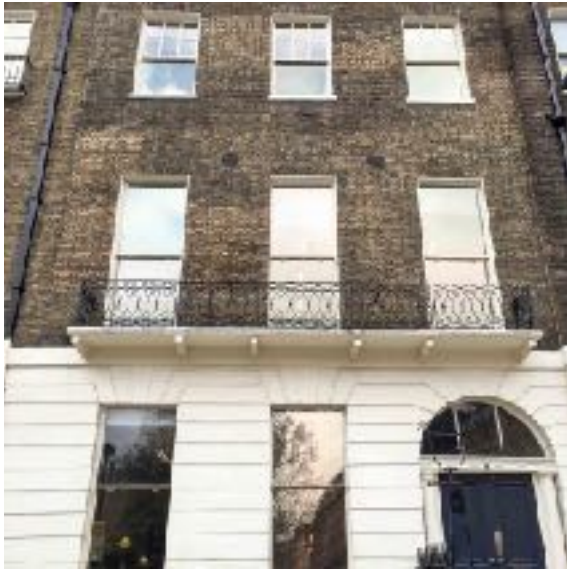
19. Front Elevation.

Whilst there are signs of minor and local repairs in the brickwork, the front facade of the building appears free from significant structural defects.
