**Barrett Mahony Consulting Engineers**  
Civil . Structural . Project Management  
London: 12 Mill Street London, SE1 2AY, UK.  
Tel: 020 3750 3530  
Email: bmce@bmceuk.com Web: www.bmceuk.com

**DOCUMENT  
LEAD  
SHEET**

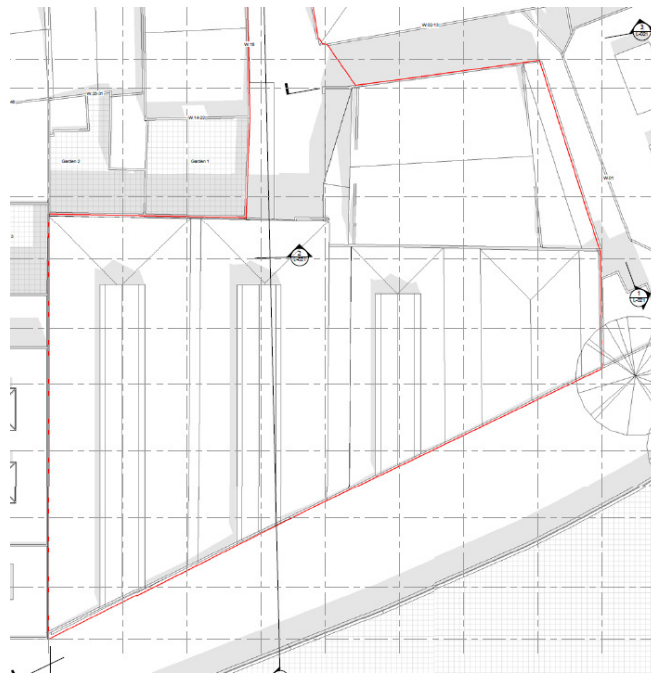
**Figure 2: Existing Roof Layout**

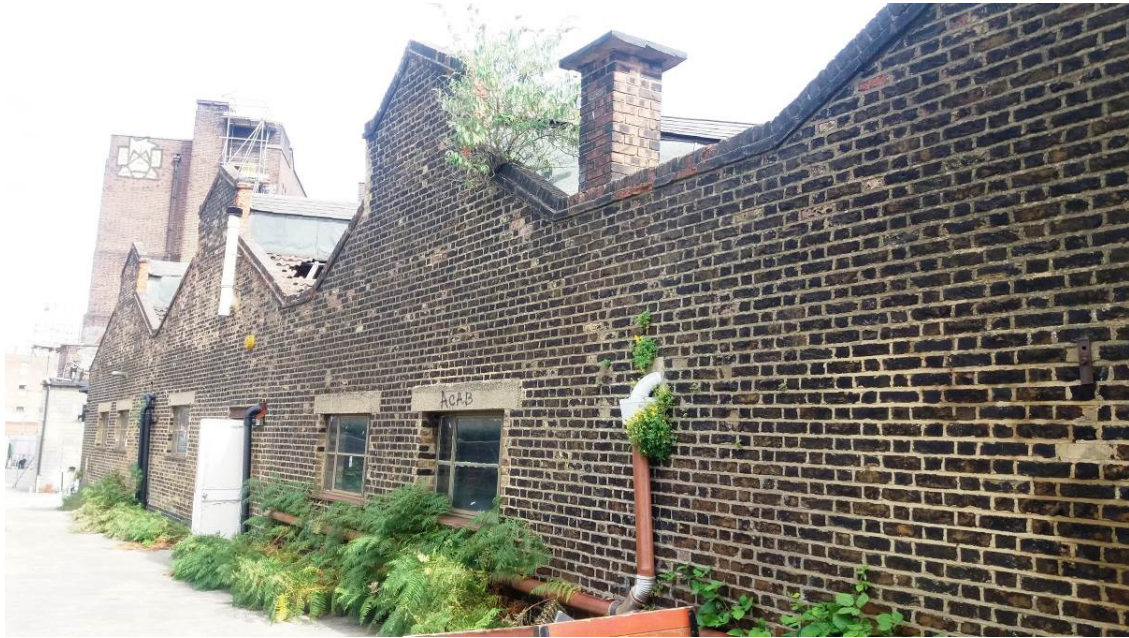
**P01 – View of rear elevation showing damage to roof and lack of wall restraint**

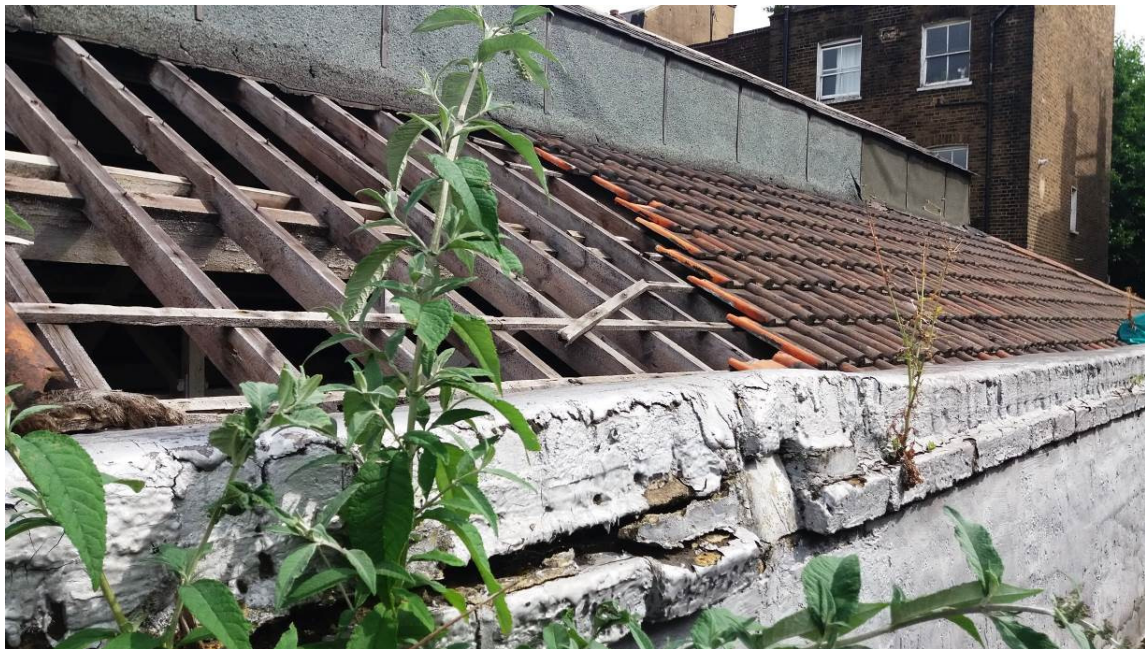
**P02 – View from roof level of existing hole in roof and damage to parapet caused by vegetation growth**

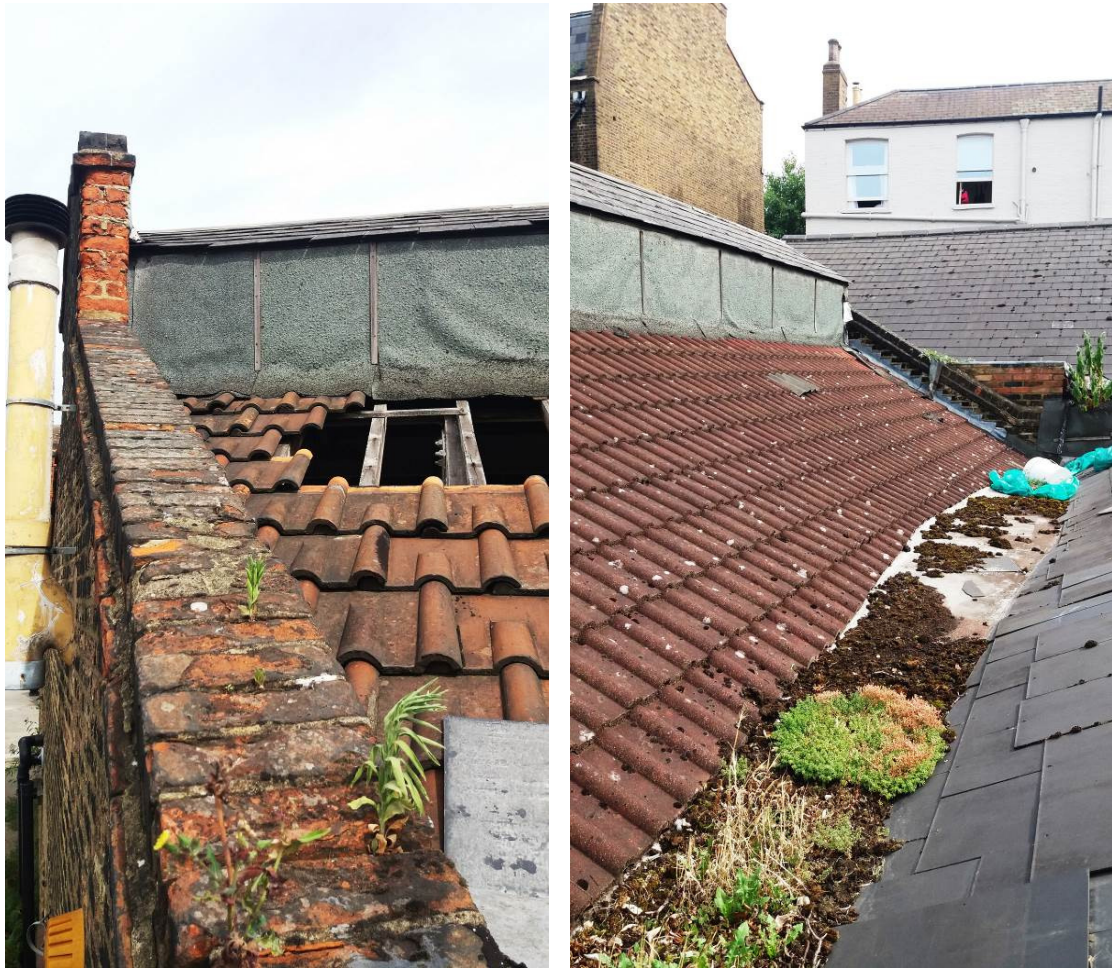
**P03 & P04 – View from roof level showing damage and dilapidation of roof**

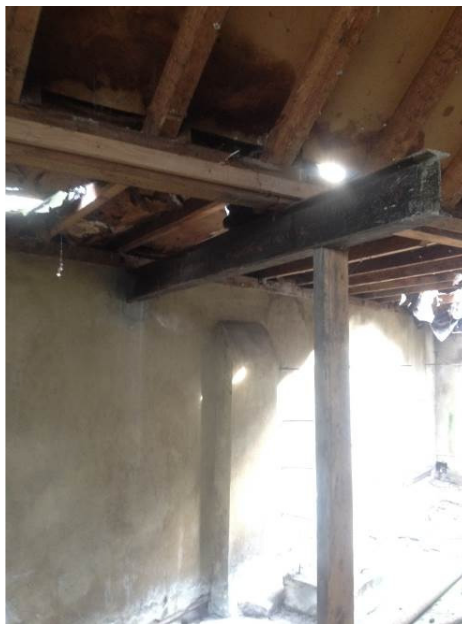
**P05 – Remedial steel beam support to collapsing roof**

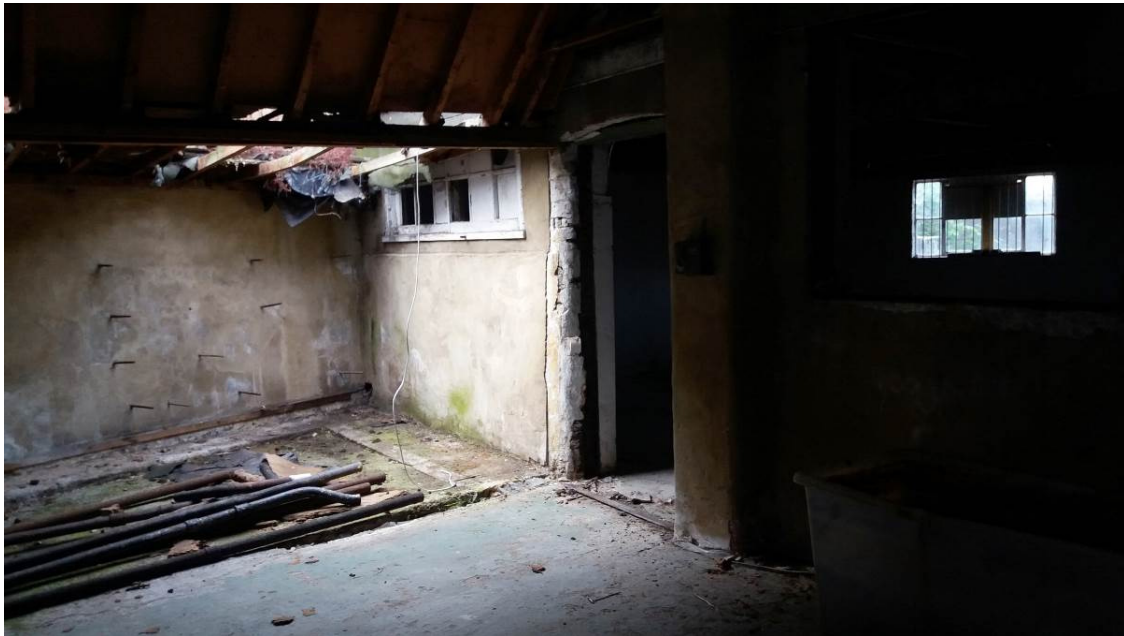
**P06 – Failure of roof rafters & collapse of roof**

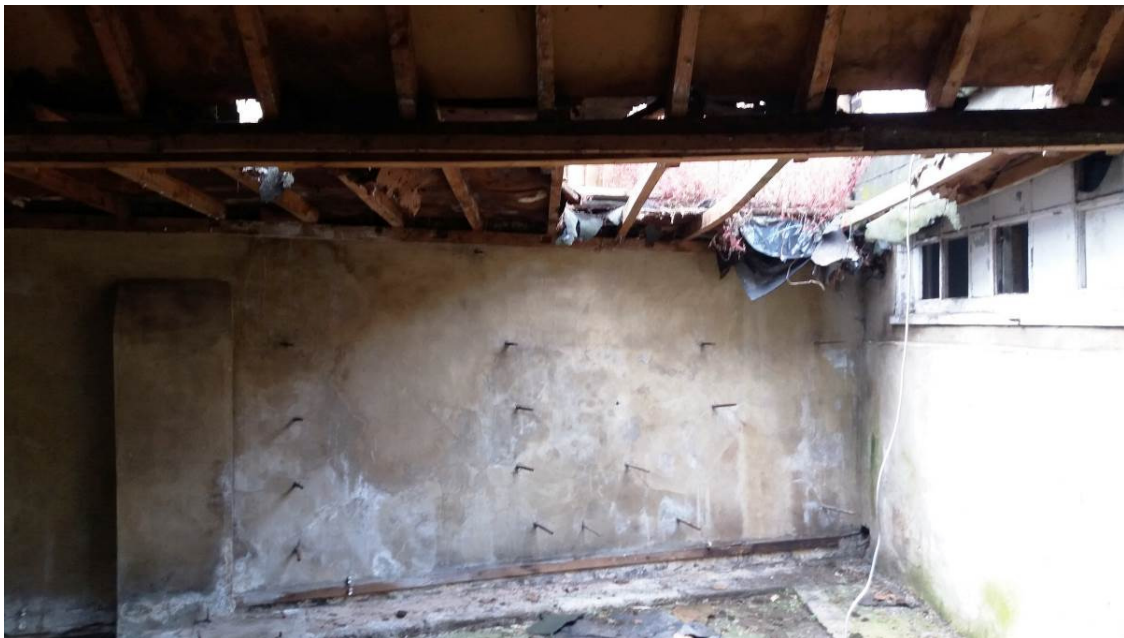
**P07 – Failure of roof rafters & collapse of roof**

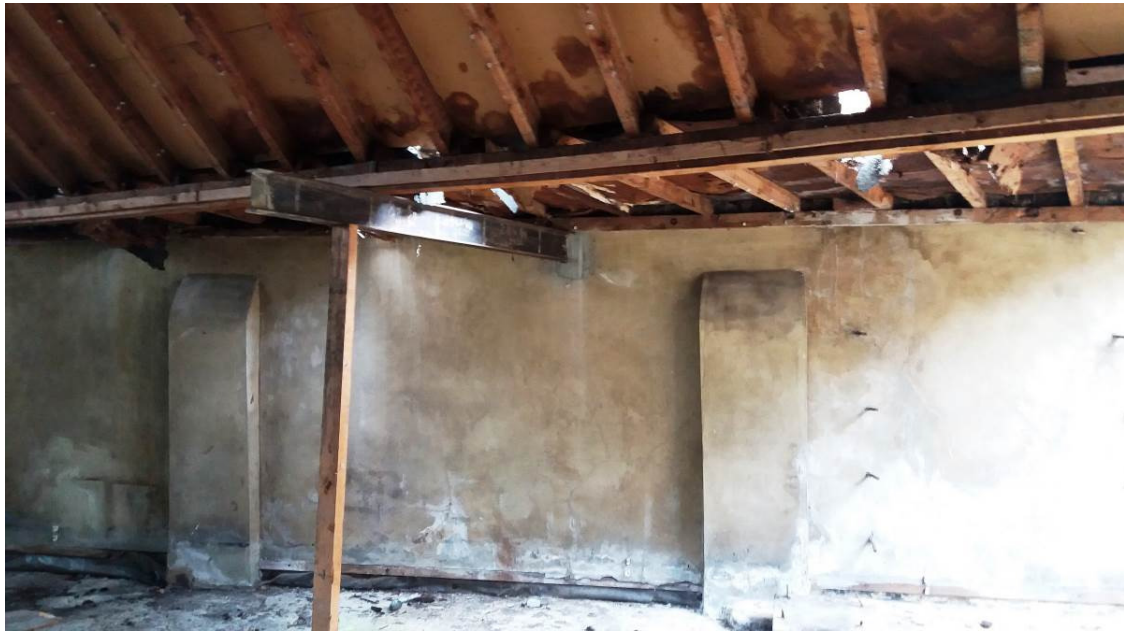
**P08 – Failure of roof purlin support beam & failure of waterproofing to roof**

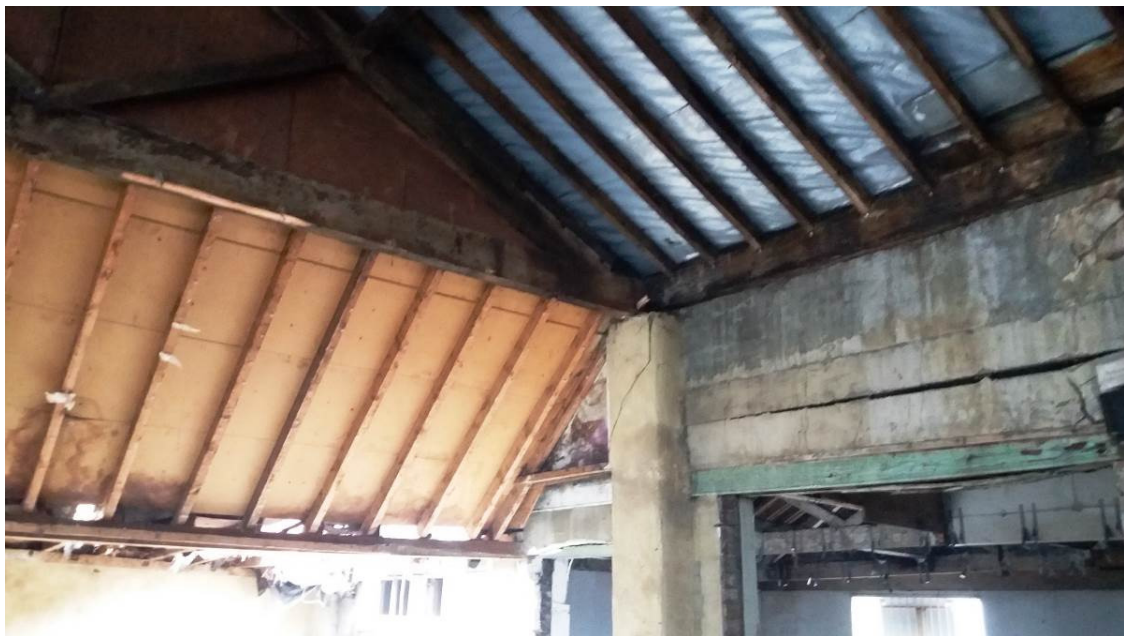
**P09 – Water ingress to existing roof**

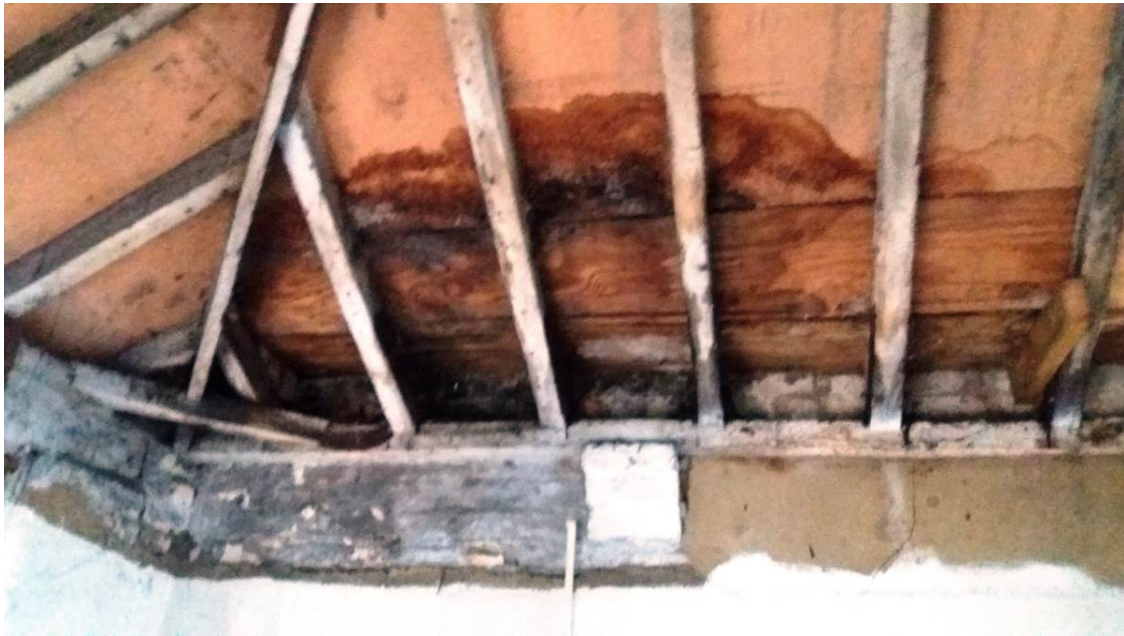
**P10 – Rotting roof boards and rafters due to waterproofing failure**

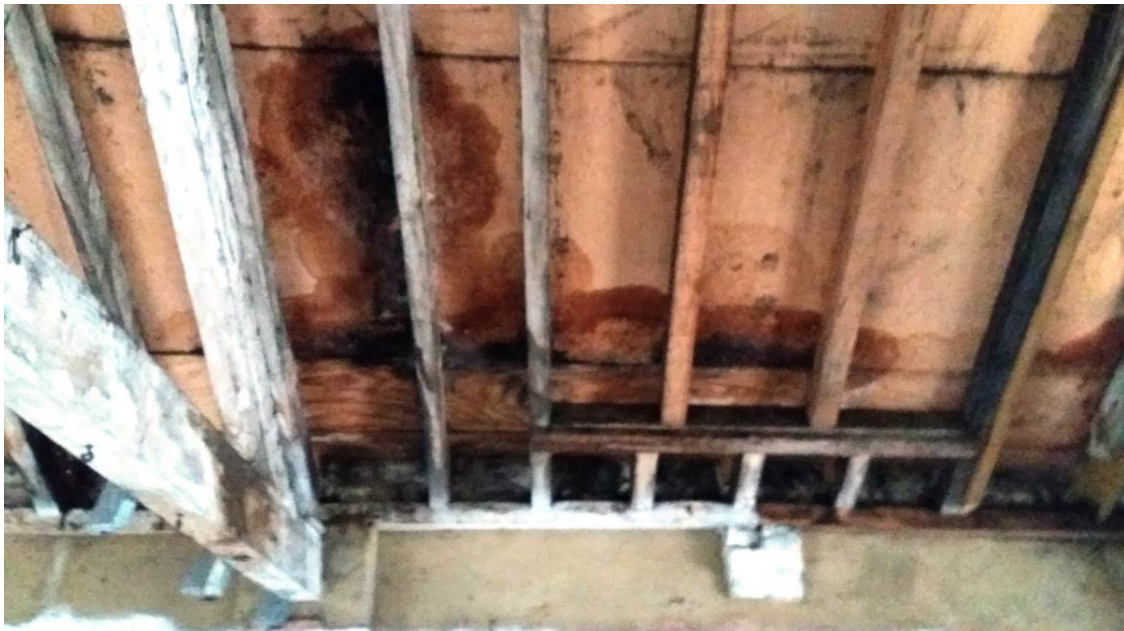
**P11 - Rotting roof boards, rafters and truss end due to waterproofing failure**

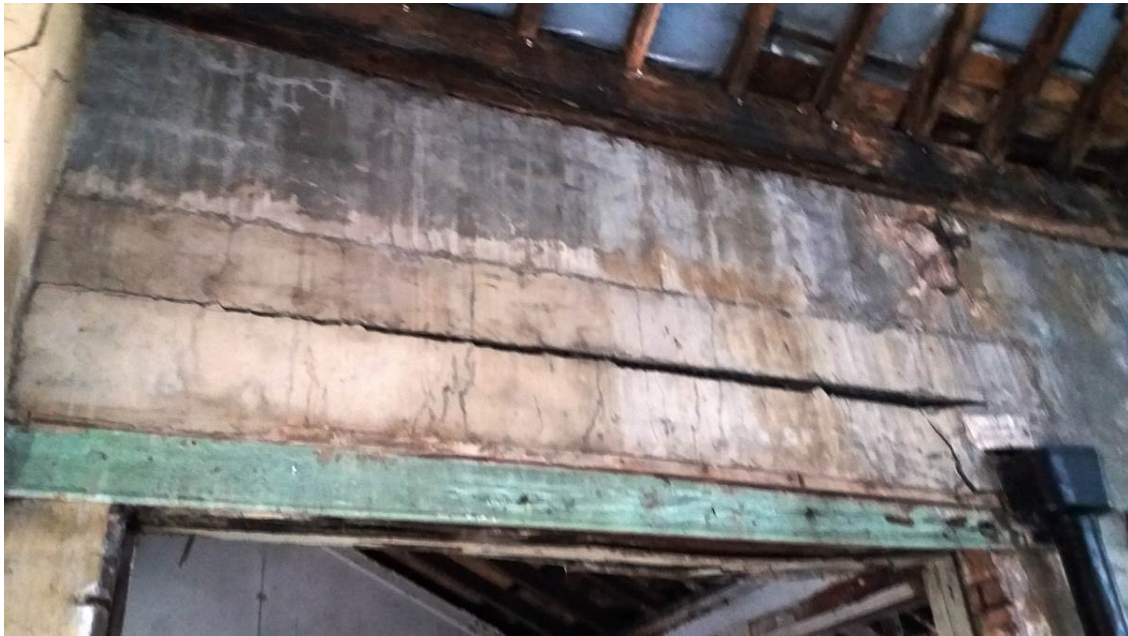
**P12 – Wet rot to wall plate and rafters due to waterproofing failure**

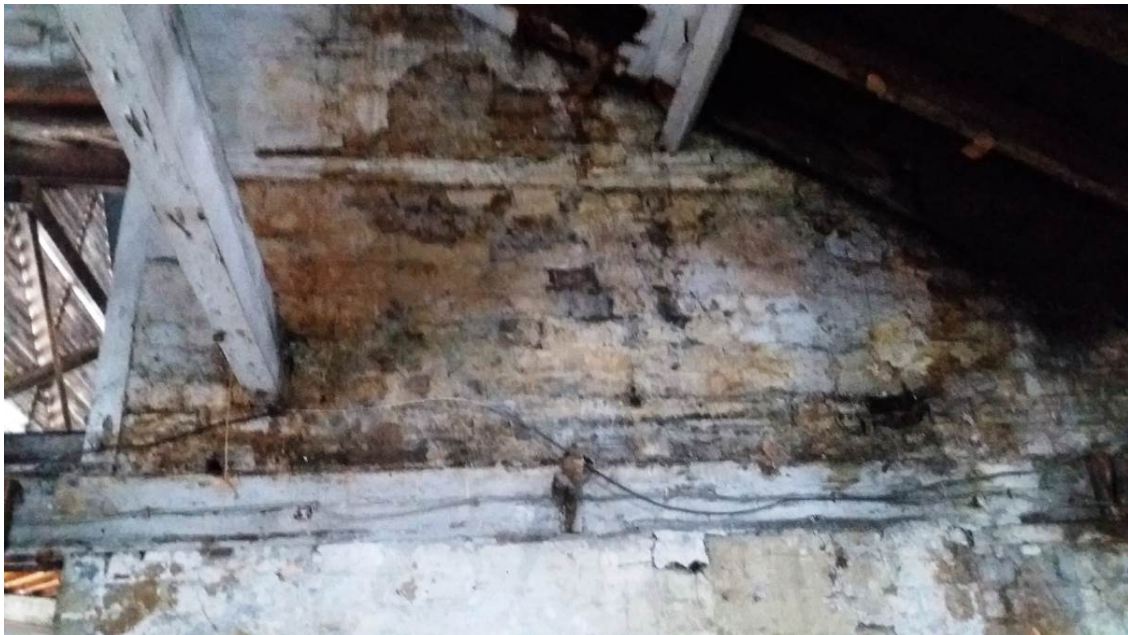
**P13 – Deterioration of fabric of structural walls due to roof failure**

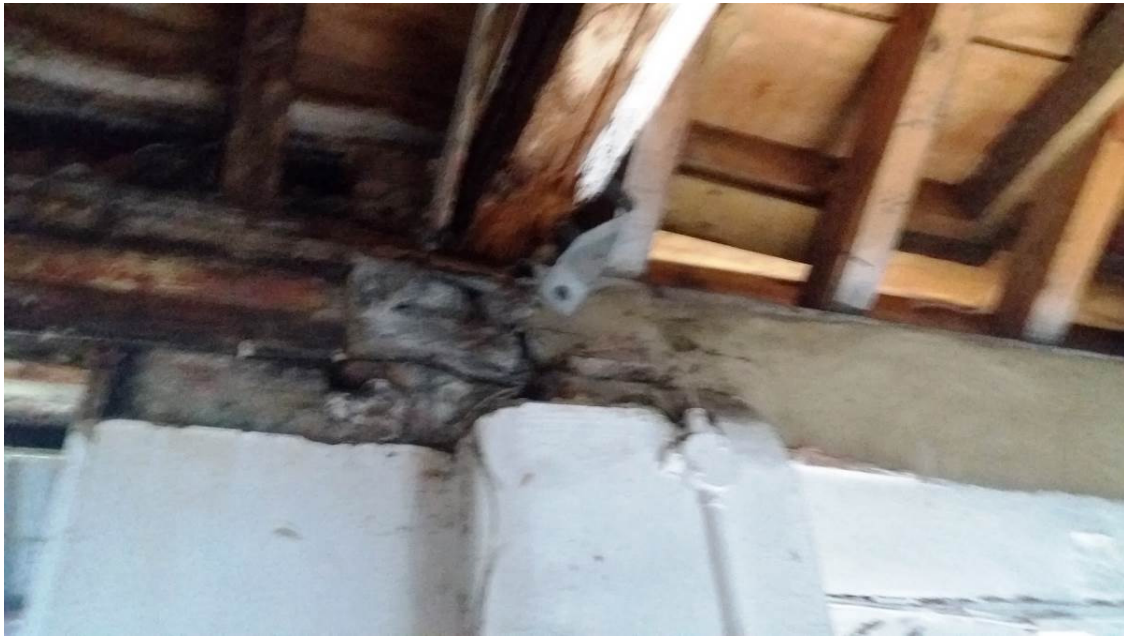
**P14 – Rotting of roof structure at bearing point**

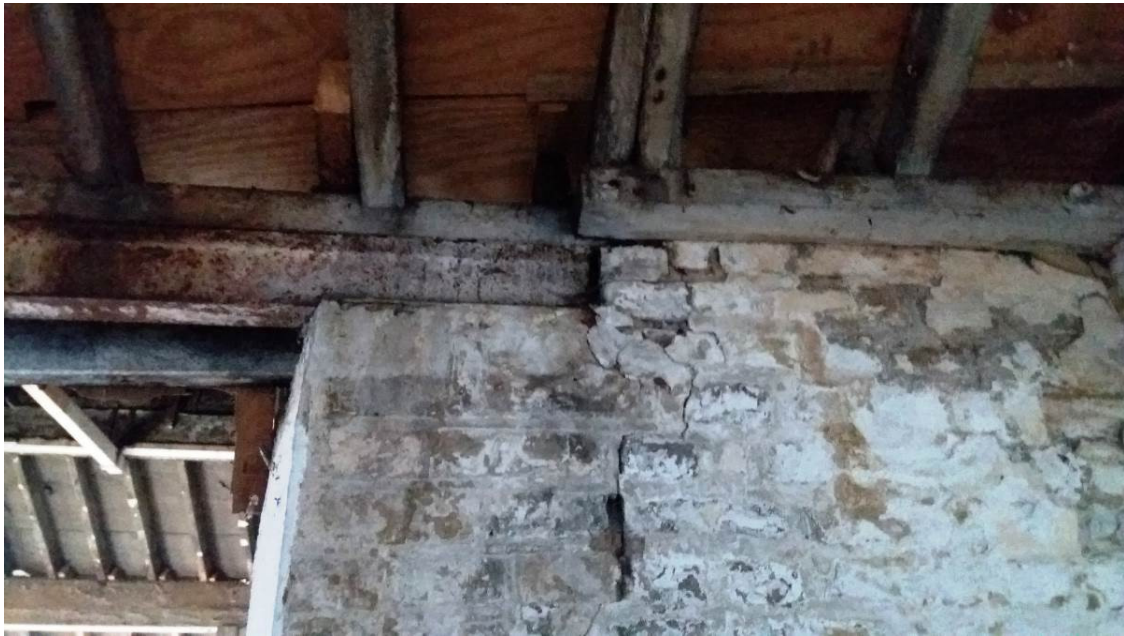
**P18 – Cracking of masonry below caused by inappropriate bearing of roof member.  
Corrosion of existing steel beam**

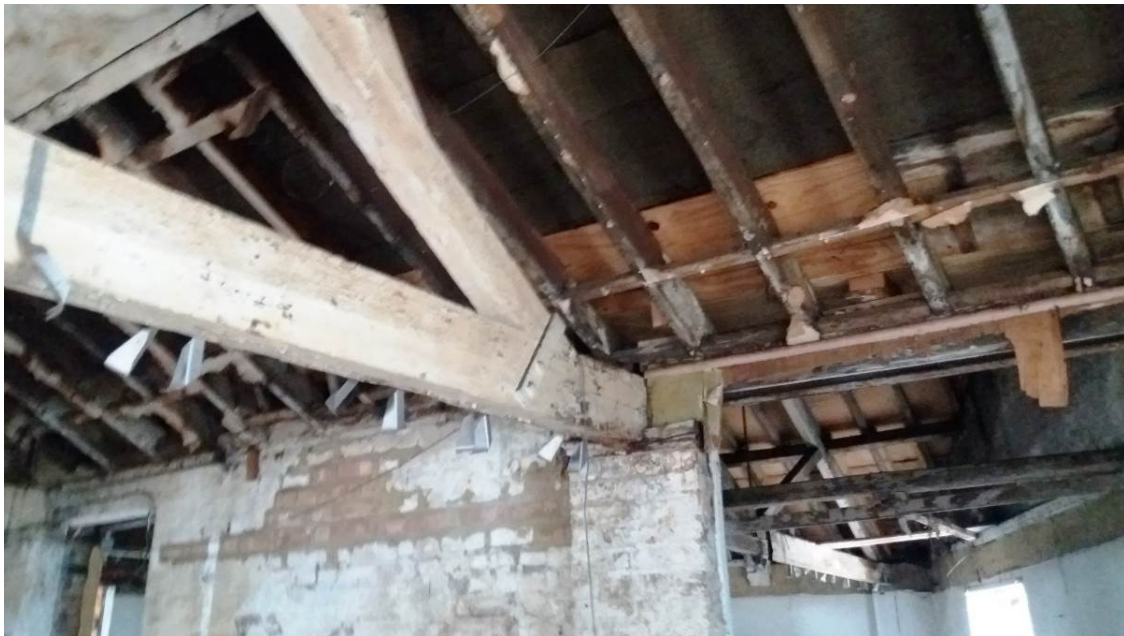
**P19 – Inadequate bearing of roof truss**

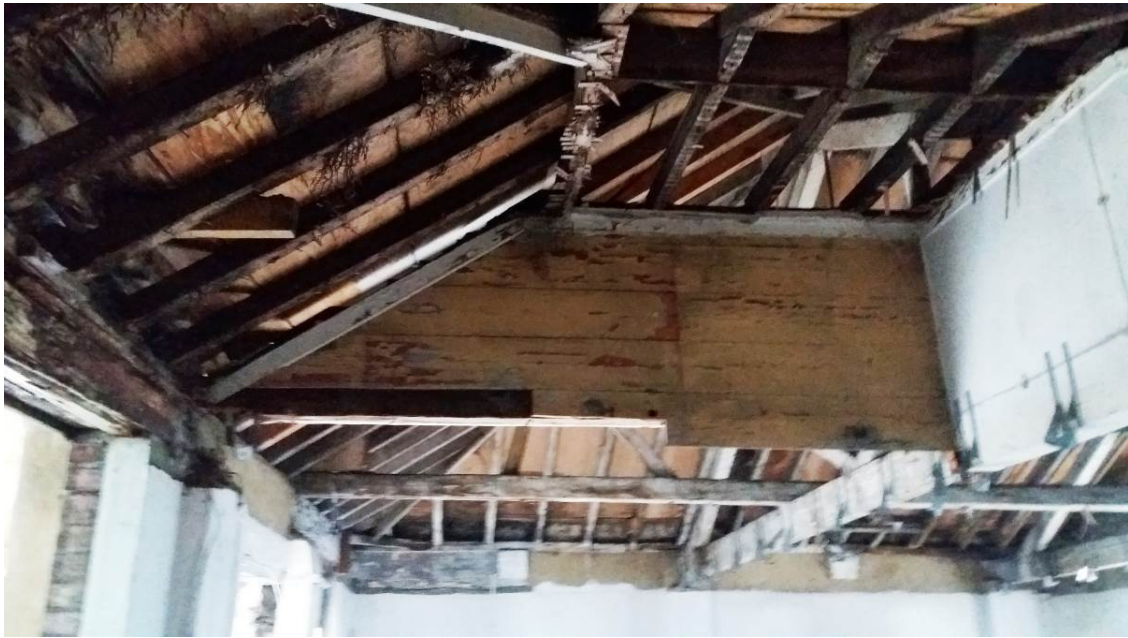
**P20 – Internal vegetation on rafters caused by water ingress and wet rot to roof boards, rafters, and supporting timber beam**

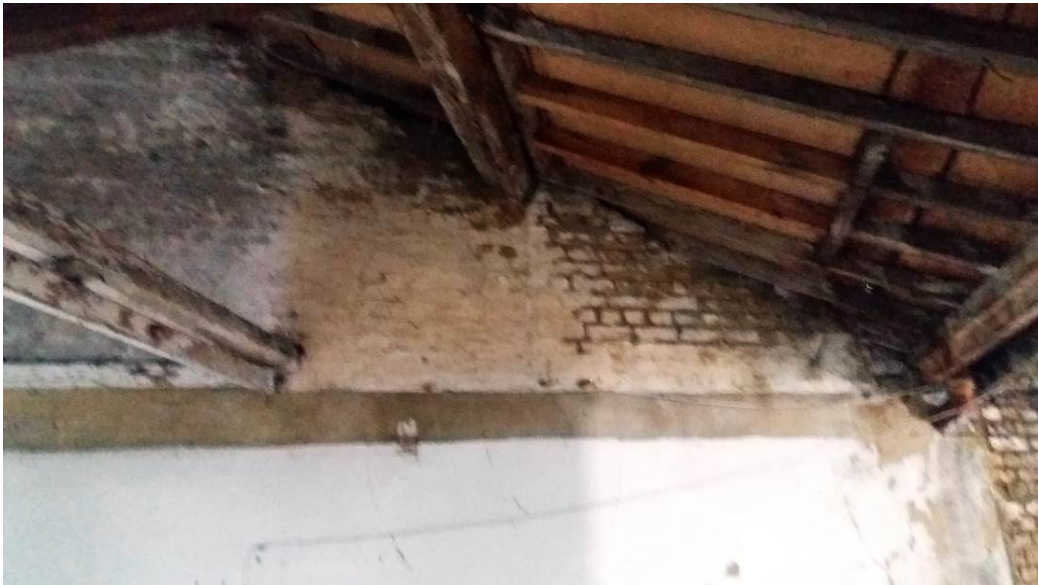
**P21 – Water ingress due to failed waterproofing detail impacting masonry walls**

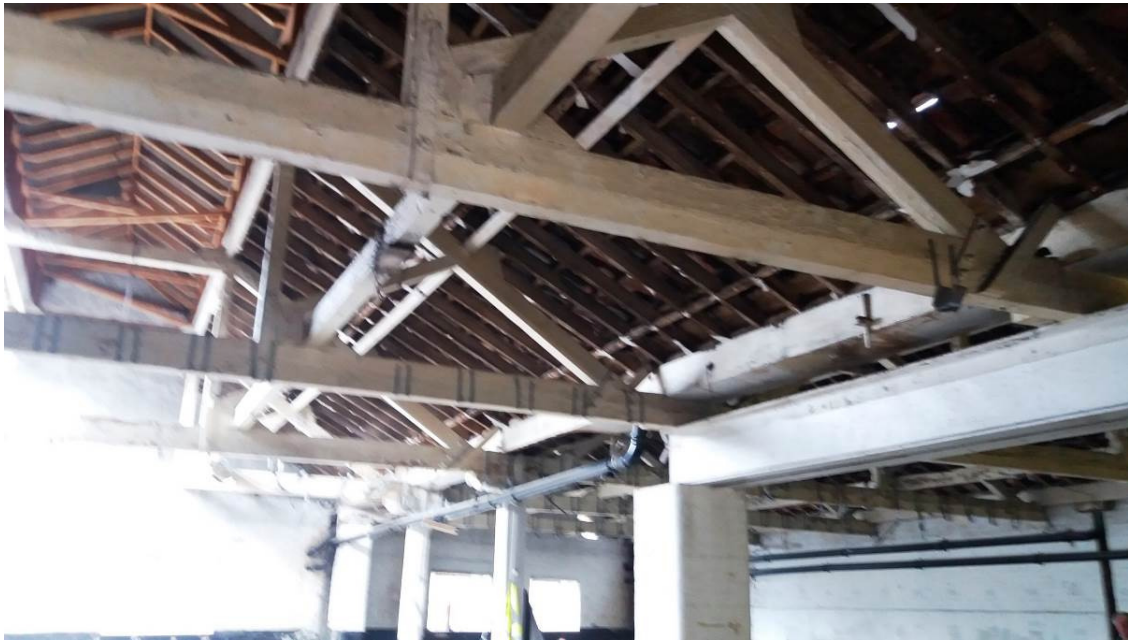
**P22 – Existing roof structure supported on steel beam**

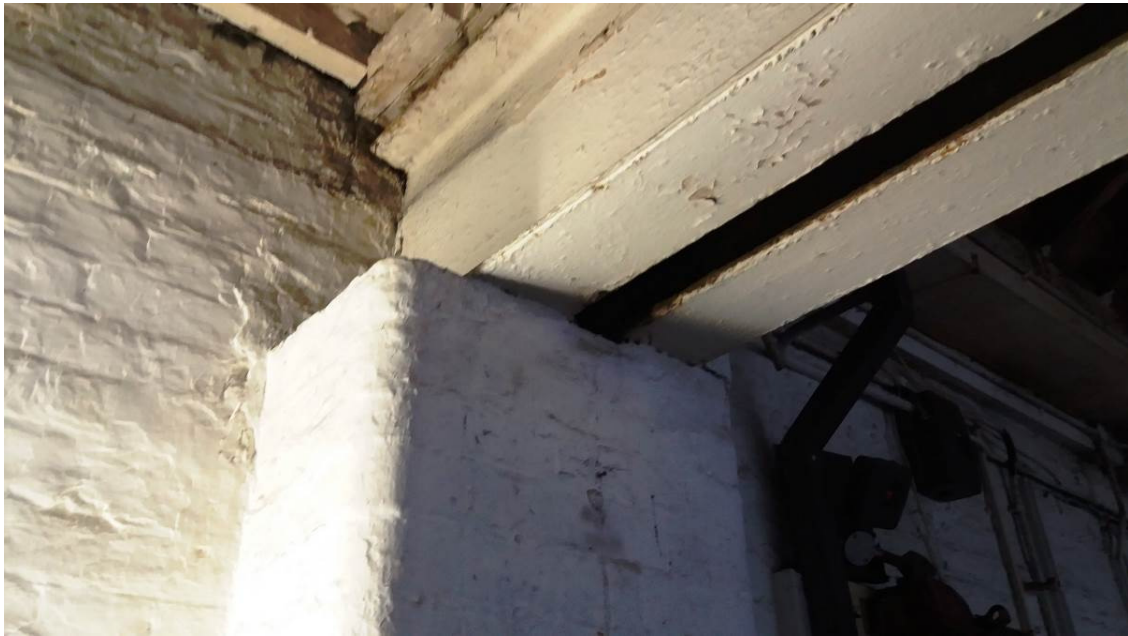
**P24 – Corrosion and flaking paintwork to supporting steel beam**

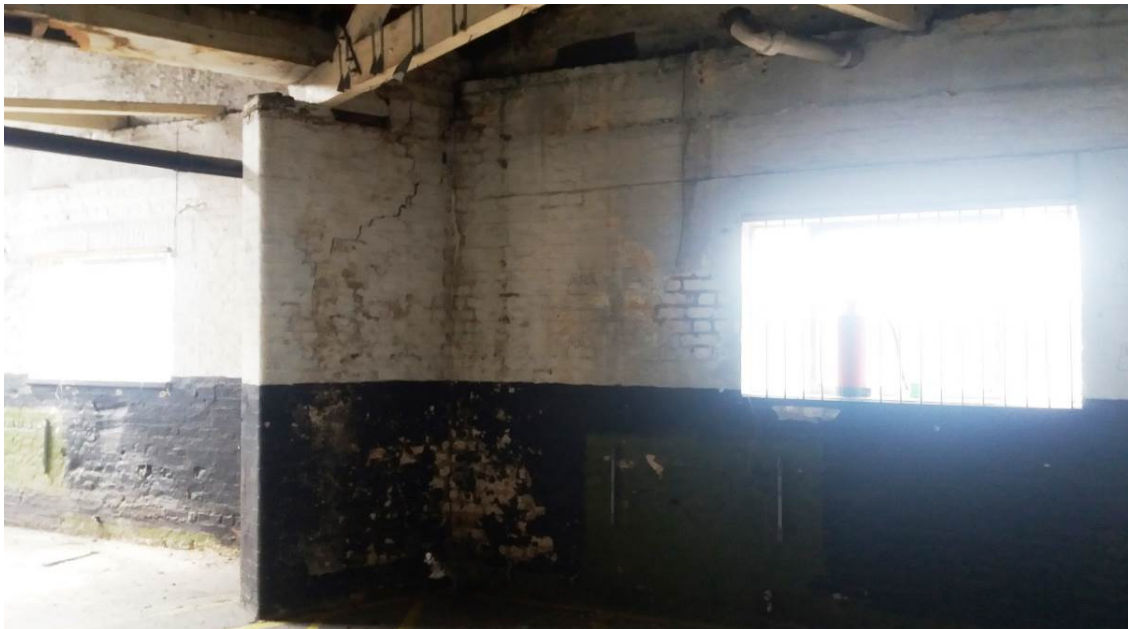
**P25 – Inadequate bearing of existing roof truss.**

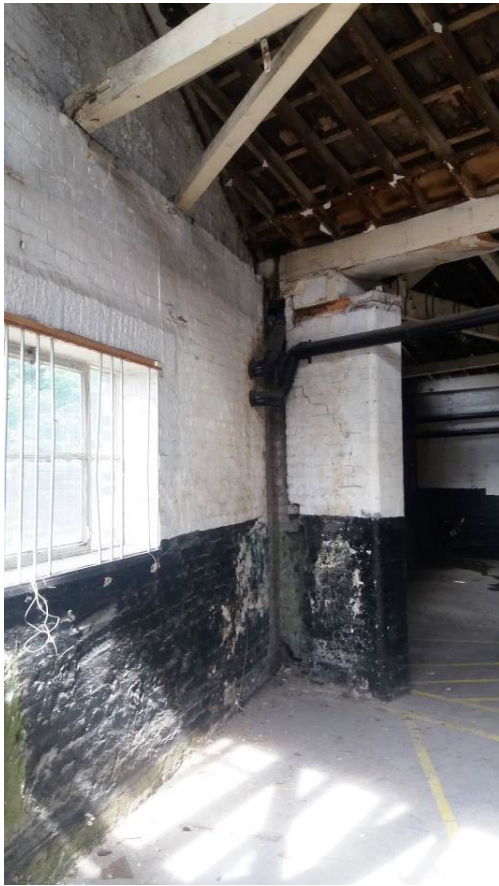
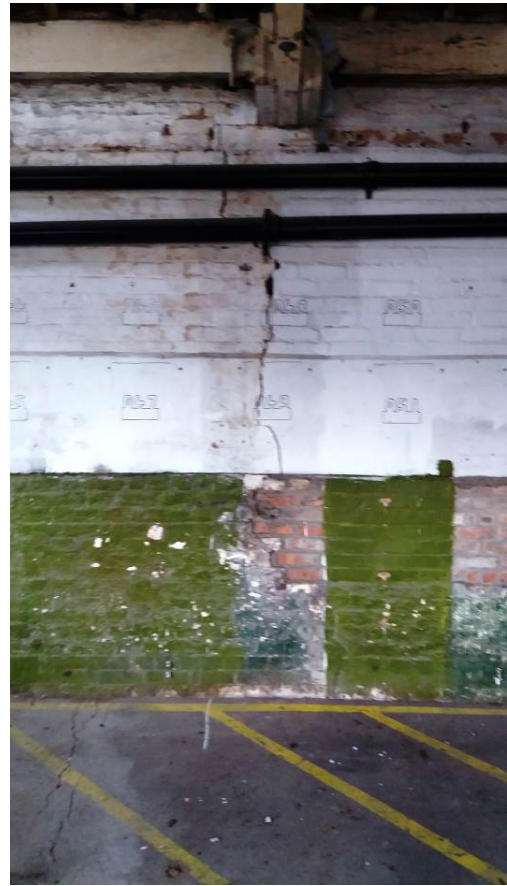
**P26 & P27 – Inadequate restraint to existing masonry walls**

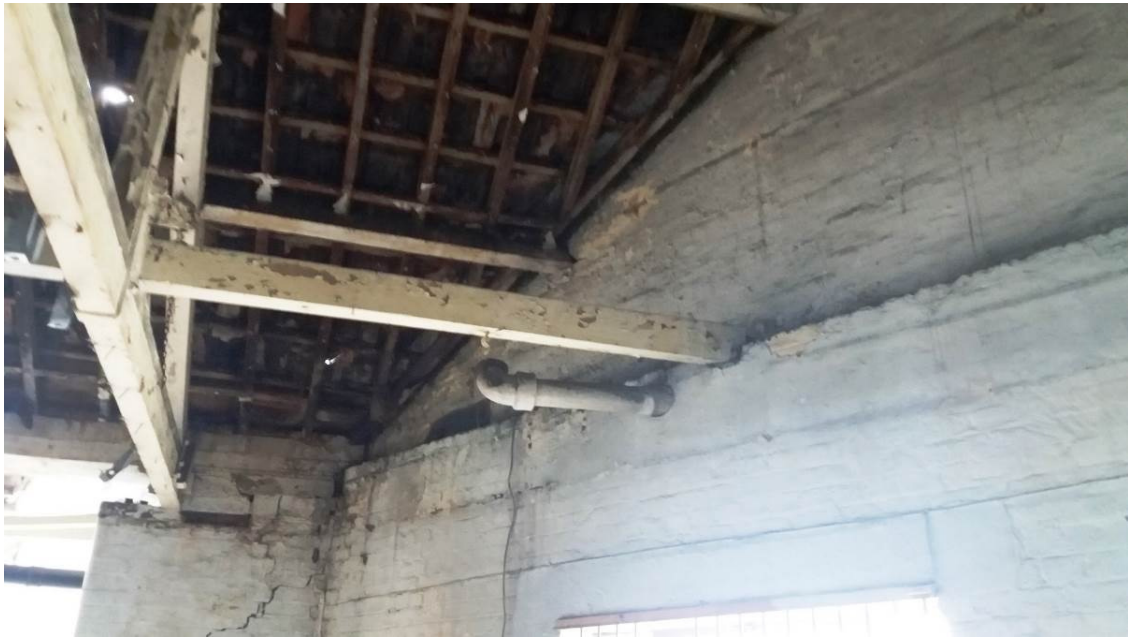
**P28 – Inadequate restraint to existing masonry walls**

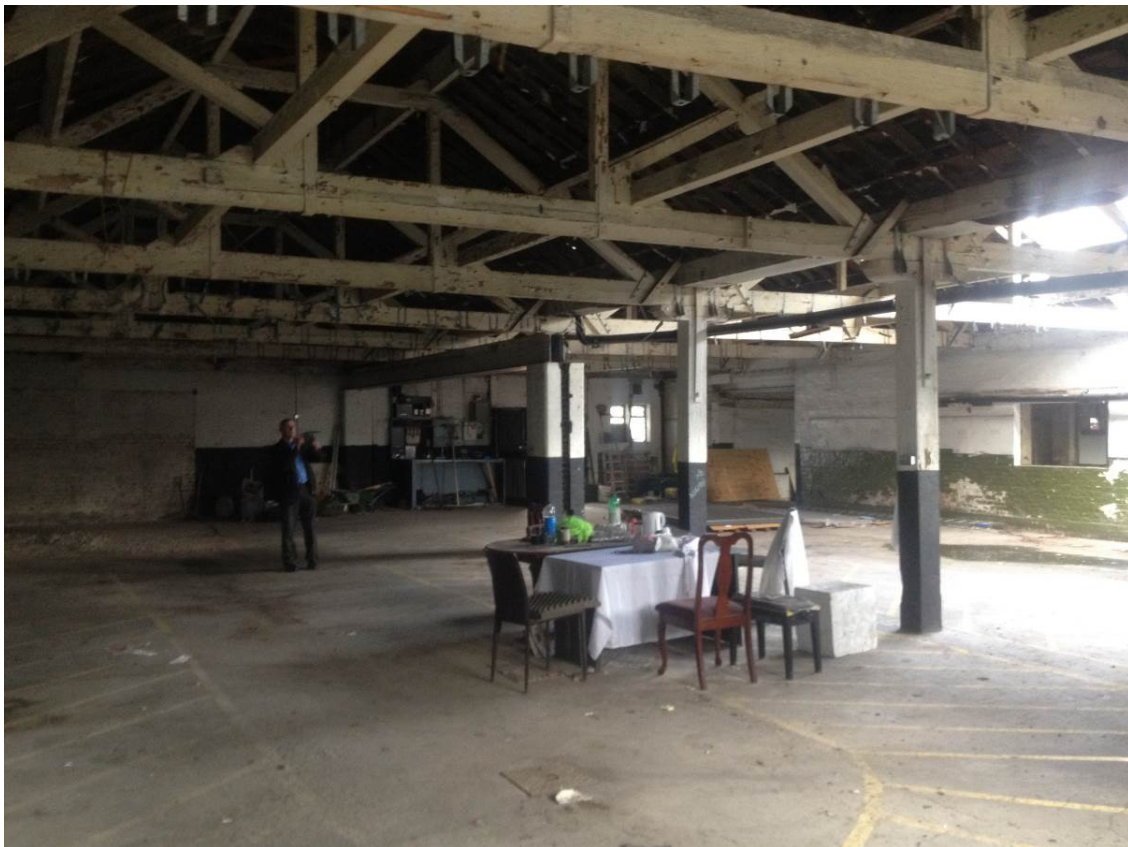
**P29 – Internal view of warehouse roof**

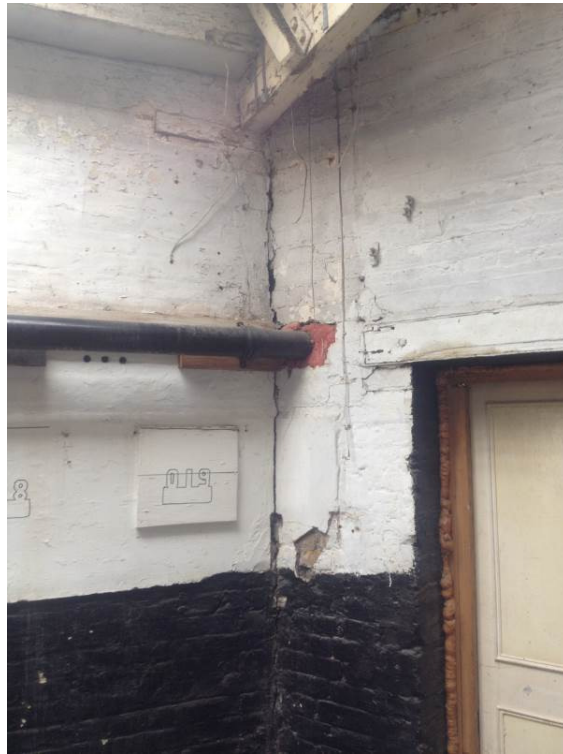
**P30 – Inadequate bearing of existing roof truss.**

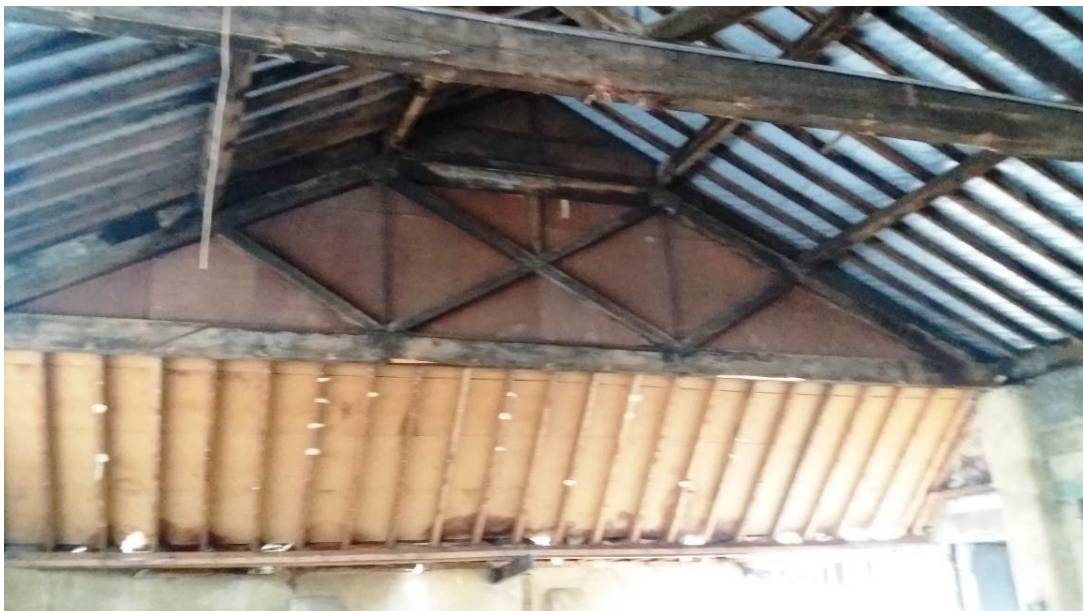
**P31 – Internal view of garage roof. No roof bracing present.**
