SITE	TITLE	REPORT NO.	DRAWING NO.	DATE
Greenwood Centre,	Exploratory Hole Location Plan	1655,GI	002 / Rev 0	June 2016
Greenwood Place, Camden,	CLIENT	DRAWN BY	CHECKED	SCALE
London, NW5 1LB	Kier Construction	LF	SG	Not to scale

APPENDIX 9 – PHOTOGRAPHS

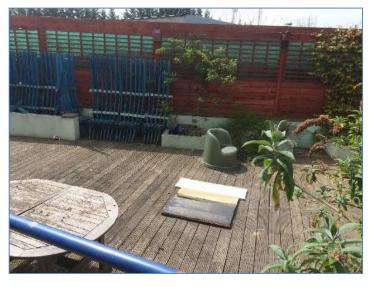
Photograph 2

Garden area within the south of the site, location of CBR4 and WS102

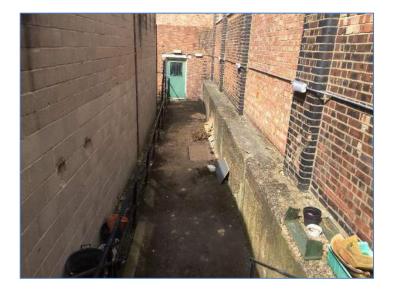
Photograph 4

Back passageway leading from the garden area toward the basement. FIP4 located toward the centre of the photo

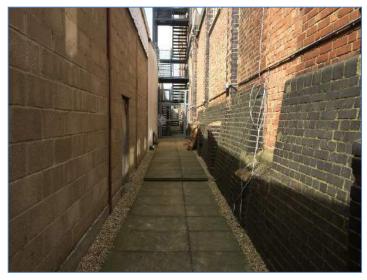
Photograph 5

Back passageway leading toward Deane House. FIP2 located closed to metal gate

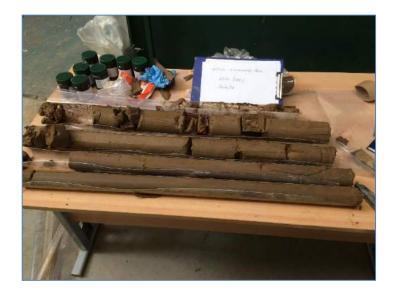
Photograph 7

Ground conditions encountered within WS101 (position CBR1)

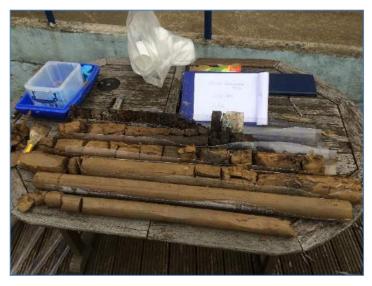
Photograph 8

Ground conditions encountered within WS102

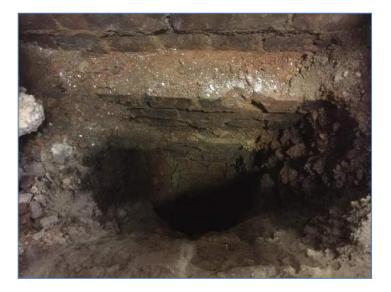
Photograph 10

Ground conditions within FIP1, continued backfill of material encountered
