Drainage Investigation Report

For Subsidence Management Services

Risk Address: 96 Haverstock Hill, Lower Belsize Park, London, NW3 2BD

Visit Date: 05/04/2016

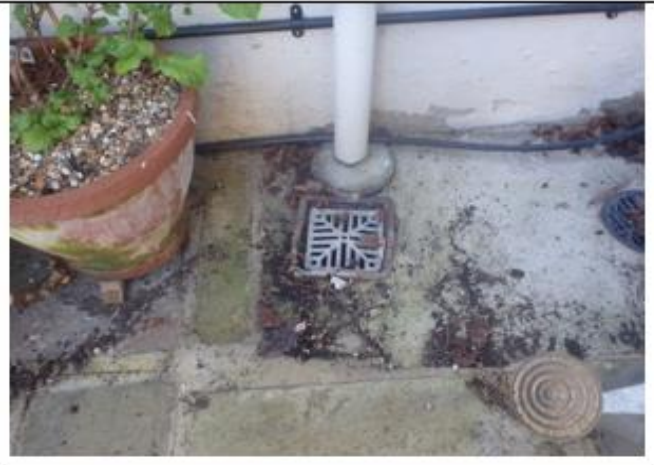
2. RWG2.

1.10	DES	Settled Deposits (fine) 20%				
1.10	SA	Survey Abandoned - Unable to push past blockages				
NOTE: This line looks to be redundant beyond junctin to RUN D						
RUN D	Start From :	RUN C	Finish at :	RWG2	Pipe Ø:	100mm
	Invert Level (m):	0.5	Invert Level (m):	N/A	Material:	Clay
COMBINED	Condition grade:	C	Direction:	Upstream	Responsibility:	Home Owner
<i>Distance</i>	<i>Code</i>	<i>Remarks</i>

0.00	SN	Start Node from RUN C				
0.10	JN	Junction at 3 o'clock from RUN E (FWG1)				
0.40	OJL	Open Joint (large)				
0.60	FN	Finish Node at RWG2				
Hydraulic Pressure Test		From	To	Result	Comments	
		RWG2	0.5	FAIL

2. To excavate and replace existing gully including 1m of adjacent pipe work to the junction to RUN E as this falls within close proximity of the gully.

Repair Item	Description	Unit	Rate (£)	Quantity	Amount (£)
UK0010	Remove existing UPVC pipework in isolated lengths, refix with new 69mm UPVC pipework (incl. brackets).	nr	£14.25	1.00	£14.25
UK0015	Extra over for bends.	nr	£8.31	1.00	£8.31
UK0595	Gully, 225mm x 225mm. Remove existing and replace with new PVCu item. Bed, surround and backfill .	nr	£146.43	1.00	£146.43
UK0605	Excavate & remove isolated length. Replace in new 110mm PVCu. Bed, surround & backfill. n.e. 1000mm deep.	nr	£131.47	1.00	£131.47
UK0880	Short Radius Bend. Remove existing item and replace with new 110mm PVCu.	nr	£14.89	2.00	£29.78
UK1060	Extra over pipework for surrounding drain run in 100mm thick concrete.	m	£14.40	1.00	£14.40
UK0025	Protection Temporary works to floors, 1000 gauge polythene.	m2	£1.79	2.00	£3.59
UK8120300	Hardcore Filling to excavations over 250 mm average thick.	m	£35.35	1.00	£35.35
UK2050005	Disposal by hand excavated contaminated/saturated material off site.	m3	£45.30	1.00	£45.30

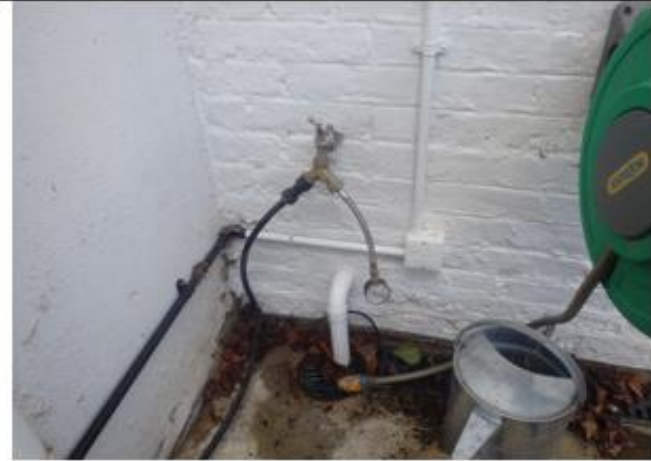
3. FWG1/Mains water pressure test.

0.00	SN	Start Node from RUN D				
0.50	WL	Water Level 10%				
0.90	LR	Line of drain deviates right 90°				
0.90	FN	Finish Node at FWG1				
Hydraulic Pressure Test		From	To	Result	Comments	
		FWG1	0.5	PASS		
RUN F	Start From :	CMH1	Finish at :	ACO Outlet	Pipe Ø:	100mm
	Invert Level (m):	0.5	Invert Level (m):	N/A	Material:	Clay
STORM	Condition grade:	C	Direction:	Upstream	Responsibility:	Home Owner
<i>Distance</i>	<i>Code</i>	<i>Remarks</i>

Water Main Test	From	To	Result	Notes
	ESV	Outside Tap	PASS	No drop in 20 minutes from 3.1 bar

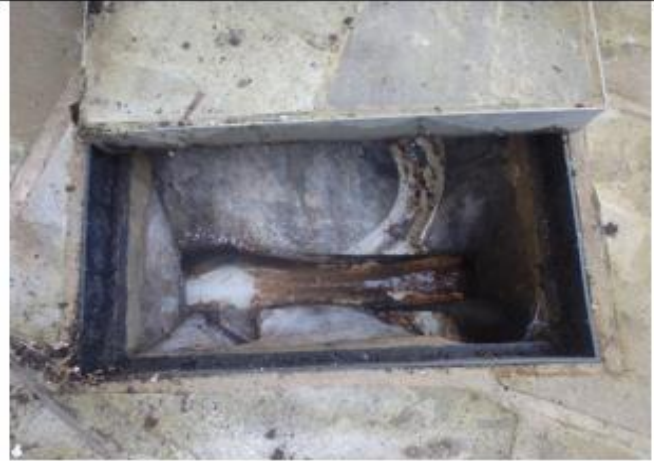
4. CMH1.

A visual inspection of the manholes revealed them to be in good condition.

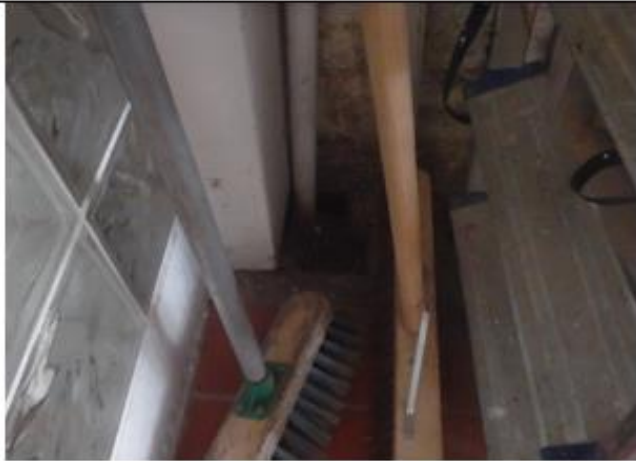
9. FWG2.

0.00	SN	Start Node from CMH2				
2.10	MC	Material of drain changes at this point to clay				
2.50	FN	Finish Node at FWG2				
Hydraulic Pressure Test		From	To	Result	Comments	
		CMH2	FWG2	PASS		
RUN L	Start From :	CMH2	Finish at :	CMH3	Pipe Ø:	100mm
	Invert Level (m):	0.86	Invert Level (m):	1.2	Material:	Cast Iron
COMBINED	Condition grade:	A	Direction:	Downstream	Responsibility:	Home Owner
<i>Distance</i>	<i>Code</i>	<i>Remarks</i>

Drain Run K: CMH2 Upstream to FWG2**Pipe Diameter:** 100mm**Responsibility:** Home Owner**Hydraulic Pressure Test:** PASS**CCTV Survey Result:** No Structural Damage**Recommended Repair:** No repairs have been recommended as the drain line was found to be free from defects.

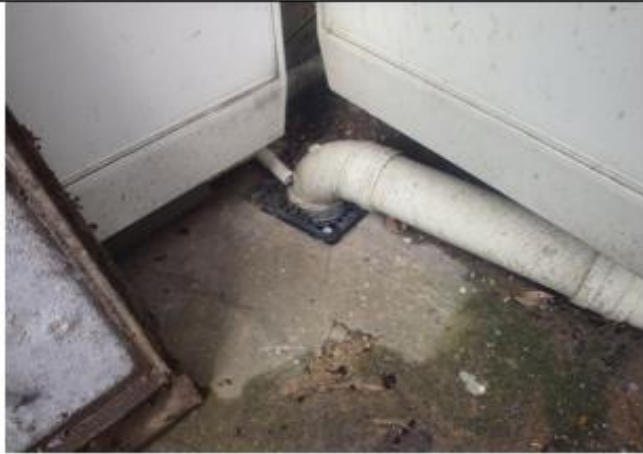
13. CWG1.

RUN N	Start From :	CMH3	Finish at :	CWG1	Pipe Ø:	100mm
	Invert Level (m):	1.2	Invert Level (m):	0.2	Material:	Liner
COMBINED	Condition grade:	A	Direction:	Upstream	Responsibility:	Home Owner
<i>Distance</i>	<i>Code</i>	<i>Remarks</i>				
0.00	SN	Start Node from CMH3				
1.00	MC	Material of drain changes at this point to clay				
1.30	LR	Line of drain deviates right 30°				
1.80	FN	Finish Node at CWG1

Hydraulic Pressure Test	From	To	Result	Comments
	CMH3	CWG1	PASS

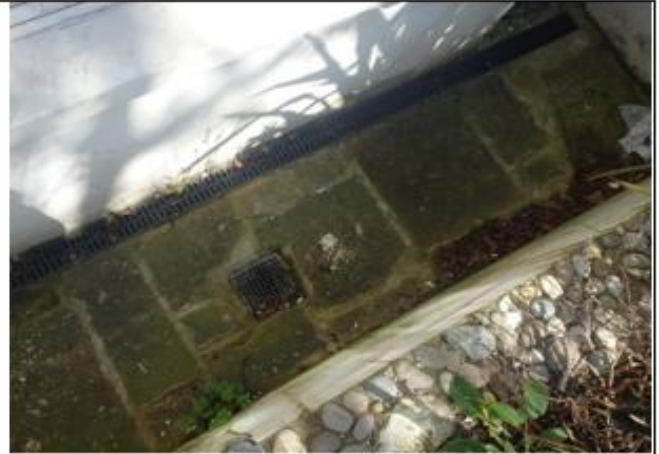
14. RWG3/Aco drain.

RUN O	Start From :	CMH3	Finish at :	RWG3	Pipe Ø:	100mm
	Invert Level (m):	1.2	Invert Level (m):	0.2	Material:	Cast Iron
STORM	Condition grade:	B	Direction:	Upstream	Responsibility:	Home Owner
<i>Distance</i>	<i>Code</i>	<i>Remarks</i>				
0.00	SN	Start Node from CMH3				
1.50	RFJ	Roots Fine at Joint 5% at 8 o'clock				
2.60	OJM	Open Joint (medium)				
5.70	RFJ	Roots Fine at Joint 5% at 8 o'clock				
6.20	MC	Material of drain changes at this point to Plastic				
6.40	FN	Finish Node at RWG2

Hydraulic Pressure Test	From	To	Result	Comments
	CMH3	RWG3	FAIL

Drain Run F: CMH1 Upstream to ACO Outlet**Pipe Diameter:** 100mm**Responsibility:** Home Owner**Hydraulic Pressure Test:** FAIL**CCTV Survey Result:** Structural Damage - Hole and crack in the pipe at 0.8m**Recommended Repair:**

3. To carry out an isolated excavation of the pipe between the ACO and the Manhole and connect to the manhole for completion.

Repair Item	Description	Unit	Rate (£)	Quantity	Amount (£)
UK0605	Excavate & remove isolated length. Replace in new 110mm PVCu. Bed, surround & backfill. n.e. 1000mm deep.	nr	£131.47	1.00	£131.47
UK1080	Cut out & replace drainage channel including reforming manhole benching.	nr	£109.00	1.00	£109.00
UK0025	Protection Temporary works to floors, 1000 gauge polythene.	m2	£1.79	2.00	£3.59
UK8120300	Hardcore Filling to excavations over 250 mm average thick.	m	£35.35	1.00	£35.35
UK1045	Removal, set aside and reinstatement of concrete slab paving n.e 100mm thick.	m2	£24.61	1.00	£24.61
Total (Excl VAT)					£304.01

Repair Item	Description	Unit	Rate (£)	Quantity	Amount (£)
UK0595	Gully, 225mm x 225mm. Remove existing and replace with new PVCu item. Bed, surround and backfill .	nr	£146.43	1.00	£146.43
UK0605	Excavate & remove isolated length. Replace in new 110mm PVCu. Bed, surround & backfill. n.e. 1000mm deep.	nr	£131.47	1.00	£131.47
UK0880	Short Radius Bend. Remove existing item and replace with new 110mm PVCu.	nr	£14.89	2.00	£29.78
UK1060	Extra over pipework for surrounding drain run in 100mm thick concrete.	m	£14.40	1.00	£14.40
UK0025	Protection Temporary works to floors, 1000 gauge polythene.	m2	£1.79	2.00	£3.59
UK8120300	Hardcore Filling to excavations over 250 mm average thick.	m	£35.35	1.00	£35.35
UK2050005	Disposal by hand excavated contaminated/saturated material off site.	m3	£45.30	1.00	£45.30
UK1045	Removal, set aside and reinstatement of concrete slab paving n.e 100mm thick.	m2	£24.61	1.00	£24.61

UK1135	Drain Lining - Initial Set-Up Fee (0-3.0m)	nr	£332.64	1.00	£332.64
UK1140	Drain Lining - 100mm. Install Structural liner into existing 100mm underground drain. 3mm Wall thickness.	m	£55.52	2.00	£111.03
Total (Excl VAT)					£874.61
