# Engineer's Report

Our Reference **IFS-AVI-SUB-14-0052426**  
Claim Reference **14C600459**  
Prepared for **Aviva**

Report Date **15 August 2014**  
Policyholder **Hill Limited**  
Address **96 Haverstock Hill, London, NW3 2BD**

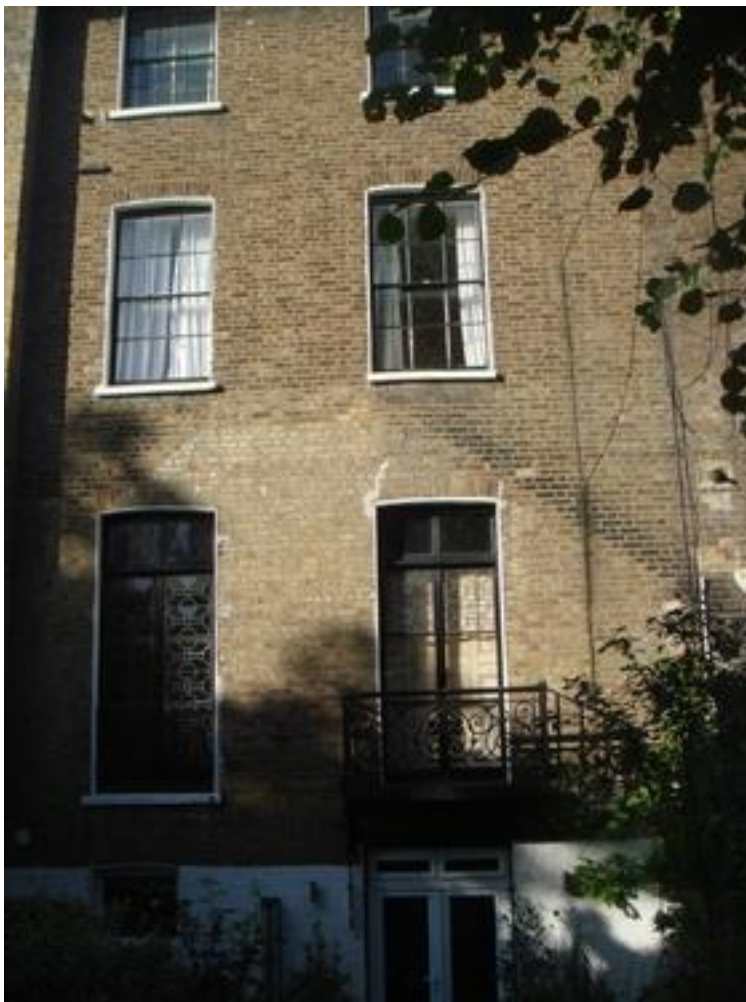
FIGURE 03 Rear Elevation.

No crack damage was recorded.

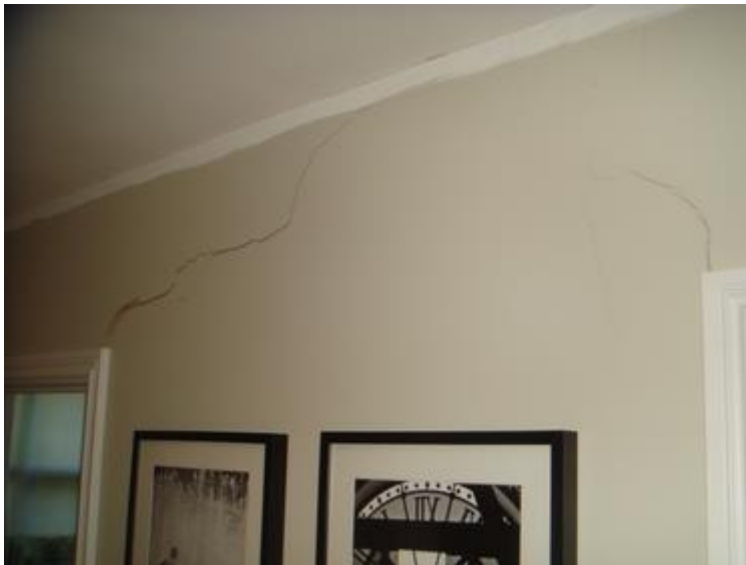
Diagonal tapering cracks in the region of 10 - 15 mm in width were recorded to the right side and rear walls of the bedroom around the ensuite and hallway doors. A further vertical tapering crack in the region of 1 - 2 mm in width was recorded to the front right of the room underside of the window.

FIGURE 04 Crack damage to the garden flat front left bedroom.

Generally cracks 1mm wide or less will be filled (internal) or re-pointed (external). Internally, where the cracks are wider than 1mm, but less than 5mm the underlying brickwork or block work will be exposed and prior to making good the plaster finishes the cracking will be covered with expanded metal lath. Where cracks are 5mm across or wider, some form of bed joint reinforcement will be introduced.

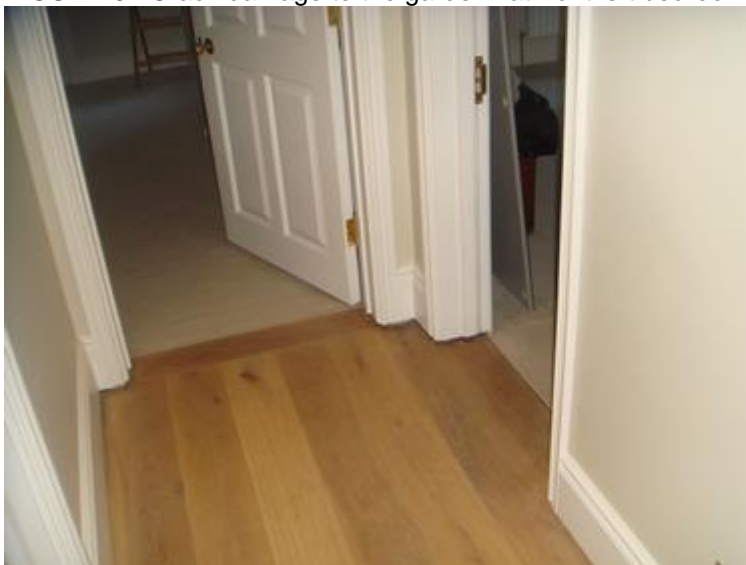
The hallway timber flooring was recorded with downwards movement of approximately 25 - 30 mm resulting in a gap with the skirting. Diagonal tapering cracks in the region of 2 - 3 mm in width were recorded to the left side wall of the hallway to above both the bedroom and bathroom doors.

FIGURE 05 Garden flat hallway floor movement.

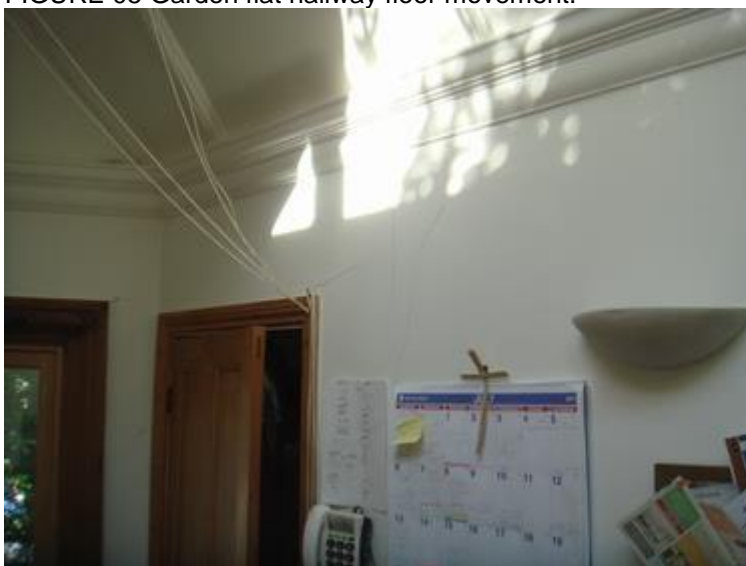
A number of both horizontal and diagonal cracks in the region of 1 - 3 mm in width were recorded to the front left of the kitchen to above the hallway and lounge doors.

FIGURE 06 Ground floor flat crack damage recorded to the front right kitchen.
