## **Subsidence Claim Addendum Report**

Our Reference: IFS-AVI-SUB-14-0052426

Claim address: Haverstock Hill, London, NW3 2BD

This report has been prepared to support an application to remove statutory protection on implicated vegetation and removal of the same in order to stabilise the garden flat.

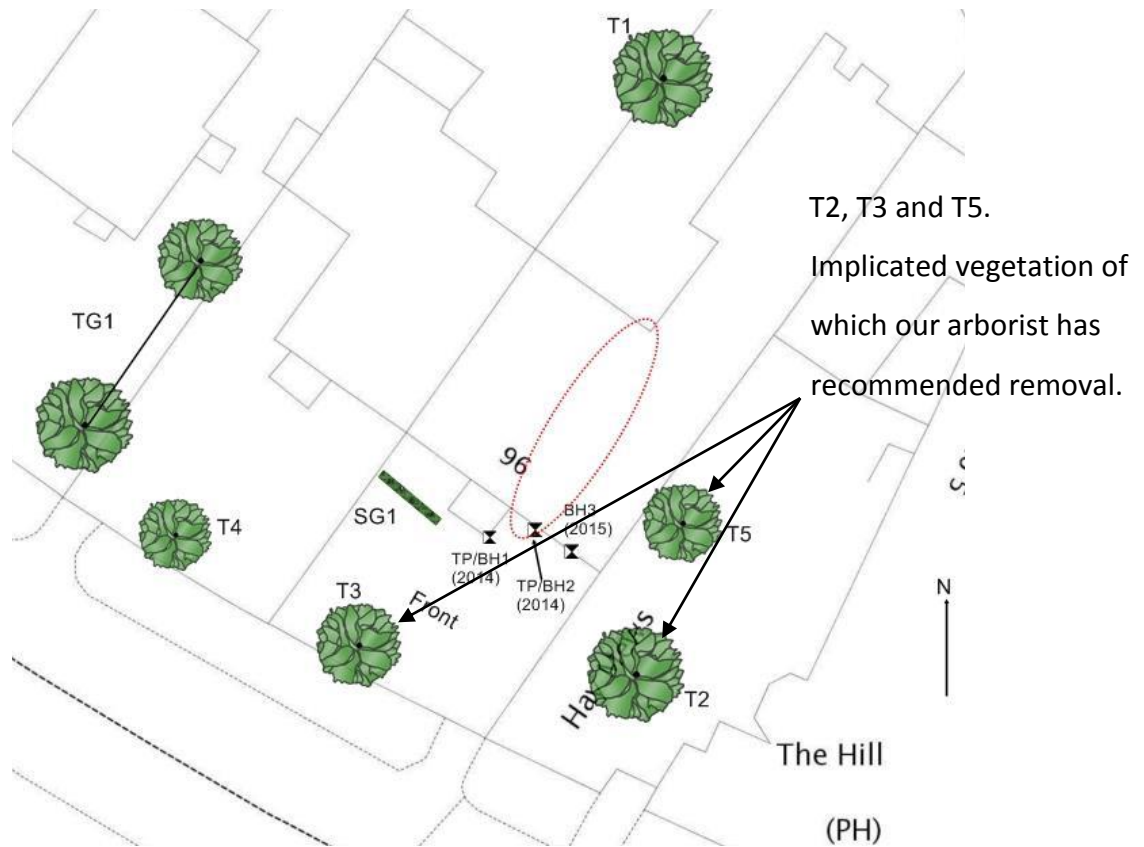
Figure 1 – site plan showing the location of the principal vegetation in relation to the property

The arboricultural consultant has advised that they have implicated T2 (Acer), T3 (Elm) and T5 (Pear), also based on their assessment, the footings of the subject property fall within the anticipated rooting zone of this vegetation.

The implicated vegetation is therefore deemed to retain the capacity to be causal to the current movement and building damage. In assessing the potential drying influence of the vegetation on site, T2 (Acer) and T3 (Elm) are considered the dominant features and accordingly the arboriculturist has identified them as the principal cause of subsidence.

T5 (Pear) cannot be discounted as contributing to the overall level of soil drying proximate to the area of damage and is therefore also considered to retain a contributory influence, albeit in a limited or secondary capacity .

The arboricultural consultant has recommended the removal of T2 (Acer), T3 (Elm) and T5 (Pear).
