LEVEL MONITORING

for Subsidence Management Services

96 Haverstock Hill, Lower Belsize Park, London, NW3 2BD

Client:	Subsidence Management Services
Client Contact:	Raymond Borrow
Claim Number:	14C600459
Client Reference:	IFS-AVI-SUB-14-0052426
Policy Holder:	Haverstock Hill Limited
Report Date:	4 October 2016
Our Ref:	M3868

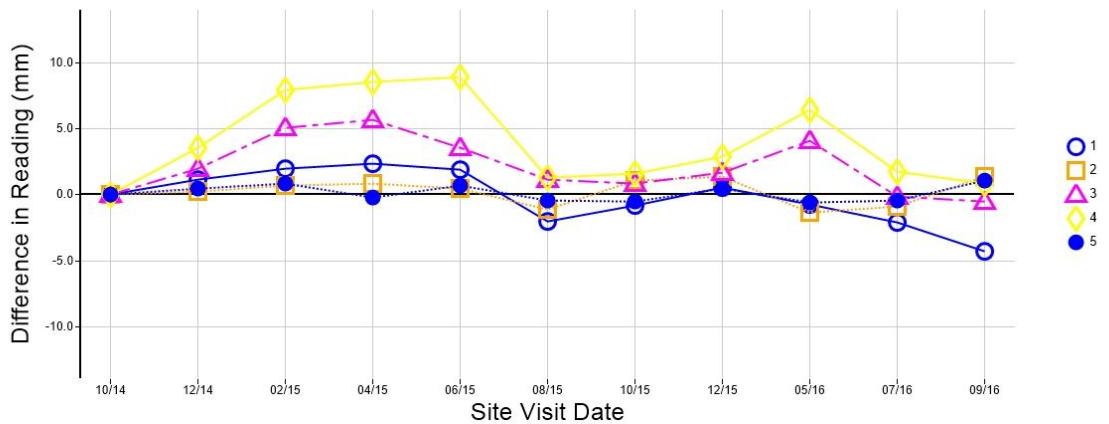
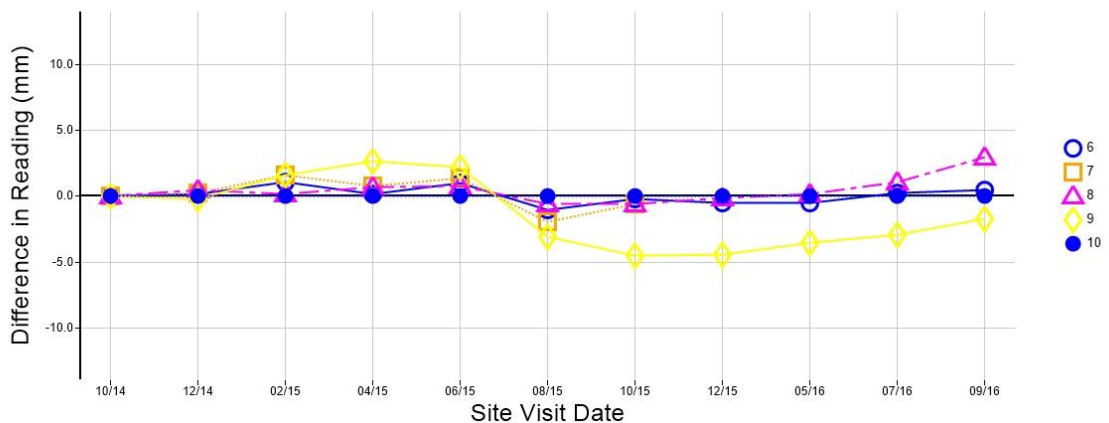
Level Monitoring Difference Graphs

The following graphs display the progressive movement that each Level Monitoring Station recorded at each separate site visit date to give an overall look at how much the property is moving.

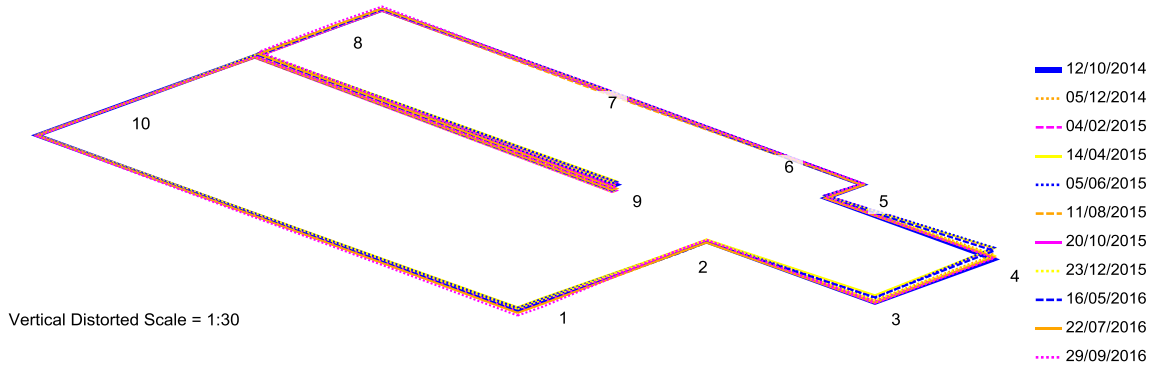
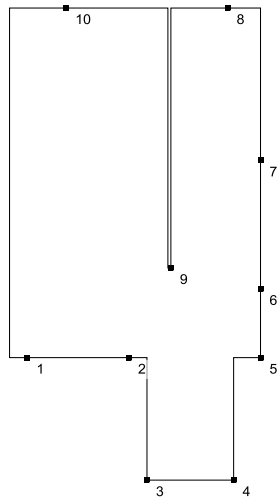
Level Monitoring Displacement Map

The following image shows an isometric representation of the movement of the property, based on the Level Monitoring Stations that were installed.
