Arboricultural Consultancy for Aviva

1. Case Details

Insured	Haverstock Hill Limited	Address	96 Haverstock Hill, London, NW3 2BD		
Client	Subsidence Management Services	Contact	Emily Bogie	Claim No.	IFS-AVI-SUB-14-0052426
ES Ref	NL/0110140922/TP-REV3	Consultant	Andrew Cayley Bsc (Hons) Arb, M.Arbor.A	Contact No.	0330 380 1036
Report Date	02/10/2015 Revised: 16/10/2015, 08/06/2016 & 24/10/2016

5. Technical Synopsis (Revised)

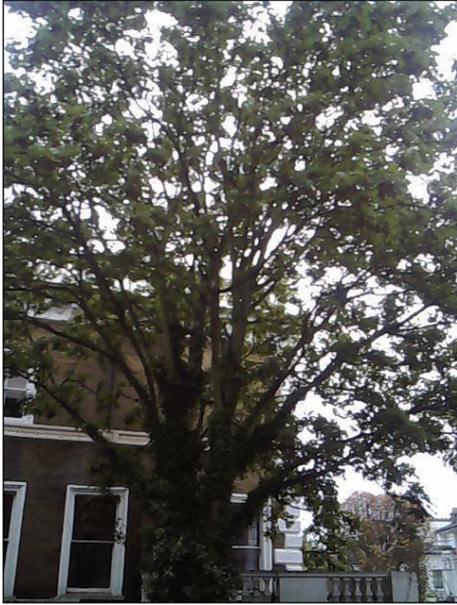
T2 - Acer

Our survey of the site identified T2 (Acer) and T3 (Elm), which, given their position relative to the damage it is our opinion that the roots identified emanate from these trees; there is no alternative, plausible source of the functionally active *Acer spp* and *Ulmus spp* roots other than T2 (Acer) and T3 (Elm).

In assessing the extent of damage and the potential drying influence of the vegetation on site, T2 (Acer) and T3 (Elm) are deemed to be the dominant features and accordingly we have identified them as the principal cause of the subsidence.

T2 (Acer) and T3 (Elm) are the only plausible source of these roots, whilst Level Monitoring has demonstrated a clear 'seasonal' pattern of movement which is consistent with the known influence of vegetation.

Tree No.	Species	Age Cat	Approx. Height (m)	Distance to Building (m)	Ownership	Action	Requirement
T2	Acer	1	17	8	F - Commercial Third Party	Remove	Remove and treat stump to inhibit regrowth.
T3	Elm	1	15	10.5 (to front elevation; 5.5m to front steps)	C - Insured	Remove	Remove and treat stump to inhibit regrowth.

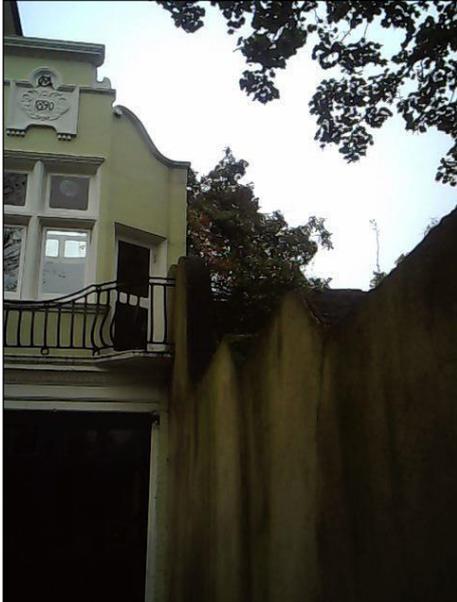
T5 - Pear

Please note: given its size and proximity to the insured property, T5 (Pear) was also considered to be causal (albeit in a limited / secondary capacity) and as such, this tree was removed.

Tree No.	Species	Age Cat	Approx. Height (m)	Distance to Building (m)	Ownership	Action	Requirement
SG1	Mixed species group including Cordyline and Fern.	1	1	1	C - Insured	Action to avoid future risk	Do not allow to exceed current dimensions by way of regular pruning.
T1	Lime	1	16	10	A - Third Party 98 Haverstock Hill London NW3 2BD	Action to avoid future risk	Crown reduce by 3m - 4m all around and maintain at reduced dimensions by way of regular re-pruning (3-years max).
T4	Lime	1	11.5	16	A - Third Party 98 Haverstock Hill London NW3 2BD	Action to avoid future risk	Do not allow to exceed current dimensions by way of regular pruning.
T5	Pear	1	9	1	F - Commercial Third Party	No Action	No Works Removed by time of site visit (03/06/2016)
