## **Response to Camden Council by Innovation Property (UK) Ltd, June 2016**

96 Haverstock Hill (our reference: IFS-AVI-SUB-14-0052426)

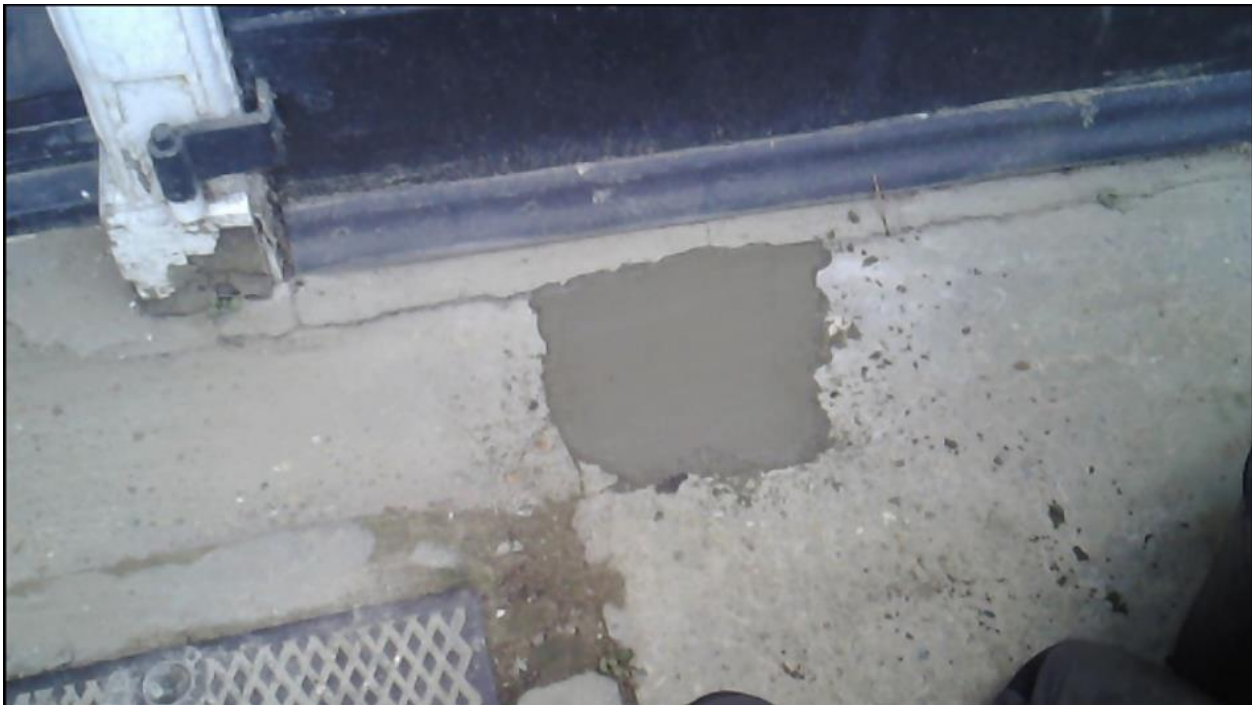
**Image 3: Showing the BH upon completion**

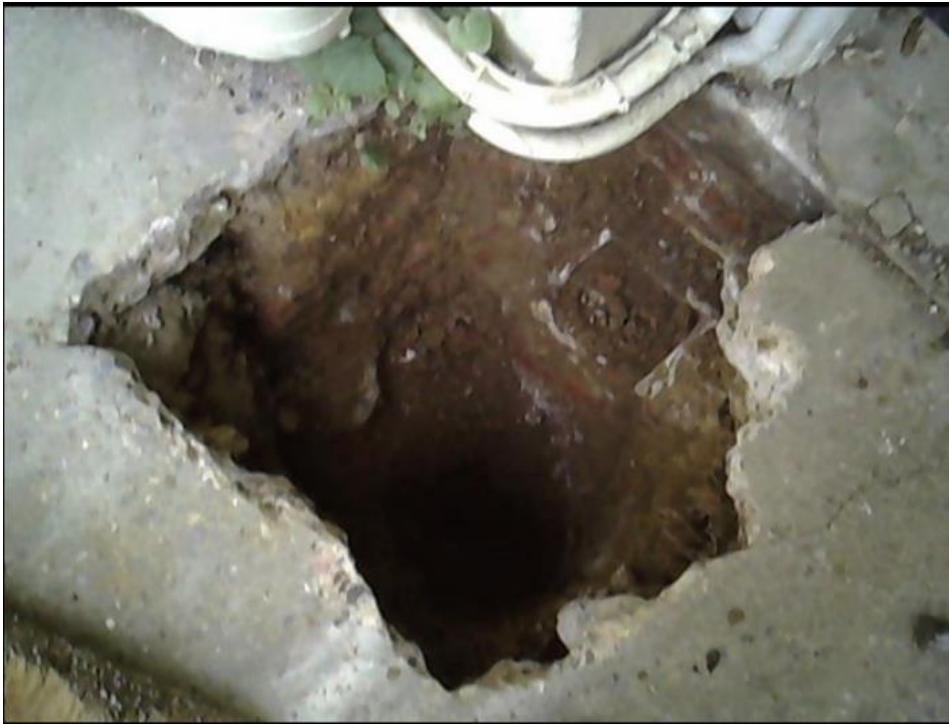
- **Site investigations on 22 October 2014 at TP/BH2 (noted in the Geotechnical Report of 3 November 2014) show functionally active roots at a depth of between 1200mm-1900mm below ground level, and below the depth of the foundations.**

**Image 4: showing TP/BH2 open prior to completion**

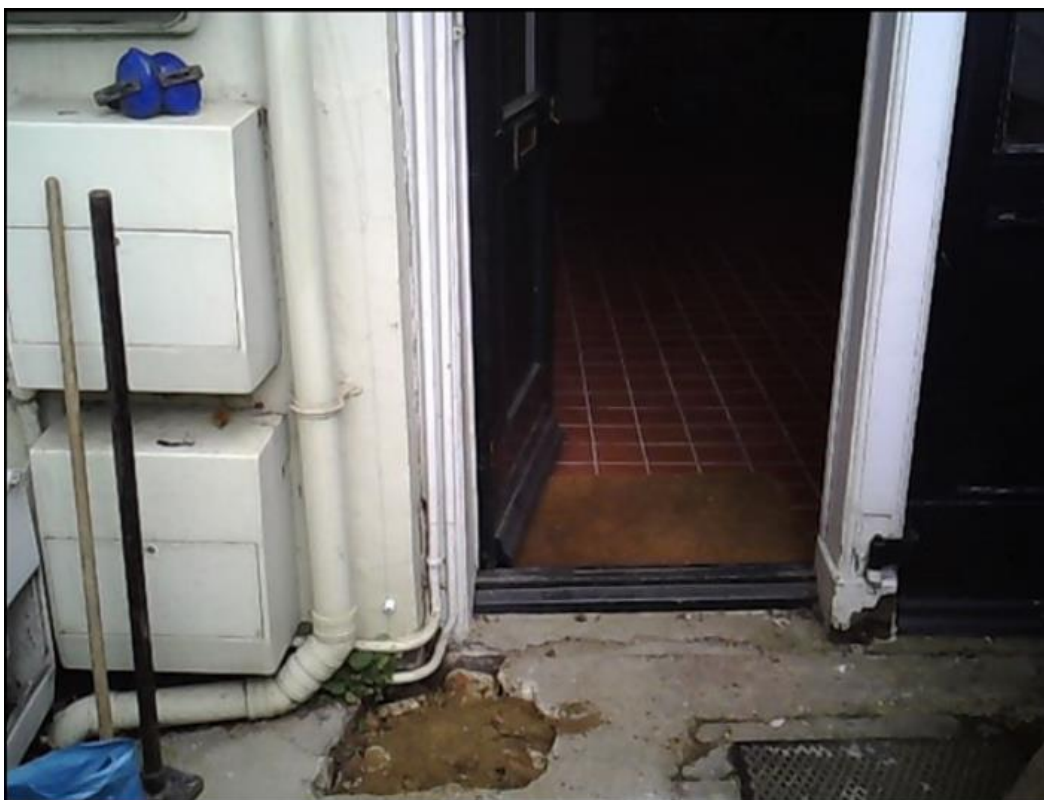
**Image 5 showing TP/BH2 once finished**

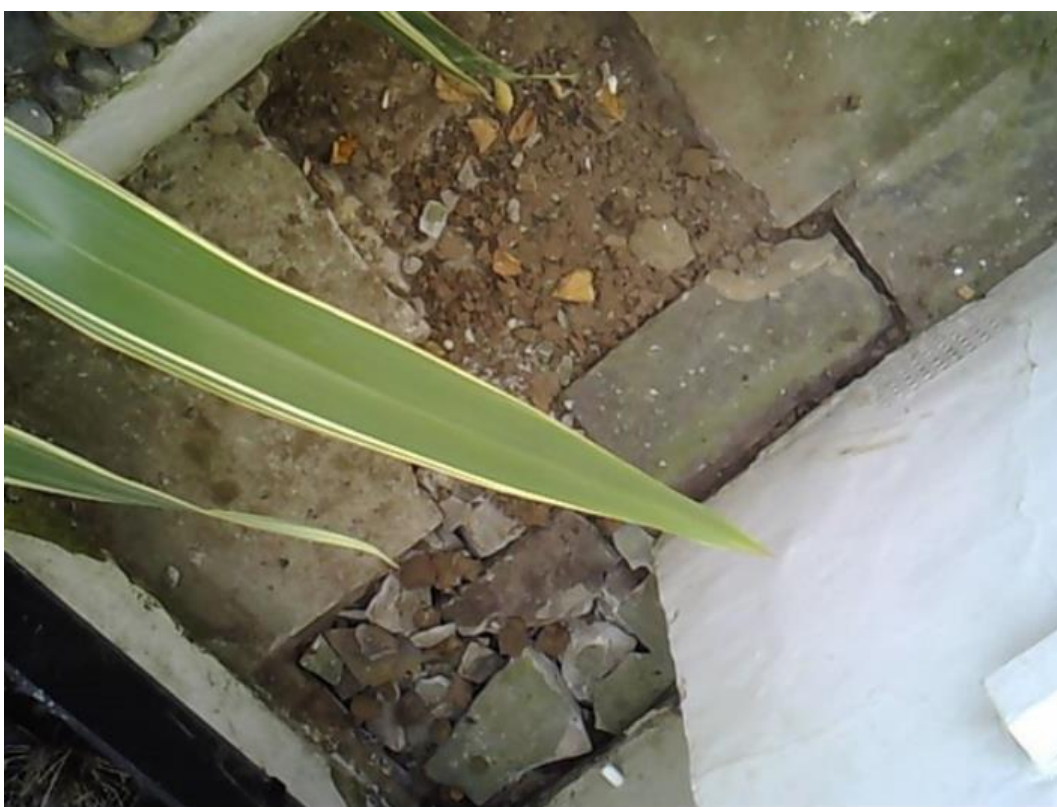
**TP/BH 1 is located to the front left side of the property and next to the bedroom bay window. A copy of the site investigation dated 03 November 2014 is attached for further information.**

**Image 6: showing the location of TP/BH1 upon completion**
