43 Cumberland Terrace London NW1 4HP

Window Existing Window Photographs

/
 OB
 270.411

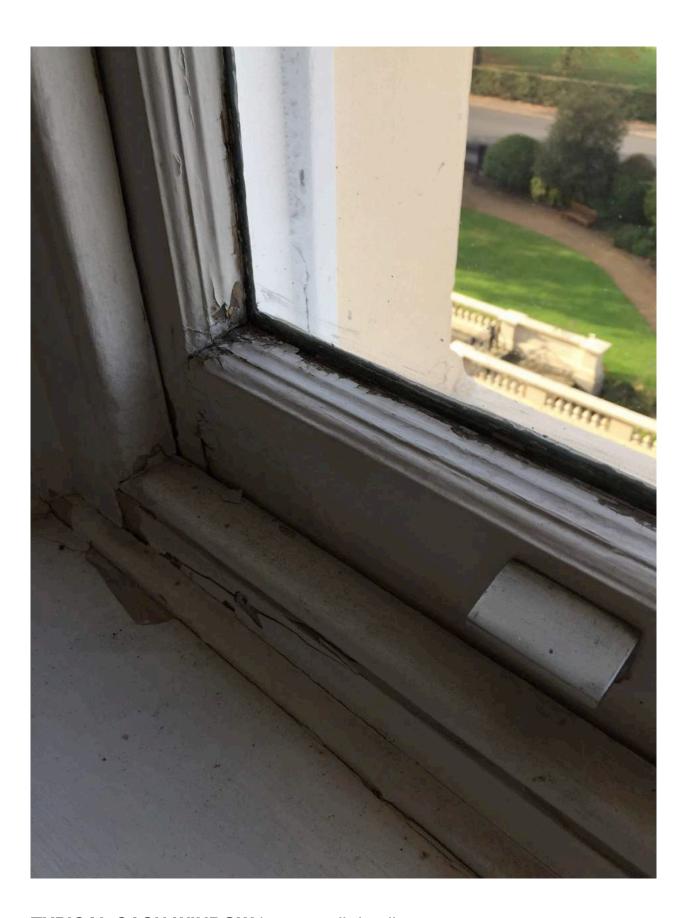
TYPICAL SASH WINDOW bottom rail detail

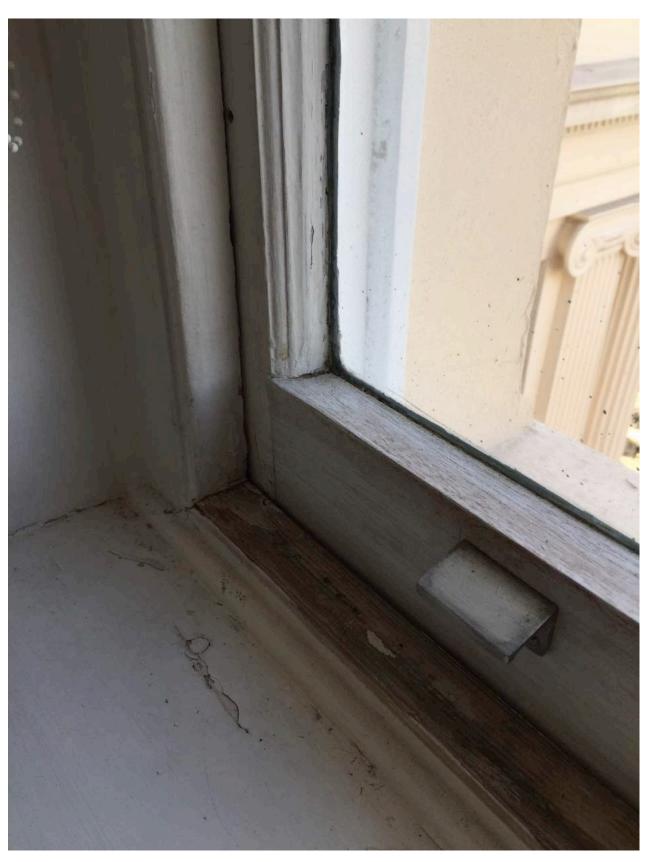
SASH WINDOW REPAIR incorrect bottom rail detail to be rectified
