# *Heritage Surveys Limited*

## Conservation Plan & Statement of Heritage Significance Report

136-180, 181-203, 204 - 238 Levita  
House and 62 – 76 Chalton Street  
Ossulston Estate  
Chalton Street  
London  
NW1 1JJ

Report date: October 2016

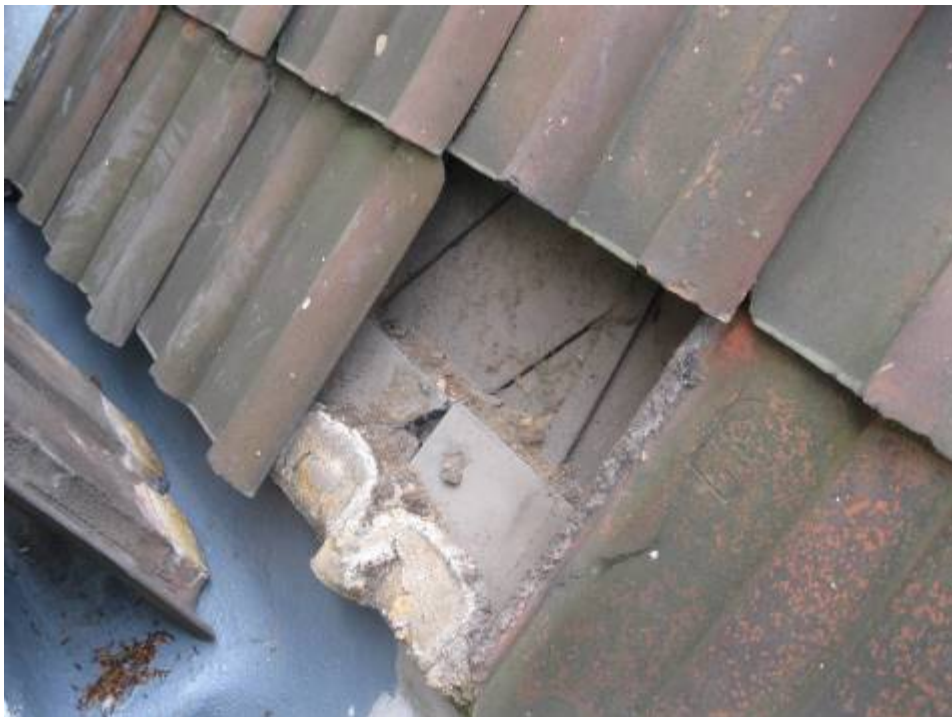
**Photograph 10**      **Tile removed, no sarking felt**

Based on a visual non-intrusive inspection, the roof structure appears to be in reasonable condition with no major deflection evident. Existing tiles are most probably original with some exceptions (see below) and are English Bridgewater pantiles (see photo). A large number of tiles are cracked, some of which will be mechanical damage, with some evidence of weathering. There is no sarking felt under the tiling. The property is prone to leaks, particularly in wind driven rain or in the event that tiles are damaged. (Photos 10 to 15). Evidence of water penetration is visible in the roof voids and former drying rooms, where lath and plaster ceilings have partially collapsed.

The proposal is to strip all of the pitched roof coverings and replace with new Sandtoft Bridgewater matching profile tiles (please refer to Appendix 2).

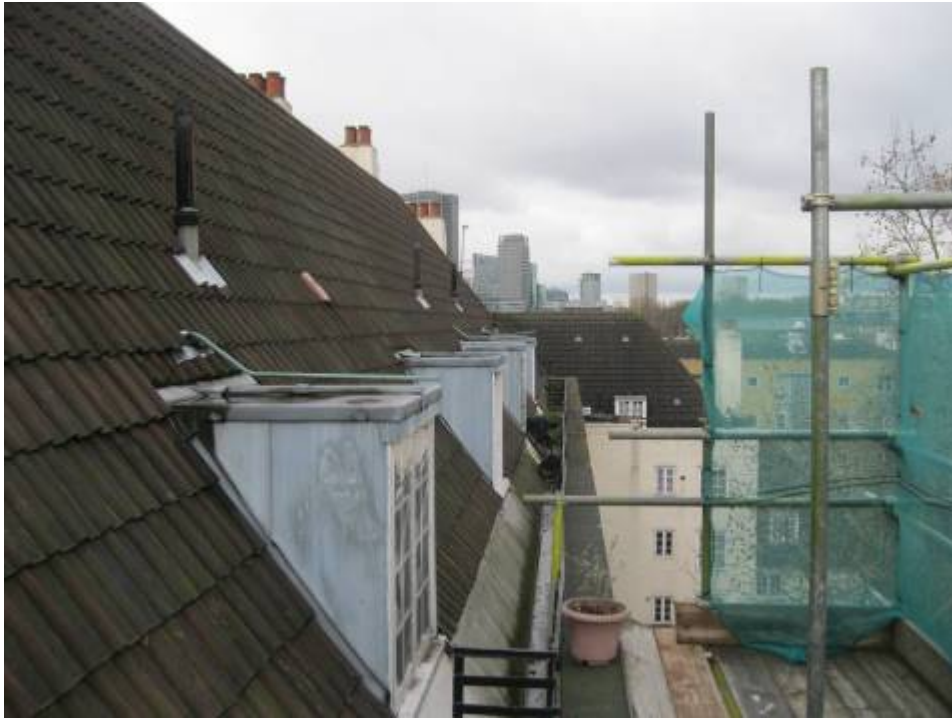
**Photograph 15 Parapet gutter and dormers 204 - 238**

These are lined with asphalt and are in a poor state of repair. (Photos 15, 16, 17 and 19). It is proposed to repair and insulate these and coat them with a liquid membrane solution, replacing lead flashings and taking the opportunity to increase the depth of the gutter to prevent potential overflowing damaging the fabric and internal finishes. This proposal will not have any external visual impact on the elevations as the works will be entirely concealed behind the high parapet walls.

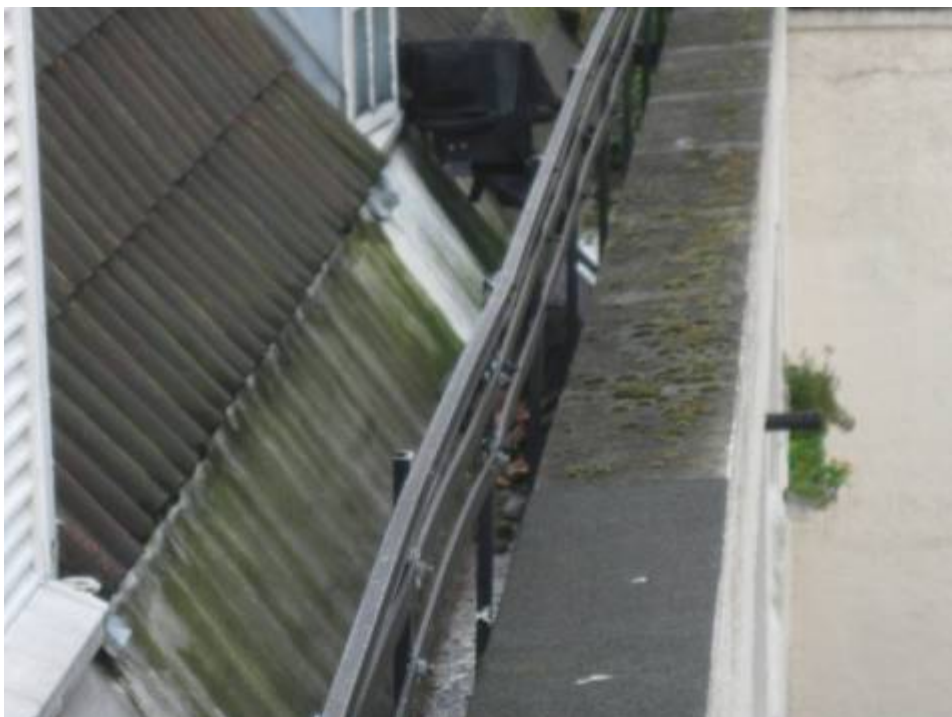
**Photograph 16 Parapet gutter and coping**

Parapet walls have stone copings. These generally do not project far enough to shed rainwater correctly beyond the face of the brickwork and render, and in one area a bituminous felt covering has been laid over the copings presumably to try and prevent water penetration (photo 16). It is proposed to remove and replace all copings in a similar style to the existing but with suitable drip throatings and projections.

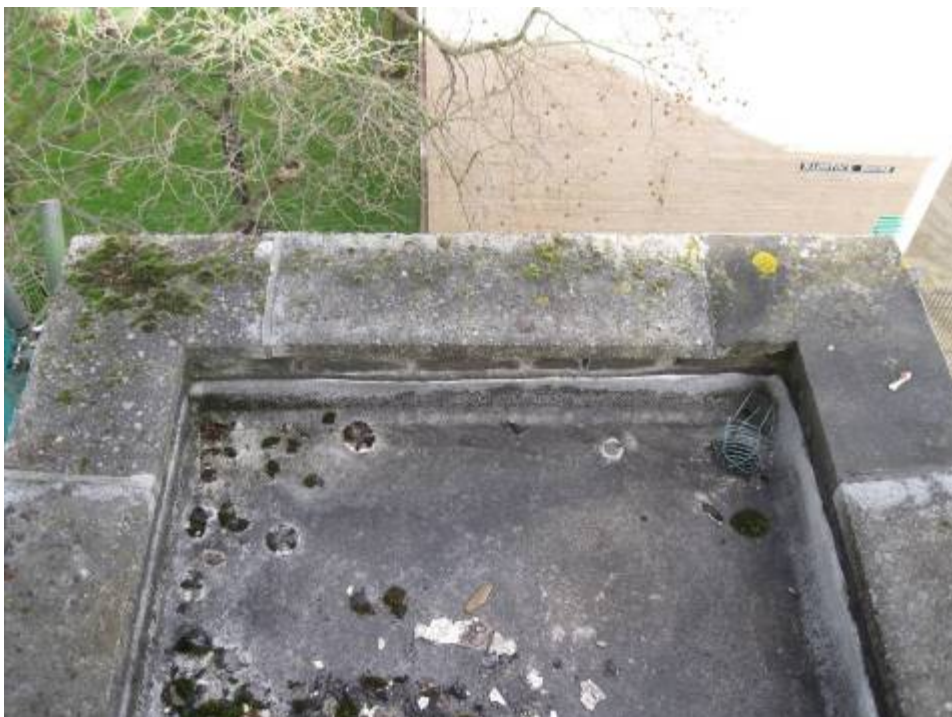
**Photograph 20**      **Small flat roof area 204 - 238**

A number of small flat roofs are provided. These are in poor condition (e.g. Photo 20) and it is proposed to recover with a liquid membrane or similar high performance coating.

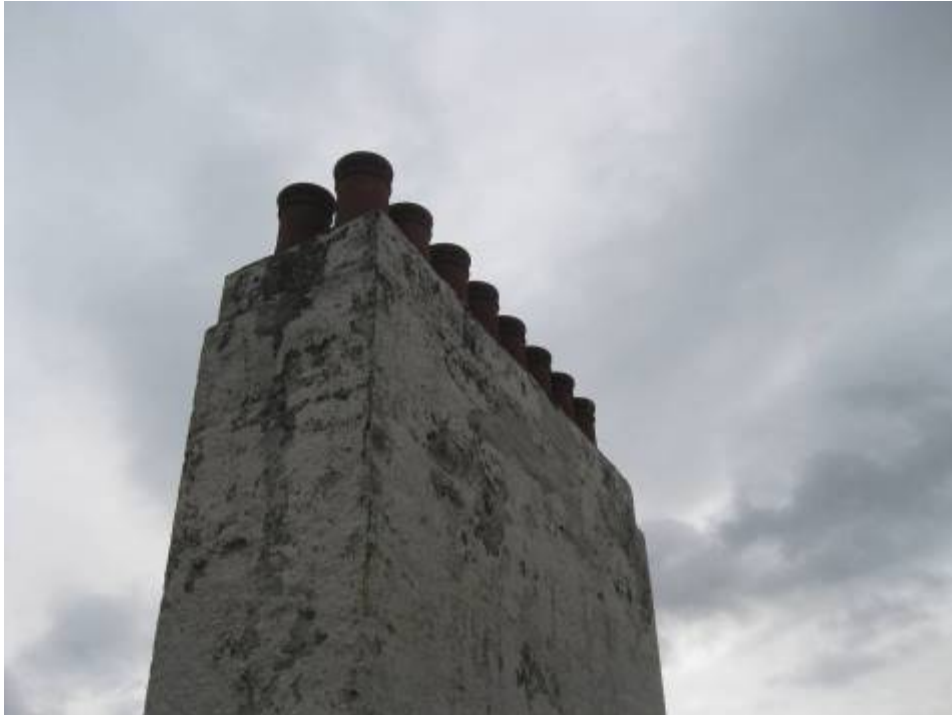
**Photograph 21** Typical chimney condition

The render is showing signs of significant defects, particularly to the chimneys where areas are spalling and the brickwork is exposed and vegetation growth is apparent (photo 21). Elevations are generally in need of repair.

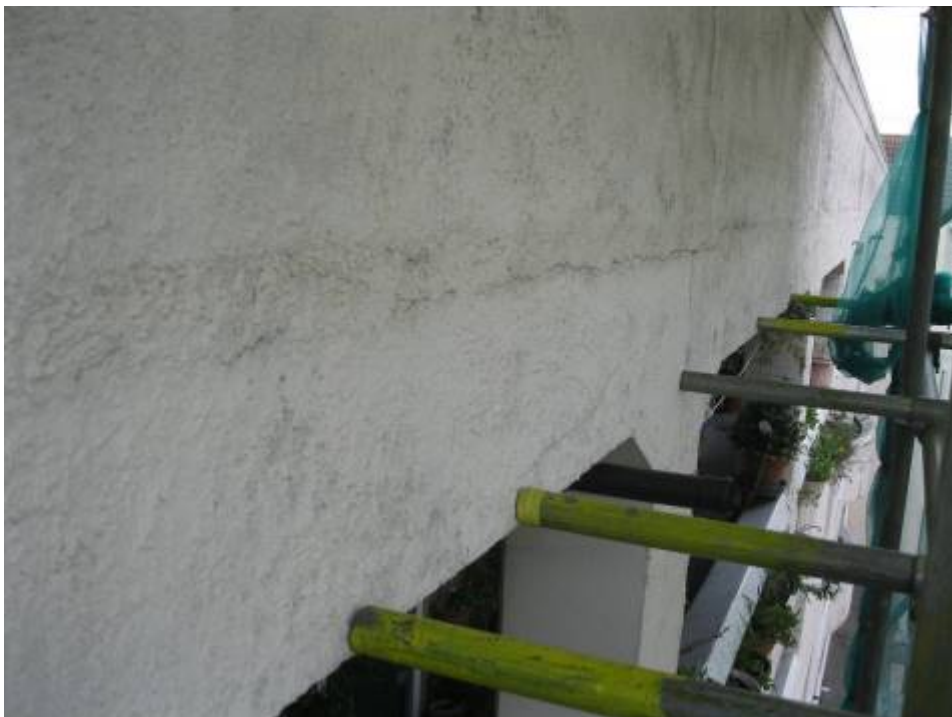
Concrete balconies and other services appear to be in fair condition but the proposal is to carry out all the necessary pre-decoration repairs e.g. to the access balcony soffits etc. The communal staircases show evidence of corrosion of steel, which is causing spalling of the concrete, and other mechanical damage. Evidence on similar blocks on the estate is that the steelwork can be quite badly corroded necessitating large repairs to the balcony beams. Photos 22 and 24 illustrates typical symptoms of this problem

**Photograph 22** Cracking to access balcony ring beam and render

The proposal will be to remove defective concrete, suitably prepare exposed steel and repair with a specialist concrete repair compound such as the Fosroc Renderoc system of repair mortars with appropriate priming of exposed steel work. Repair profiles will match the original profiles of the repaired element.

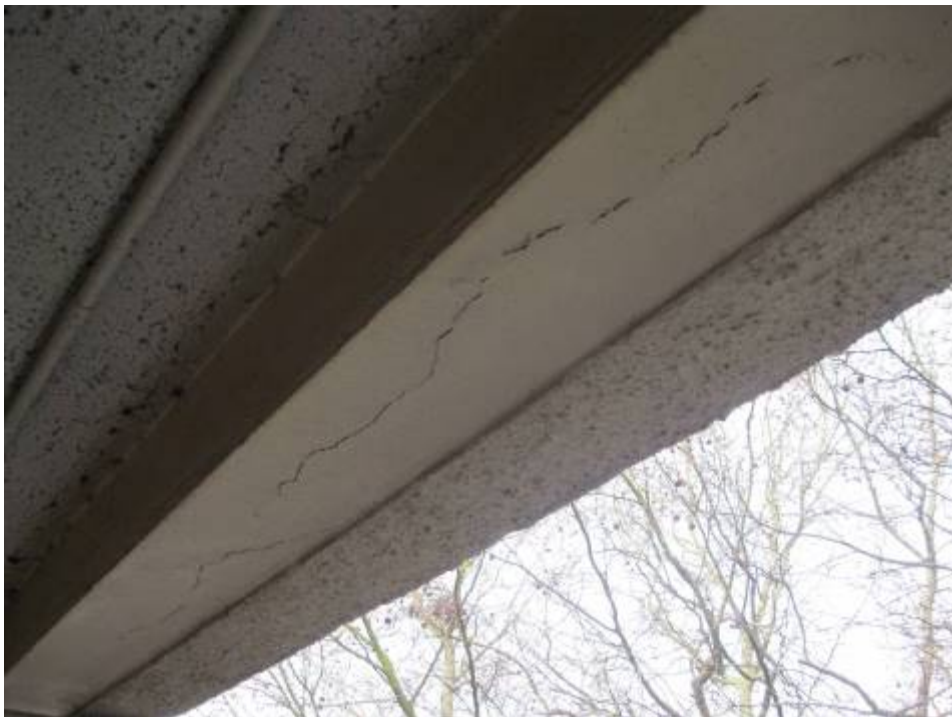
**Photograph 24      Cracking to access balcony ring beam soffit**

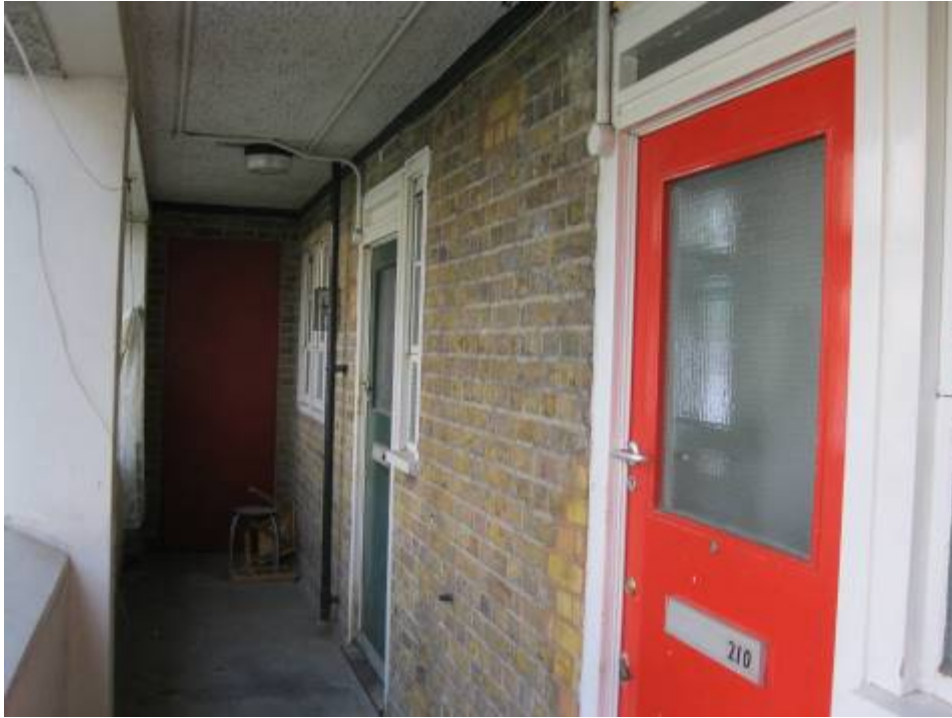
**Photograph 27** Typical flat entrance doors

Flat entrance doors are not original and are currently timber with “half glazed” upper panels. (Photo 27). The archive photos below from similar archetype blocks indicate the high waisted panelled and 6 pane glazed style provided before these modern replacements, it is unclear if these archive photos are original as built.

The proposal is to replace the doors to achieve a Secured by Design standard in terms of locking mechanisms and also to the current recommendations in relation to fire precautions.

The style of the replacement doors will be similar to those installed on Walker House and 1-21 Levita but with visual appearance of 6 glazed panes and 3 vertical panels more in keeping with the doors seen in the archive photographs. The vertical panels are to be shallow rebated style to match similar to the panel style of those on 38 – 60 Levita rather than deeper moulded sections. The proposals are indicated on drawing 5675 A (31) Type I Proposed Revision A which shows existing and proposed.

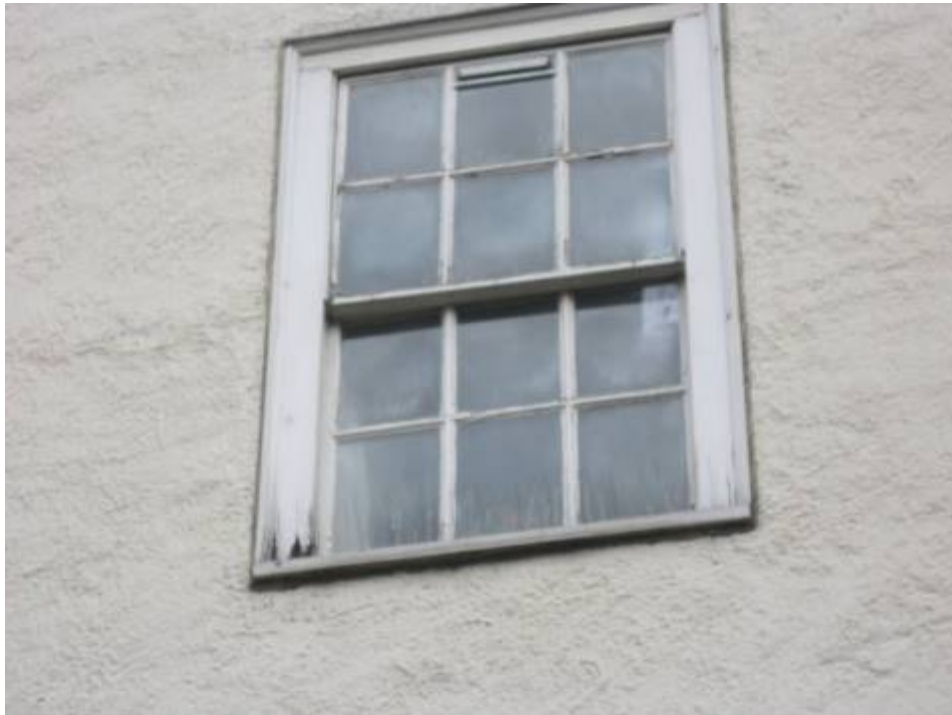
All windows are single glazed timber and many are in a poor state of repair. They have reached the end of their serviceable life with evidence of timber decay, extremely poor decorations, glazing defects, draughts and poor levels of thermal insulation. There have also been a number of non-standard alterations to the windows which spoils the elevational detail.

**Photograph 29** Window condition, note low level decay

To strive towards modern standards, it is proposed to replace all of the windows. The principle of installing double glazing has been established elsewhere in the listed estate (please see 1.8 earlier).
