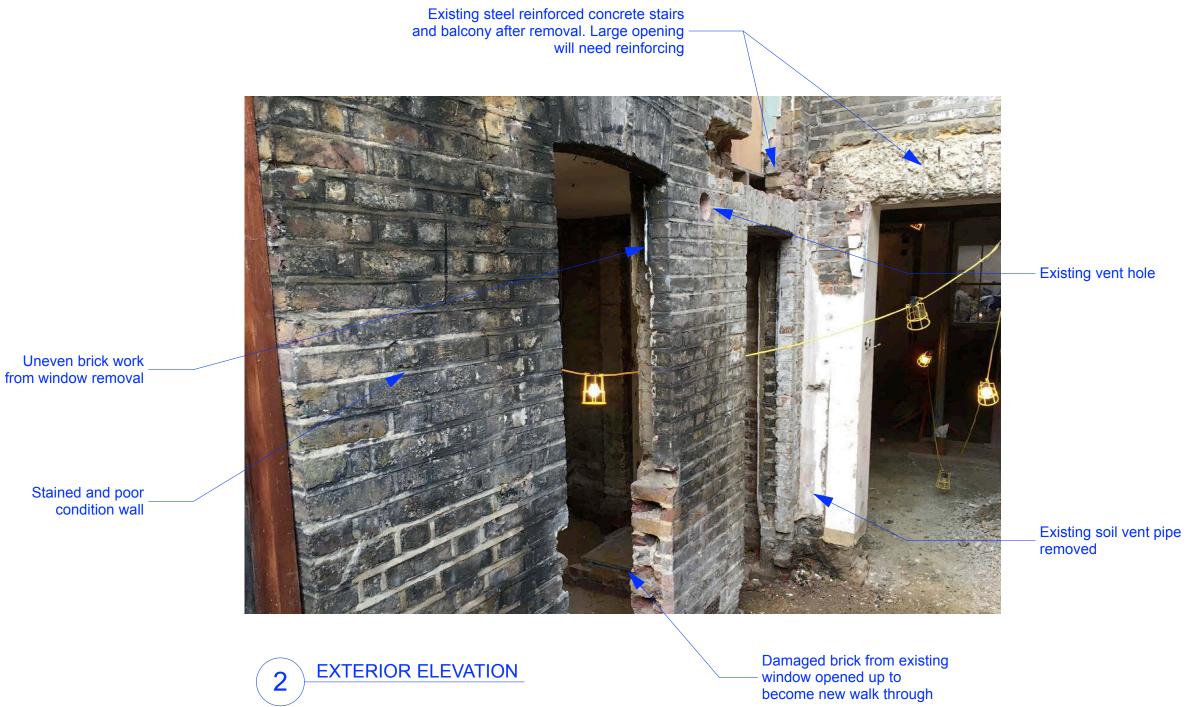
Damaged and poor condition brick work from stair and balcony removal

Existing render removed from return wall after stiar and balcony removal

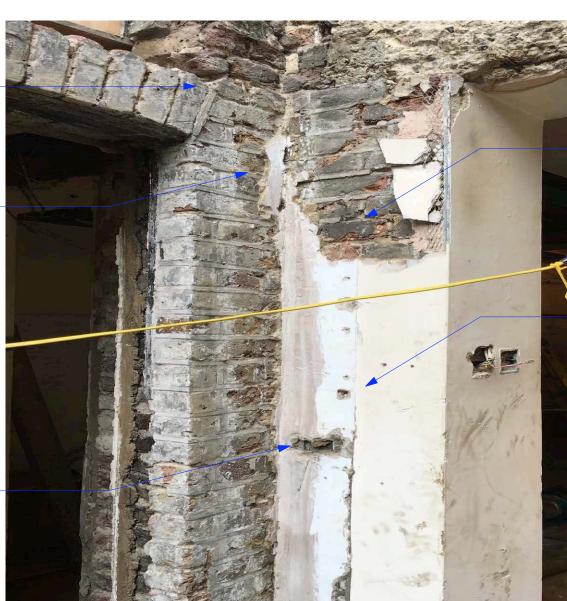
Existing brick work

- damaged from stair
and balcony removal

Existing render in poor condition

Soil vent pipe removed has left large fixing holes
