# Findings of the Fire Risk Assessment - Action Plan

PARBLK0001\_FRAR\_2013.12.09\_2015.12.09\_AP

1-39 Parnell House, Streatham Street, London, WC1A 1JB

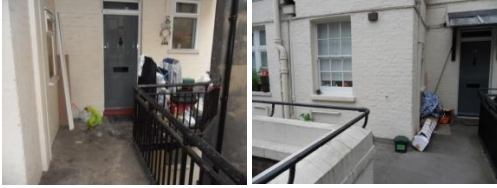
8.3	Basement and balconies / escape routes.	There is an accumulation of combustible materials throughout the basement, balconies and staircase some which may be in close proximity to electrical ignition sources and along the escape routes from the basement.	1	Remove combustible material from the basement, balconies and staircase / escape routes. The basement escape route, balconies and staircase must be maintained clear of combustible material and obstructions at all times.

1111921/4 email sent to NM Rashida due date 17.1.2014	ISSUE STAFF TASK AND SEND EMAIL AS THIS IS VERY URGENT	Completed on 12.2.2014
