## SITE INVESTIGATION FACTUAL REPORT

Report No: 246119  
Client: Crawford Claims Management  
Site: 4B Hampstead Hill Gardens, Hampstead

Client Ref: SU1404491-  
Date of Visit: 13/02/2015

**Home Emergency Response - Subsidence Investigation - Drainage Services – Crack & Level Monitoring – Property Video Surveys**

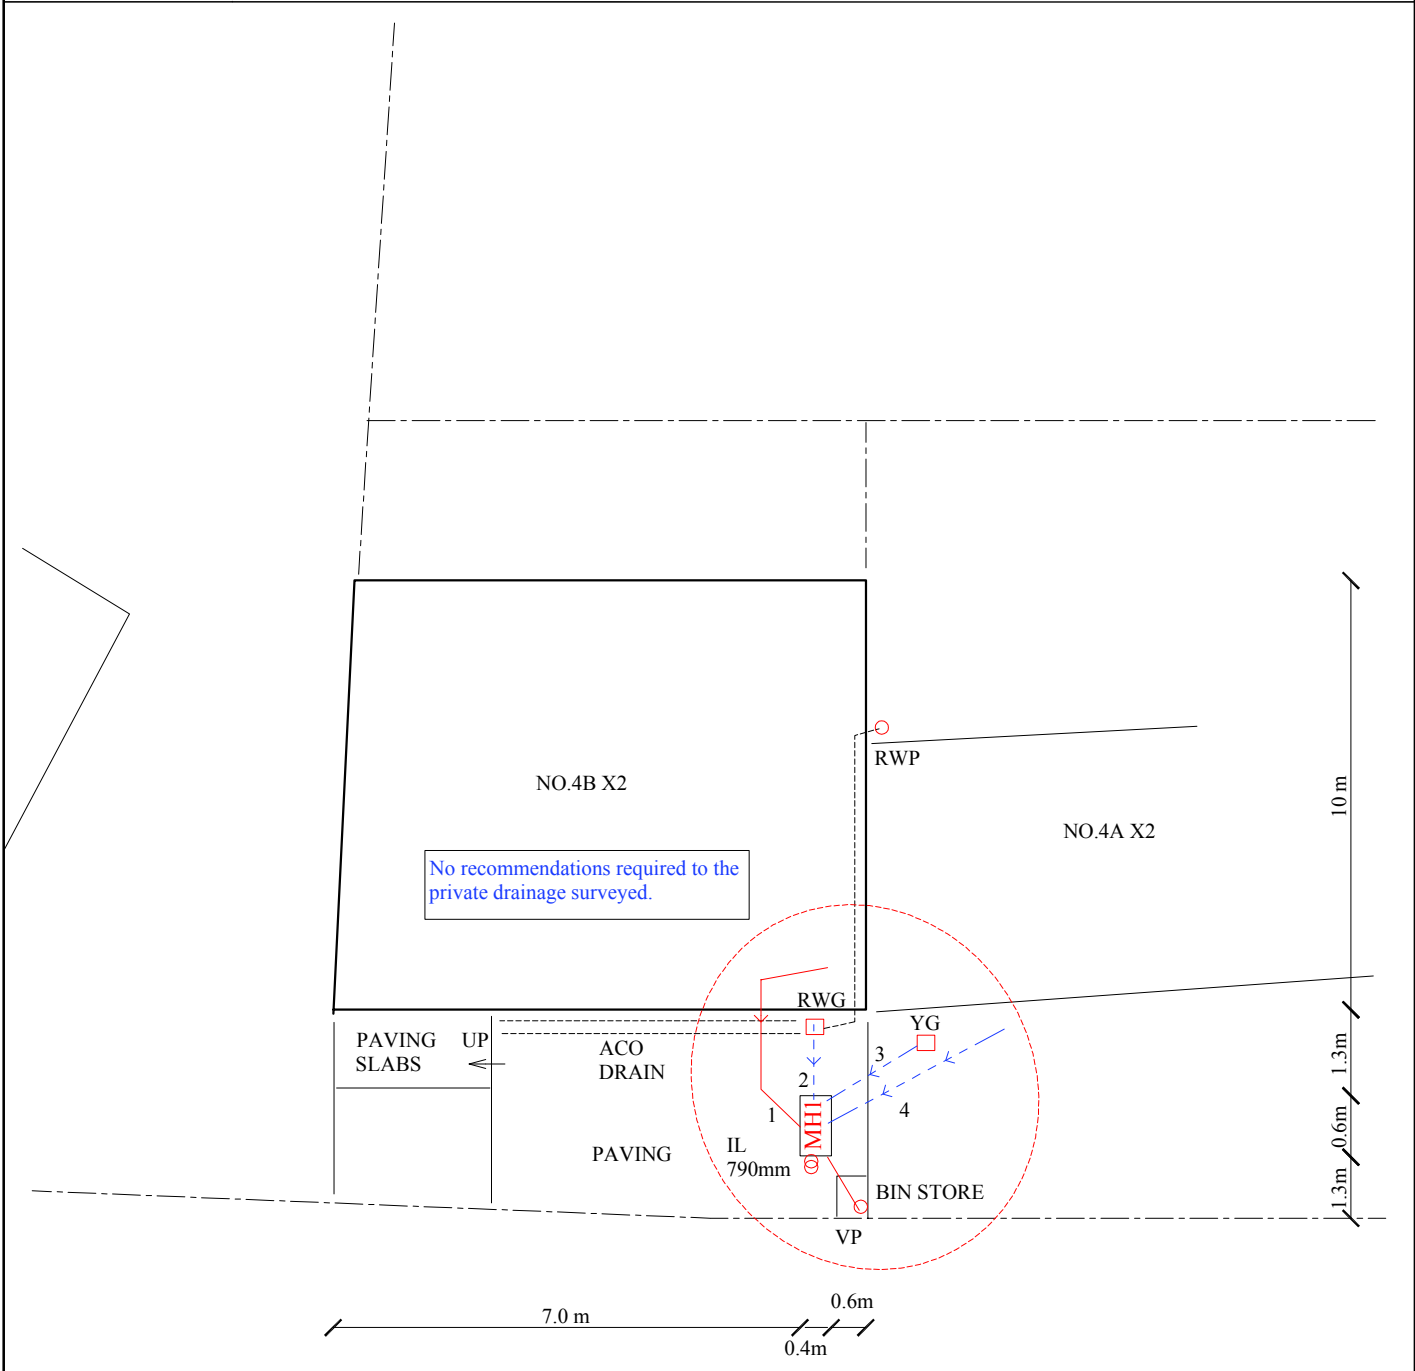
# Drainage Layout Plan

No recommendations required to the private drainage surveyed.

Manhole 1 & the main run at the front of the property is shared, therefore owned by the water authority. Repairs may be the responsibility of the water authority.

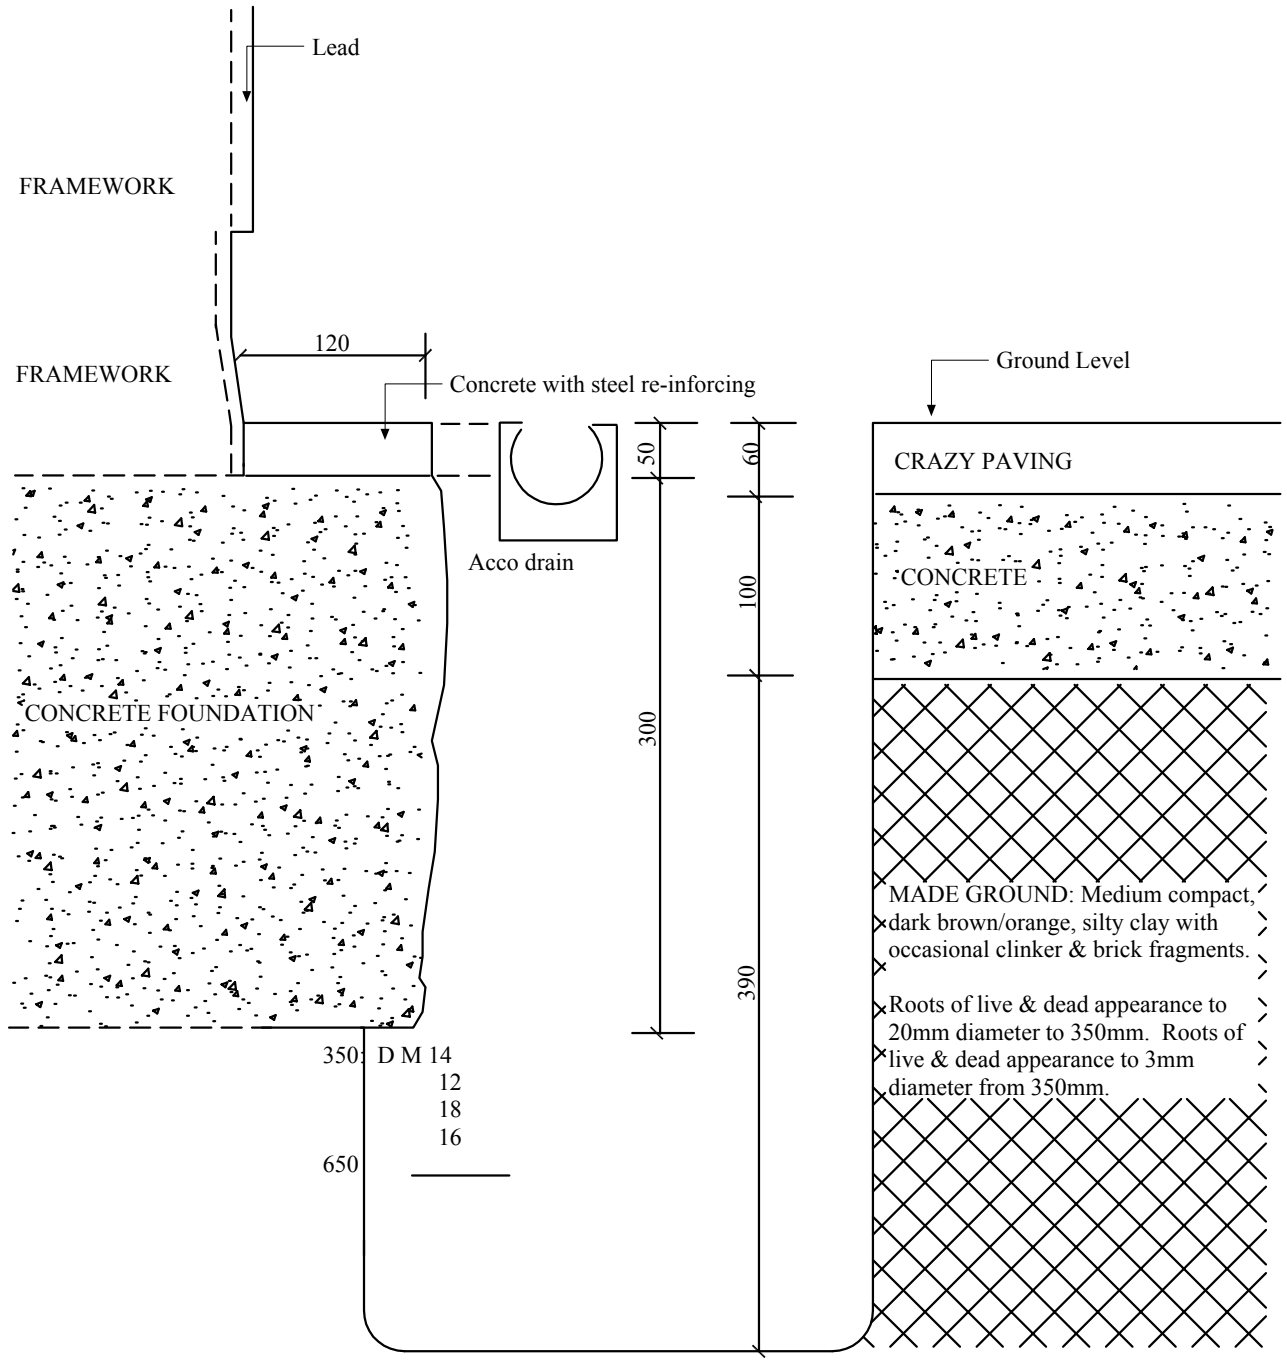
# Trial Pit No: 1

FOR STRATA BELOW 550mm SEE BH LOG 1

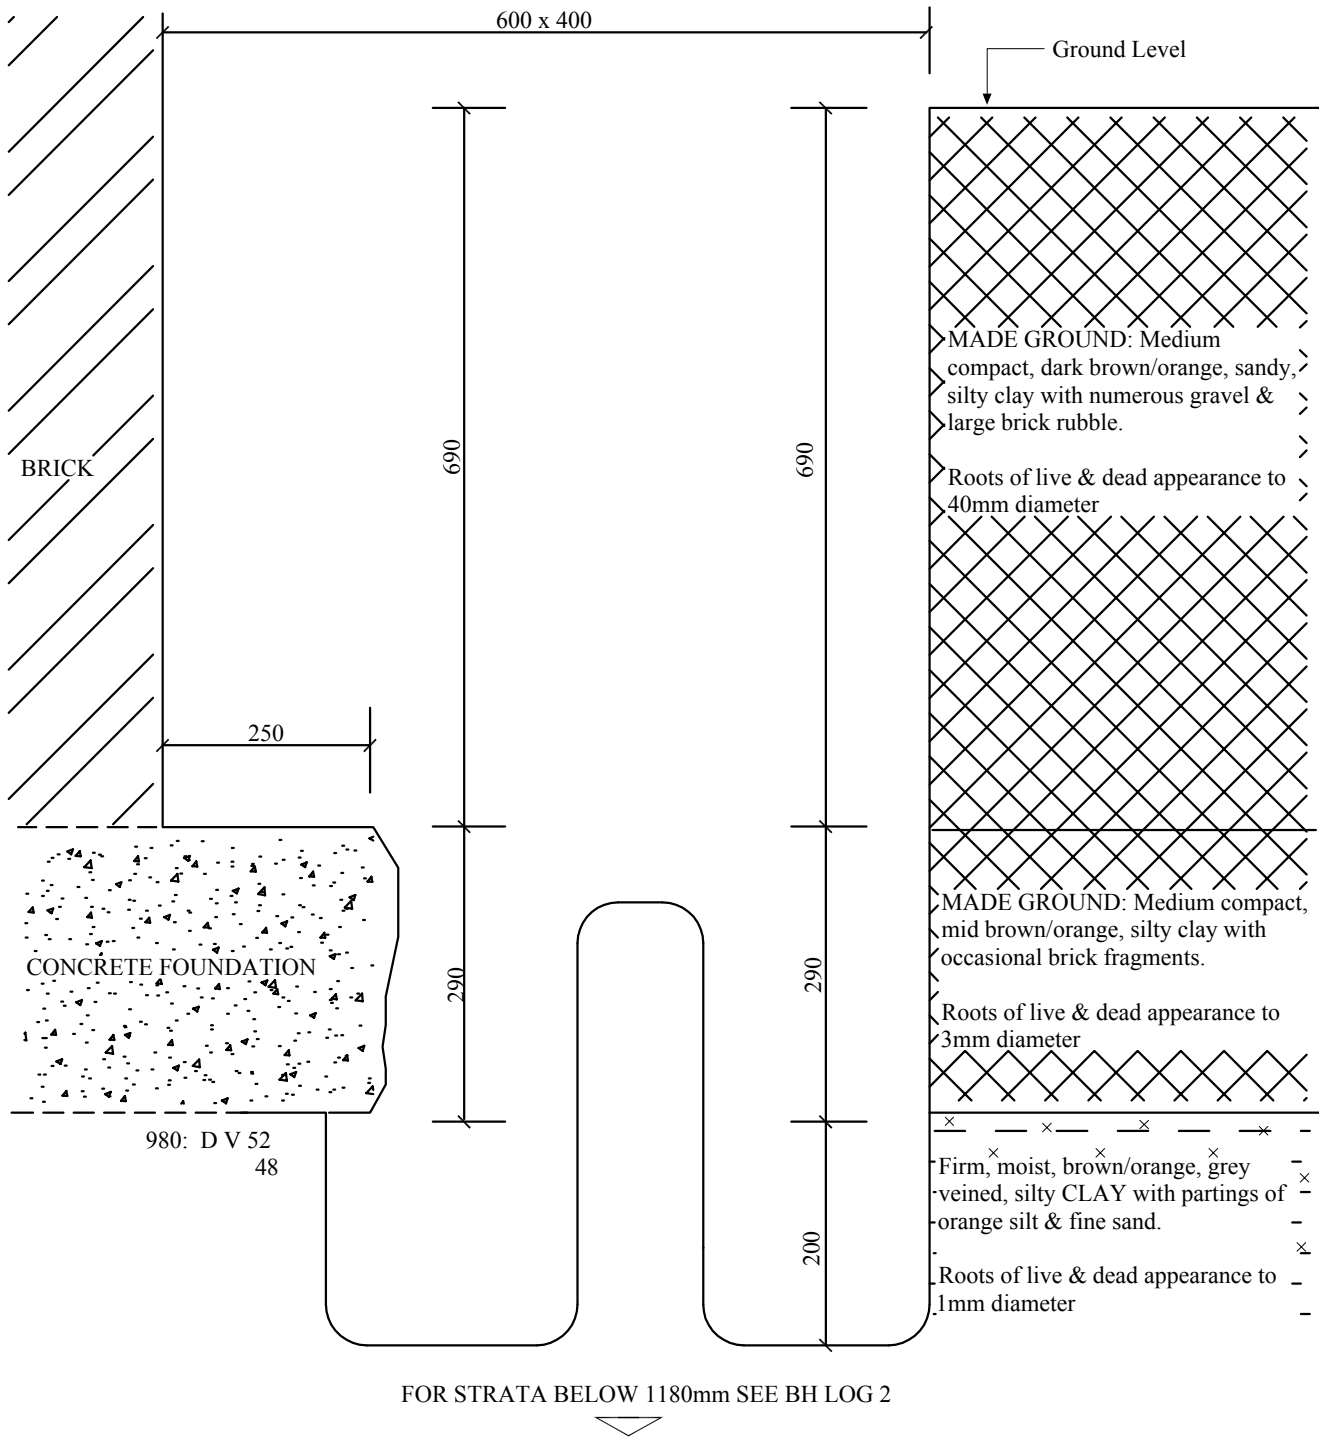
# Trial Pit No: 2

Remarks: All measurements in millimetres.  
 Water strike at 980mm. Standing water level at 1140mm in Trial Pit on completion. Borehole augered at rear of Trial Pit to avoid water
