ADDENDUM TECHNICAL REPORT

Crawford Reference: SU1404491

**4B Hampstead Hill Gardens
Hampstead
London
NW3 2PL**

SUBSIDENCE CLAIM

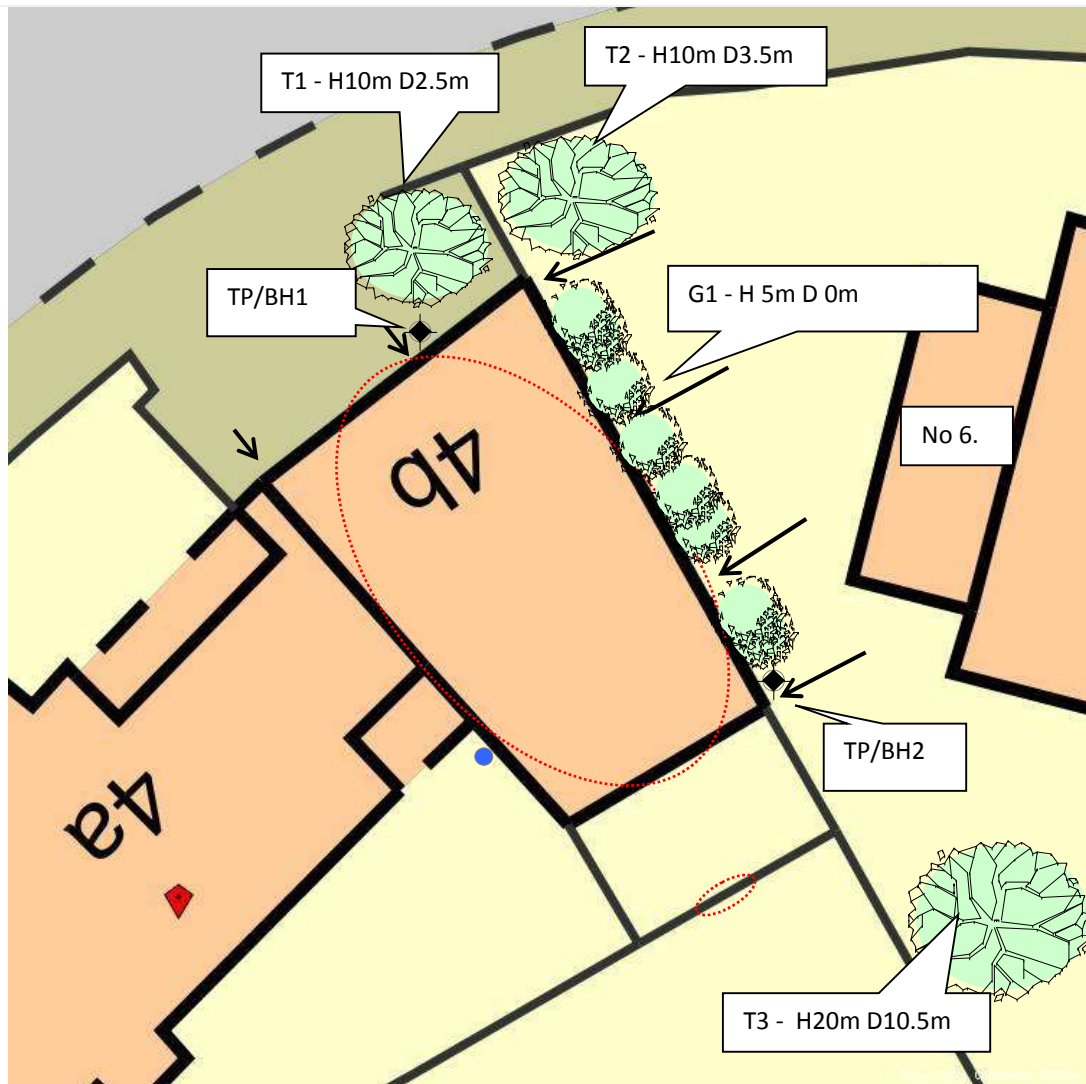
Site Plan

The movement is pronounced on points 2, 3 and 4 toward the front and left flank of the property, which are the points closest to the nearby Hornbeam tree, T1. The Hornbeam tree T1 is therefore considered to be the primary cause of movement. The monitoring is not uniform around the property so nominal seasonal movement can be discounted as a cause.

MWA have formed an arboricultural report following the results of the site investigation dated 13/02/15. The report cites the Hornbeam tree T1 as the main cause of movement, with another hornbeam, T2, and a wisteria seen as a secondary cause.

The cause of the movement needs to be dealt with first. From the results of the site investigation, we are satisfied that the main cause of movement to the property, **Hornbeam T1**, can be removed. We have also arranged for the **Wisteria** to be removed. Based on our analysis, we are satisfied there is no adverse heave risk to the property.

If the decision is favourable, our Mitigation Unit will arrange for the tree works to be undertaken. Following completion of the tree management works, we will undertake a suitable period of monitoring to confirm stability has been achieved by the removal of T1 alone before undertaking repairs to the property. If movement is ongoing, an application to fell **T2** will be considered.

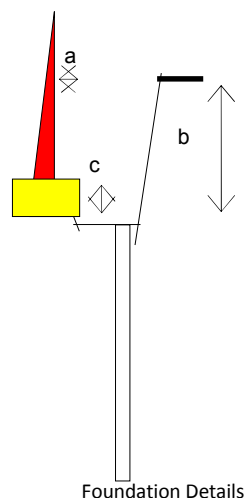
Trial Hole 1 revealed a concrete footing founded at a depth of 0.35m below ground level which bears onto MADE GROUND: Medium compact, dark brown/orange, silty clay with occasional clinker and brick fragments. Roots of live appearance to 3mm and 20mm diameter.

Trial Hole 2 revealed a concrete footing founded at a depth of 0.98m below ground level which bears onto firm, moist, brown/orange, grey veined, silty CLAY with partings of orange silt and fine sand. Roots of live and dead appearance to 1mm diameter.

No.	Borehole Depth	Footing (a)	Underside (b)	Thickness (c)
TH1	2.30 m.	120 mm.	350 mm.	300 mm.
TH2	3.00 m.	250 mm.	980 mm.	290 mm.
