ADDENDUM TECHNICAL REPORT

**Crawford Reference: SU1404491**

**4B Hampstead Hill Gardens  
Hampstead  
London  
NW3 2PL**

**SUBSIDENCE CLAIM**

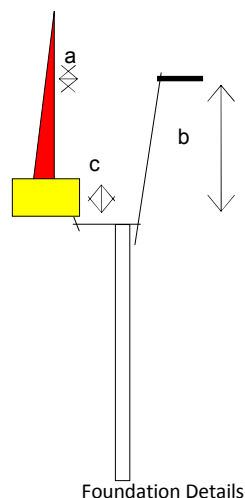
Foundation Details

Trial Hole 1 revealed a concrete footing founded at a depth of 0.35m below ground level which bears onto MADE GROUND: Medium compact, dark brown/orange, silty clay with occasional clinker and brick fragments. Roots of live appearance to 3mm and 20mm diameter.

Trial Hole 2 revealed a concrete footing founded at a depth of 0.98m below ground level which bears onto firm, moist, brown/orange, grey veined, silty CLAY with partings of orange silt and fine sand. Roots of live and dead appearance to 1mm diameter.

No.	Borehole Depth	Footing (a)	Underside (b)	Thickness (c)
TH1	2.30 m.	120 mm.	350 mm.	300 mm.
TH2	3.00 m.	250 mm.	980 mm.	290 mm.
