3rd ADDENDUM TECHNICAL REPORT

Crawford Reference: SU1404491

**4B Hampstead Hill Gardens
Hampstead
London
NW3 2PL**

SUBSIDENCE CLAIM

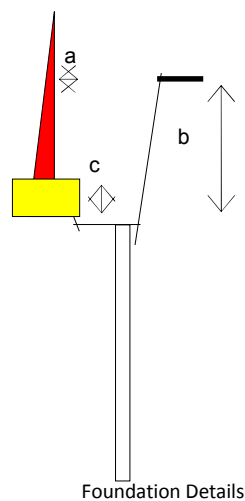
Trial holes were excavated to expose the foundations - see site plan for location and the diagram below for details.

Trial Hole 1 revealed a concrete footing founded at a depth of 0.35m below ground level which bears onto MADE GROUND: Medium compact, dark brown/orange, silty clay with occasional clinker and brick fragments. Roots of live appearance to 3mm and 20mm diameter.

Trial Hole 2 revealed a concrete footing founded at a depth of 0.98m below ground level which bears onto firm, moist, brown/orange, grey veined, silty CLAY with partings of orange silt and fine sand. Roots of live and dead appearance to 1mm diameter.

No.	Borehole Depth	Footing (a)	Underside (b)	Thickness (c)
TH1	2.30 m.	120 mm.	350 mm.	300 mm.
TH2	3.00 m.	250 mm.	980 mm.	290 mm.
