Arboricultural Appraisal Report

Subsidence Damage Investigation at:

4B Hampstead Hill Gardens
 Hampstead
 London
 NW3 2PL

CLIENT: Crawford & Company
 CLIENT REF: SU1404491
 MWA REF: NW200315.01REV1
 MWA CONSULTANT: David Mahon (B.Sc Hons MICFor MArborA)
 REPORT DATE: 19.06.2015

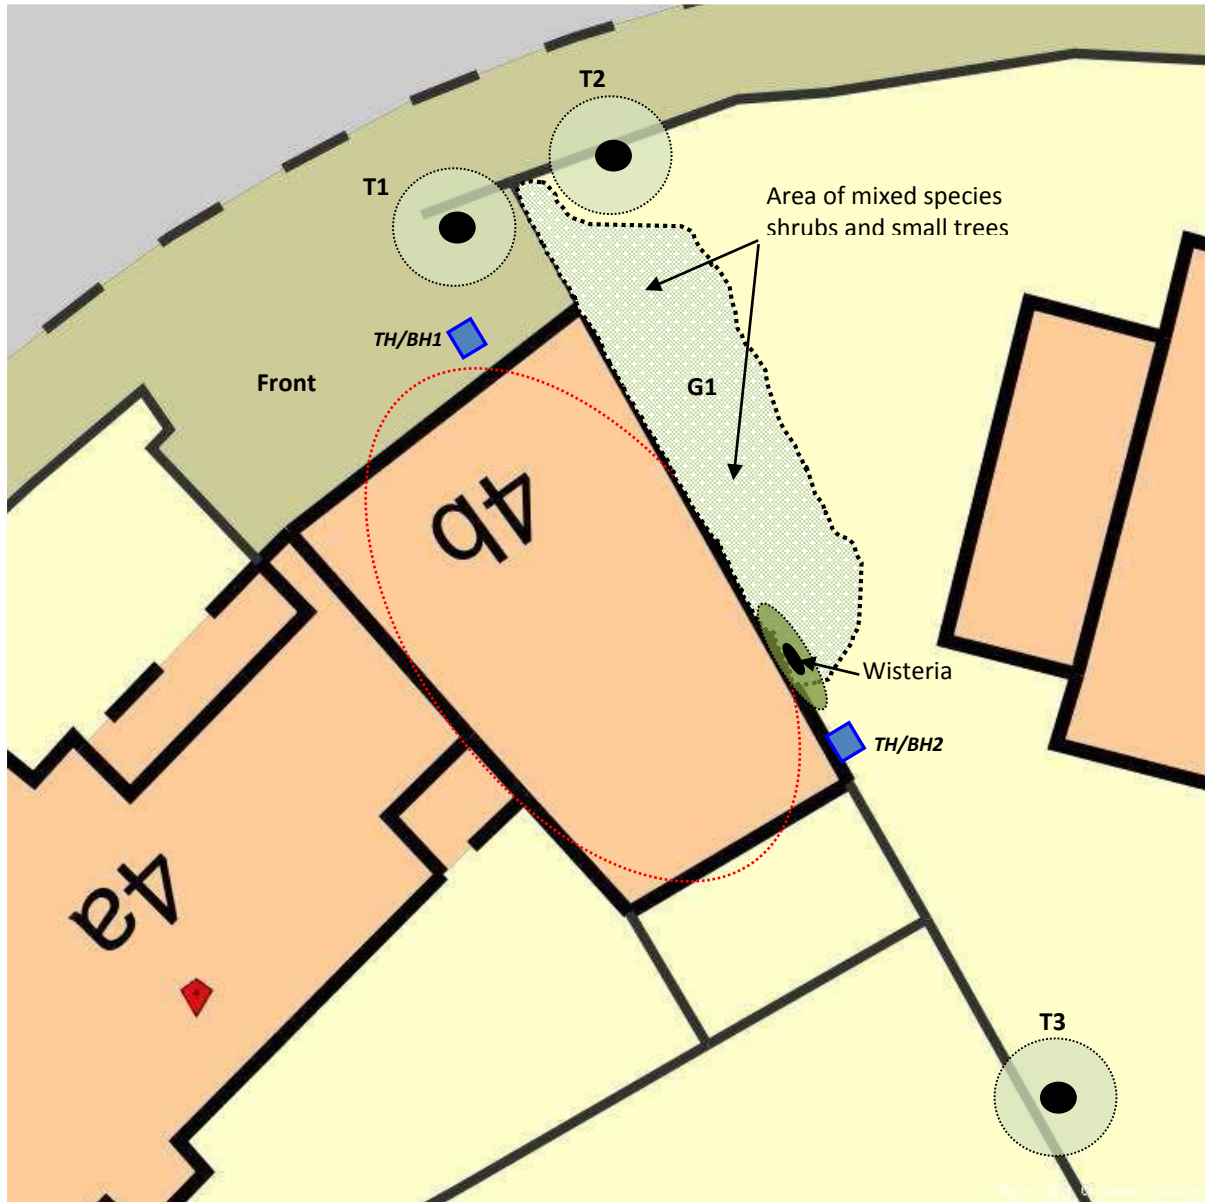
SITE PLAN

Approximate areas of damage

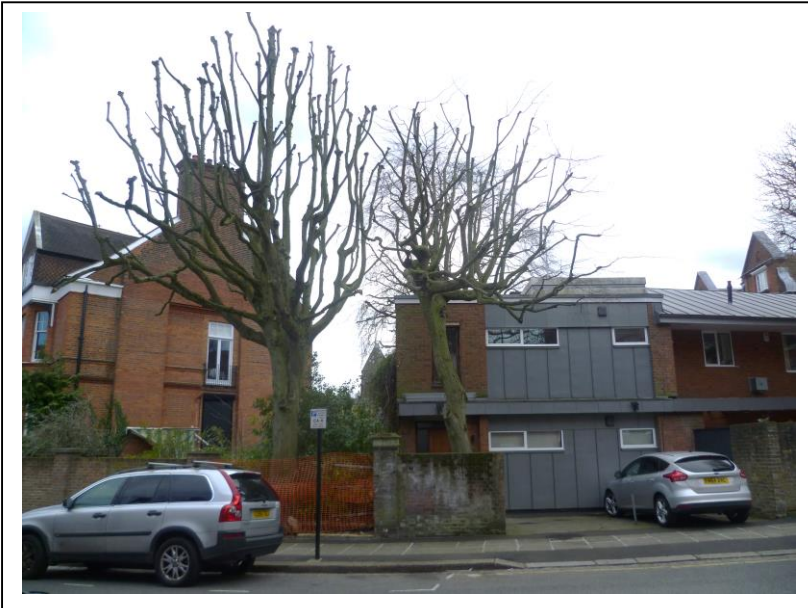
Based on the technical reports currently available, engineering opinion and our own site assessment we conclude the damage is consistent with shrinkage of the clay subsoil related to moisture abstraction by vegetation. Having considered the available information, it is our opinion that T1 is the principal cause of damage with T2 and G1 being contributory but secondary factors.

View of T1 and T2

If an arboricultural solution is to be implemented to mitigate the current damage and allow the soils beneath the property to recover to a position such that an effective repair solution can be implemented we recommend that T1, T2, the wisteria and other elements of G1 within 3.0m of the left hand flank wall are removed.

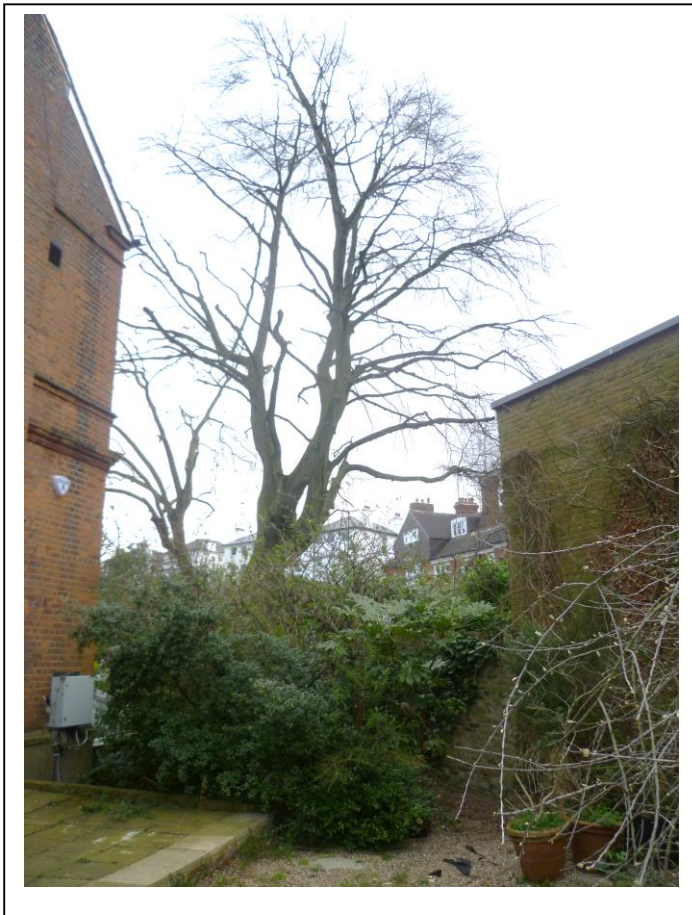
The beech T3 is a large tree and has also been reduced in the recent past although its dimensions prior to the pruning is unknown. The property falls within the anticipated zone of influence of this tree although there is no positive root identification which directly implicates the tree in the damage.

View of T3

The beech T3 may also be involved however in our view the removal of the hornbeams and sections of G1 will be sufficient to restore stability. If movement persists following current claim the role of T2 may need to be reviewed.

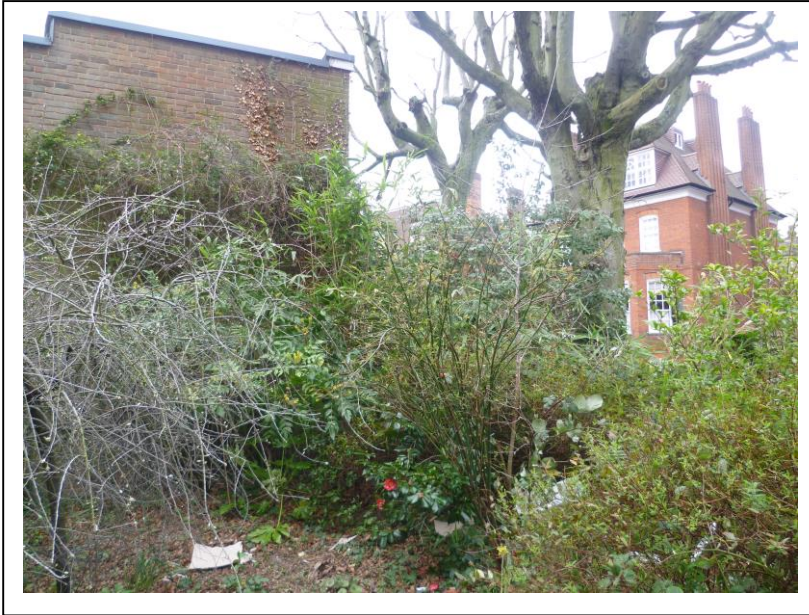
The mixed species group G1 comprises relatively small plants however their collective impact on soil moisture will be significant.

View of G1

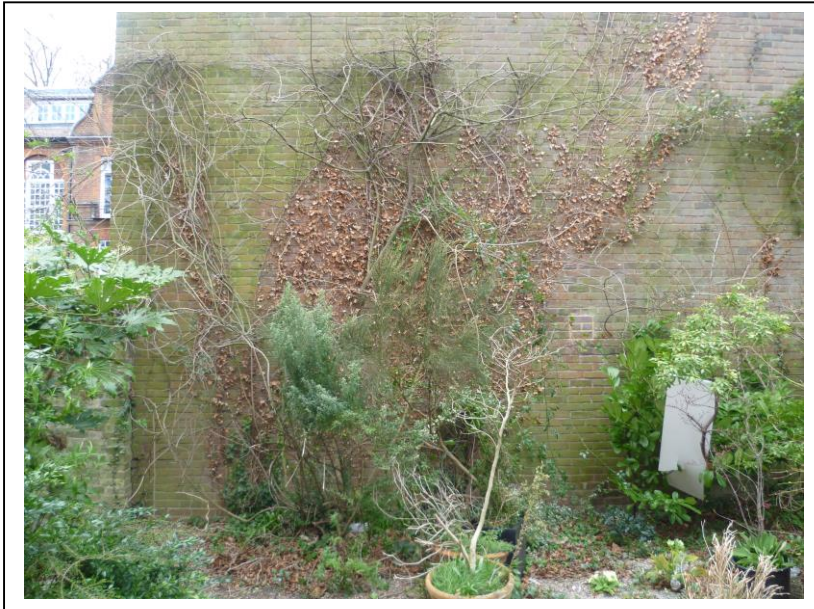
Roots were observed to 2000mm bgl and 2600mm in BH1 & BH2 respectively and recovered samples have been positively identified (using anatomical analysis) as *Carpinus* spp (hornbeam) and *Leguminosae* spp the origin of which will be T1 and T2 and the wisteria in G1 confirming the influence of this vegetation on the soils below the foundations.

View of wisteria
