BEDFORD SQUARE No.48  
LONDON

FIRST FLOOR FRONT ROOM  
Decorative Ceiling Condition

November 2016

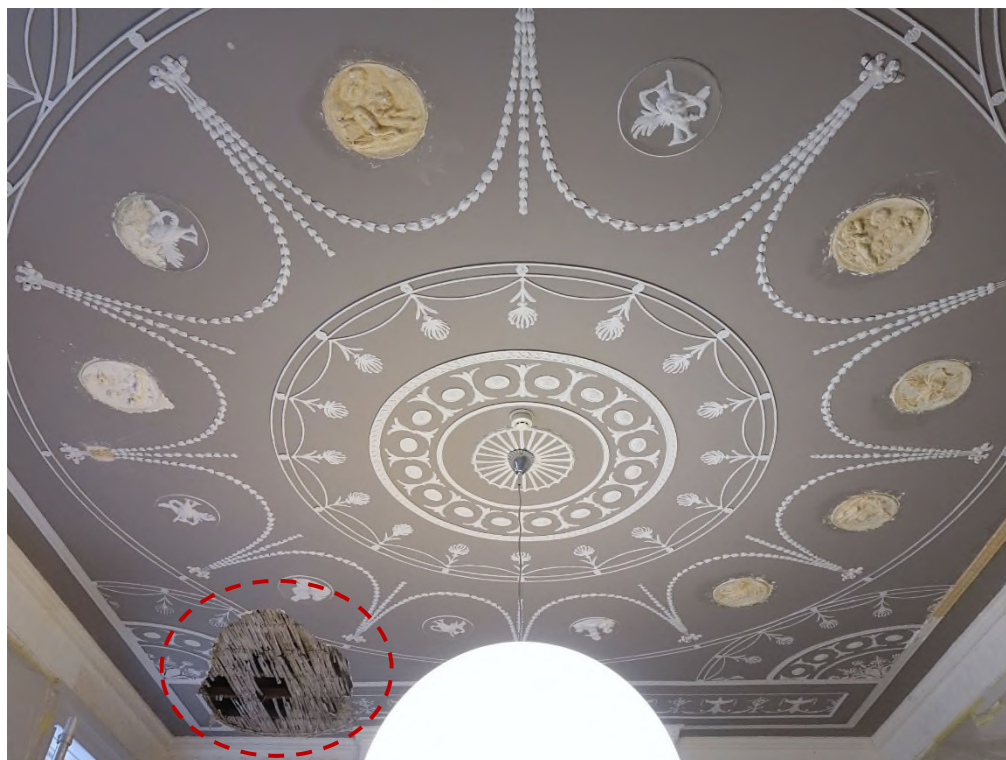
Fig 02 First floor front ceiling view east with plaster loss 15/10/16

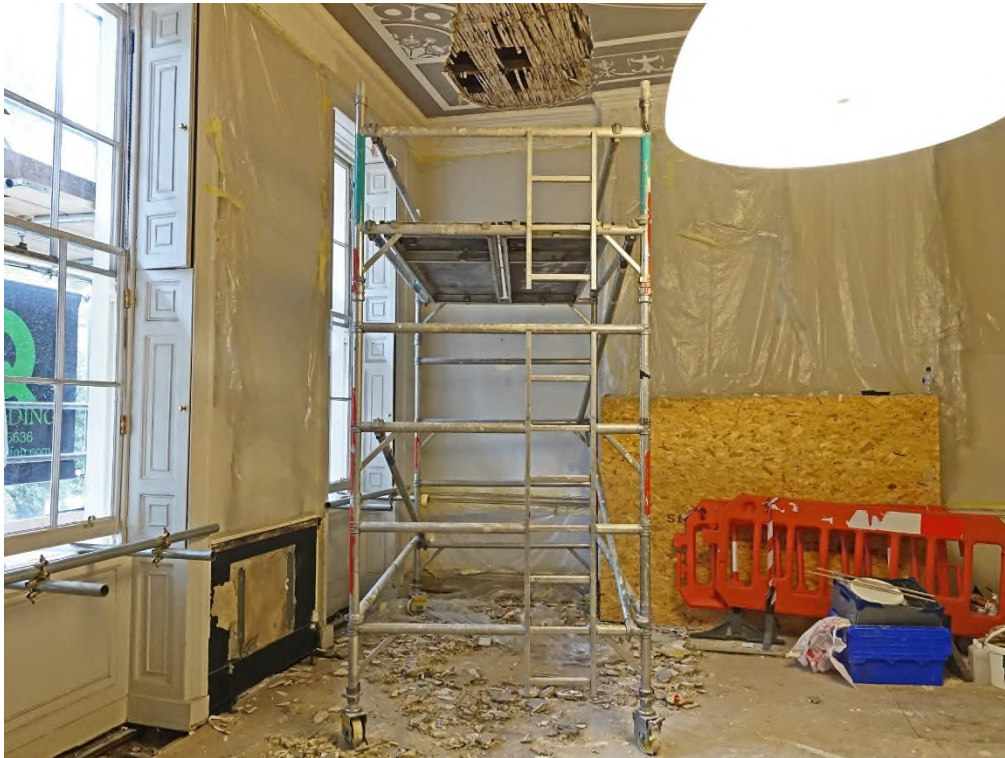
A section of plasterwork has been lost from the north west corner of the ceiling (Figs 03-05) measuring approximately 2,400 mm by 1,200 mm revealing overlapped lathwork (Figs 05 & 06) and evidence of previous water ingress within the area evidenced by staining on the supporting floor and ceiling joists and bright orange rusting of lath nails.

The demised section of plasterwork in the north east corner appears to have resulted from an accumulation of factors including poor original plastering methods – the overlapping of laths creating a line of weakness, water ingress, past intervention and repair. The second floor rooms were originally designed with light domestic loadings probably as bedroom and dressing room, and not that of offices with, high occupancy, filing cabinets and desks. It is clear that the additional loading, though not the primary cause of loss, is not conducive to the long term preservation and survival of the decorative plaster ceiling beneath. Survival thus far has been greatly aided by the floor joists and ceiling joists being separate structures. However, they are not independent of each other as the trusses and trimmers connect the two together and thus are capable of transferring loads from floor to ceiling – as evidenced by the ceiling deflection beneath and partition deflection above.

Fig. 03 Ceiling plaster loss in NE corner

Plasterwork in the area of loss in the north west section should be carefully cut back in line with the joists and support structure above. Care should be taken cutting through laths not to destabilise other areas beyond the batten perimeter restraint in removing and forming a neat rectangular area between north wall, east wall, trimmer and truss where plasterwork has separated from laths as illustrated in Fig. 35. Working to the west of the loss to reveal the next line of lath fixing nails would be the recommended limit.

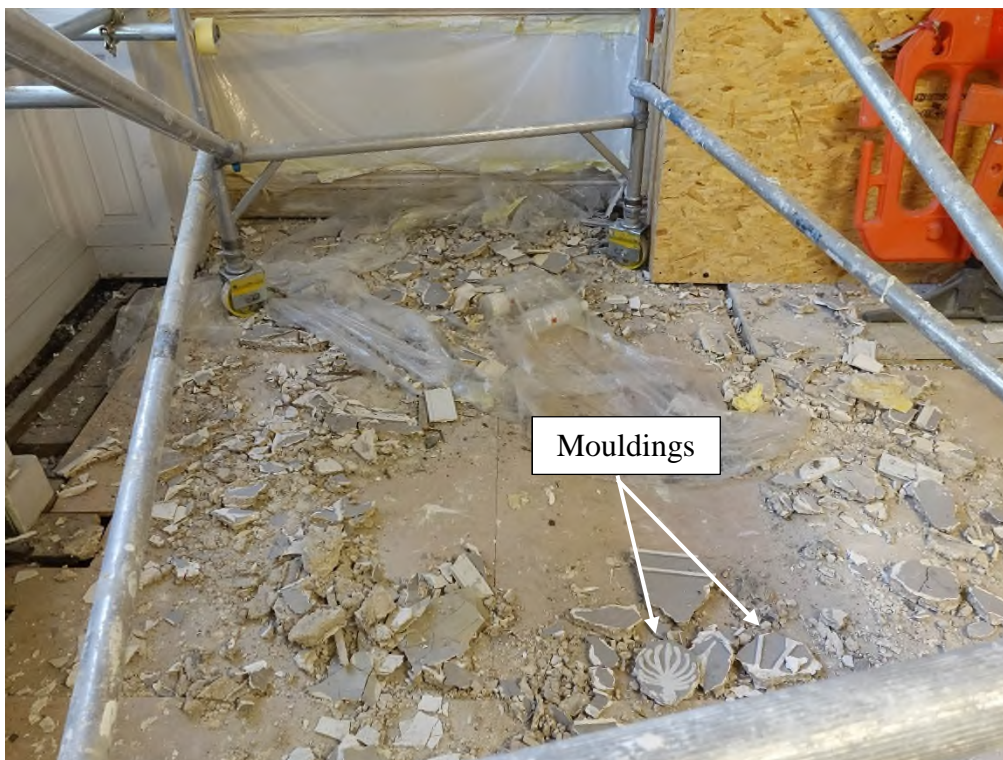
Fig. 04 Ceiling debris and mouldings on the floor

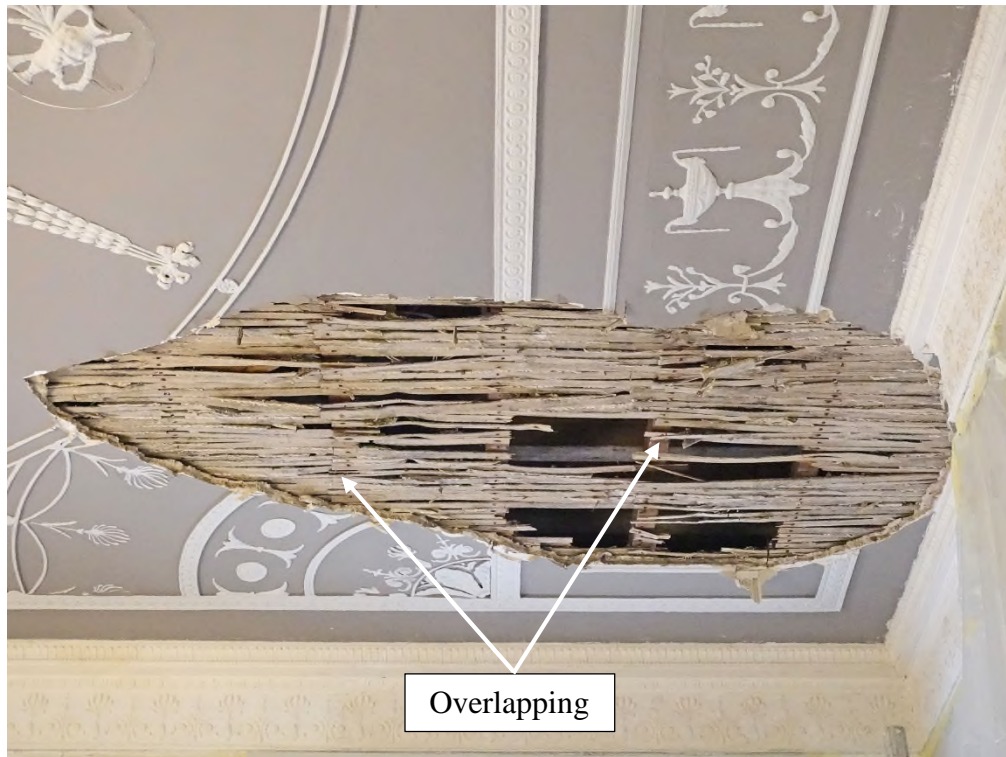
Fig. 05 View of ceiling loss towards north window wall

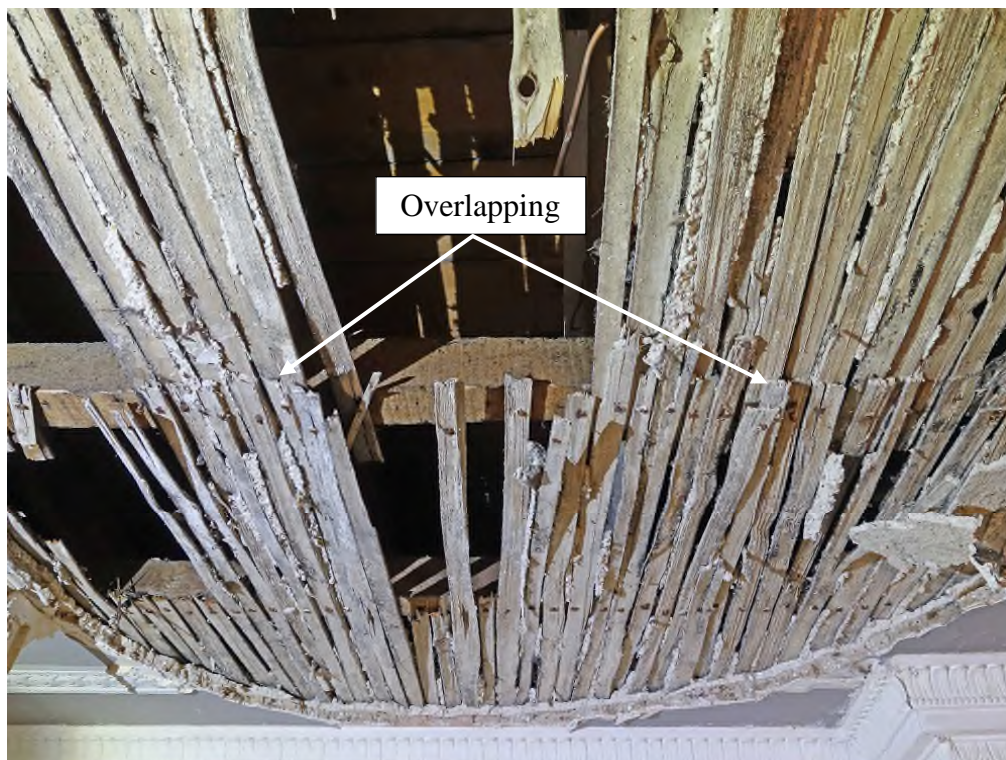
Fig. 06 Loss showing overlapping laths view east

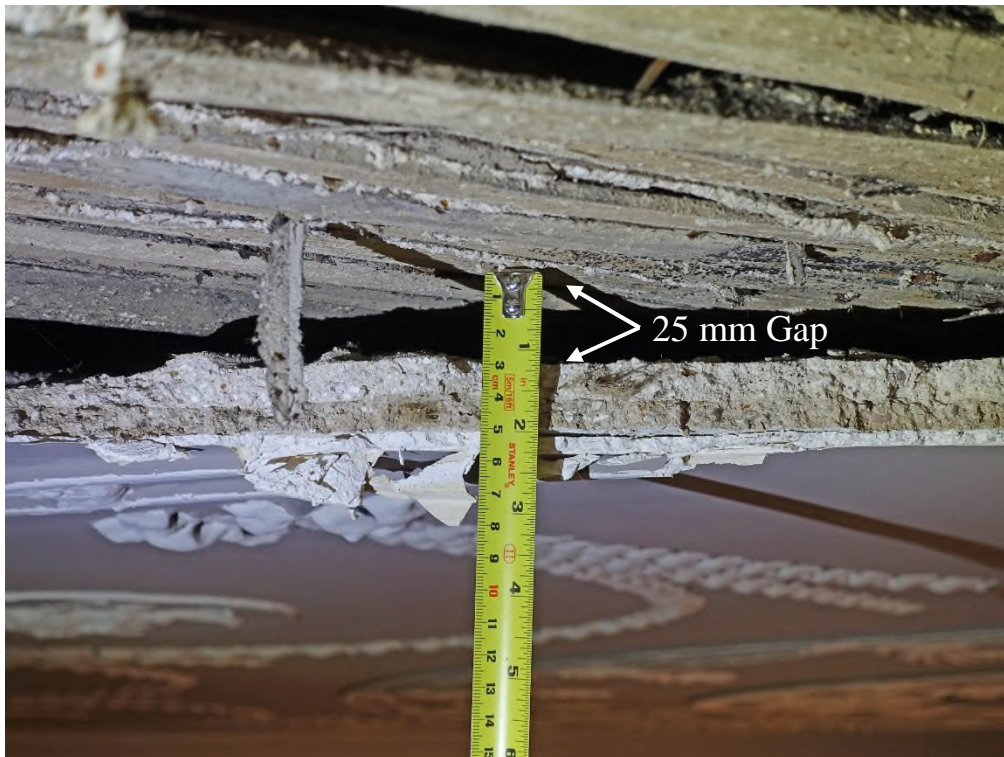
Fig. 07 Gap of 25 mm between ceiling plaster back and laths

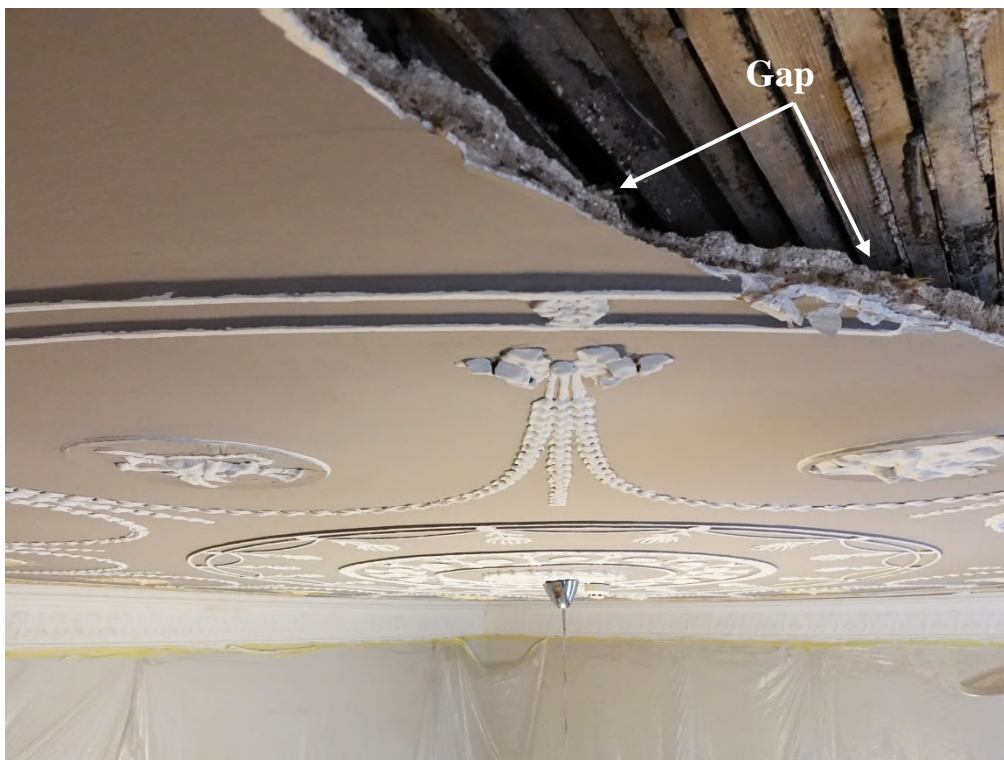
Fig. 08 Deflection of ceiling visible from NE view to SW

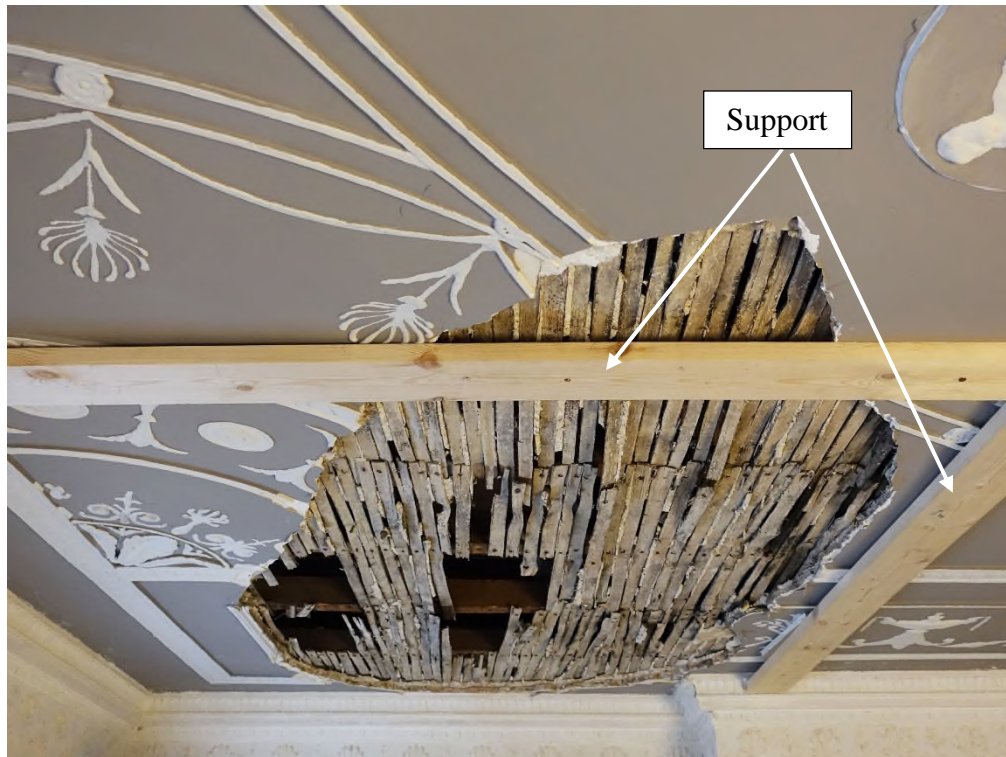
Fig. 09 Temporary 'first aid' restraint of plaster around hole perimeter

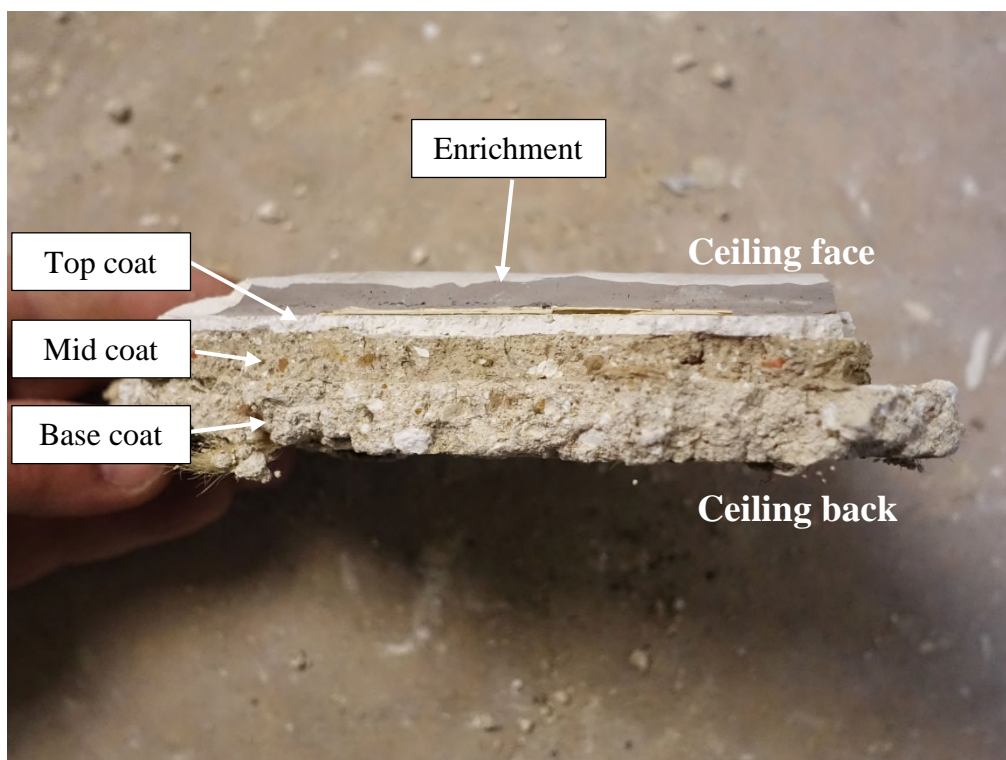
Fig. 10 Three coat haired plaster with coarse aggregate

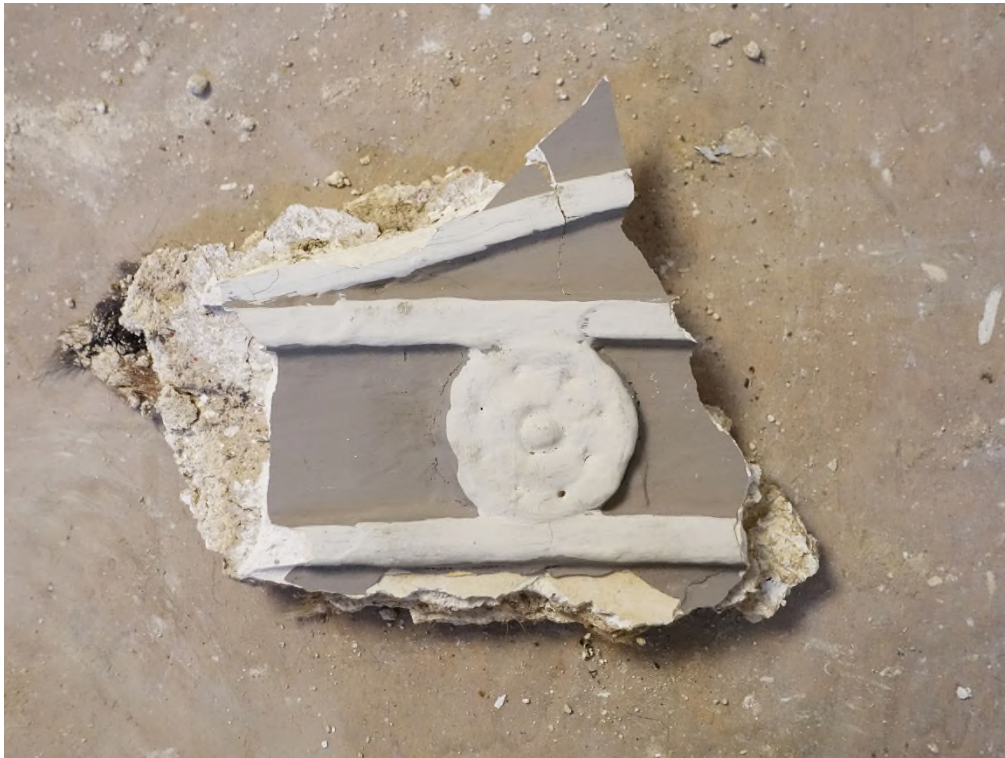
Fig. 11 Decorative cast plaster moulding applied to flatwork

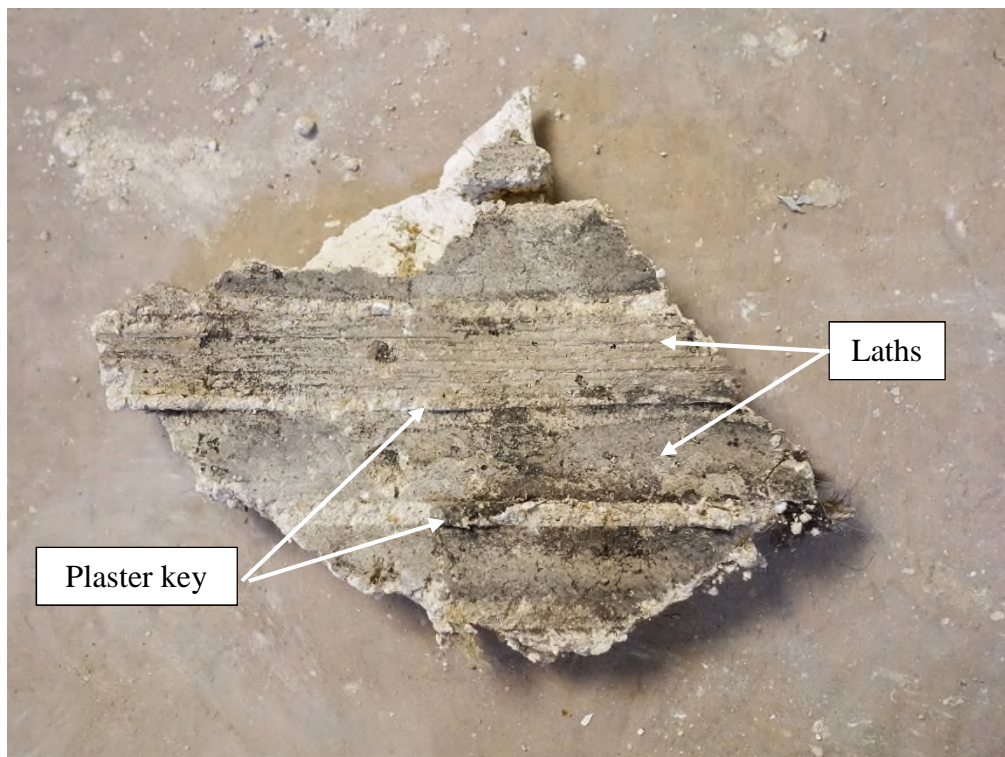
Fig. 12 Pattern of laths and broken key on fragment back

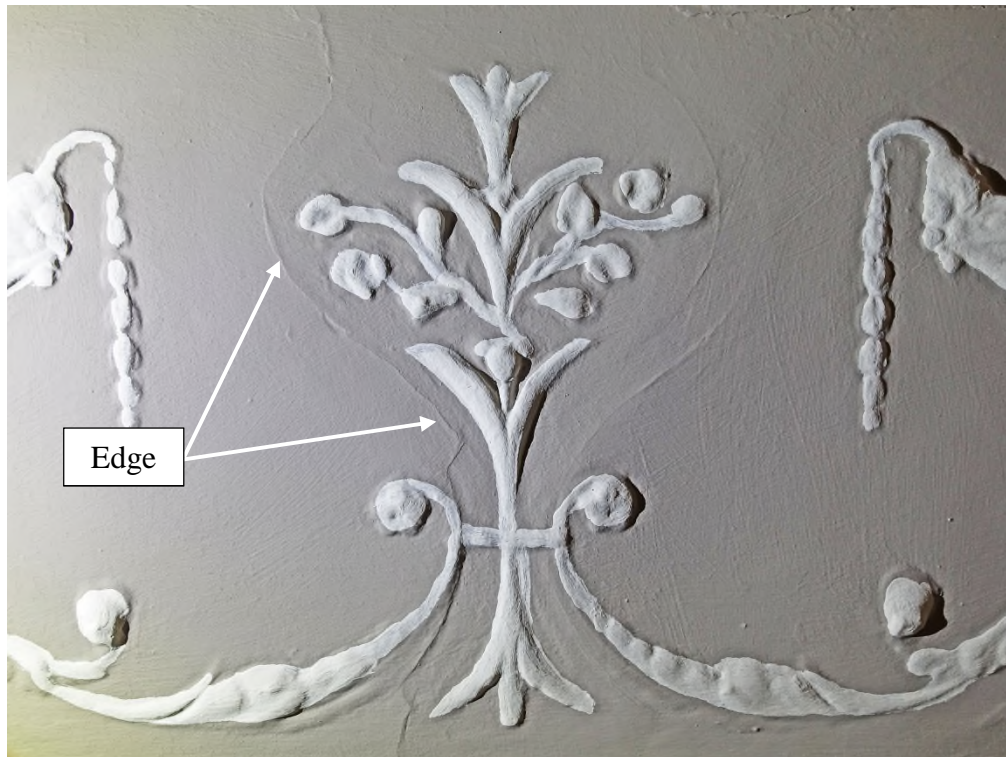
Fig. 13 Edge of cast enrichment evident in raking light

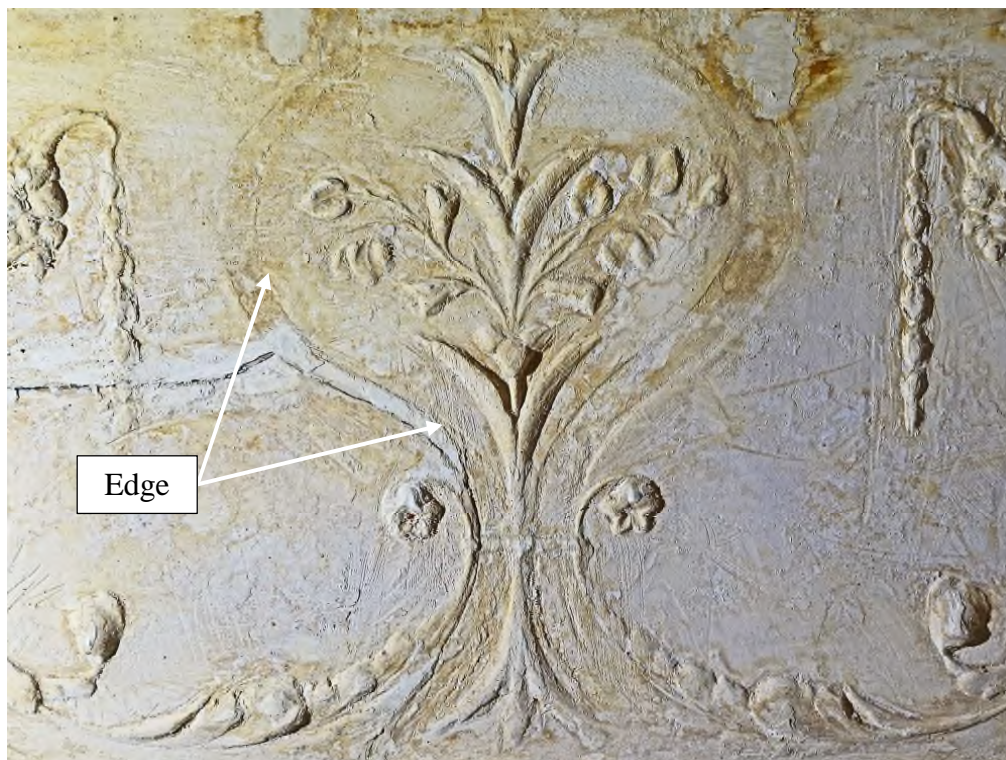
Fig. 14 Enrichment edge exposed from beneath paint

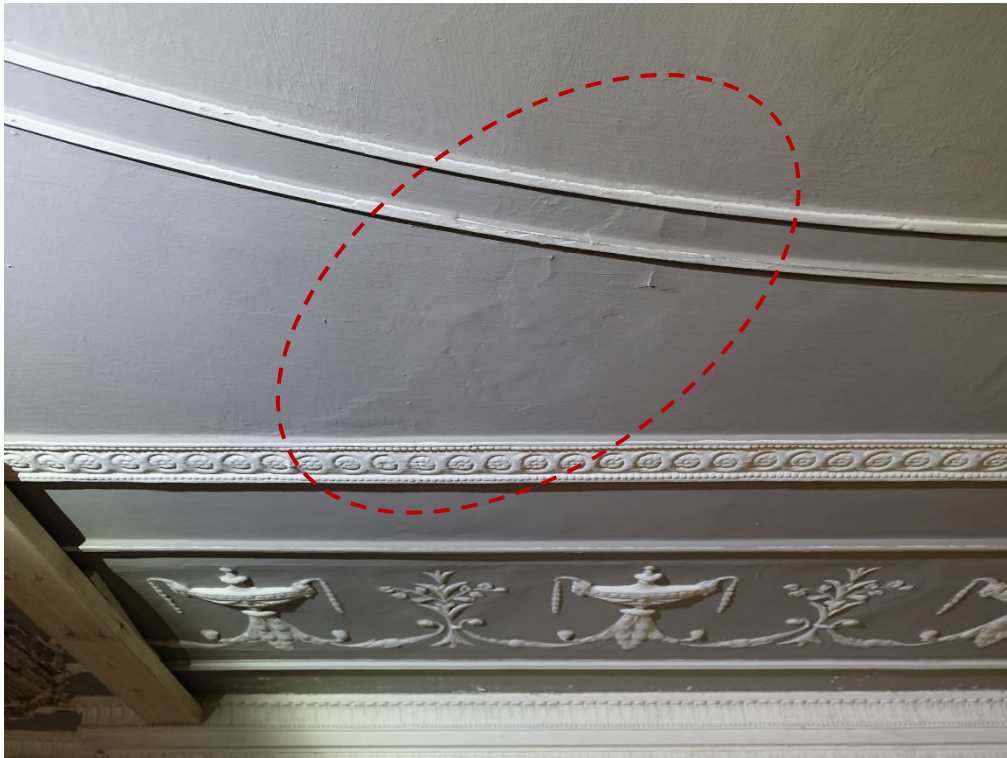
Past repair campaigns of ceiling plasterwork are visible in raking light over the fireplace (Figs 15 & 16) and in the north west quadrant (Fig. 17) equating with deflection of the supporting structure – especially the westernmost N-S truss above, evidenced by the distorted door (Fig. 18) installed in the second floor partition at the north end against the exterior wall.

Fig. 15 Evidence of past repairs above fireplace adjacent to loss

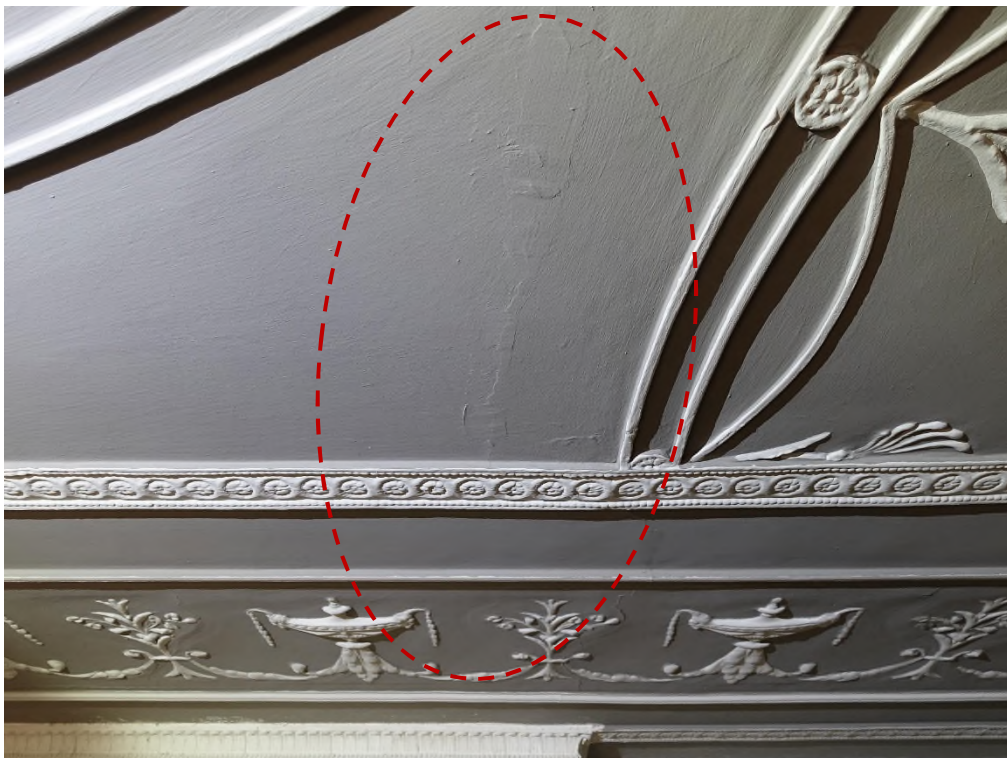
Fig. 16 Previous intervention over south side of fireplace

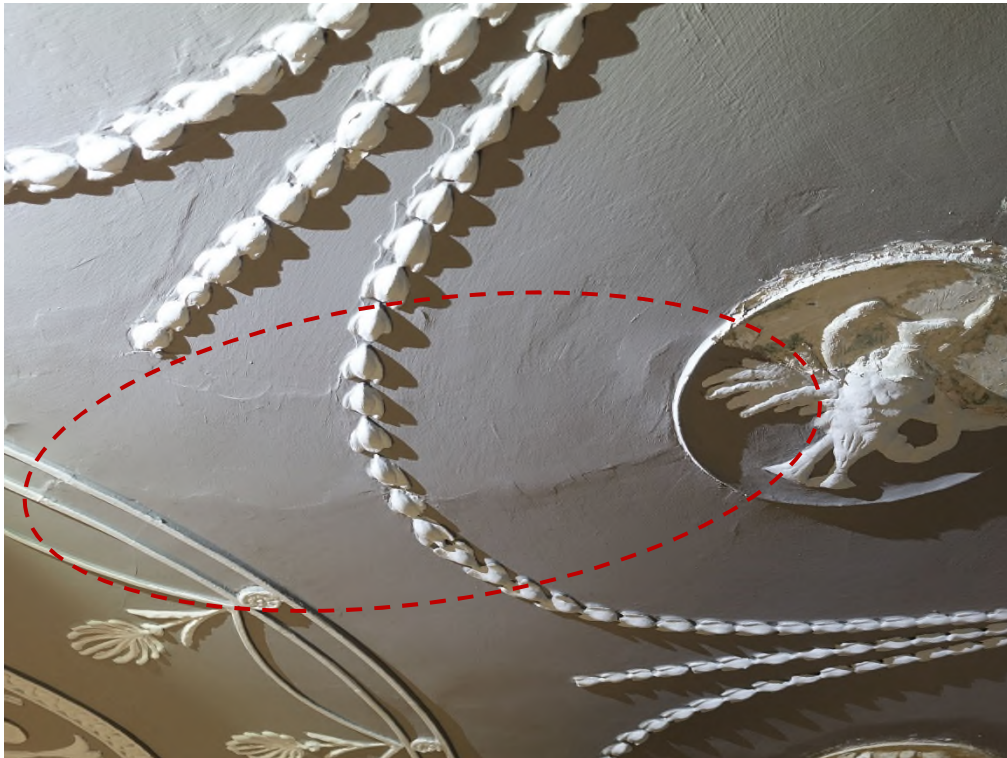
Fig. 17 Deflection and previous repairs to ceiling in NW quadrant

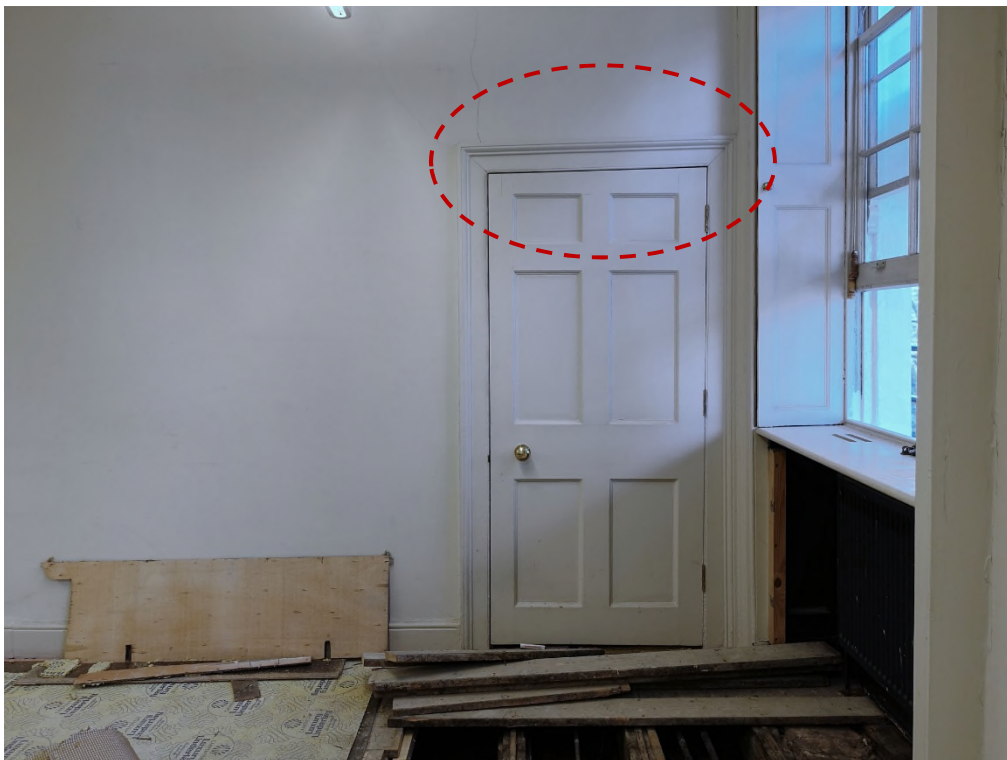
Fig. 18 Deflection of N-S partition and door distortion above on second floor

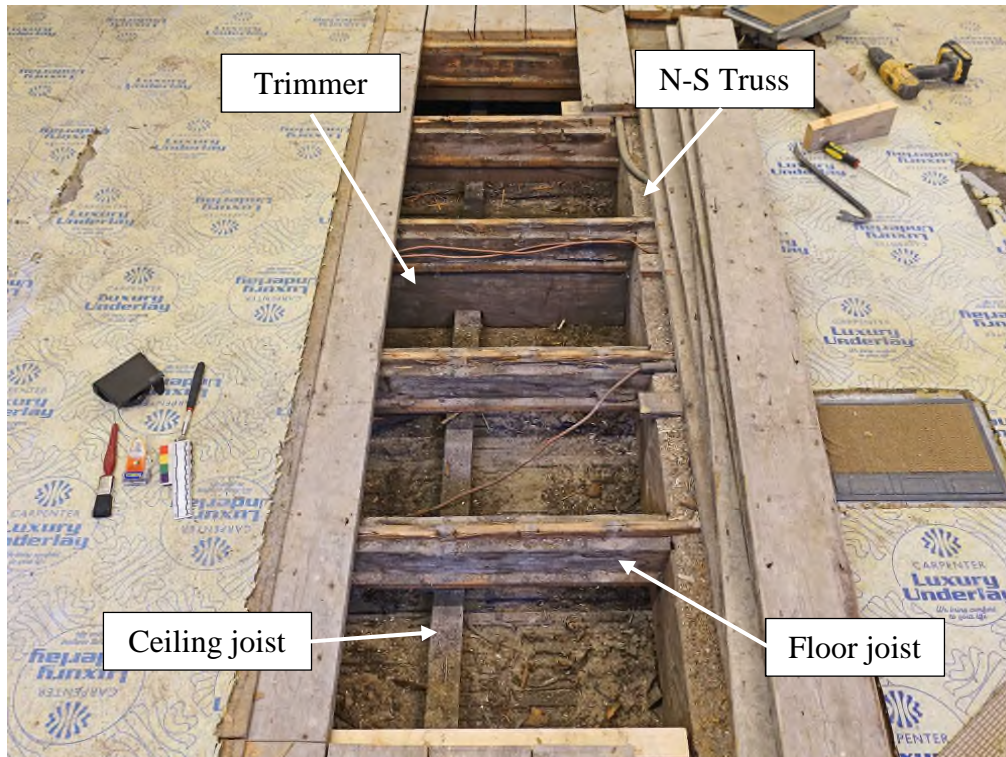
Fig. 23 Ceiling back exposed on second floor east room central area 'A'

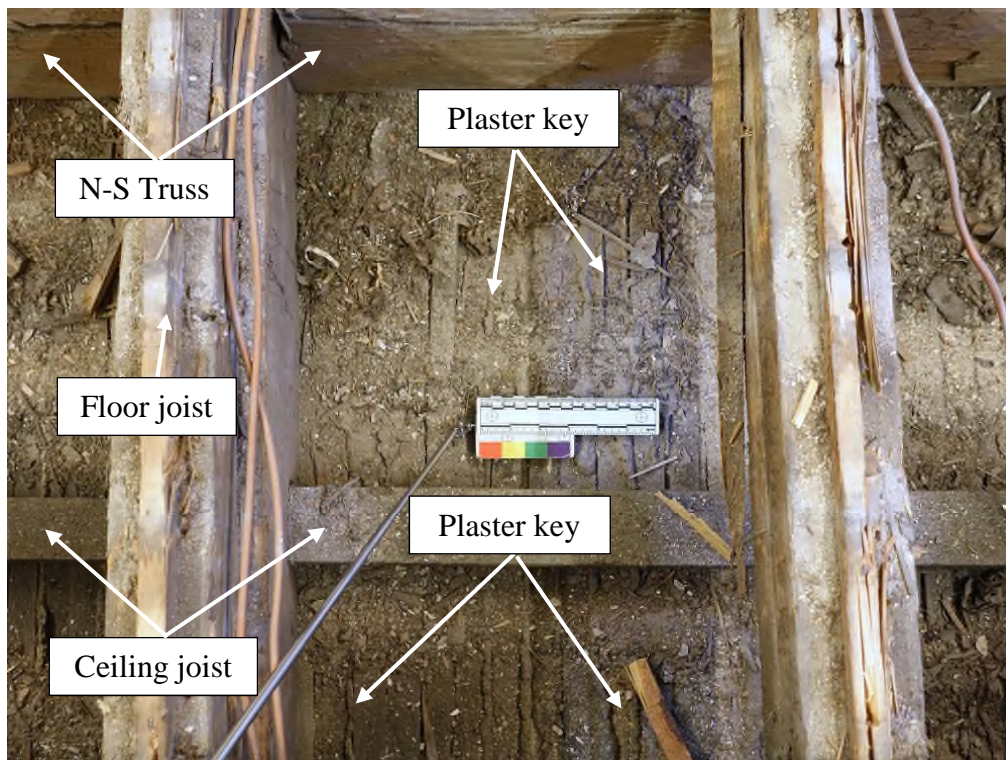
Fig. 24 Ceiling back showing moderate plaster key in central area 'A'

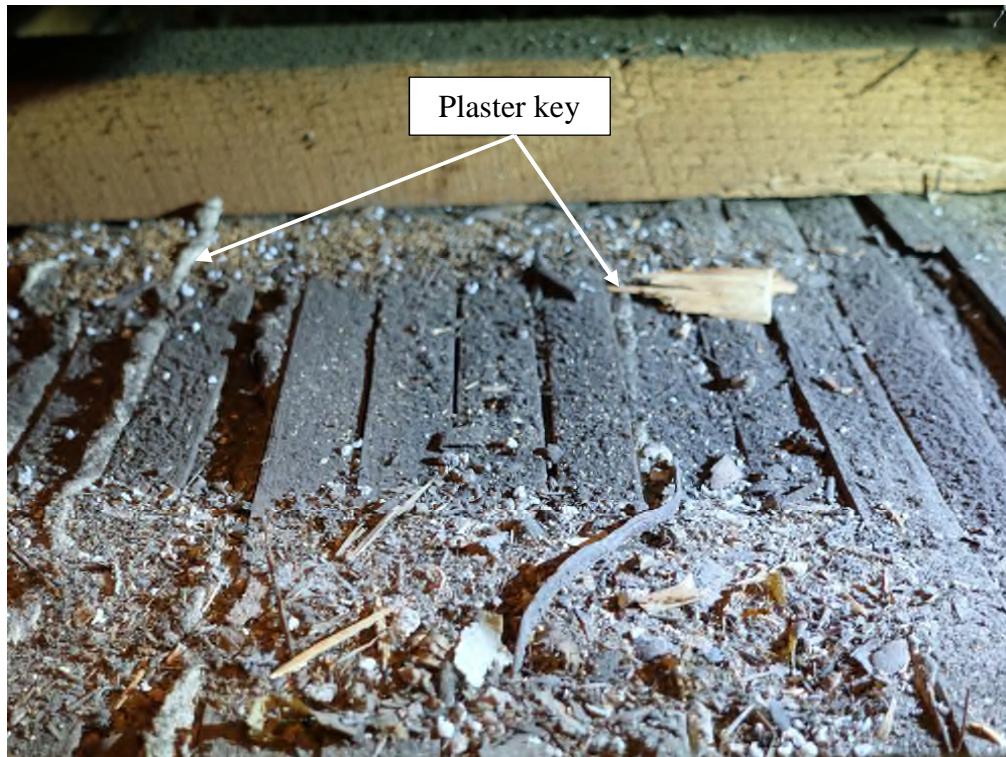
Fig. 25 View beneath central boards shows area of key loss

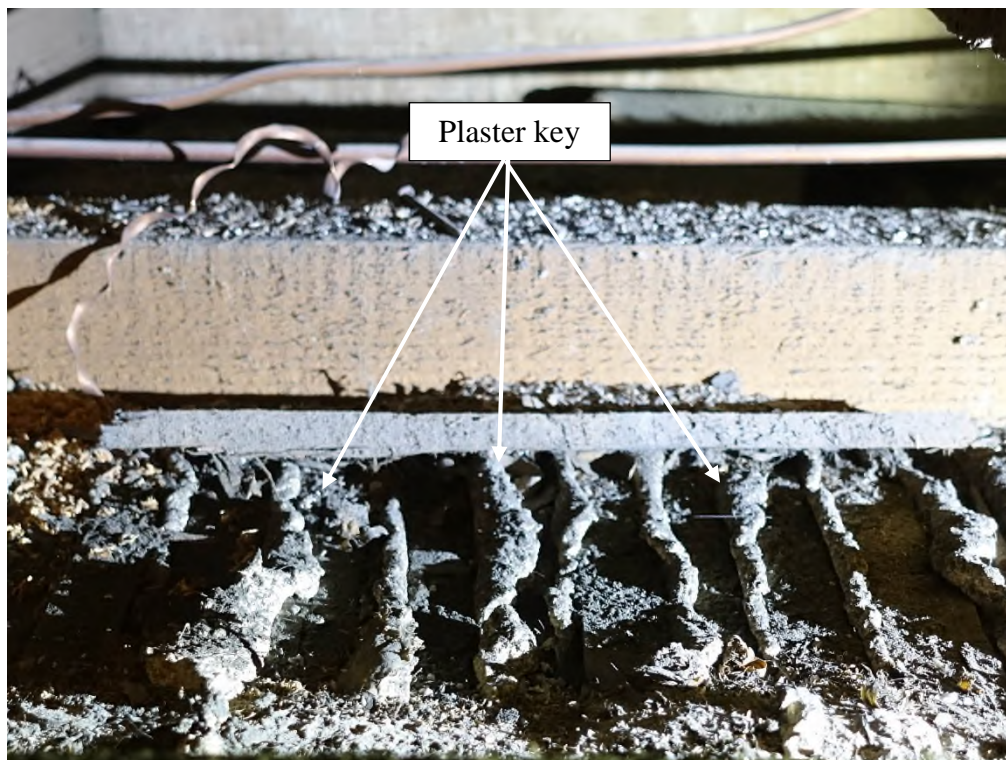
Fig. 26 View in different direction shows good plaster key

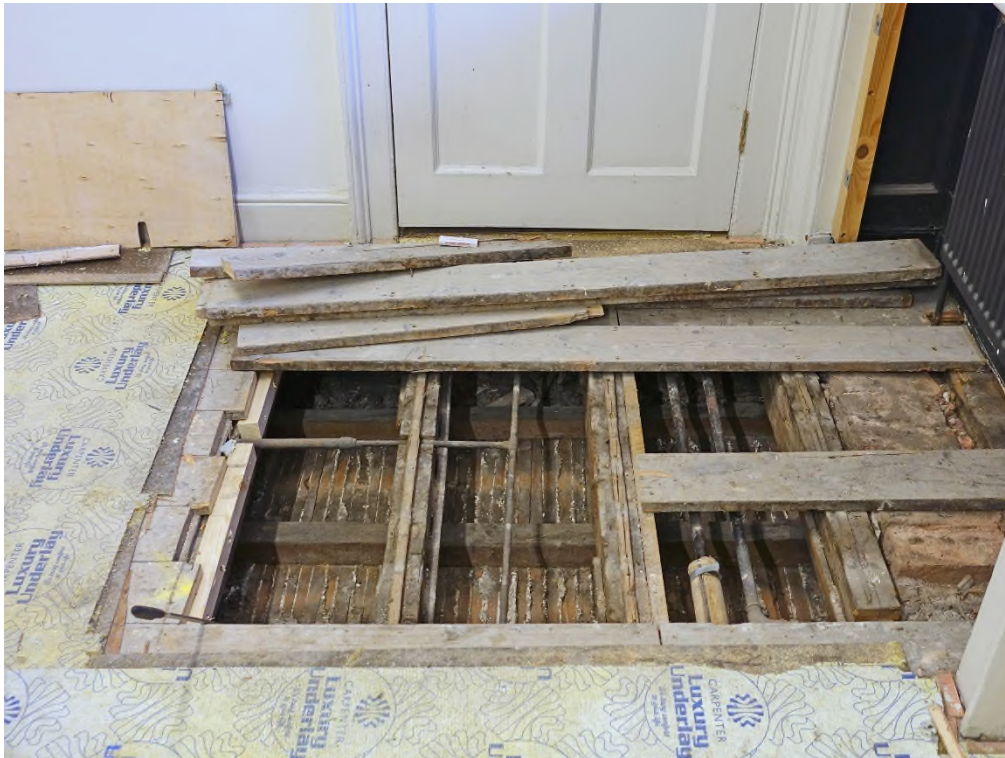
Fig. 27 Exposed ceiling back in east room NW corner 'B'

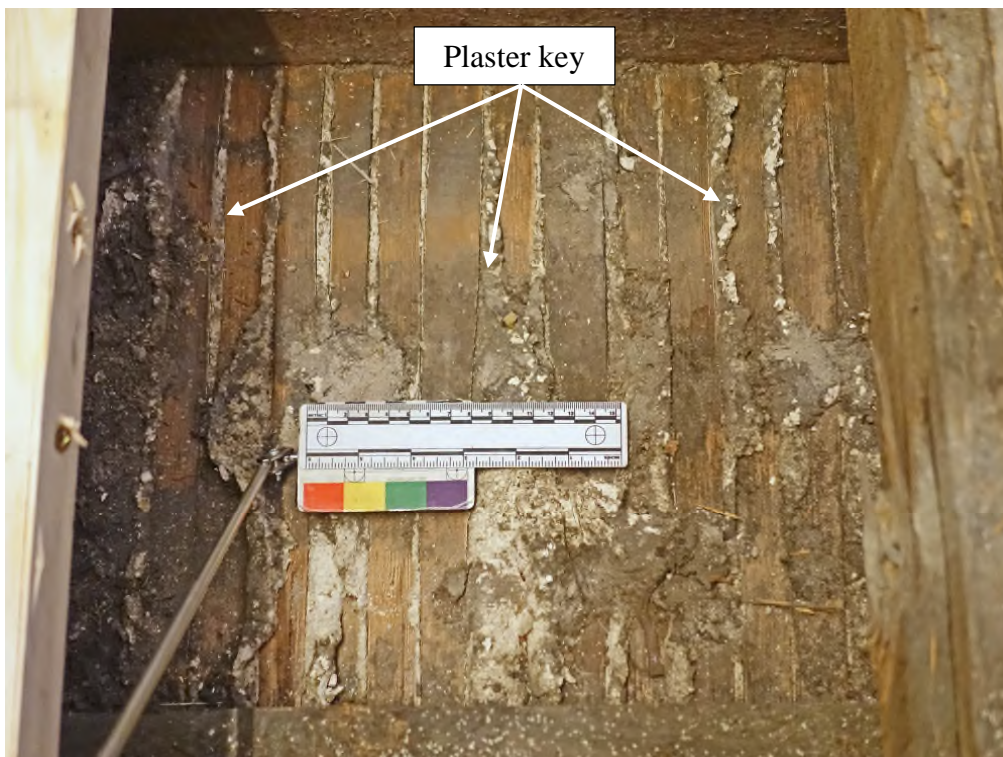
Fig. 28 Adequate plaster key with 150 mm reference scale

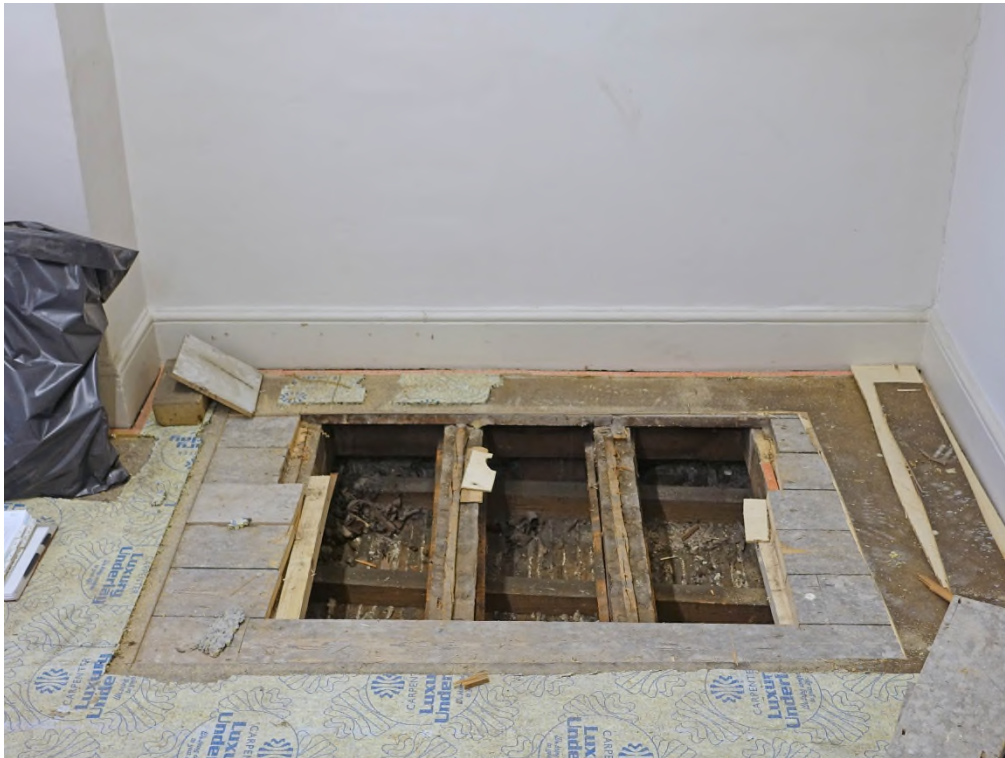
Fig. 29 East room in NW corner adjacent to fireplace 'C'

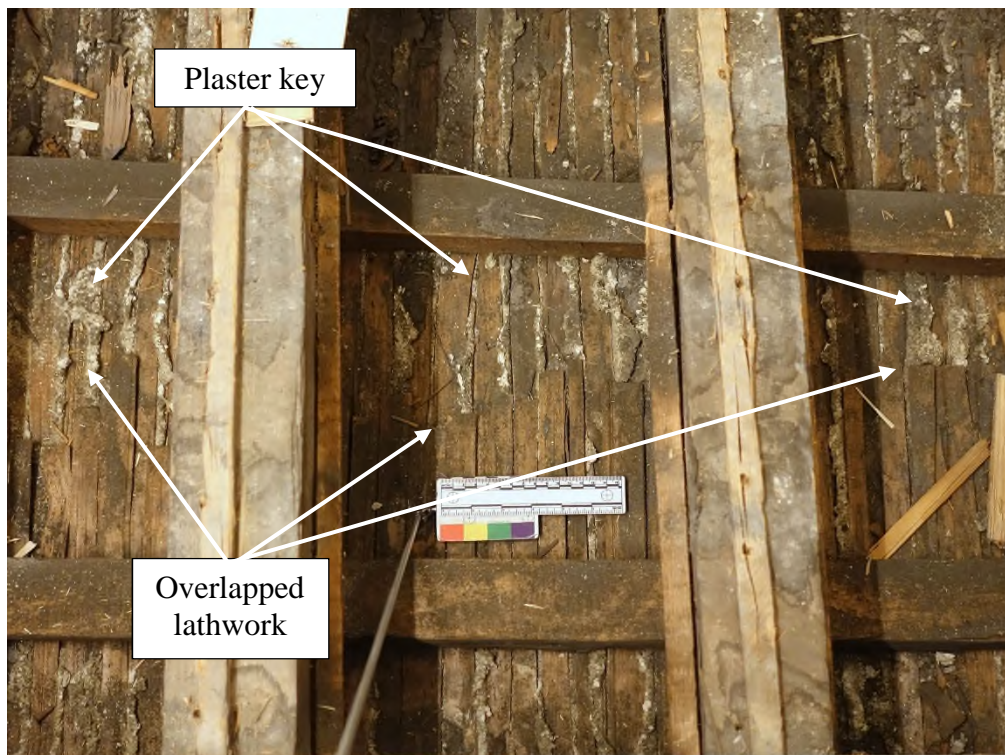
Fig. 30 Formation of plaster key restricted by overlapped laths

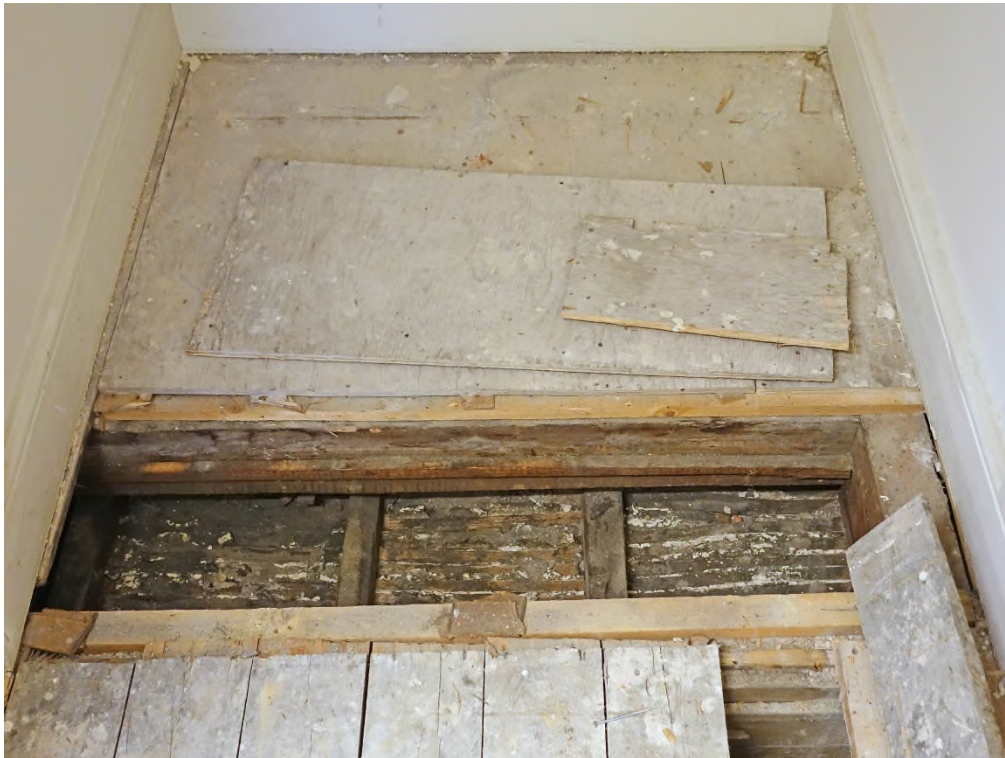
Fig. 31 Ceiling back exposed in SW corner cupboard of west room 'D'

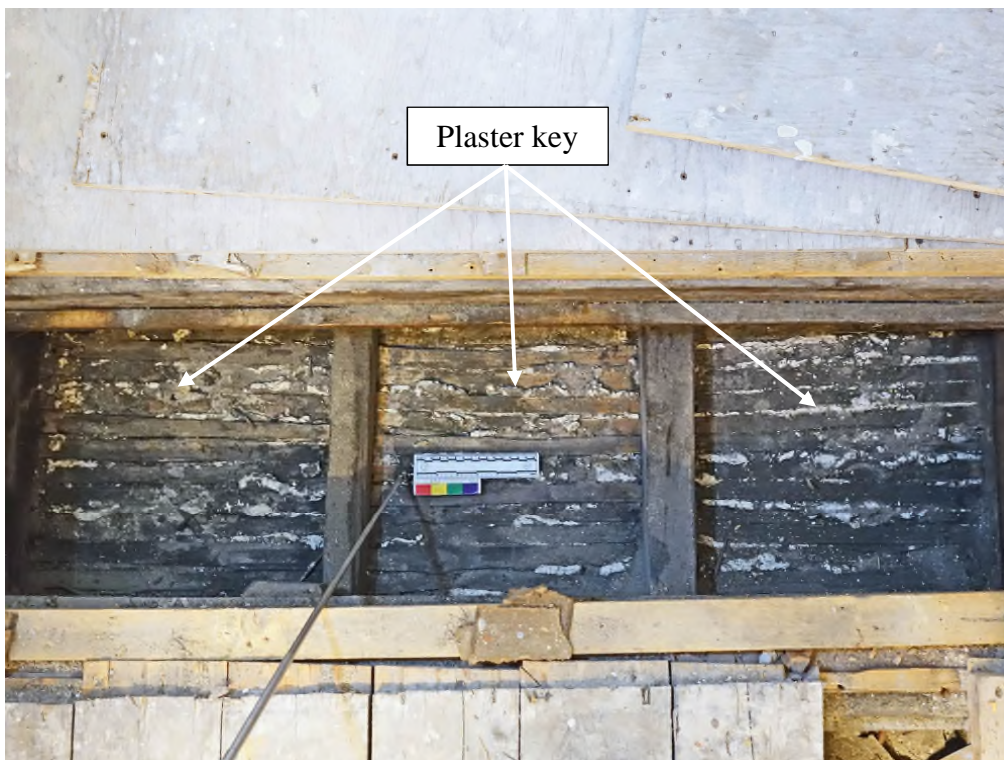
Fig. 32 Plaster key well formed in SW corner

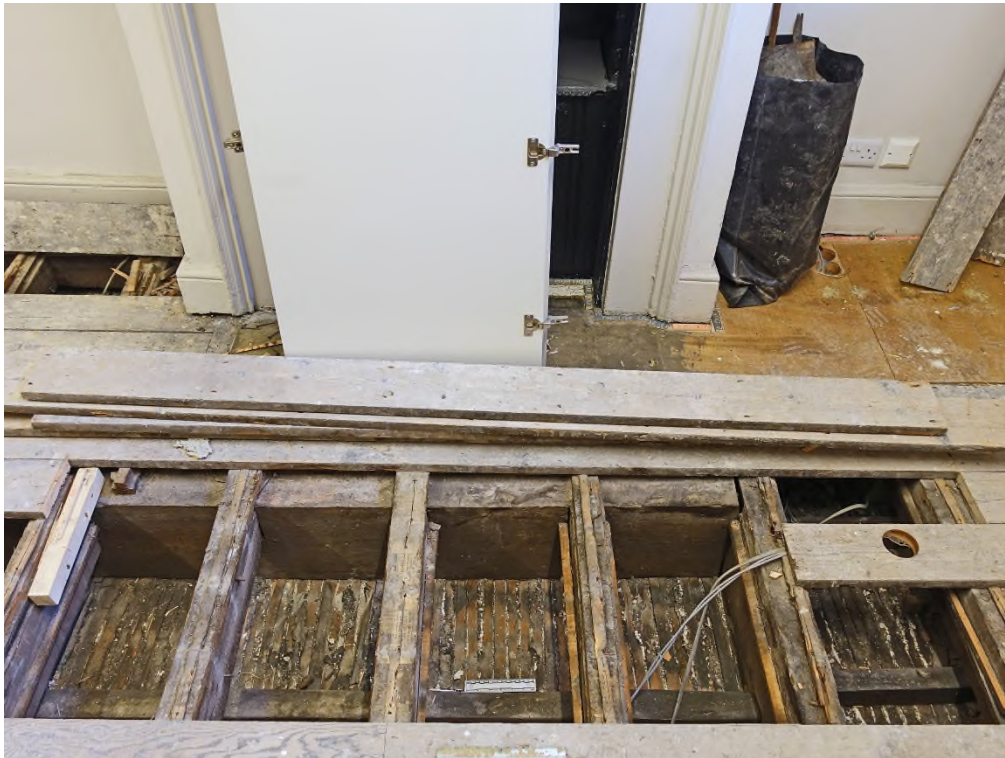
Fig. 33 NW corner of ceiling in west room adjacent to small fireplace 'E'

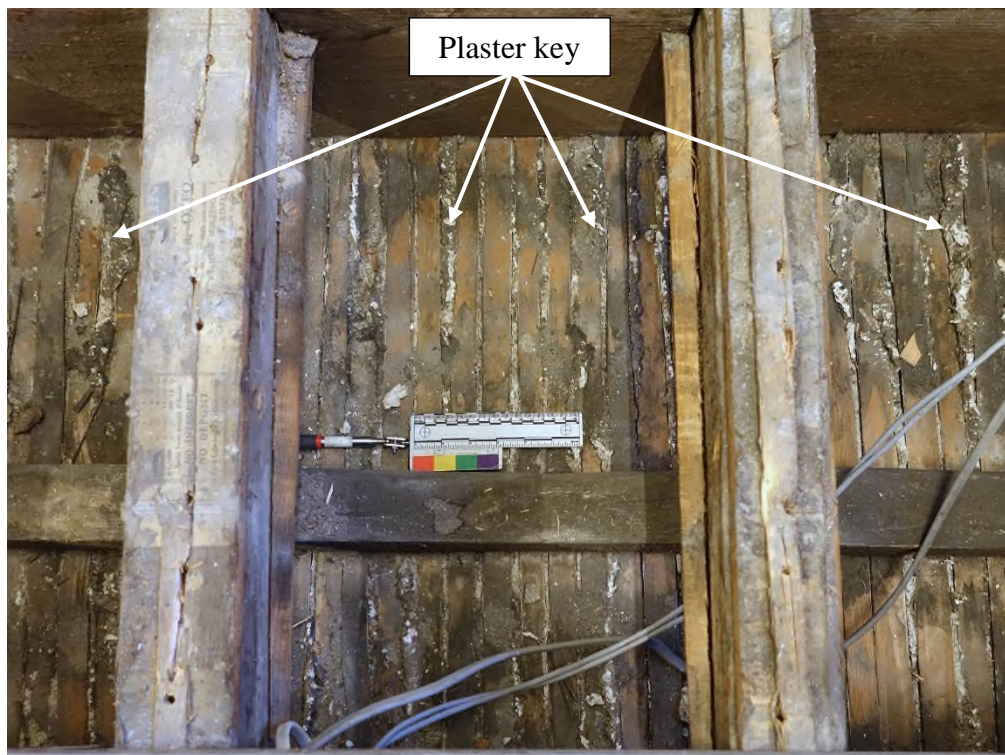
Fig. 34 Plaster key variable in the NW corner
