BS 5837:2012 Tree Survey & Arboricultural Impact

Address: 15a Well Walk, Hampstead, London

Report prepared by Peter Holloway BSc(Hons) FArborA CEnv

Date 20th October 2012

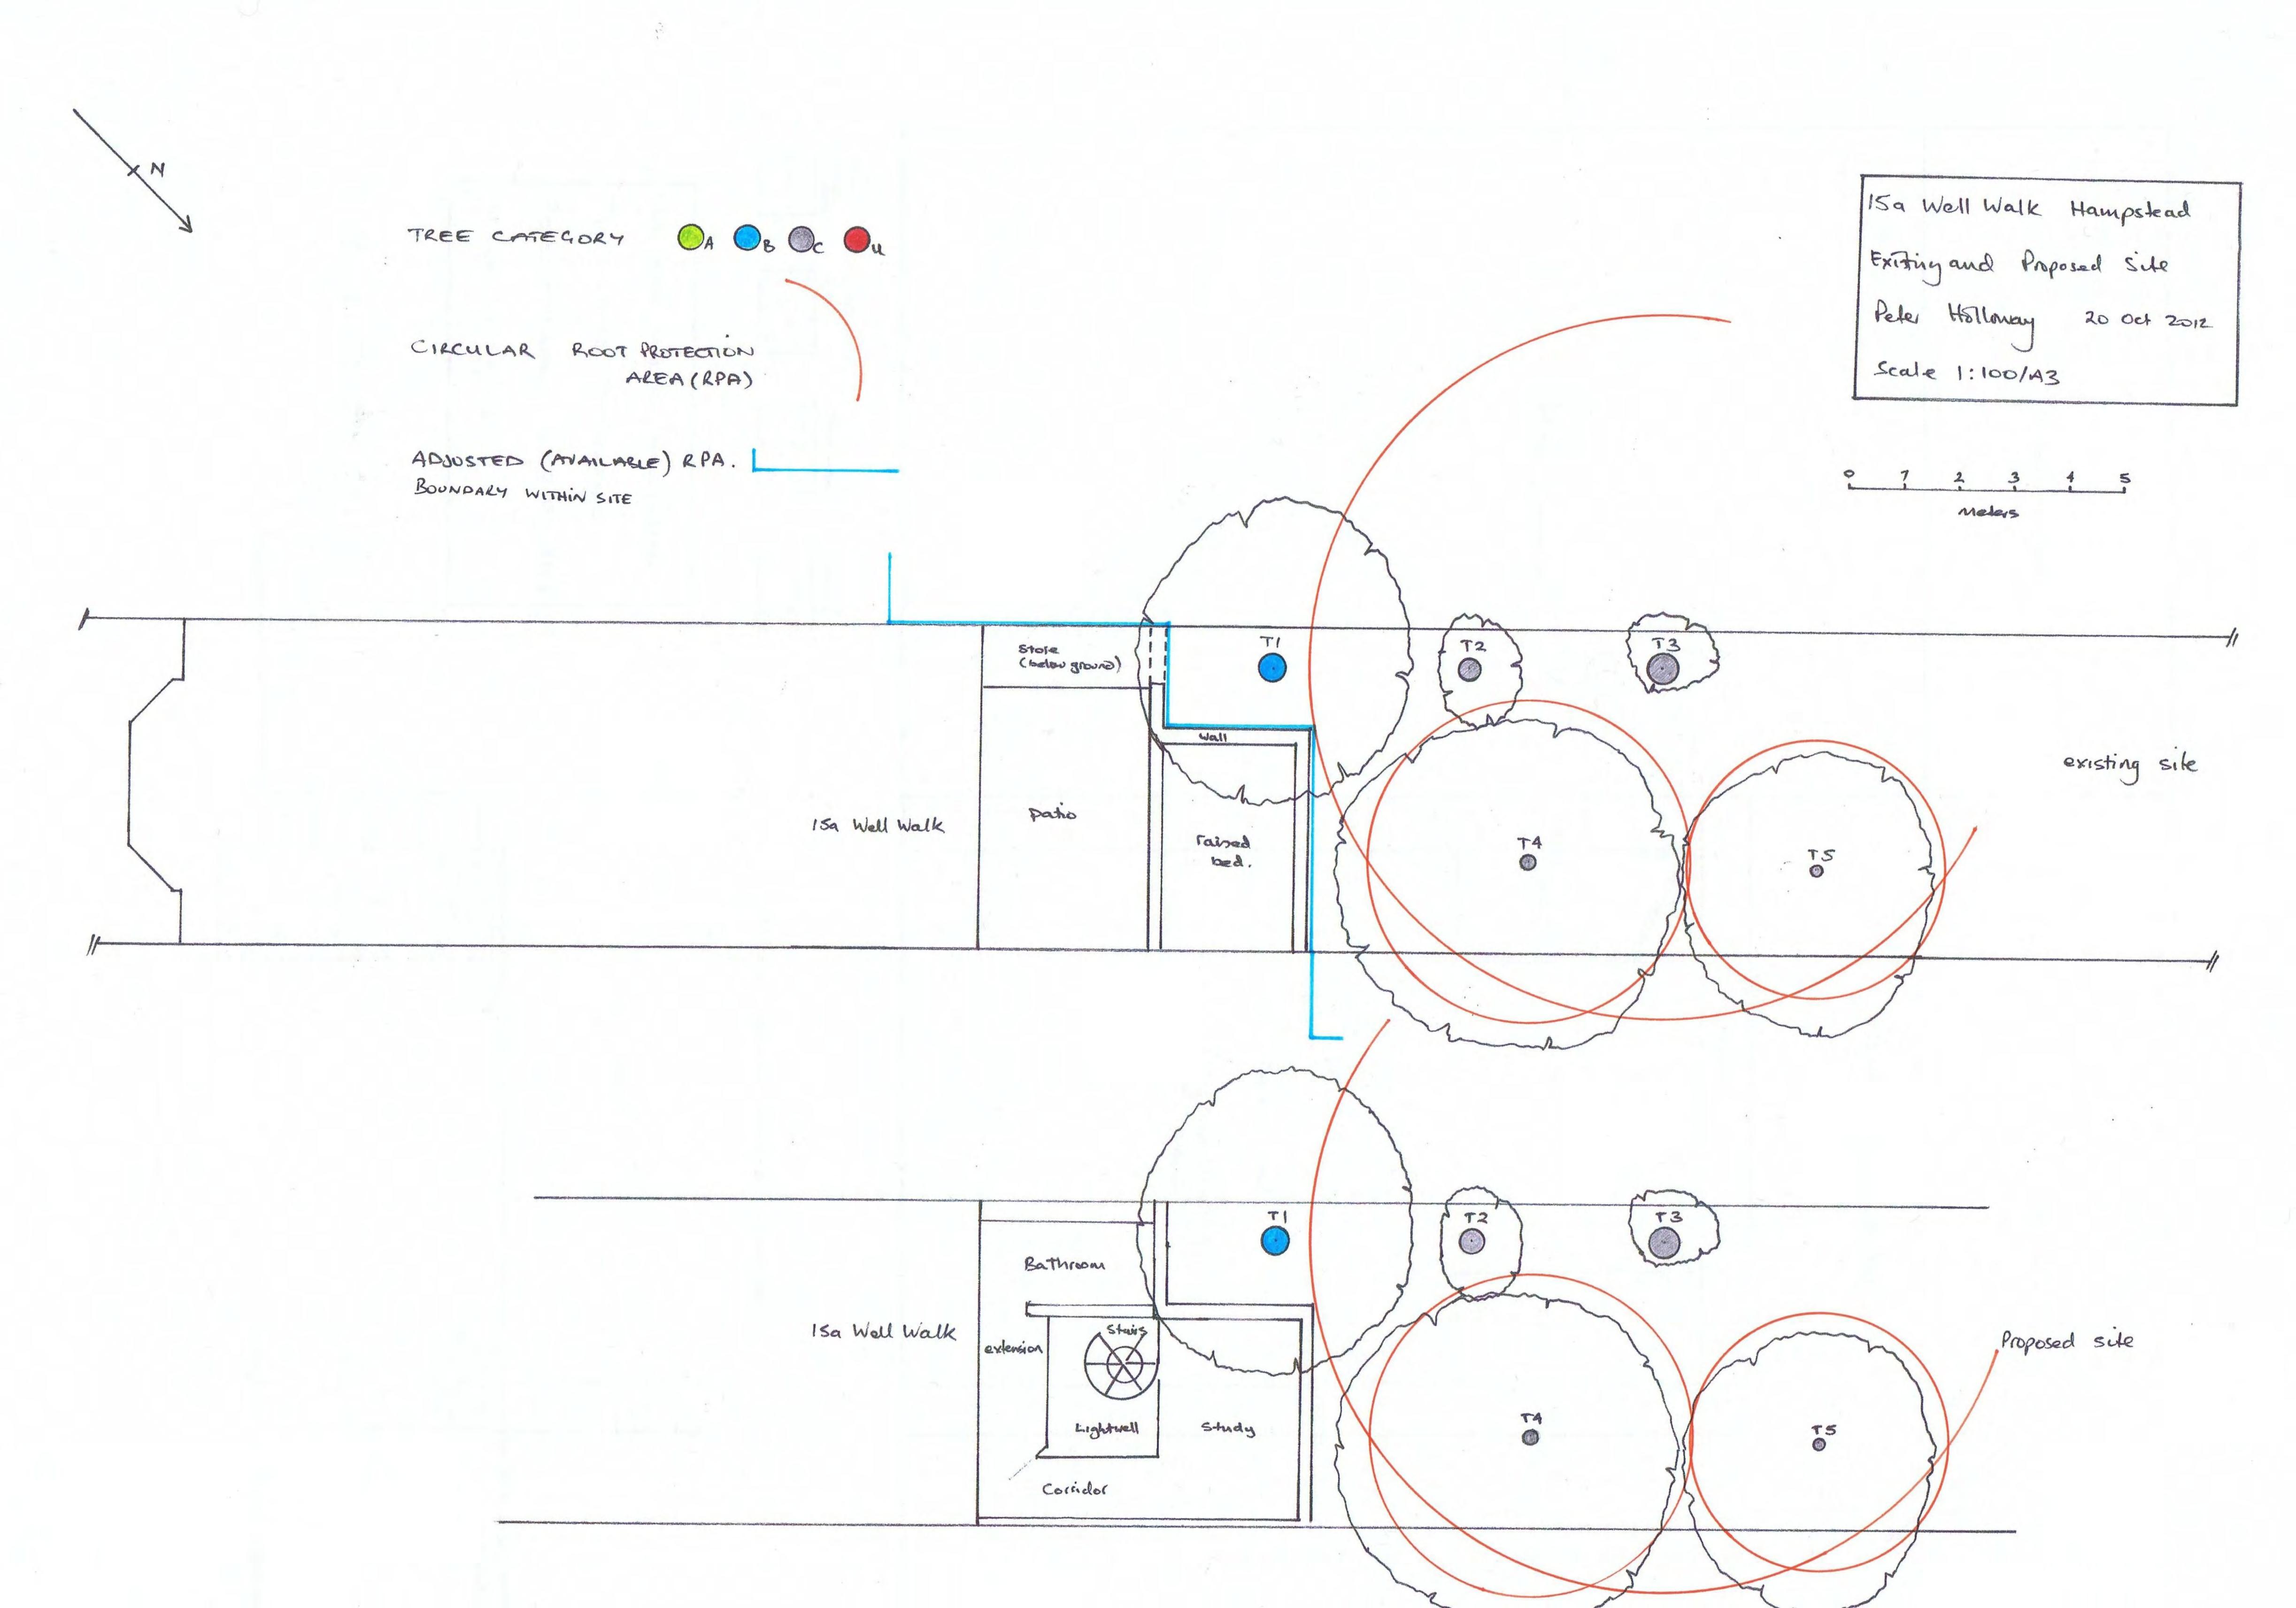
# 12. Appendix 3 Existing & Proposed Site Plan with Tree Constraints

- 7.3 As a result of the trial hole excavations I have shown a modified RPA on the drawing in Appendix 3. This demonstrates that the proposal will not have any direct impact on the trees in the garden.

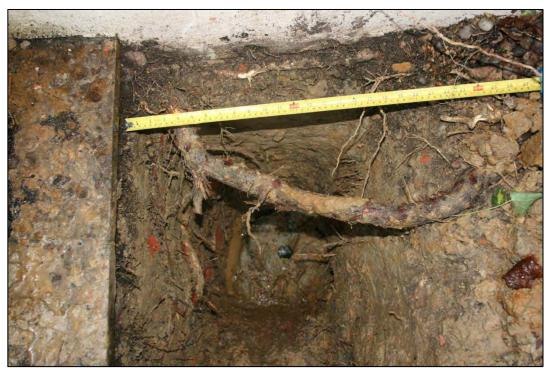
- 6.1 The trial hole results are included in Appendix 4.
- Two roots were discovered in Trial Pit 1 (TP1). One was 20mm in diameter and one was 40mm in diameter. The species of root was not known but if they came from the Lime tree they had grown through the wall and would need to be removed to repair the wall. Nor roots could be seen growing beneath the wall or wall foundation.
- 6.3 No roots were discovered in Trial Pit 2 (TP2).
- 6.4 There were a number of small white roots from the ivy in the surface soil of both trial pits.
- The sub-soil in the trial holes from approximately 300mm deep was sandy and saturated at the bottom of the pits. Water was rising to within 50cm of the top of the pit indicating that it was waterlogged. The pits needed to be bailed out to be inspected.

6.6 I doubt whether the two roots discovered were from the Lime tree because I could not see how they could have grown through the wall. I suspect that they may have originated from a shrub in the raised bed that is no longer present. A pile of spoil and the walls prevented me tracing the origins of these roots.

P1: Trial Pit 1 showing two roots high retaining wall at top.

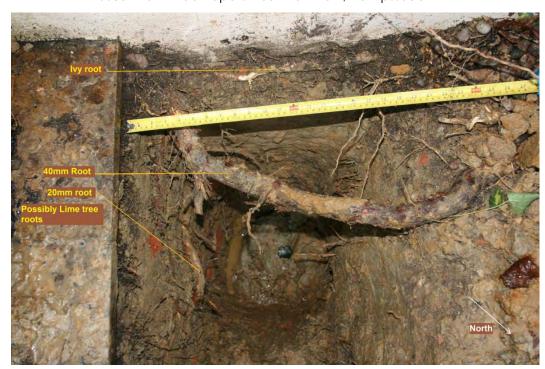
P2: Annotated Photo of TP1

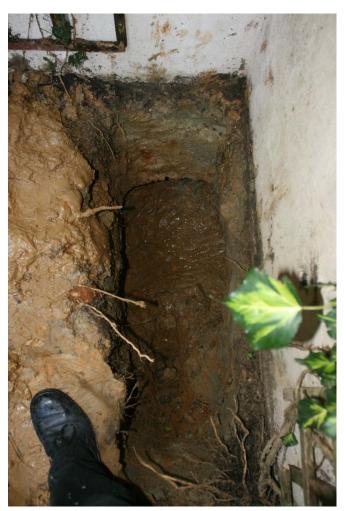
P3: Trial Pit 2 showing ivy roots near the surface.

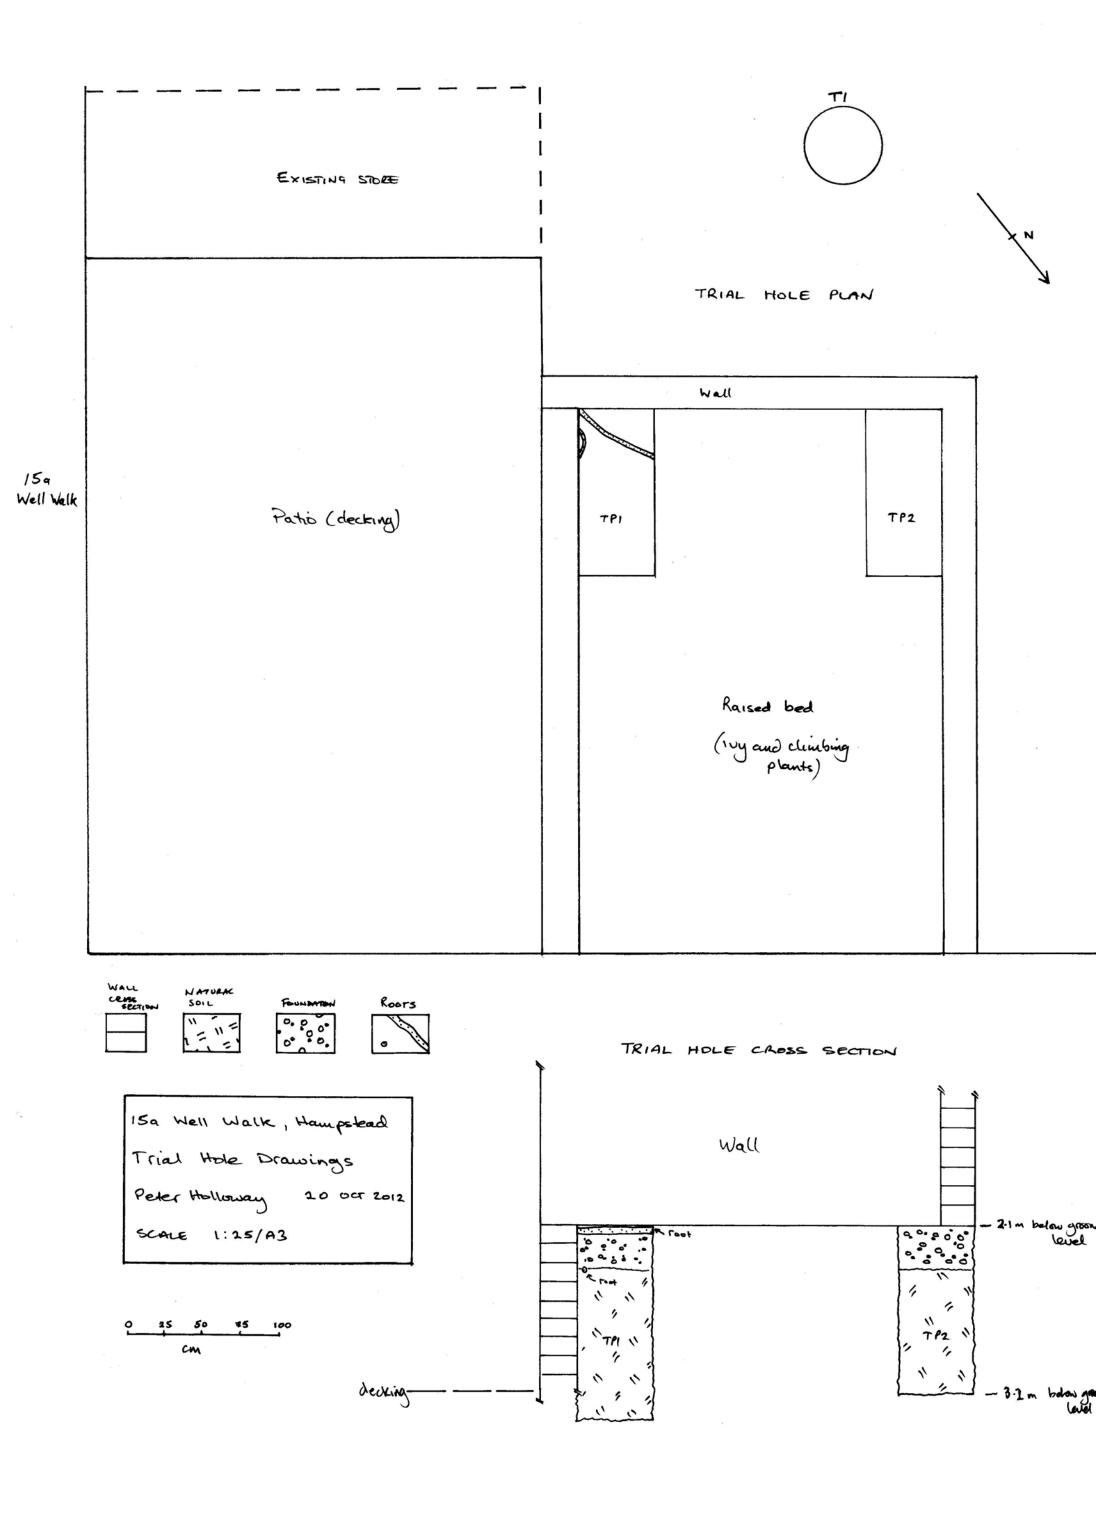
A3.4 Plan and cross section of Trial Hole results.

- A3.1 The plan of the trial hole excavations is attached at A3.4.
- A3.2 Two trial holes were excavated at the most suitable location at the base of the retaining wall adjacent to Lime tree T1. It was not possible to excavate for roots along the whole length of the wall as it would undermine support for the foundations.
