## Proposed Work

Garden Flat of Maryon Hall, 19 Frognal Lane, London NW3 7DB

### A. Explanation of the sources considered and expertise consulted in resolving the flat's problems

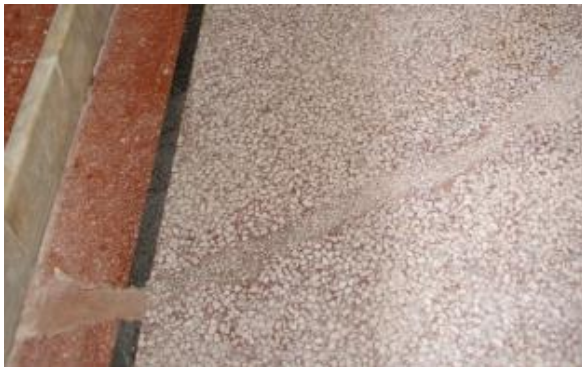
**Photo 1:** Part of filled crack in living room terrazzo floor

- vi) The significant void under the living room terrazzo floor created by erosion - washing out of silt fines by water escaping from the drainage system by the front door and possibly by ground water action over many years - is to be filled by injection through a few small holes made through the existing crack in the floor. This is to prevent water collecting under the floor, and provide support for the floor. The large floor crack (see photo 1), now filled, has been there for many decades, but with a large void below the floor (it previously was laid onto the soil below) we have some concern for its weight-bearing strength, and wish to rectify this, as well as improving the previous crack fill whose marble chips are of too small a grade. It is thought this will tend to stop water flowing below the floor which would in turn prevent further erosion and void formation in the future.

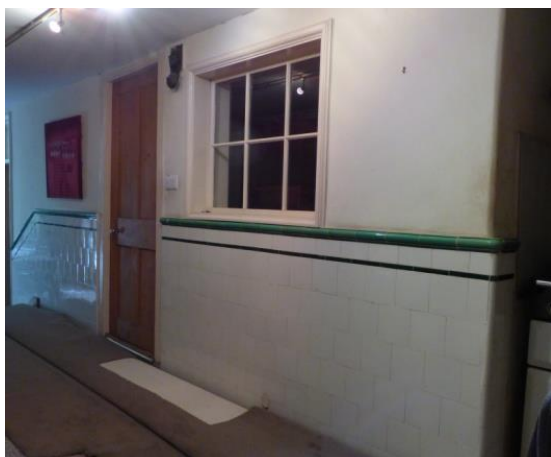
*Photo 2: White & green tiling in current kitchen*

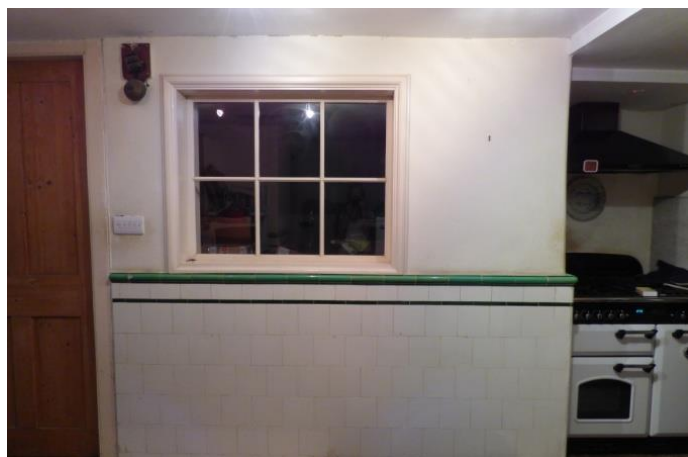
*Photo 3: Wall section above white & green tiling to be removed*

By retaining the tiled wall between the current kitchen and hall (currently pierced by a modern window) but taking it down to the level of the top of the tiles (see photo 3) and retaining its curved-off end, this area will be opened up into the new dining area beyond (part of the current kitchen), making it possible to pass food and crockery to and from the kitchen and the dining area. This will also open out the area so that it feels more spacious and less like a corridor, though the fact that it was a corridor will still be clear from retention of the original green and white tiling. The current doorway to the current kitchen area will be removed, and the Victorian door re-used within the flat.

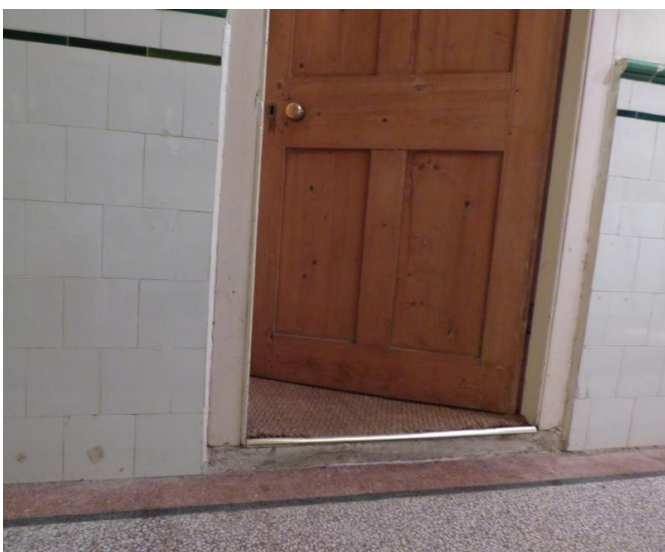
The current hall was poorly tanked in the 1970s, is very damp (see photo 11 in the Design & Access Statement), and the small 4cm difference in height from the hall into the main flat (see photo 4) means that many guests both trip up and fall down this step. A trial pit has confirmed that in the current hall area there is no existing Victorian terrazzo beneath the concrete floor.

**Photo 4:** Small 4cm step from terrazzo floor in current kitchen up to concrete hall floor - the cause of many trips

Since the new kitchen area requires re-tanking and insulating we would like to lower this floor by 4cms to the level of the terrazzo. We have now obtained advice on the feasibility and the calculations required to lower the current hall floor from structural engineer Jacqui Osborne (see drawings 'Structural Proposed Floor Plan 14084-010'; 'Structural Proposed Details 1 14084-020.pdf'). This is in addition to her calculations for providing support to allow removal of a section of wall between the hall and cupboard behind, and lowering the wall between the hall and kitchen (drawings 'Structural Proposed Floor Plan 14084-010'; 'Structural Proposed Details 1 14084-020'; 'Structural Proposed Details 2 14084-022').

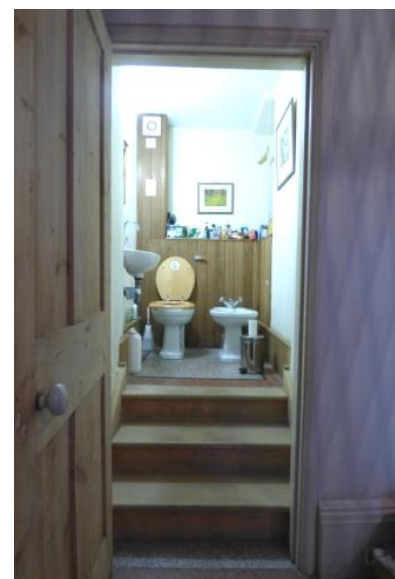
- 3) Lowering Bedroom 1's en-suite WC floor.** The en-suite WC to the main bedroom is accessed via three steps (see photo 5). These steps are proving problematic at night time and it is proposed that while modernising the sanitary ware here, the terrazzo floor be very carefully cut out, lowered and moved outwards to the terrazzo of the rest of the bedroom, removing the three steps (see drawings 'Structural Proposed Floor Plan 14084-010.pdf' section 4-4 and 'Structural Proposed Details 2 14084-022.pdf'). The gap behind will be filled by sympathetic and hygienic flooring under the WC. While this removes a feature of this part of the room, the wooden steps here are not original: the previous steps had rotted due to flooding incidents and dampness here and required replacement in 1997. This would help enable us to remain in the flat for 25-30 years. We have concerns that night-time visits to the WC up three steps would become dangerous as we become more elderly. There has already been a nasty fall here, and permission to do this would be welcomed.

**Photo 5:** Three steps up to en-suite WC off Bed 1 (previously a corridor)

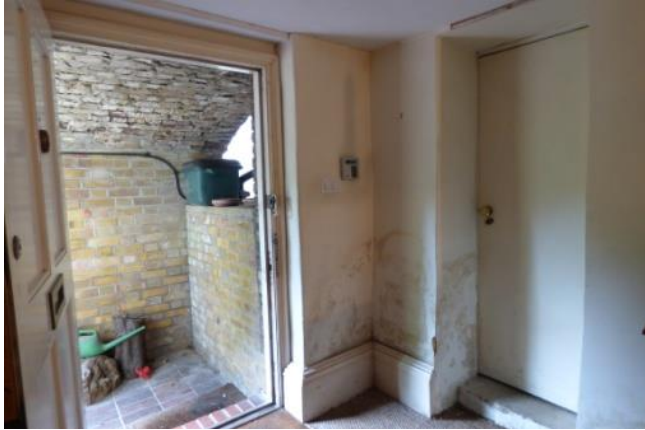
- 4) The doorway to the pottery studio / workshop area – 68cms wide and reduced further by the door posts - is very narrow (see photo 6). Given the wall thickness here, this makes it very difficult to move larger furniture/ objects through and turn the corner. This doorway is unlikely to be original and, probably in the 1960s, was fitted with a modern door (since replaced with a more fire-resistant door) and a concrete step for the change in levels. The doorway could have previously been unnecessary as there was originally a wide (102cm) entrance to the corridor where the cooker is currently (see photo 3). It is proposed that the doorway to the pottery studio / workshop be widened here to 94cms, but the sense of an original 51cm-thick wall be retained by hanging the new door in its current position at the far side of the doorway and deepening the step.

**Photo 6:** *Narrow doorway to pottery/workshop area, to the right of the front door, with step*

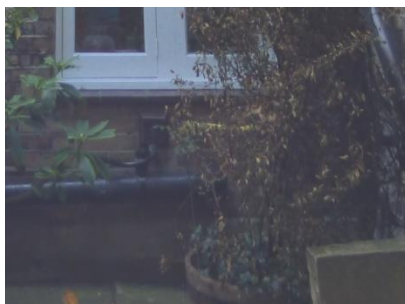
**Photo 7:** *Current extractor outlet between window and drainpipe.*

- 6) **Boiler.** The boiler will be moved to a currently unused area under the steps up to the pantry on the mezzanine floor. The flue for the boiler will share the extraction point used by the Saniflow from the main bedroom's en-suite WC, as seen in photo 5 in the Design & Access Statement and as in photo 7.

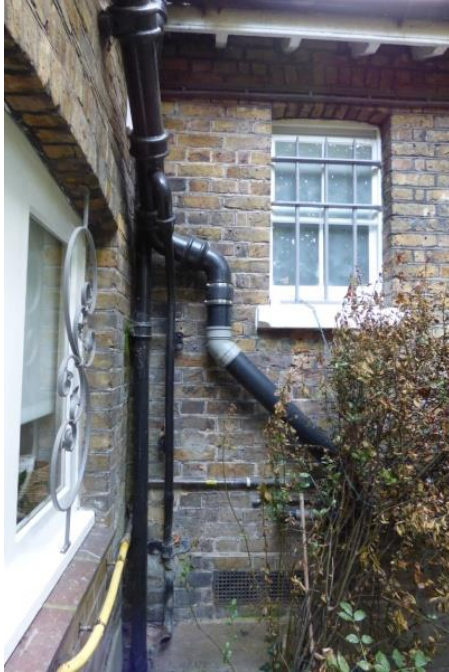
**Photo 7:** Proposed extractor site above render.

- i) One small extractor fan outlet (other extractor fan outlets remain as current, re-using those already there). The new outlet will be at the rear of the house on a wall at 90° to the line of sight here, at near ground level and partly hidden by existing drainpipes, so essentially barely visible. Its internal position is immediately above a grill on the outer wall just above the lower render (see Photos 7 and 8) so it is hoped to direct the outlet downwards to this point and to clean-up and retain the existing grill as a cover. If this proves impossible, then a similar narrower pierced metal grill will be placed above this, below the current horizontal drainpipe here.

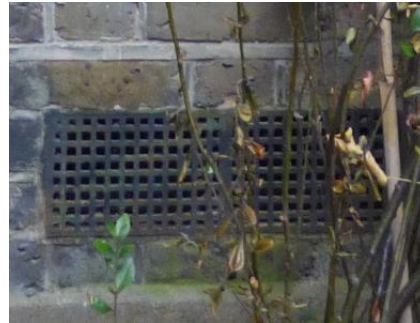
**Photo 8:** Pierced metal grill above render

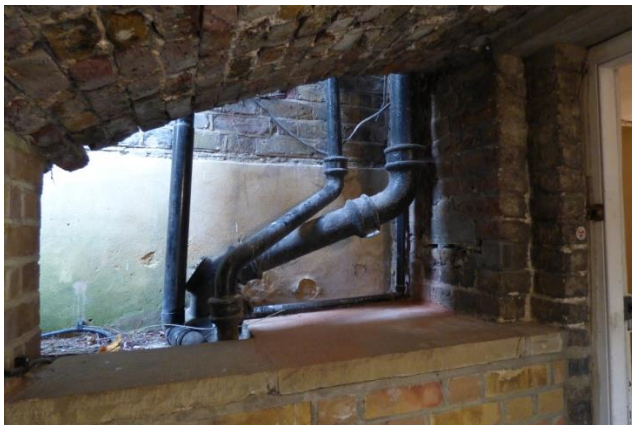
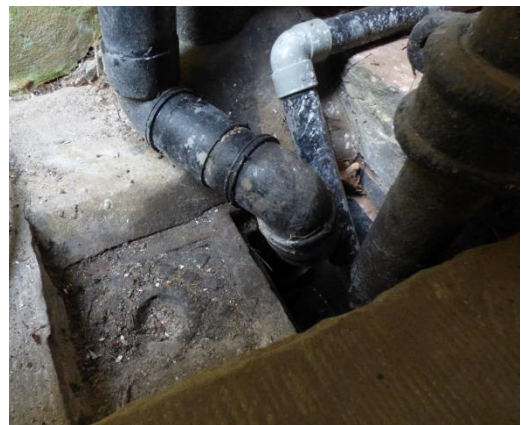
- ii) An overhaul of the down pipes from the roof of the 2-storey section and part of the main roof and mansard gully that pass the side of the front doors to the garden and ground floor flats. These pipes are a visual mess near the main entrances to the ground floor and garden flats (Photos 9 and 10). The spalling render here and to the right of the front door will be replaced with waterproof lime render.

**Photos 9 and 10:** Downpipes passing front door to the trap within modern brick 'box'.

They are also contributing to the significant intermittent flooding of the lower flat. The larger cast iron drainpipe will be retained; the smaller cast iron and several plastic and collapsing small drainpipes will be rationalised into a better quality and adequately-sized drainpipe feeding directly into a new trap, thus more sympathetic and protective for the building.
