Project: 100 Avenue Road Development, London  
 Job Description: 3D Deformation Monitoring  
 Monitoring Location: Swiss Cottage Underground Station  
 Project Reference: SAL-1311-01  
 Sheet Reference: SAL-1311-01-02 Set 00 - Perpendicular Monitoring Graphs

Project: 100 Avenue Road Development, London

Report Reference: SAL-1311-01-01 Set 00 Rev0 - Levelling

## APPENDIX G STATION & TUNNEL CONDITION SURVEY

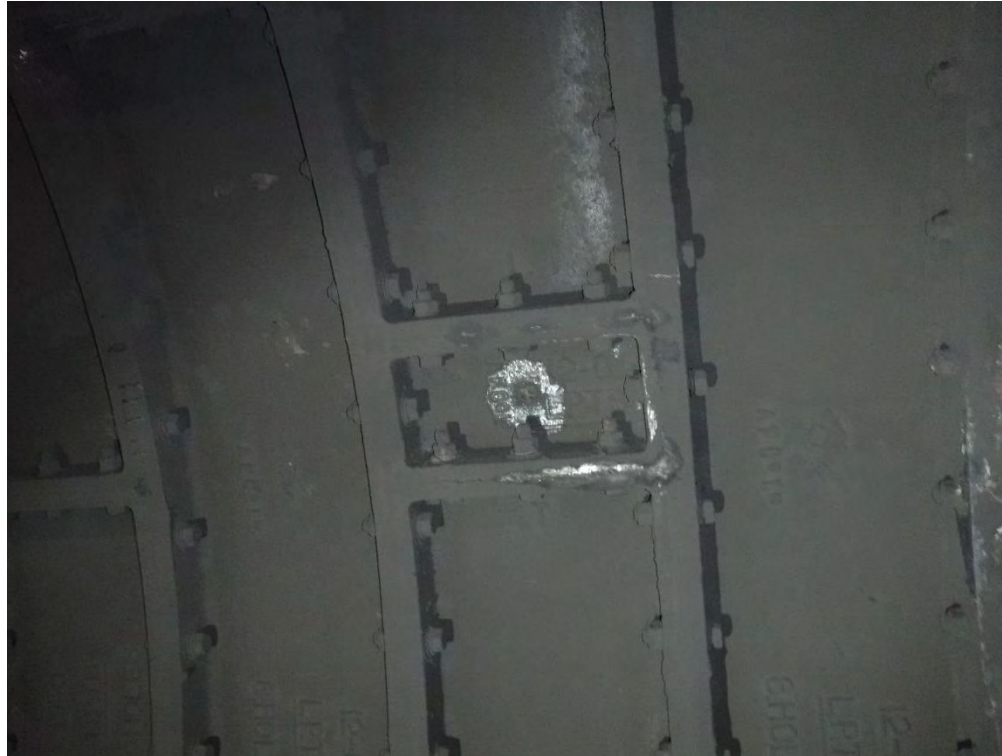
Photo-15, 70/1 @ 11 o'clock  
Water seepage about lifting hole and plate joints

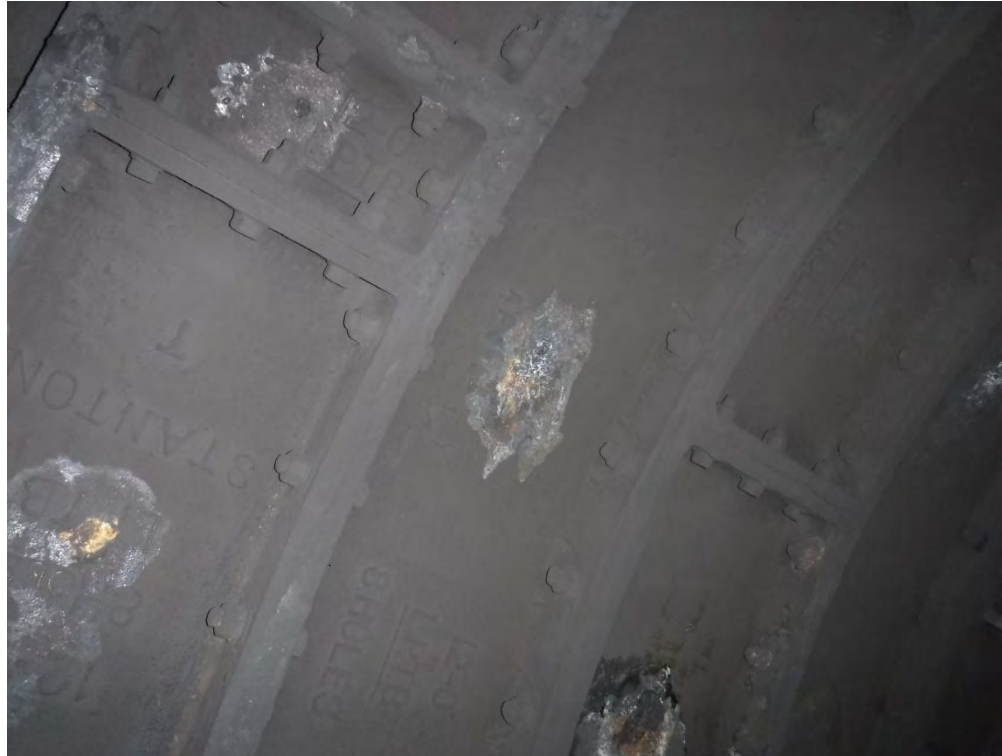
Photo-78, 60/16 @ 11 o'clock  
Areas of discolouration about lifting holes

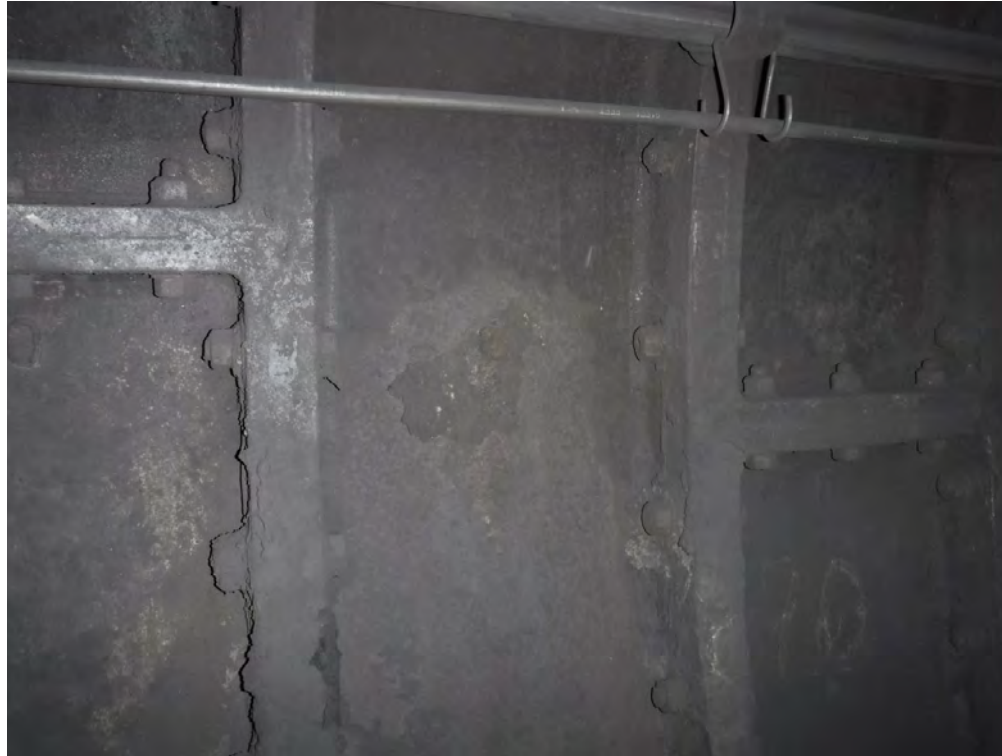
Photo-128, 40/2 @ 8 o'clock  
Encrustation at lifting hole of steel plate

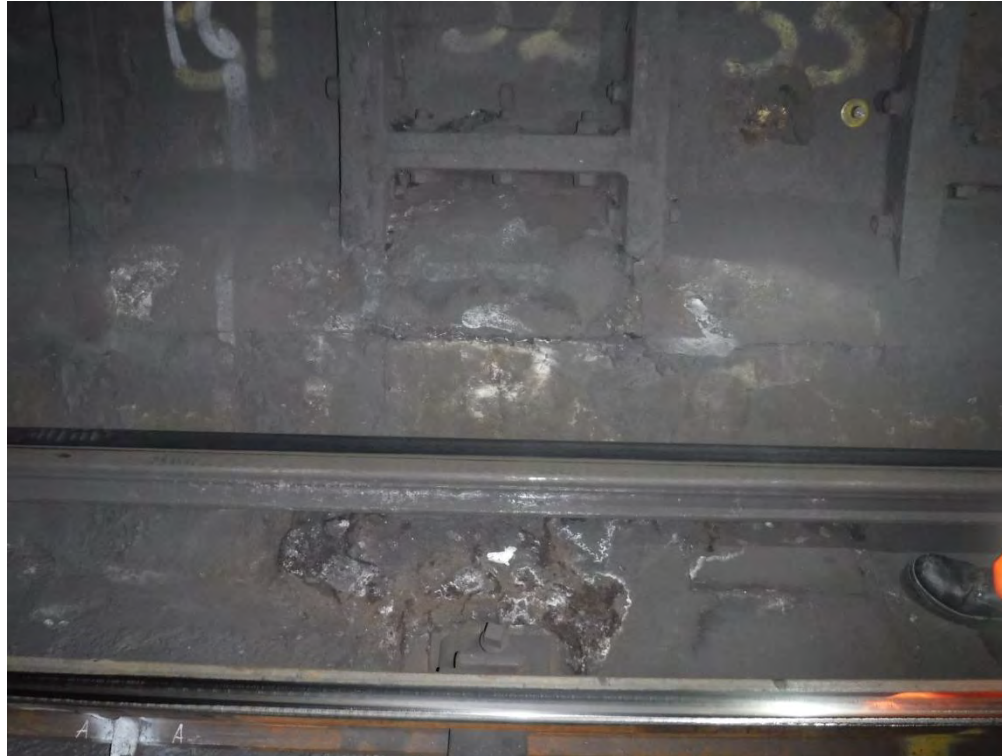
Photo-196, 20/4 @ 5 o'clock  
Encrustation at lifting hole of steel plate

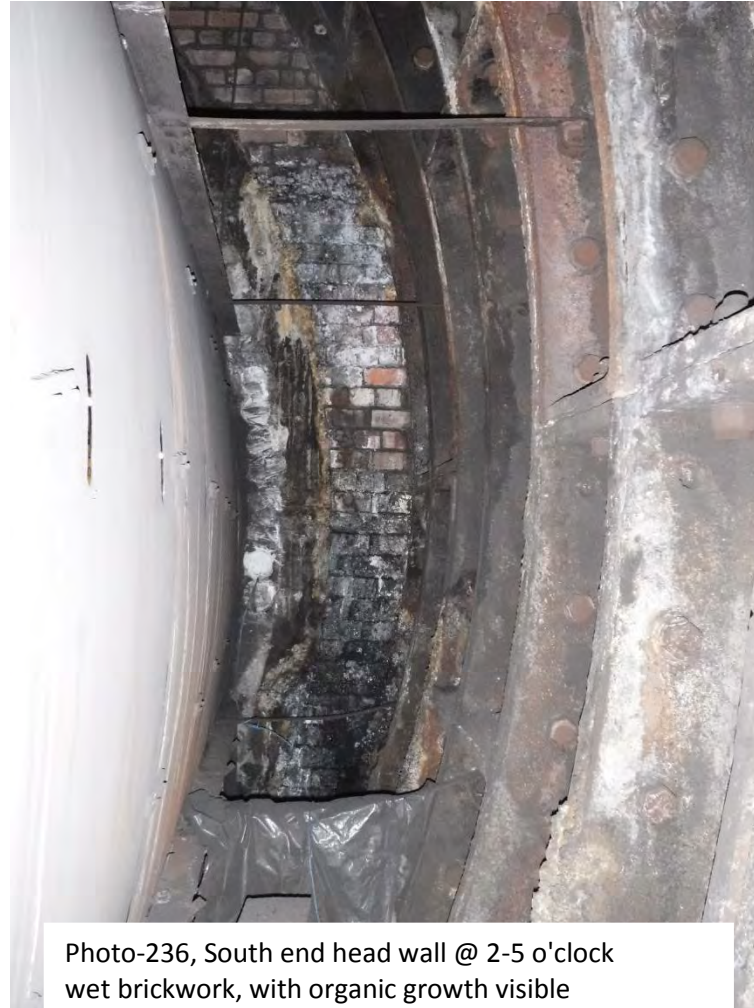
Photo-236, South end head wall @ 2-5 o'clock  
wet brickwork, with organic growth visible

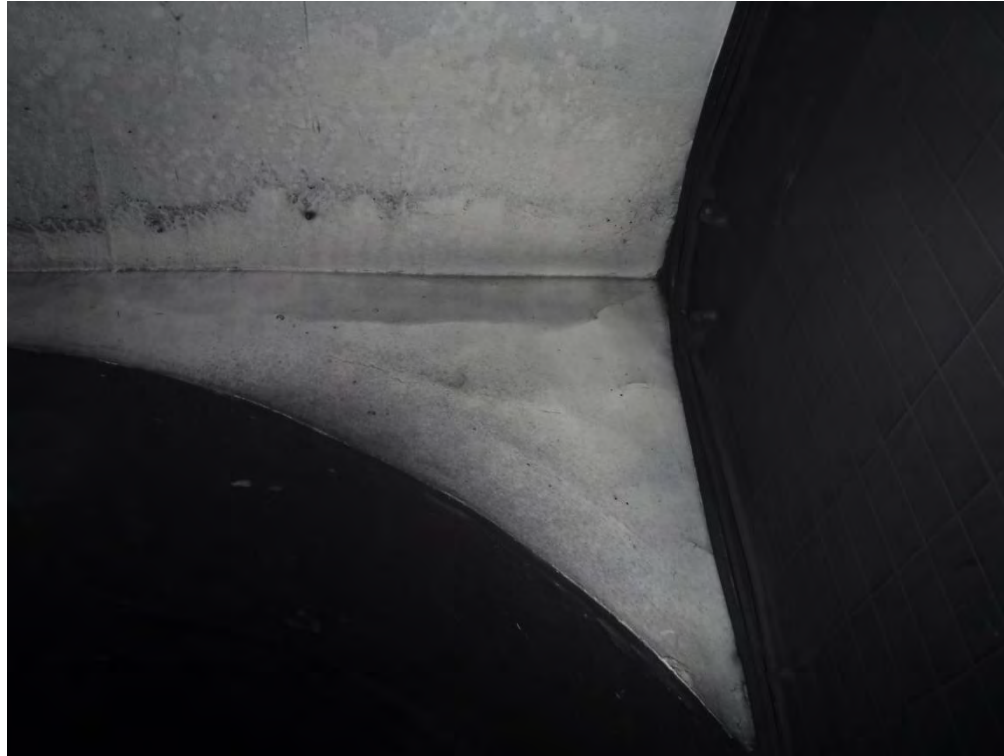
170	Rendered Wall over arch	South end head wall @ 11 o'clock Photo-238 Crack in head wall render
171	Rendered Wall over arch	South end head wall @ 12 o'clock Photo-239 Crack in head wall render
172	Rendered Wall over arch	North end head wall @ o'clock Photo-240 possible repaired crack
173	Mortar filled Steel Plate Sections	North end head wall @ o'clock Photo-241 poor quality infill

Photo-238, South end head wall @ 11 o'clock  
cracks in render of head wall

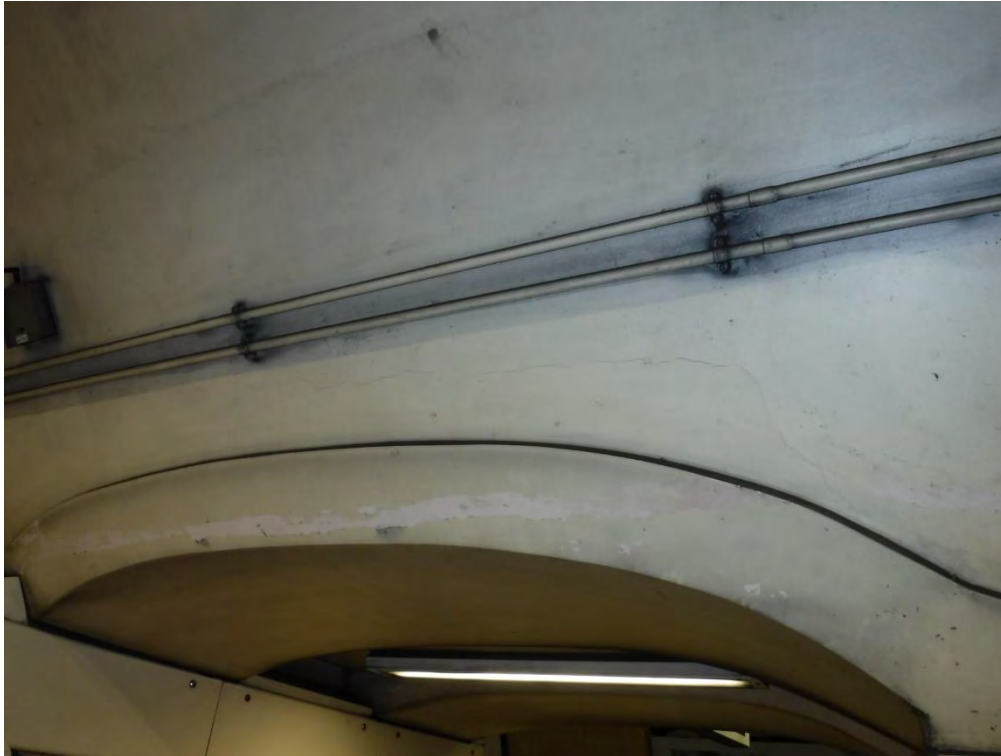
Photo-246, 1st arch to south bound tunnel  
Horizontal crack in render over length of arch
