SITE INVESTIGATION FACTUAL REPORT

Report No: 377279
Client: Crawford Claims Management
Site: 31 Heath Hurst Road, London
Client Ref: 1308651-
Date of Visit: 27/09/16

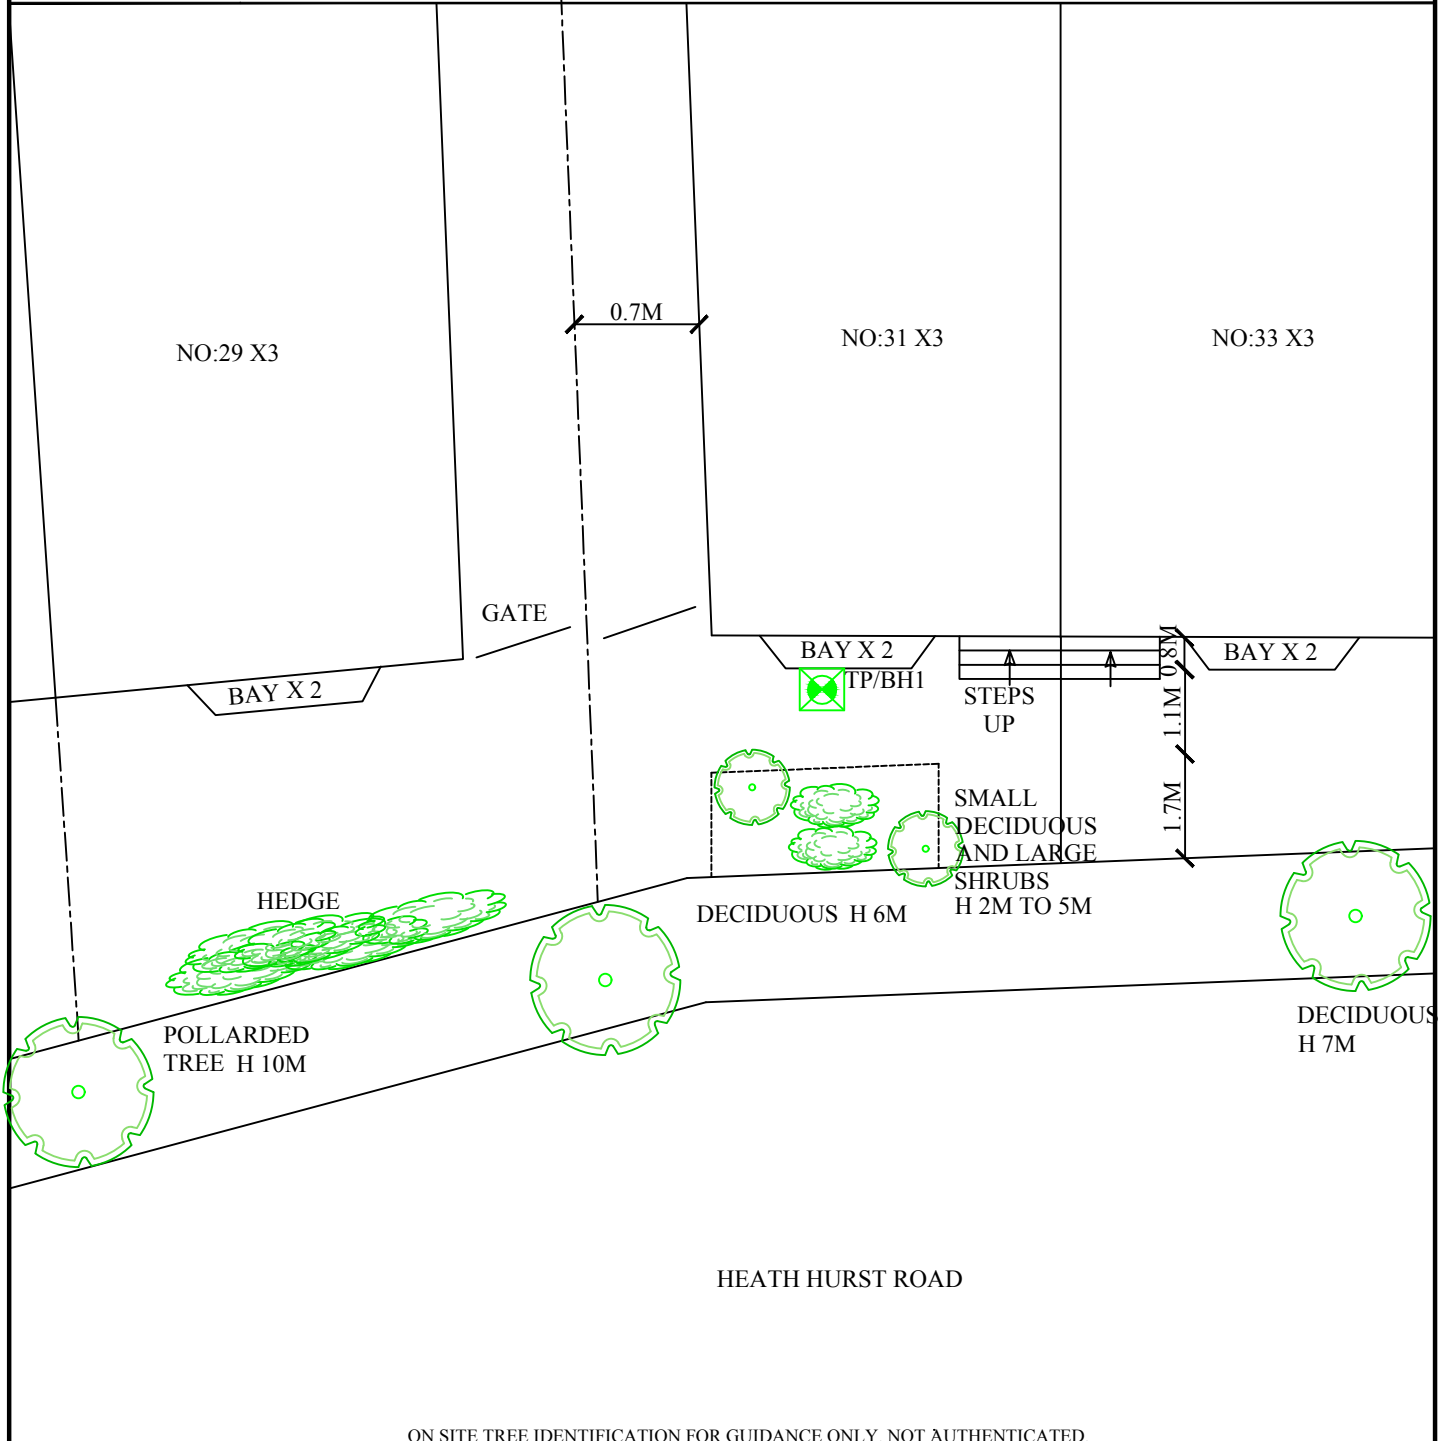
Investigation Layout Plan

Remarks: WATER SUPPLY FORM OUTSIDE TAP.
 POWER INTERNAL.
 PARKING ON ROAD (PERMIT).
 SITE ACCESS GOOD.
