# Arboricultural Appraisal Report

## Subsidence Damage Investigation at:

31 Heath Hurst Road  
London  
NW3 2RU

CLIENT:	Crawford & Company
CLIENT REF:	1308651
MWA REF:	SUB161104-830
MWA CONSULTANT:	David Williams (N.D.Arb MArborA)
REPORT DATE:	17-11-2016

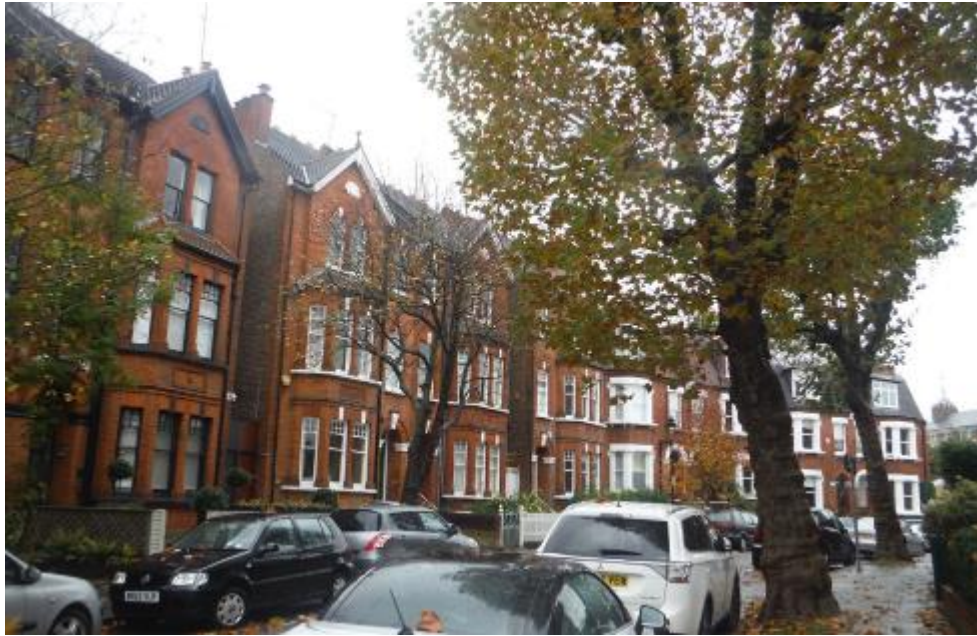
Tree No.	Species	Ht (m)	Dia (cm)	Crown Spread (m)	Dist. to building (m)	Age Classification	Ownership
T1	Whitebeam	8.7	35	5.0	8.0	Younger than property	Local Authority
Recommendation		Do not allow to exceed current dimensions					
T3	London Plane	15.0	60	12.0	14.0	Younger than property	Local Authority
Recommendation		Evidence of high pollarding within 3 years. Remove re growth from pollard points and repeat every third year.					
T4	Willow (Weeping)	11.0	40	8.0	9.0	Younger than property	Policy Holder
Recommendation		Remove and treat stump to inhibit re growth					
T5	S Birch	12.0	26	7.0	5.0	Younger than property	Policy Holder
Recommendation		Do not allow to exceed current dimensions					
T6	Horse Chestnut	6.0	12	2.5	1.5	Younger than property	Policy Holder
Recommendation		Remove and treat stump to inhibit re growth					
T7	Oak (Fastigiata)	13.0*	40*	7.0	15.0	Younger than property	Policy Holder
Recommendation		Do not allow to exceed current dimensions

View of T1 and T3

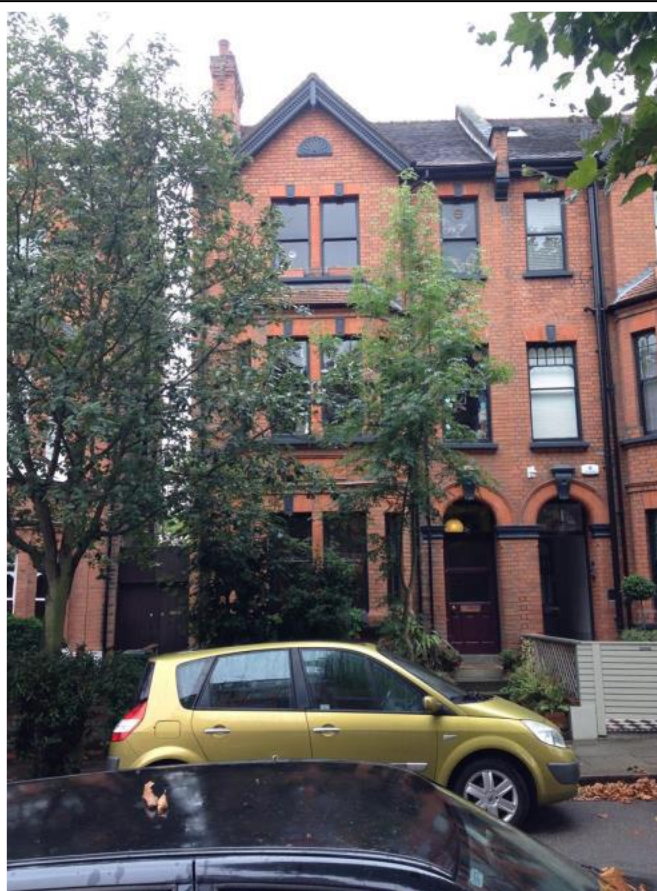
Roots were observed below the foundation underside confirming the drying action of TG1 below the front elevation. No roots were recovered from T2 which should not be relied upon to discount the causative role of this tree. *Cupressaceae spp* roots are assumed to originate from tree(s) removed some time in the past.

Based on the technical reports currently available, engineering opinion and our own site assessment we conclude the damage is consistent with shrinkage of the clay subsoil, the cause of which will be the combined drying impact of T2 and TG1 on soil volumes below the front elevation. We are confident of the causal role of T2; however, the LPA may insist on evidence of root trespass despite the trees close proximity to the dwelling.

View of T2 and TG1

Tree No.	Species	Ht (m)	Dia (cm)	Crown Spread (m)	Dist. to building (m)	Age Classification	Ownership
T2	Whitebeam	7.8	25	6.0	<5.0	Younger than property	Local Authority
Management history		No significant recent management					
Recommendation		Remove and treat stump by mechanical means to inhibit regrowth					
TG1	Ash, Sycamore, Viburnum	2.0-6.0	M/S Av7*	4.0	<2.0	Younger than property	Policy Holder
Recommendation		Remove and treat stumps to inhibit re growth

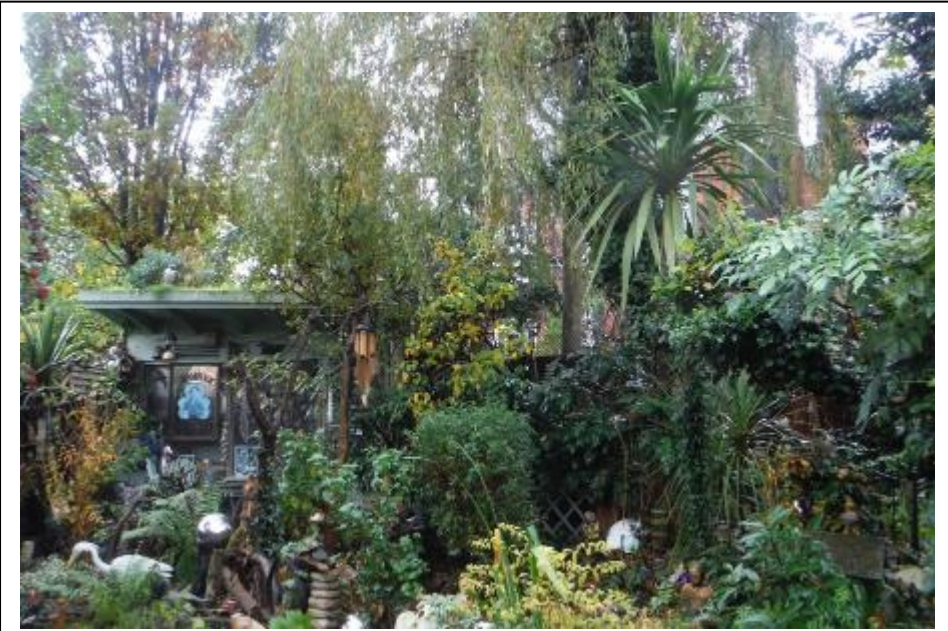
View of rear garden

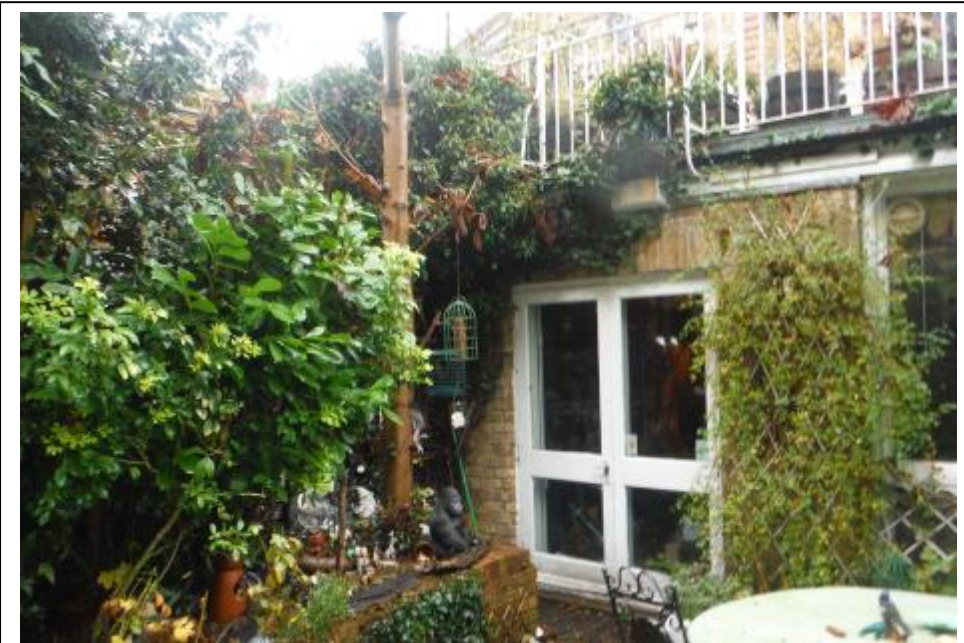
View of rear garden
