Hillview, Vale of Health, Hampstead, NW3 1AN

**Structural Report to Support Planning
Application**

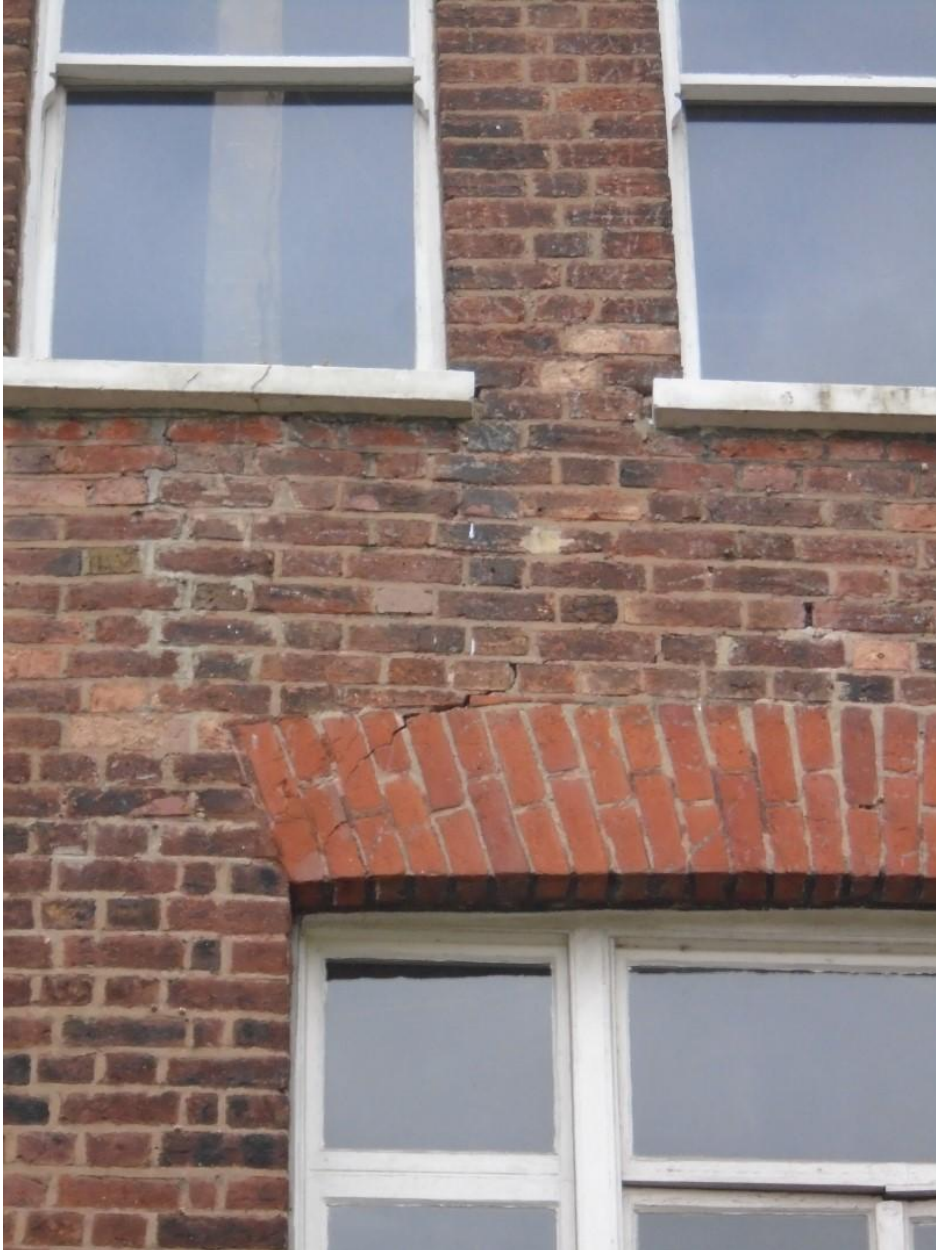
Image 1: Image of cracks in lintel to rear wall due to deformation of the wall/foundation settlement

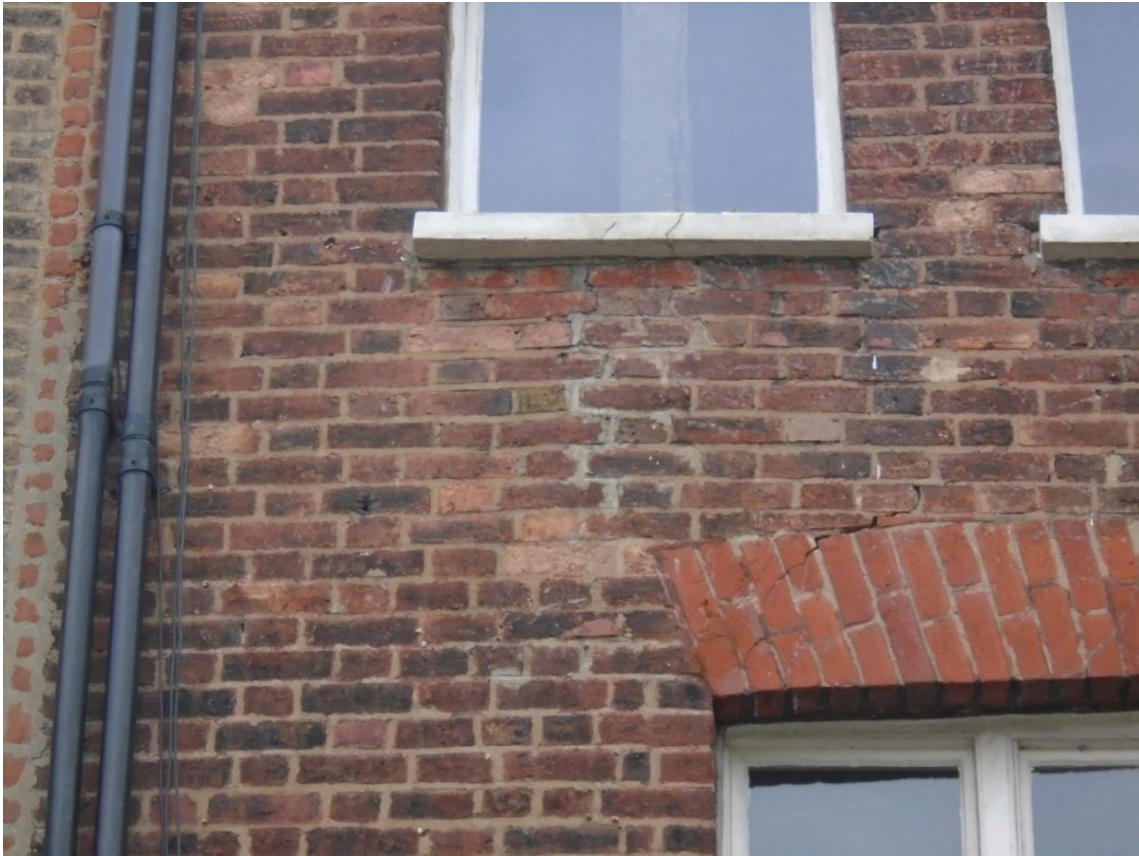
Image 2: Cracked lintel and exfoliation of brickwork to rear facade

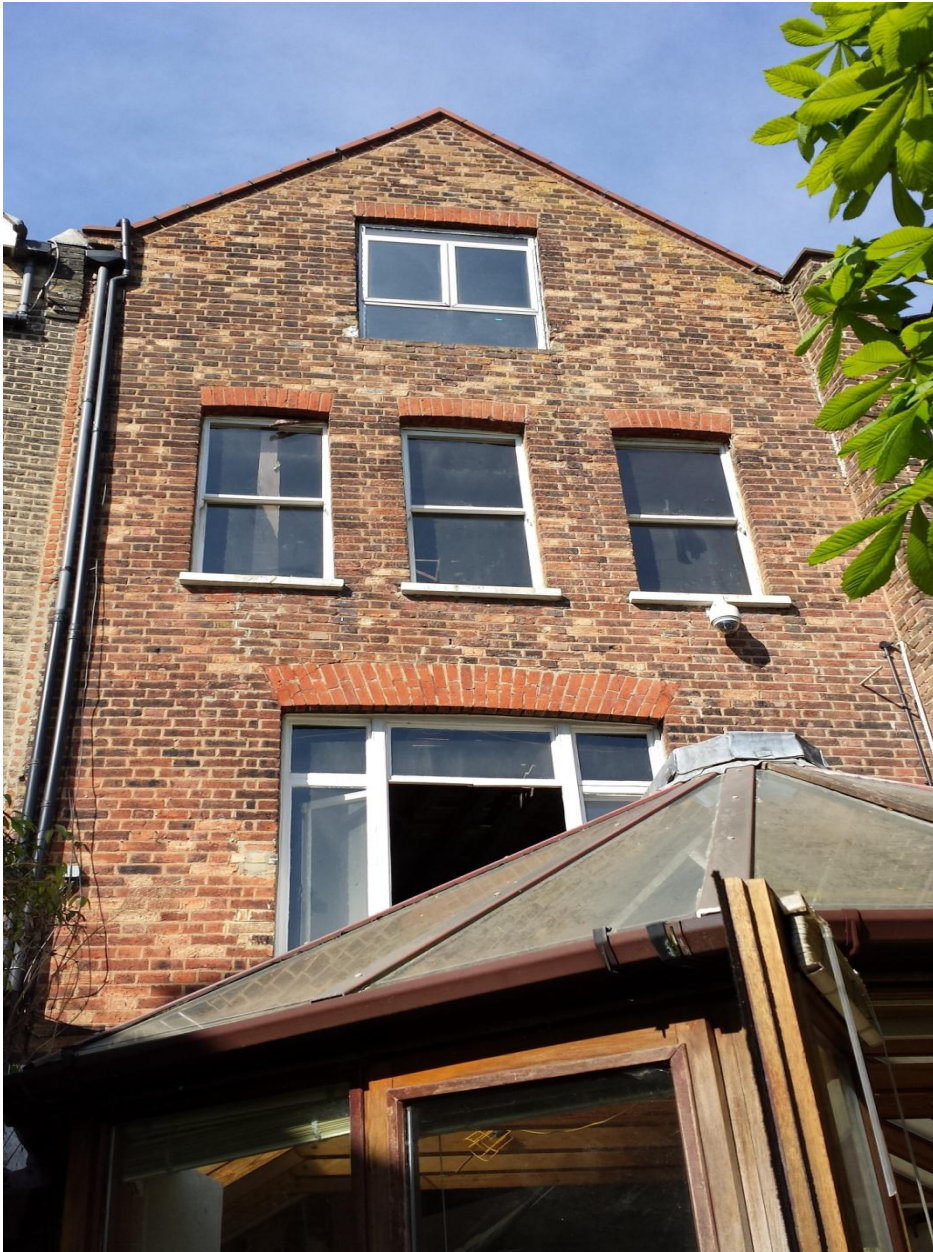
Image 3: General view of rear elevation

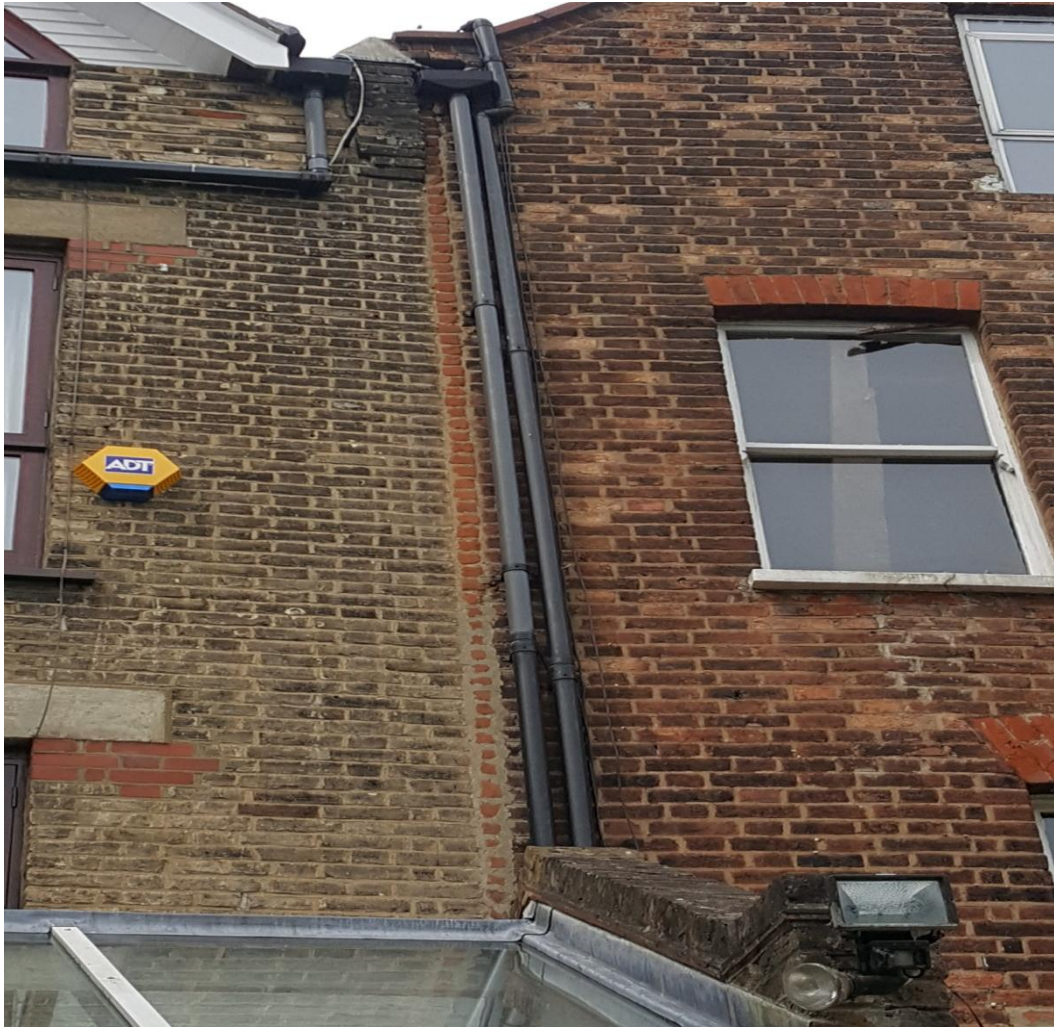
Image 5: Rear elevation showing poor condition of brickwork, sub-standard repairs and different brick bond

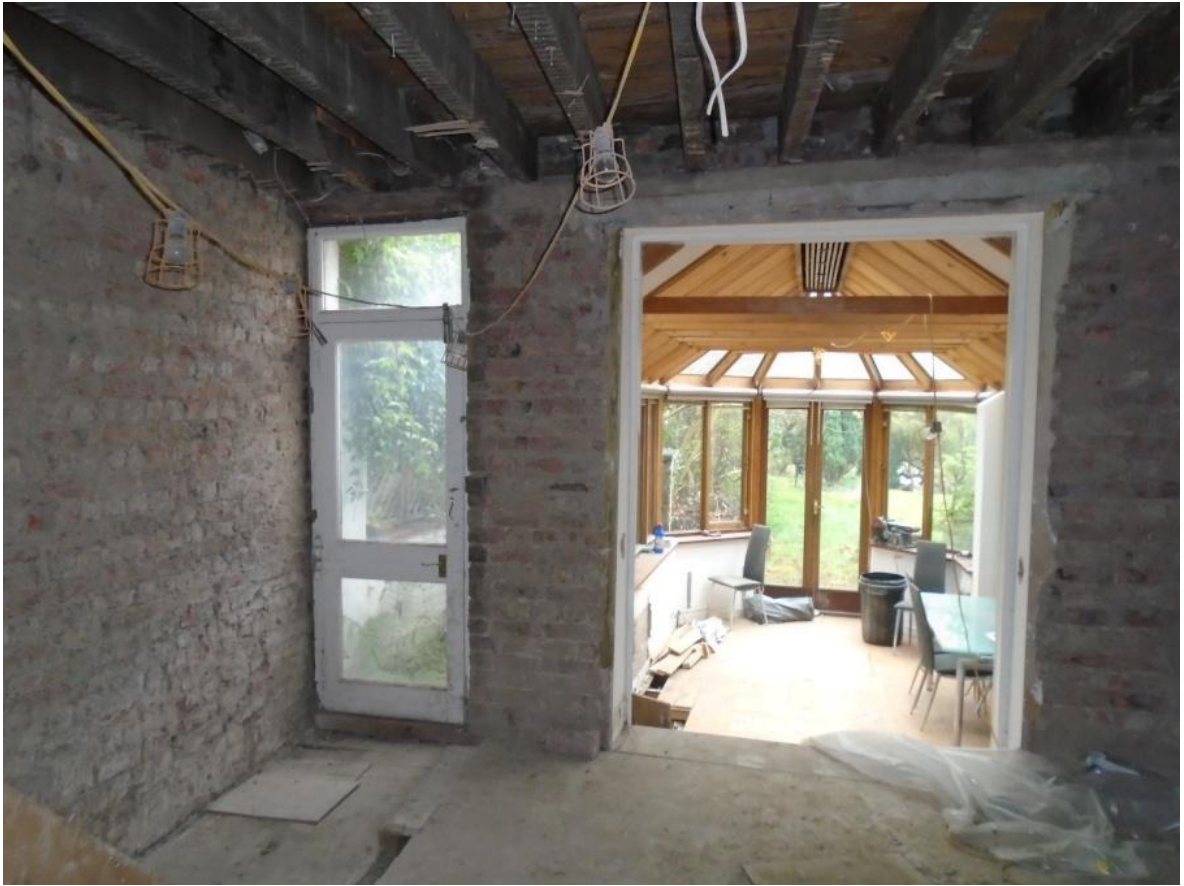
Image 6: Internal view of rear elevation showing excessive deflection of floor adjacent to rear door

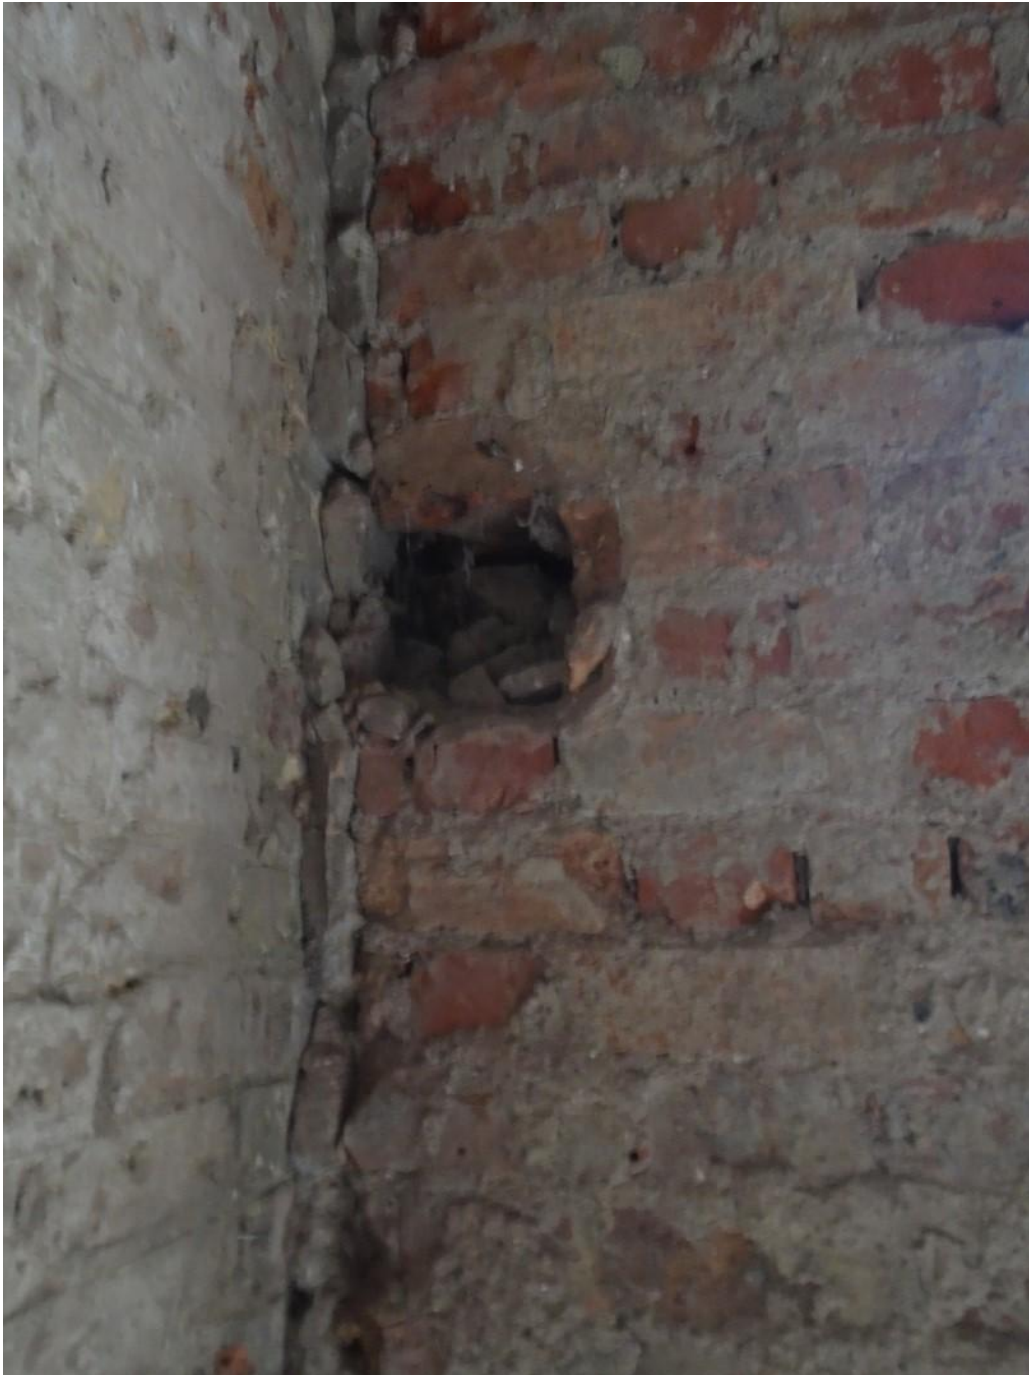
Image 7: Internal view of rear facade inadequately toothed in/tied to party wall – Image 1

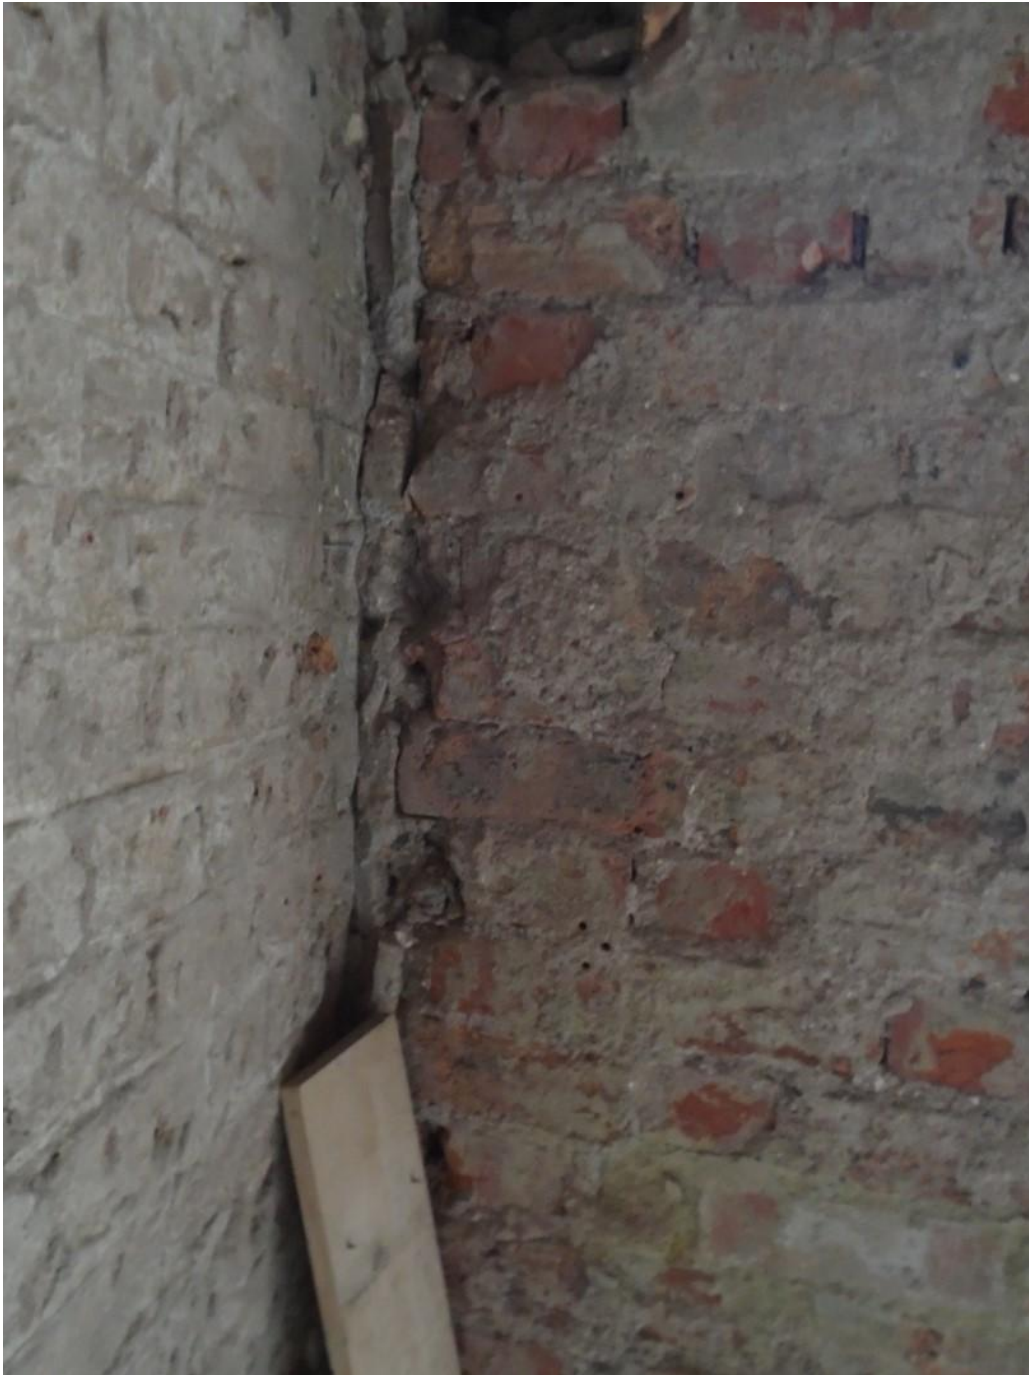
Image 8: Internal view of rear facade inadequately toothed in/tied to party wall – Image 2

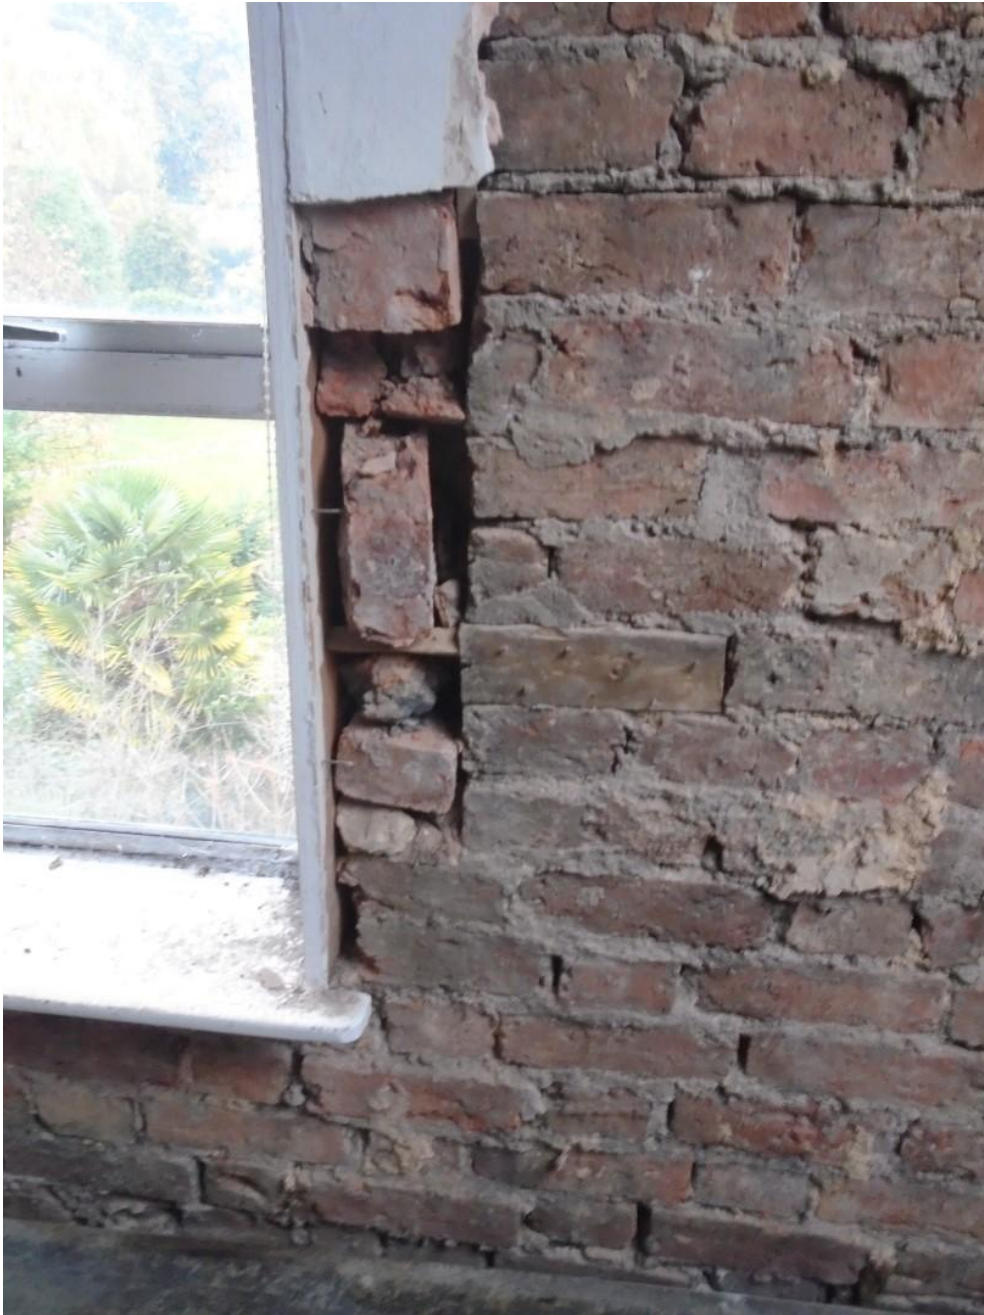
Image 9: Loose brickwork to window reveal in rear facade

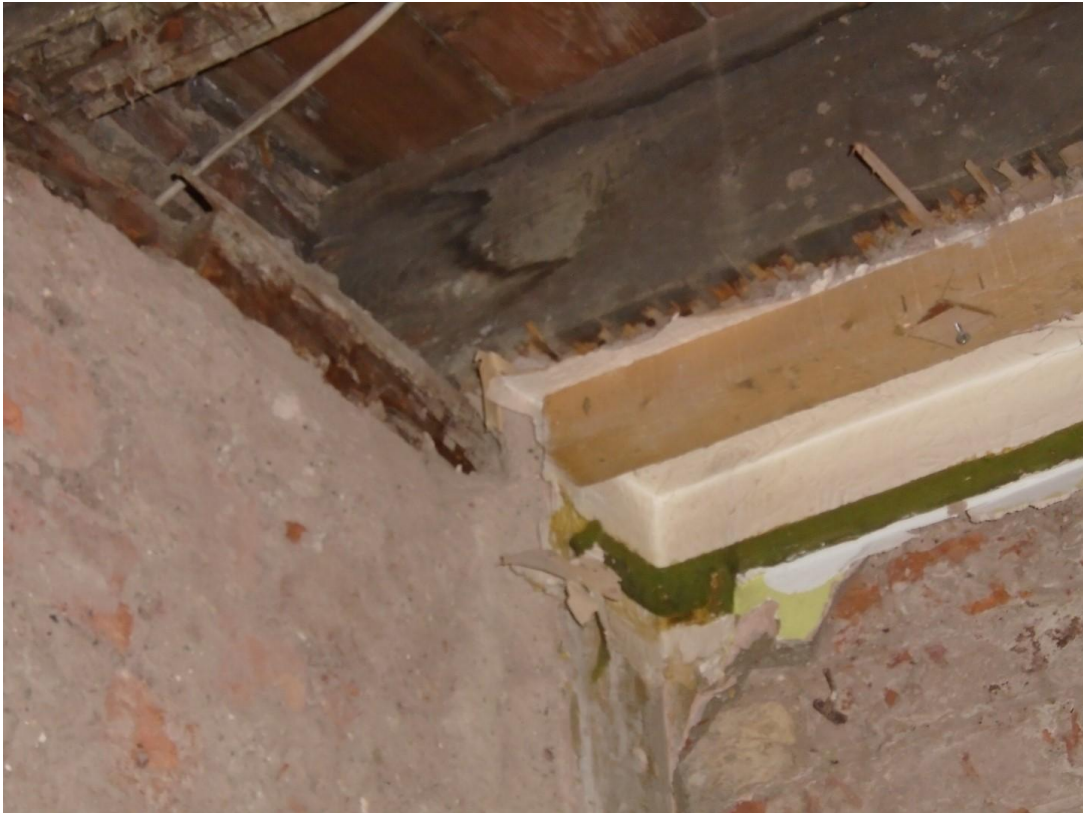
Image 10: Evidence of rot in floor joist ends and timber wall plate

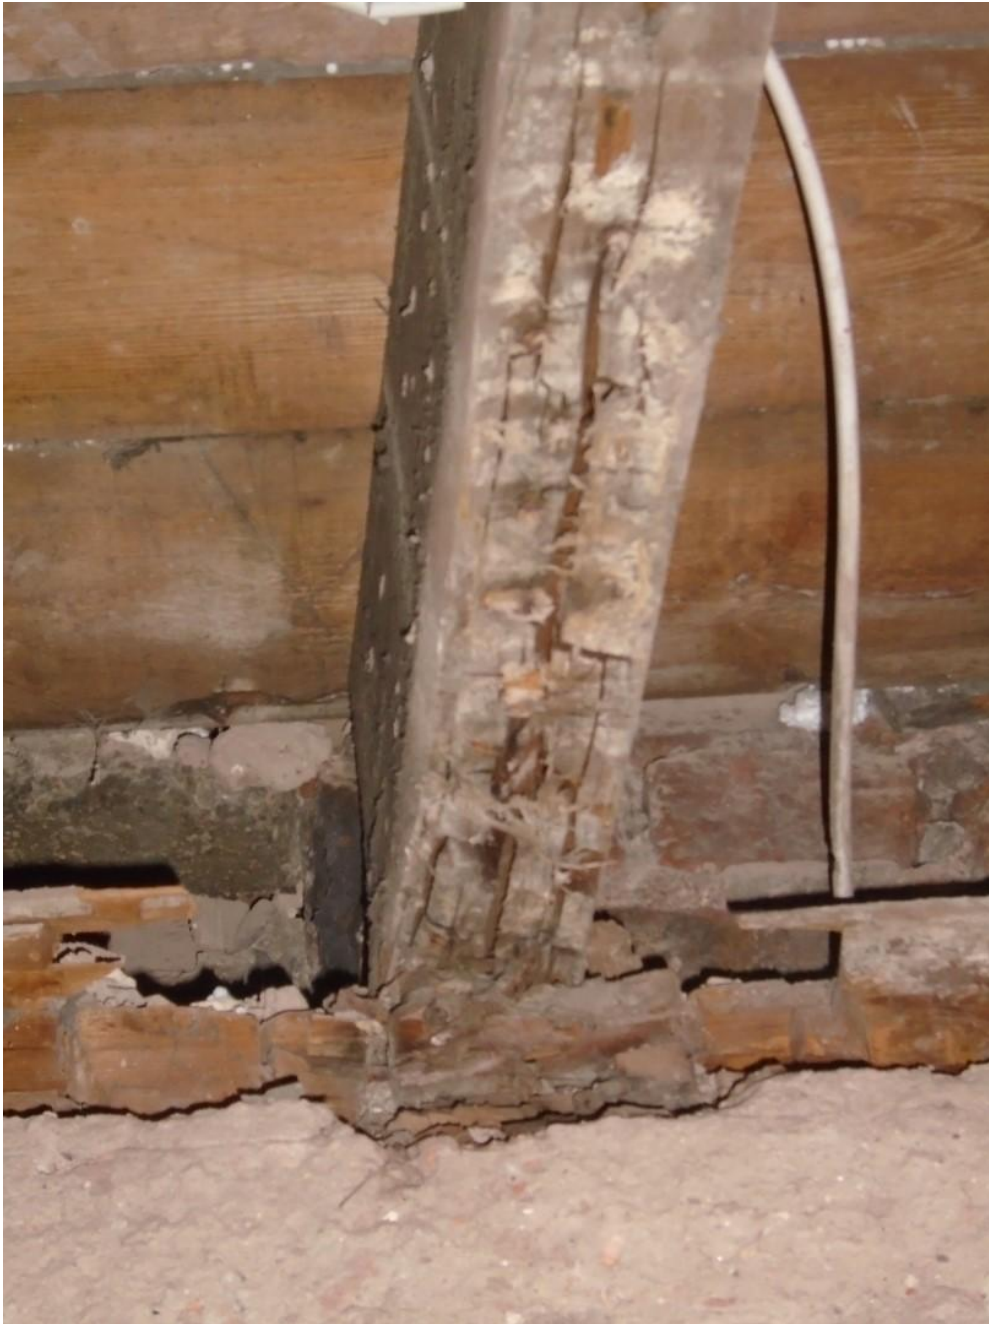
Image 11: Image of rotten floor joist

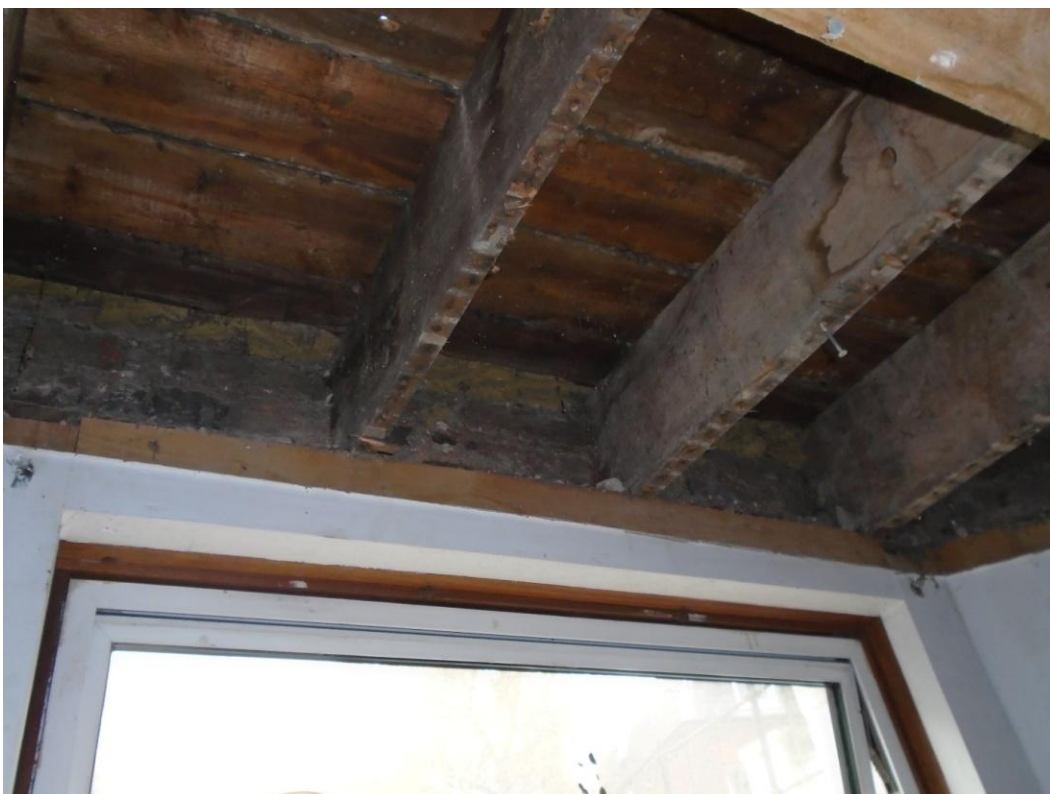
Image 13: Undersized joists and evidence of rot where joists bear on external wall

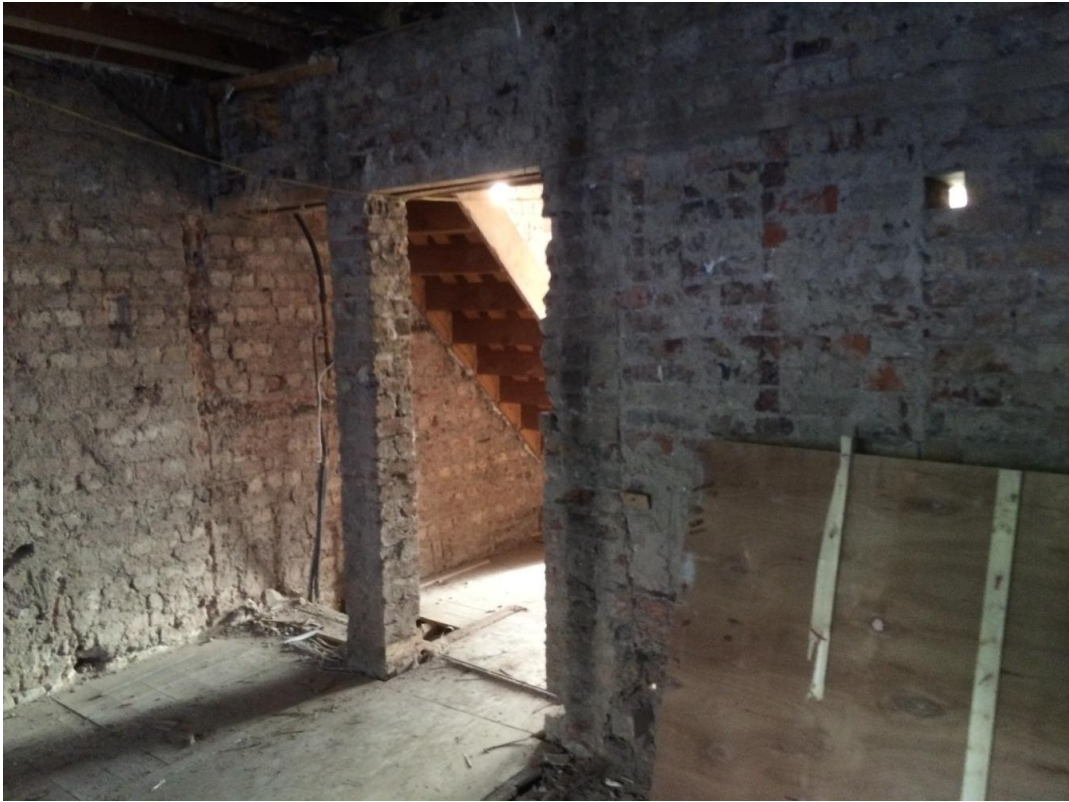
Image 14: Internal brick wall at lower ground floor, brick wall and pier in poor condition

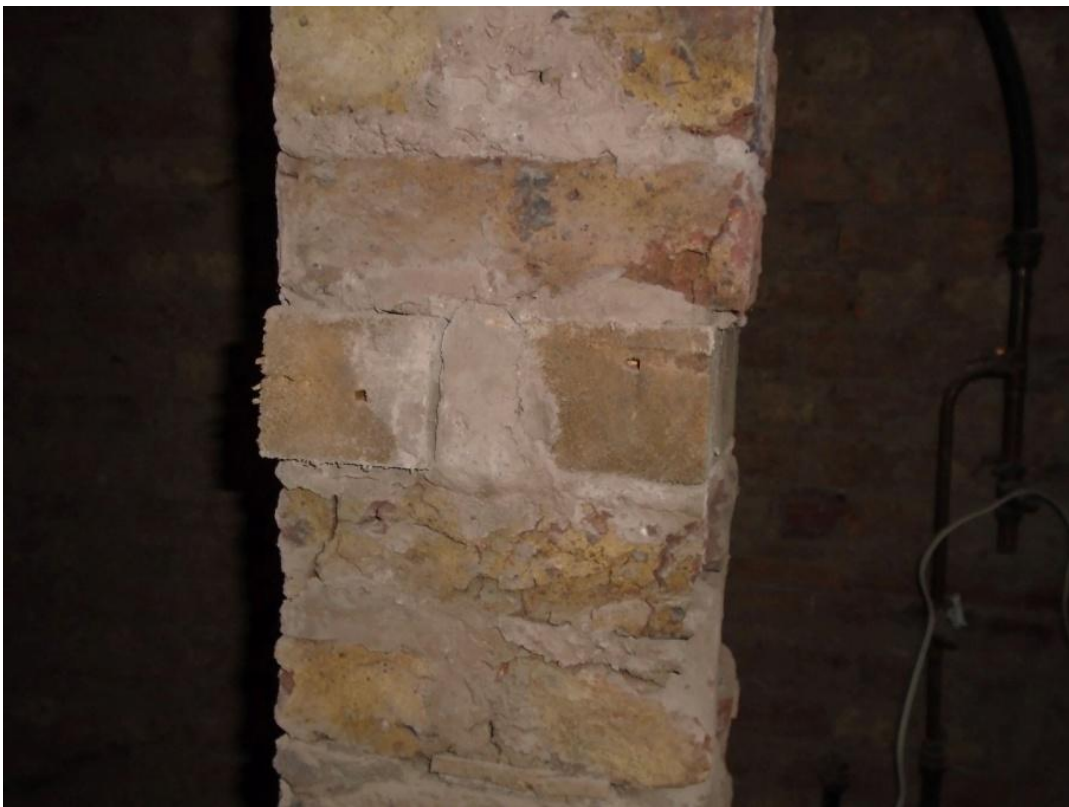
Image 15: Timber blocking embedded in brick pier approximately at mid-height

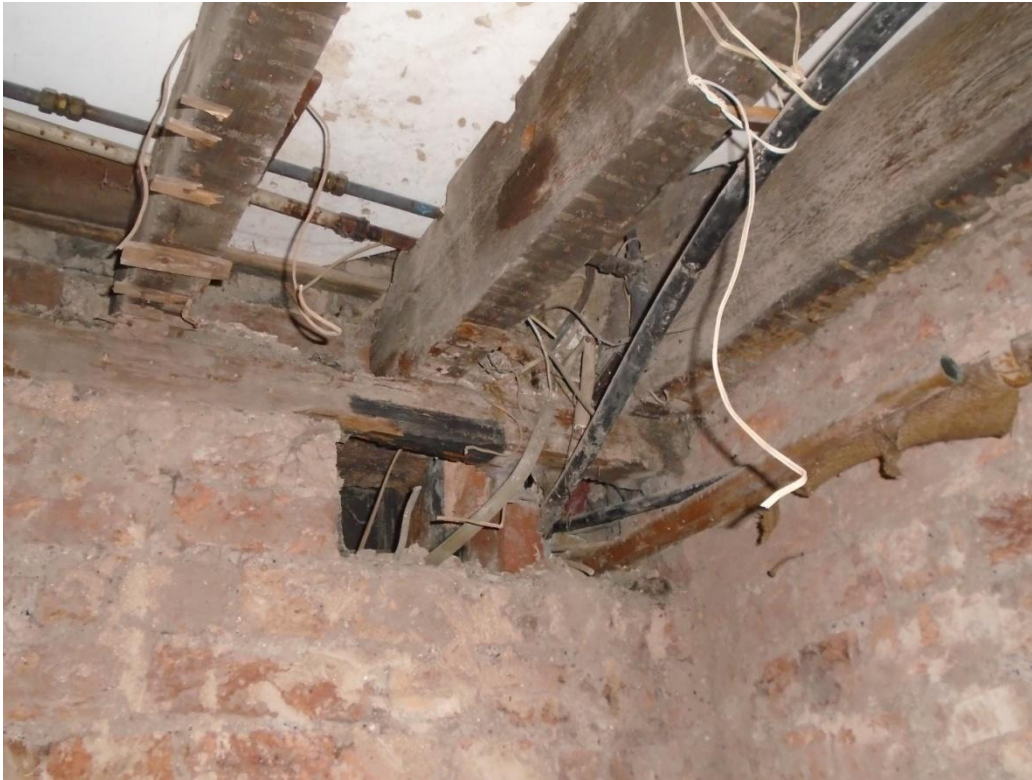
Image 16: Notching of joists and rot evident where joists bear on internal spine wall, general poor condition

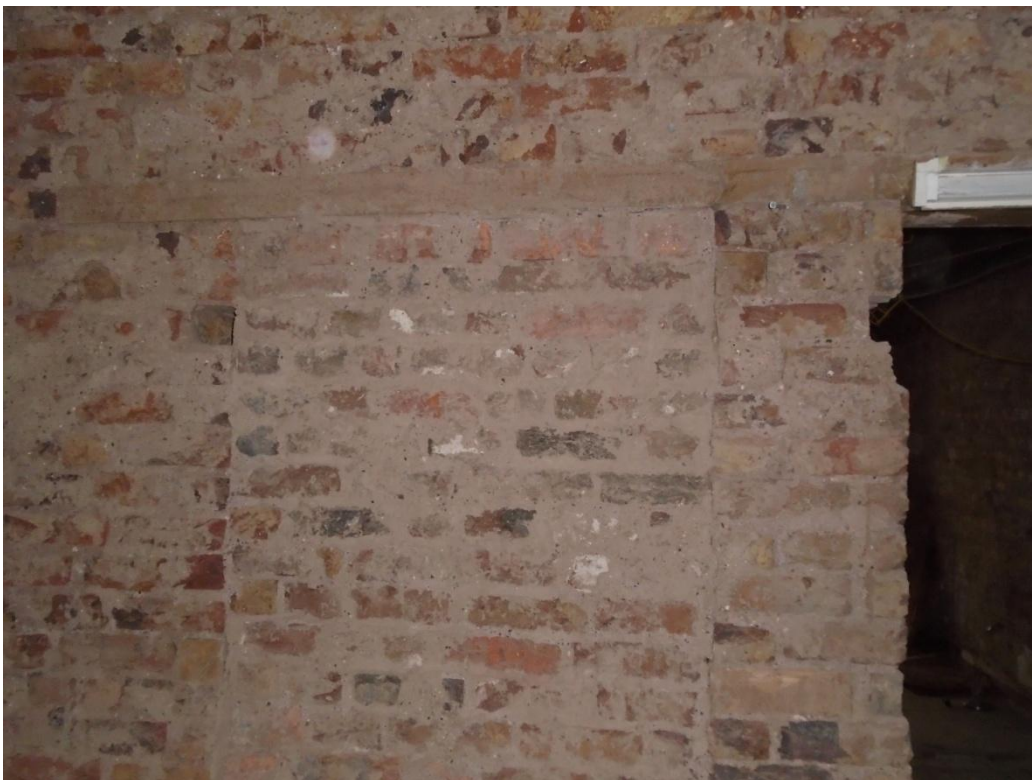
Image 17: Opening bricked up and brickwork not toothed in properly

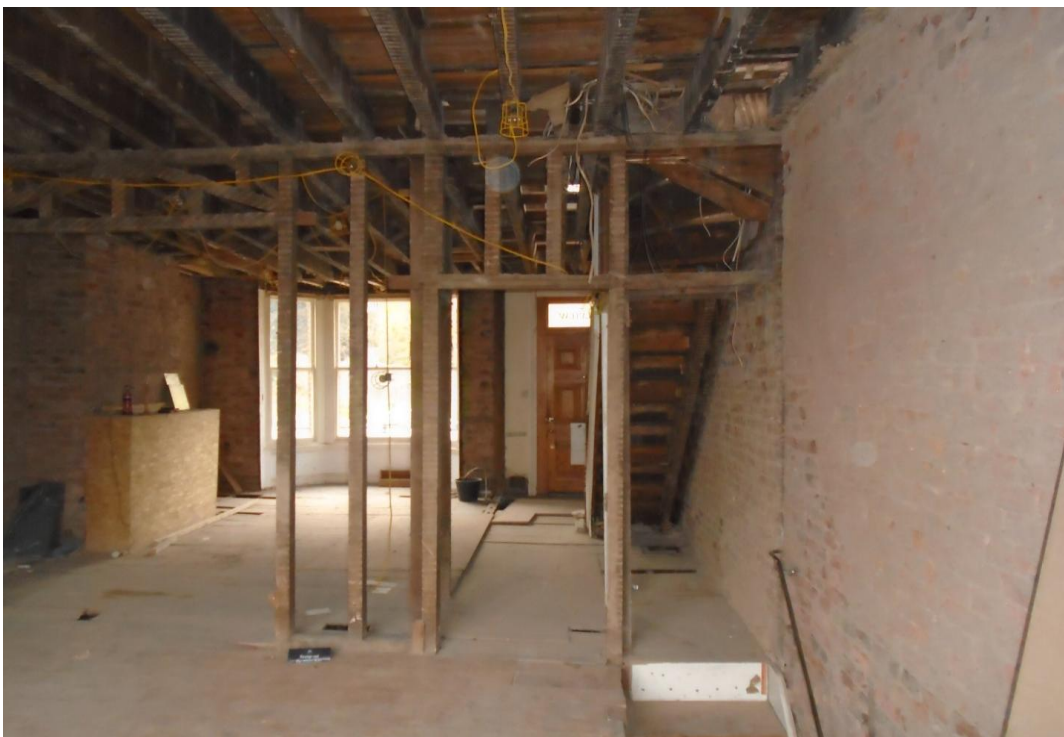
Image 20: Load-bearing stud (spine wall on upper floors) in poor condition and is structurally inadequate

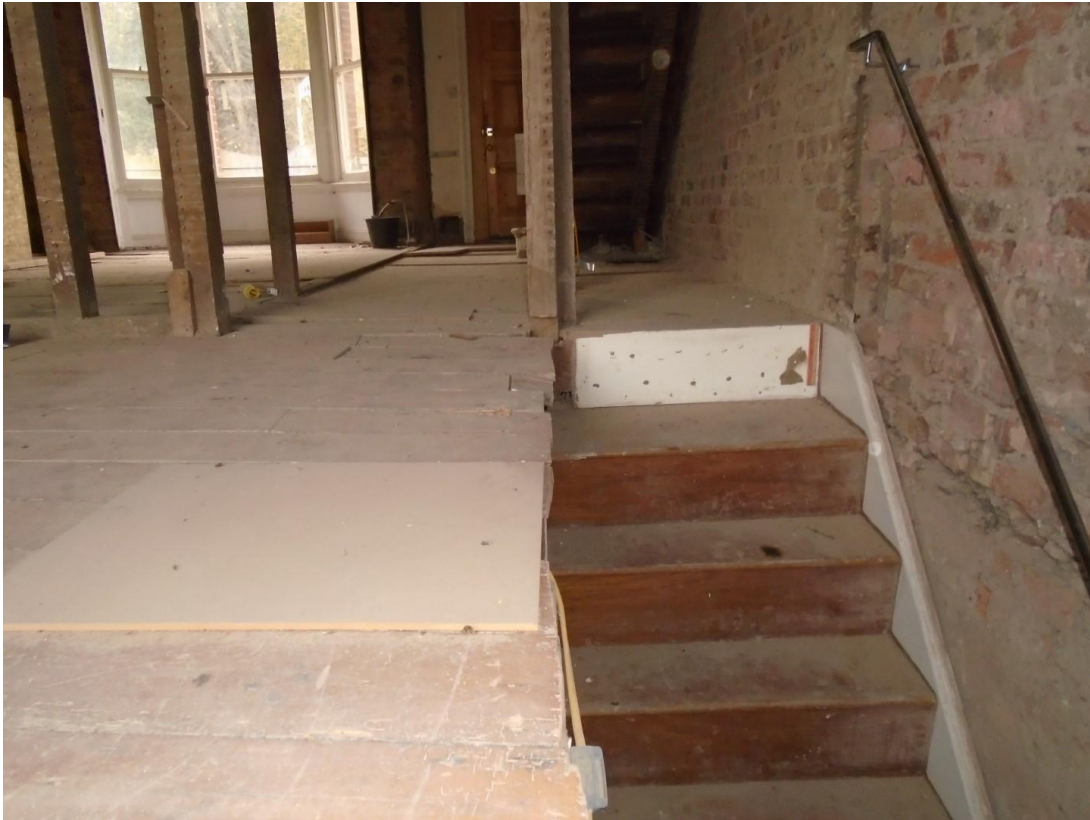
Image 21: Image showing excessive deflection of floor adjacent to stair void

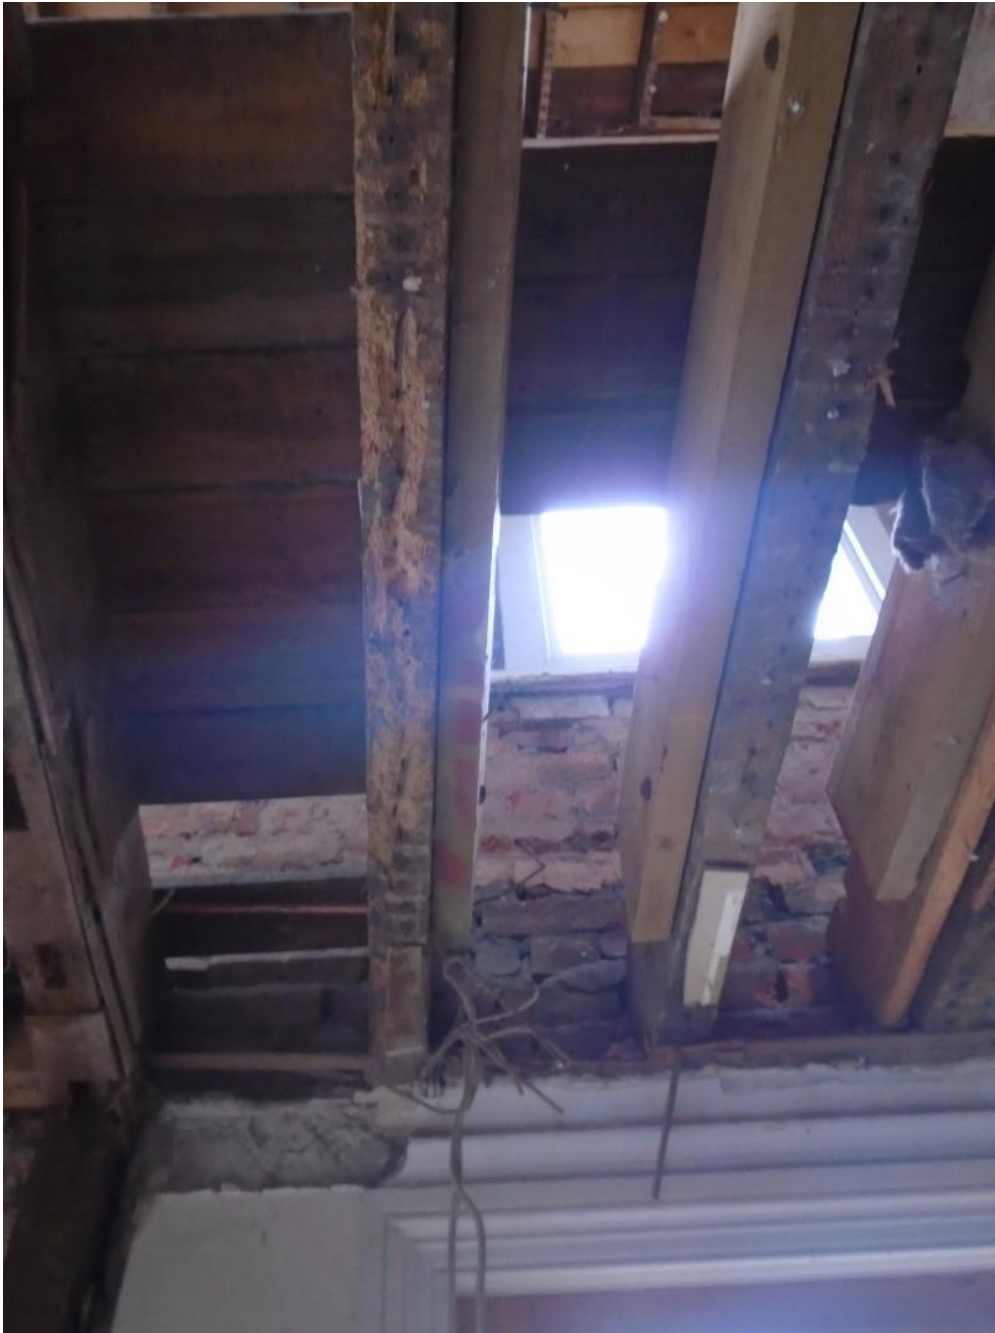
Image 22: Rotten floor joists inadequately spliced – Image 1

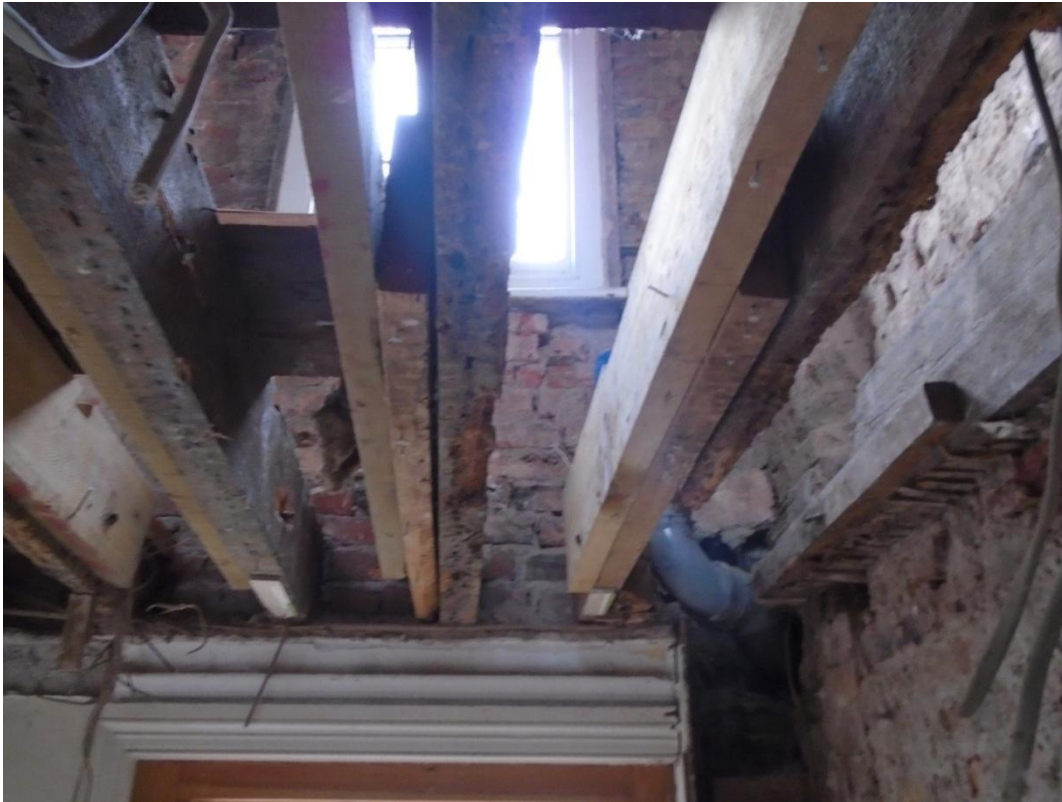
Image 23: Rotten floor joists inadequately spliced – Image 2

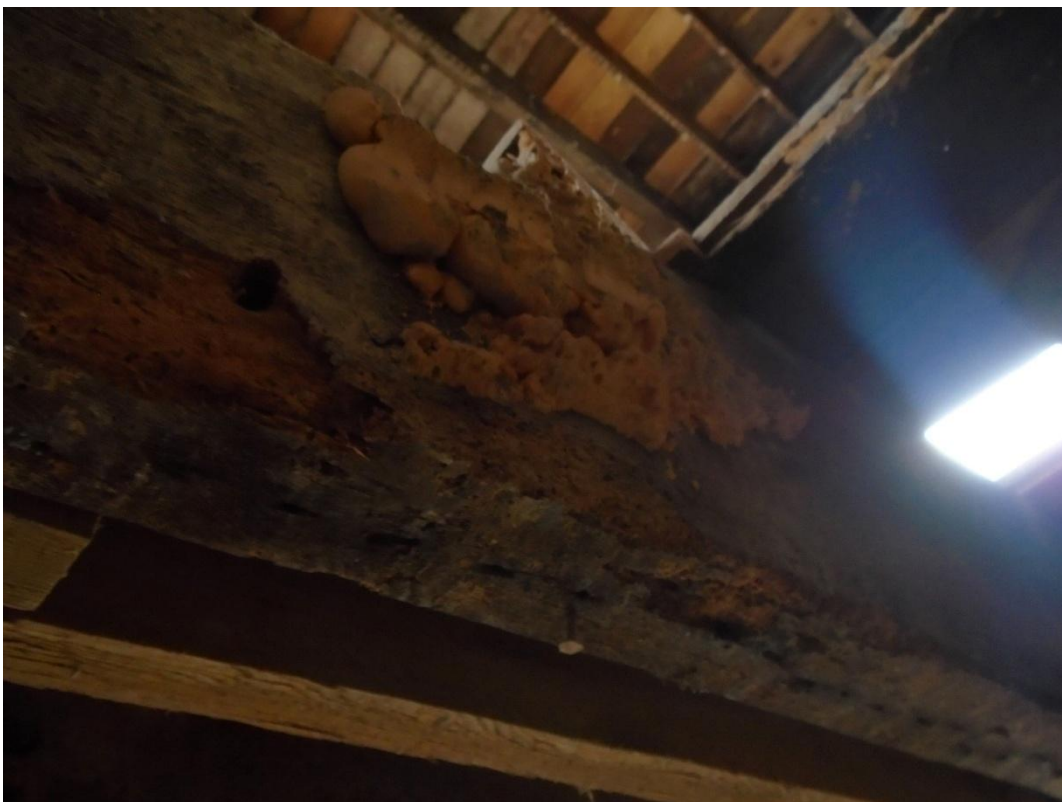
Image 24: Image of rotten joist

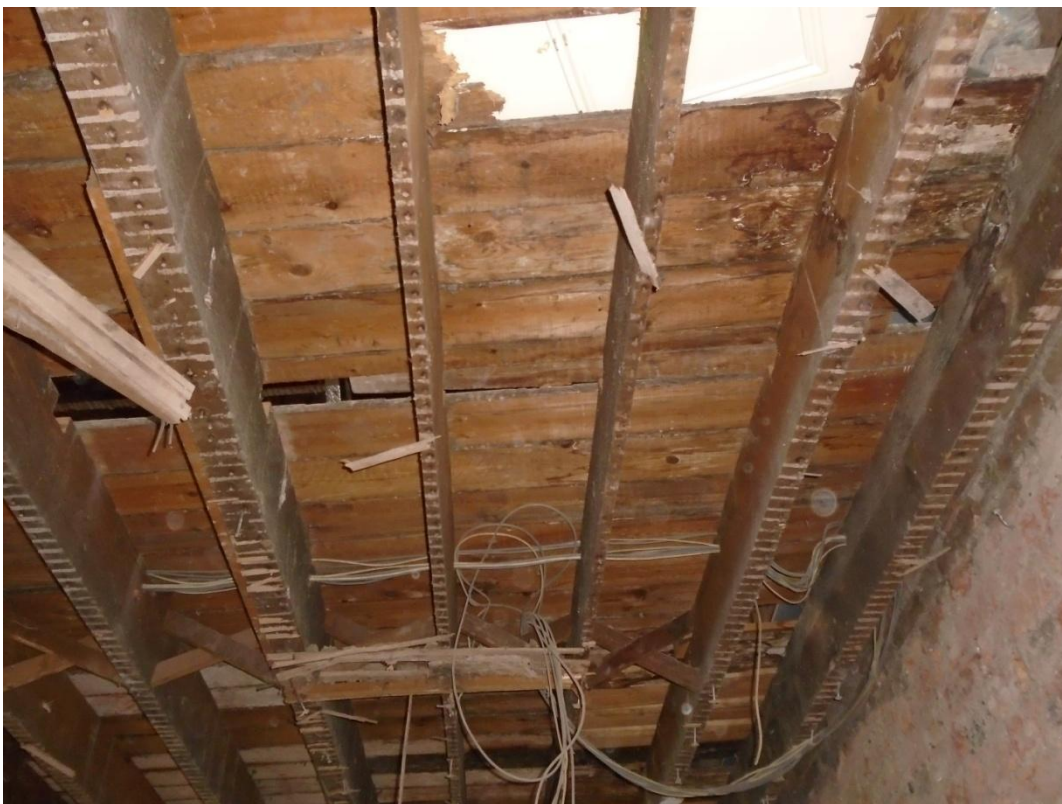
Image 26: Joists inadequately sized

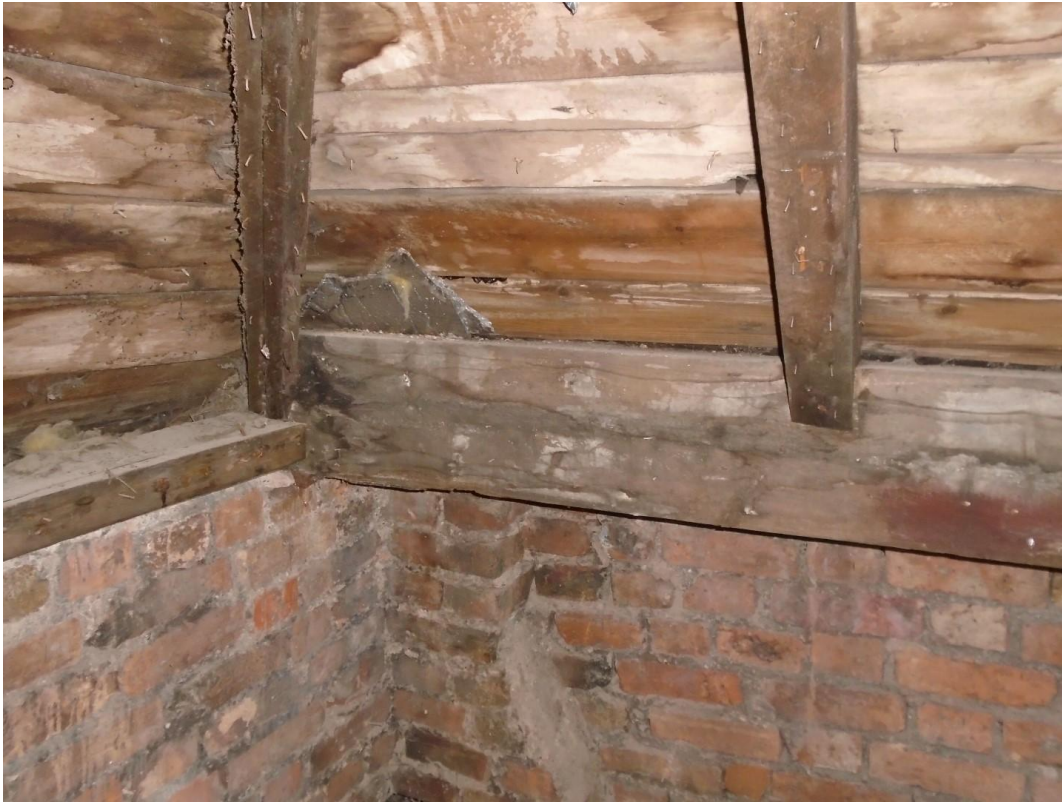
Image 27: Roof waling beam and rafter ends showing signs of rot – Image 1
