Hillview, Vale of Health, Hampstead, NW3 1AN

**Structural Report to Support Planning
Application**

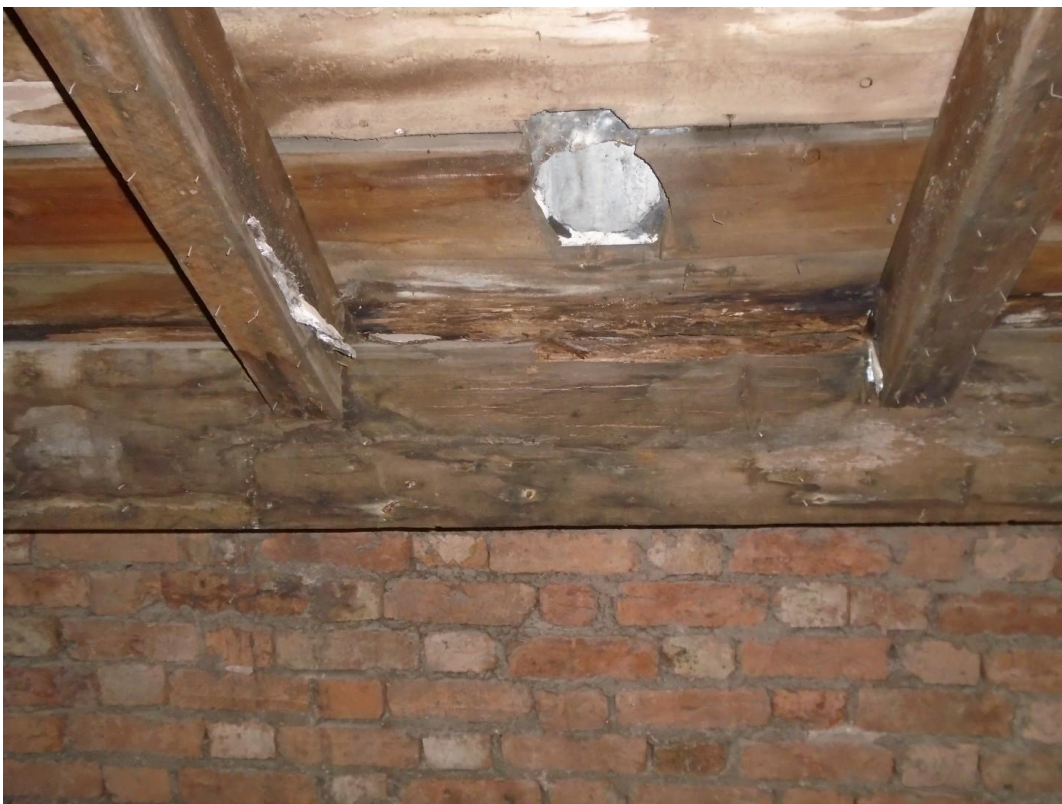
Image 28: Roof waling beam and rafter ends showing signs of rot – Image 2

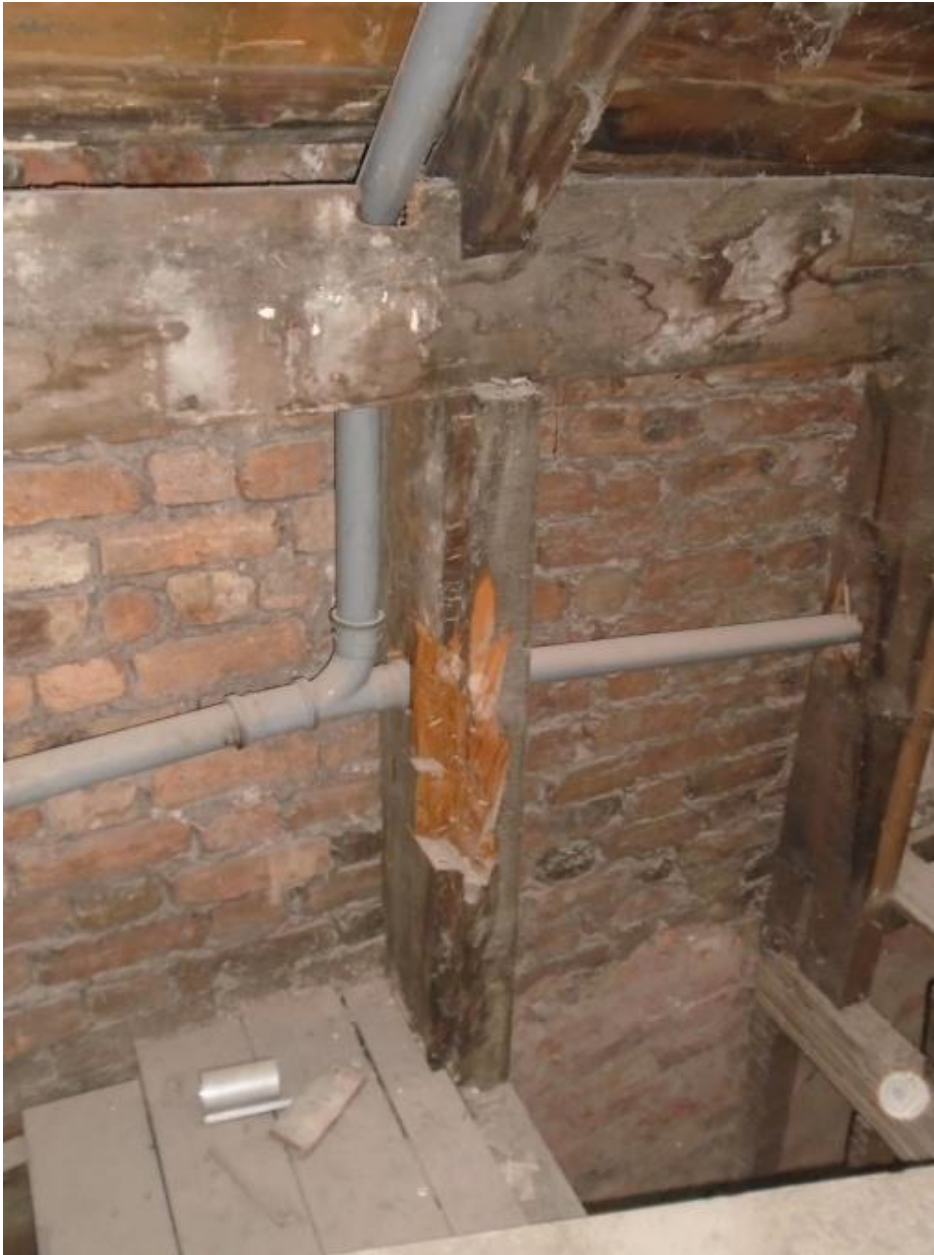
Image 29: Excessive notching to timber prop supporting roof waling beam

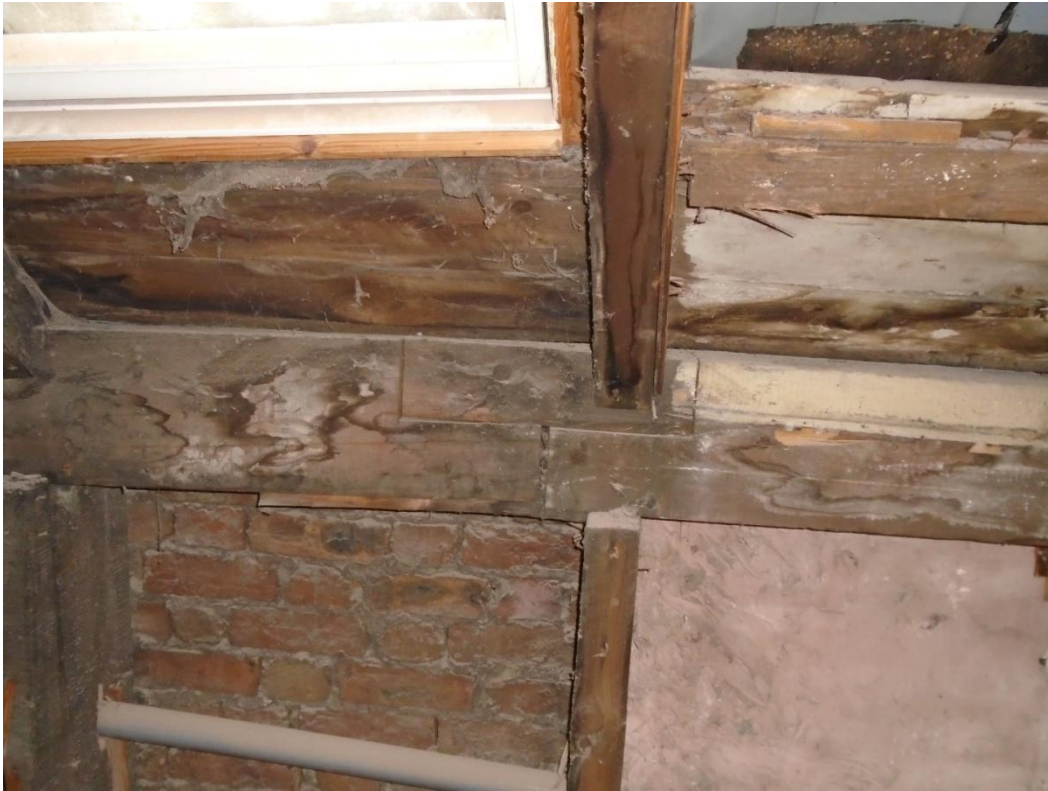
Image 30: Inadequate halving joint configuration and evidence of rot in roof waling beam

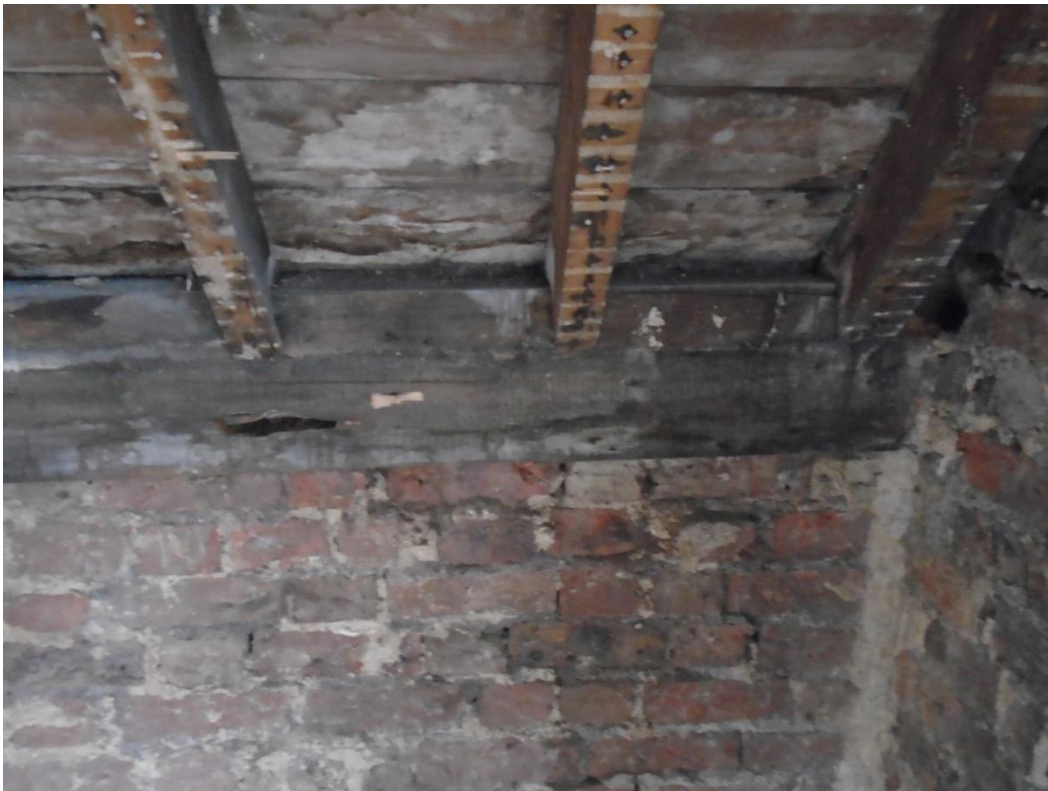
Image 31: Poor condition of brickwork and rot evident in roof waling beam and rafter ends

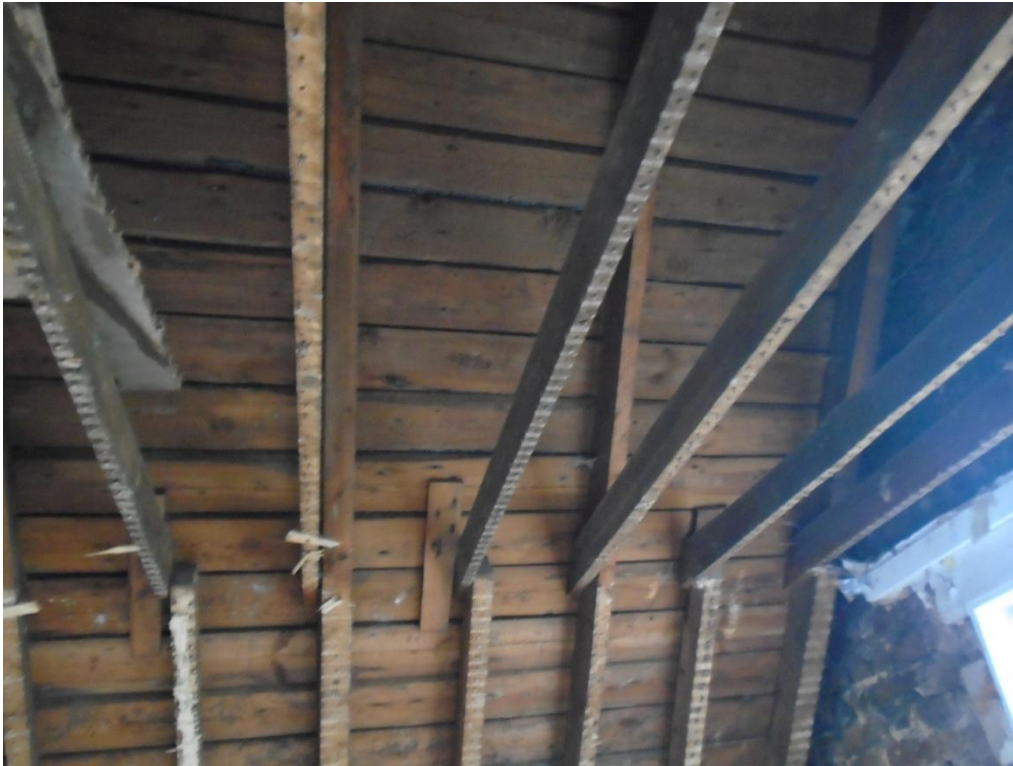
Image 32: Every second roof rafter has been cut at collar tie position over full length of roof rendering the roof structure inadequate and potentially dangerous

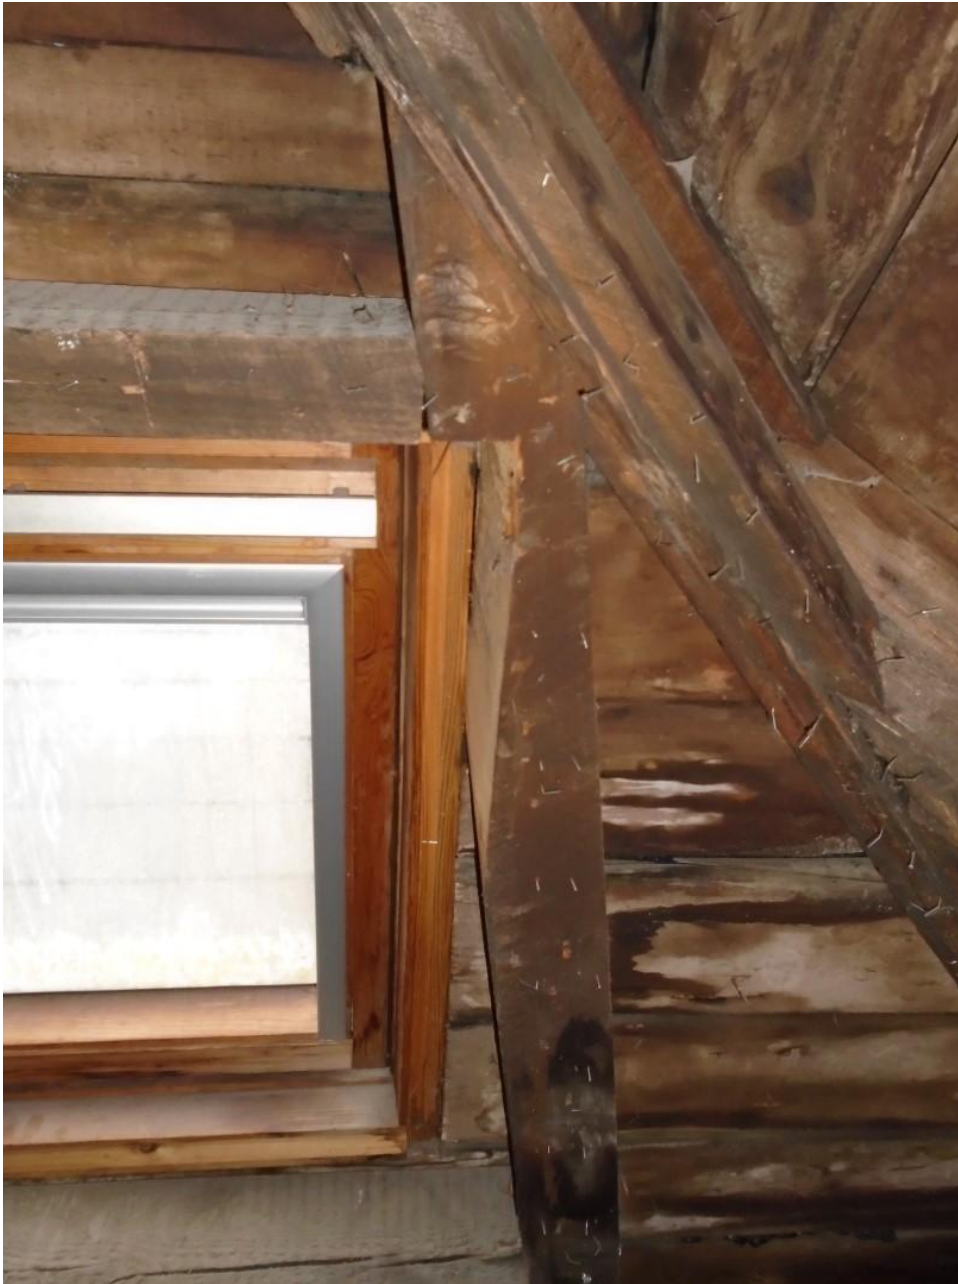
Image 33: Structural integrity of rafter compromised by excessive notching to roof light

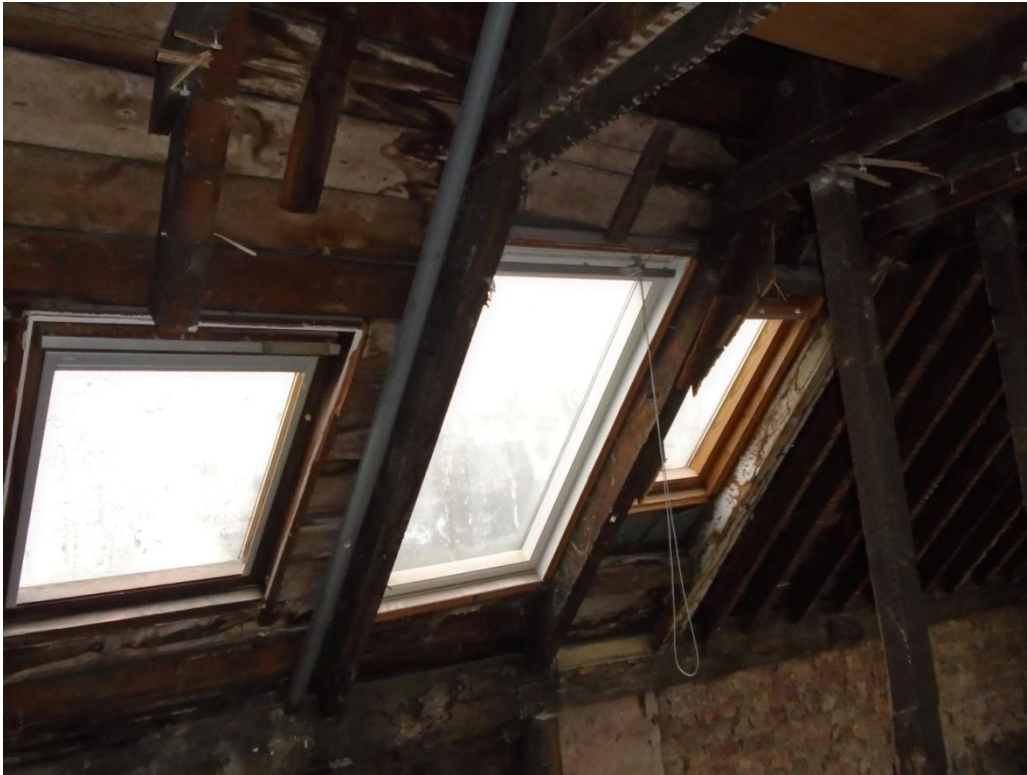
Image 34: Poor condition of roof structure and inadequate trimming around roof lights

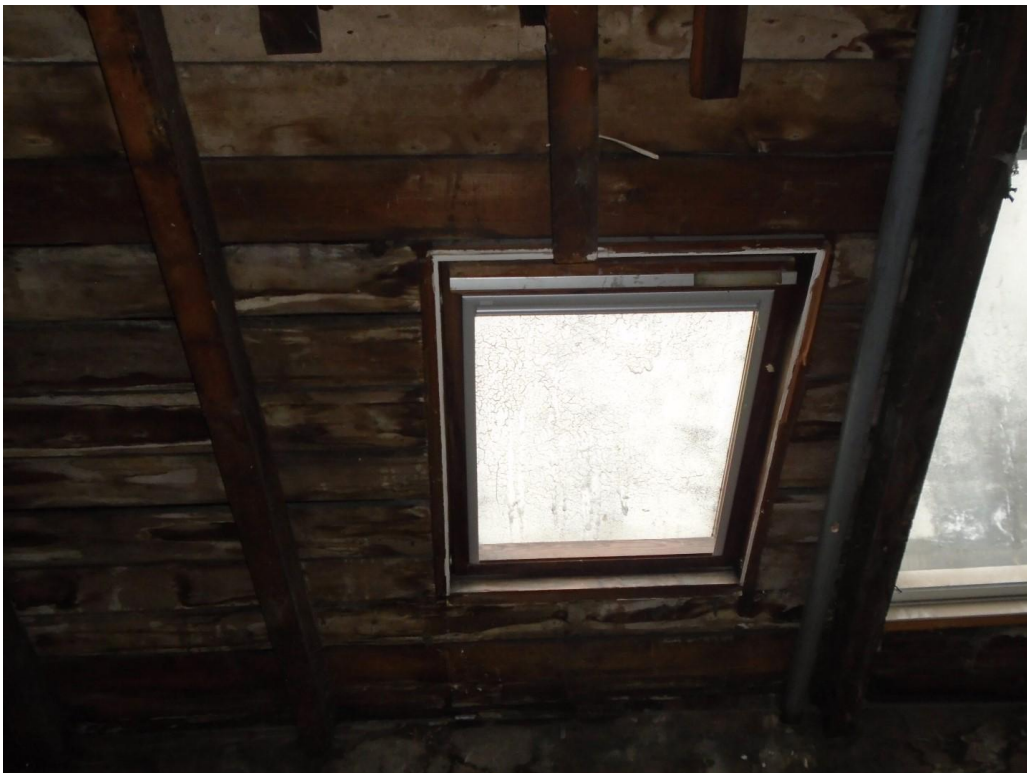
Image 35: Inadequate trimming to rafters around roof lights

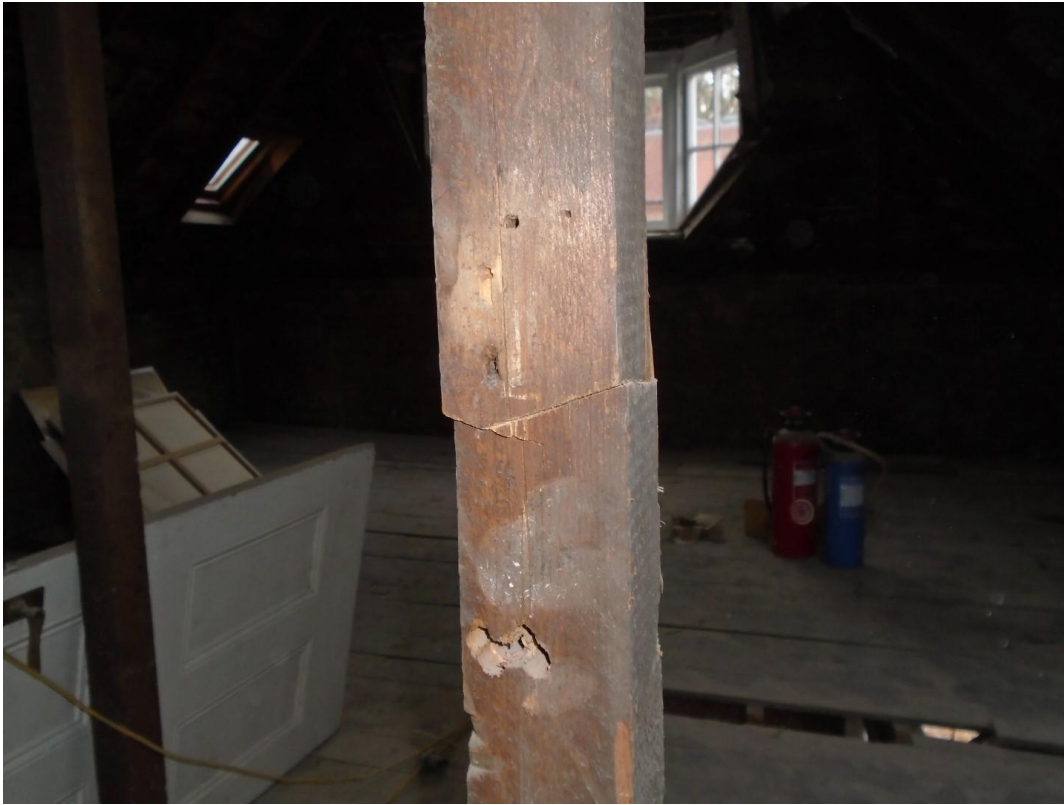
Image 36: Splice in vertical timber prop to roof structure is inadequate and potentially dangerous

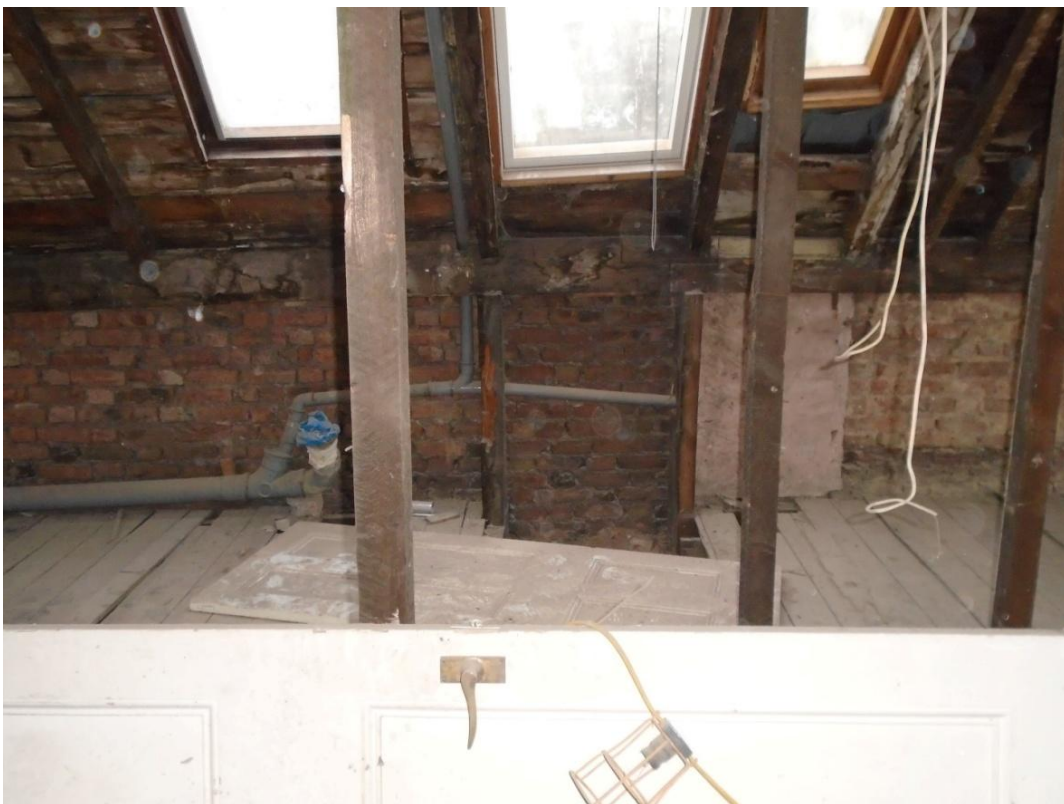
Image 37: Poor condition of waling beam and inadequate trimming to roof lights

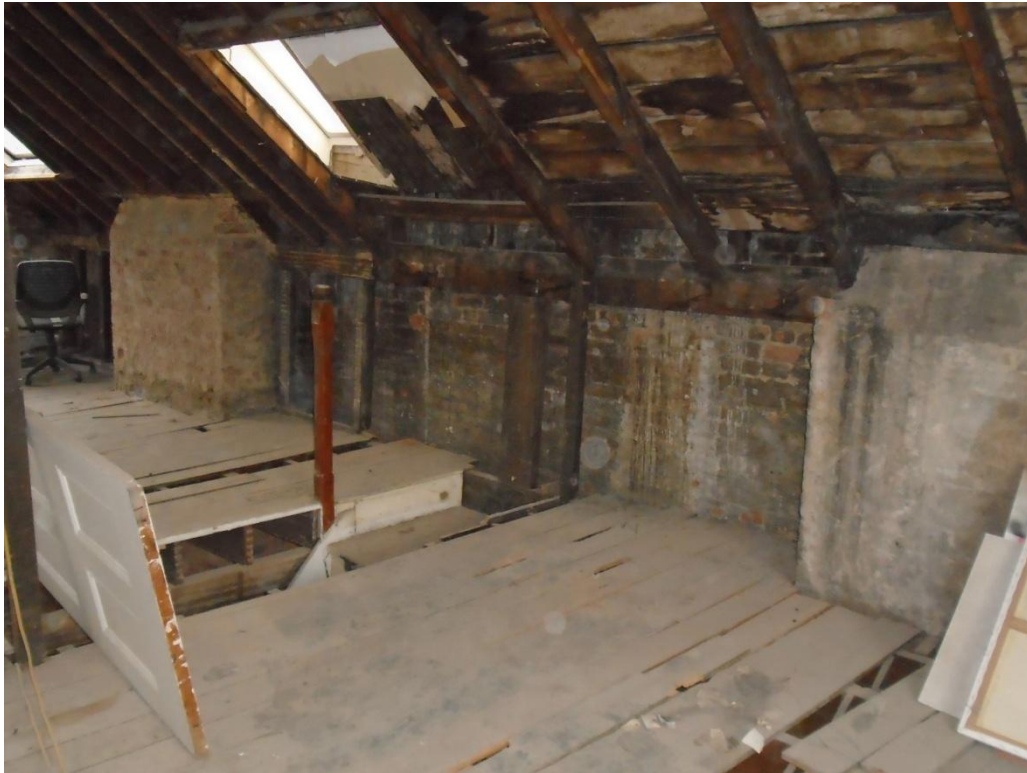
Image 38: General image of poor condition of second floor joists, brickwork, roof waling beam, roof rafters and timber boarding to roof

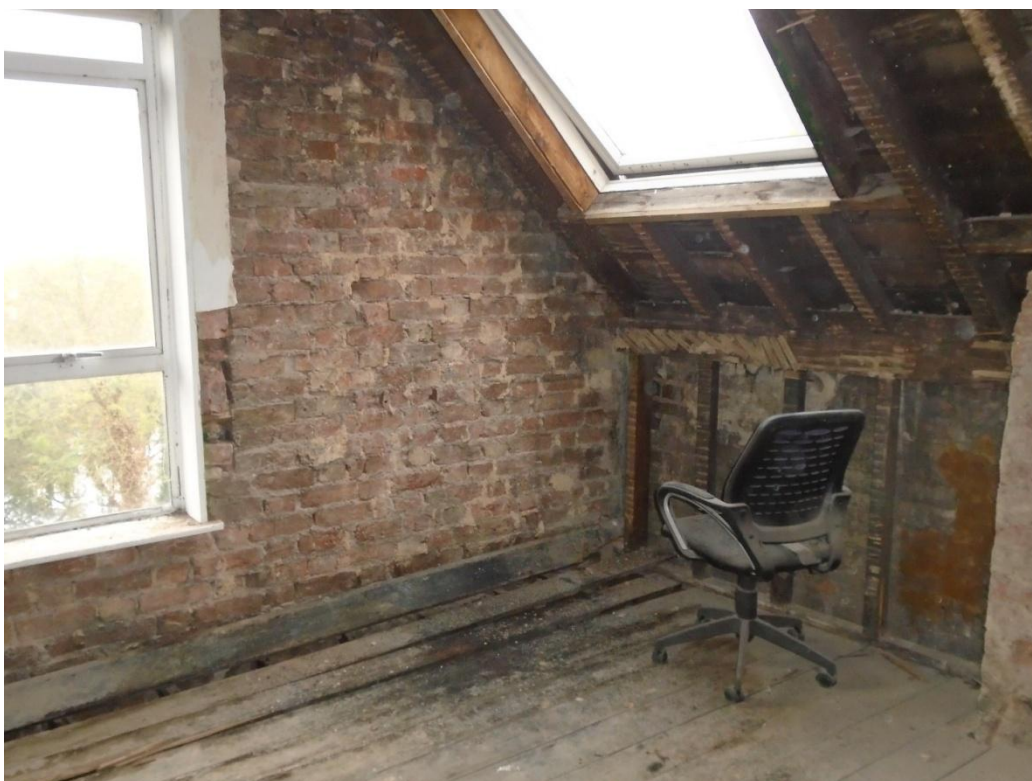
Image 39: Image of poor condition of brickwork and roof structure to rear facade

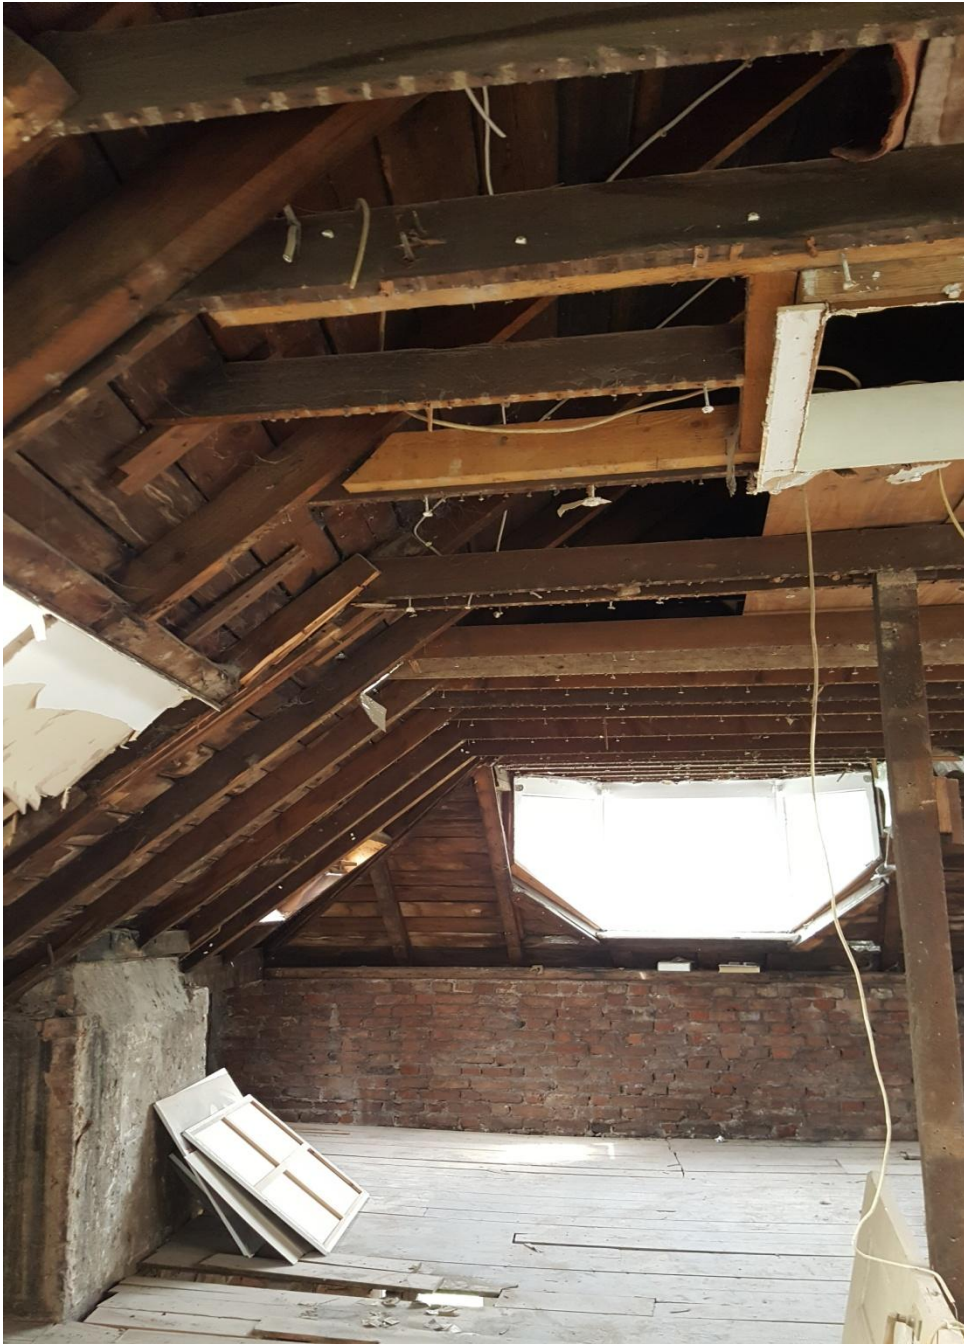
Image 40: General view of poor state of roof construction and sub standard interventions for roof lights

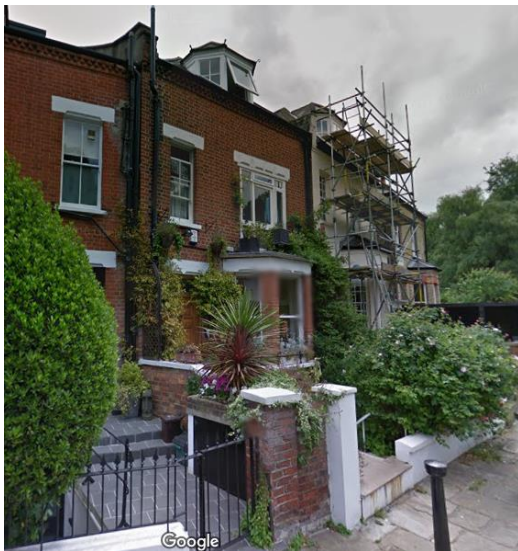
In accordance with your instructions, we revisited the above site on 28th June 2016 following our initial site investigation conducted on the 17th and 18th May 2016. The purpose of our return visit was to provide additional information on the foundations to the existing property and structures along with the drilling of two boreholes to provide information on subsoil conditions at depth beneath the site.

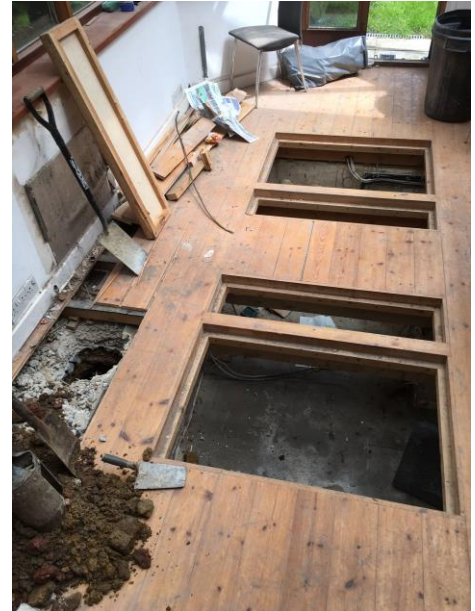
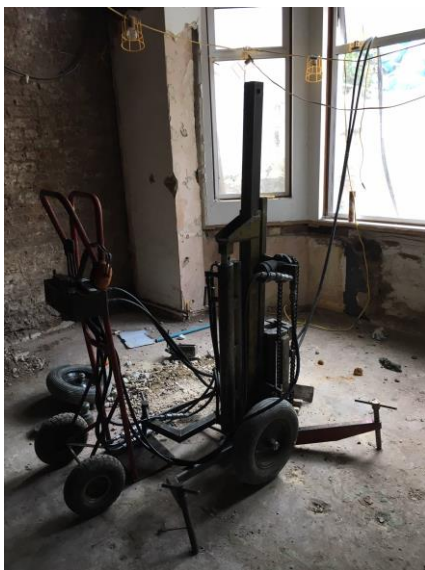
In situ strength testing was conducted at 1.00m intervals within the window sample boreholes by the performing of a Standard Penetration Testing (SPT). This test comprises the recording of the number of blows taken to drive a steel cone into the soil from the drop of a 63.5kg hammer of a distance of 760mm. This test then records the four increments of 75mm to provide an N value with the first 150mm considered the seating blow and not included as part of the N value. As such, the actual test depth is 150mm greater than stated (i.e. SPT test conducted at 4.00m actually refers to an N value at 4.15m).

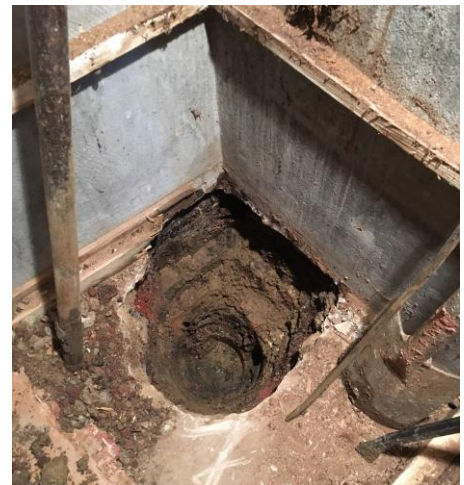
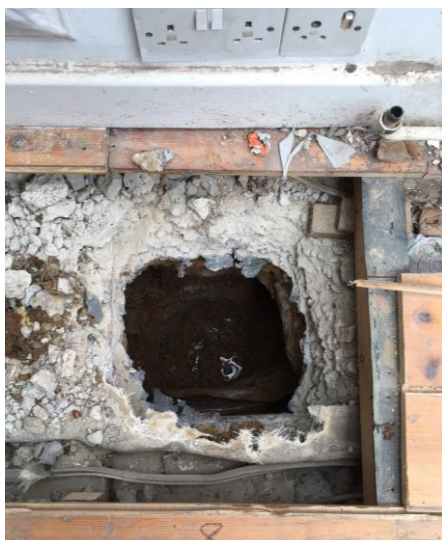
A water seepage was encountered at foundation level within this trial pit. No roots were encountered.

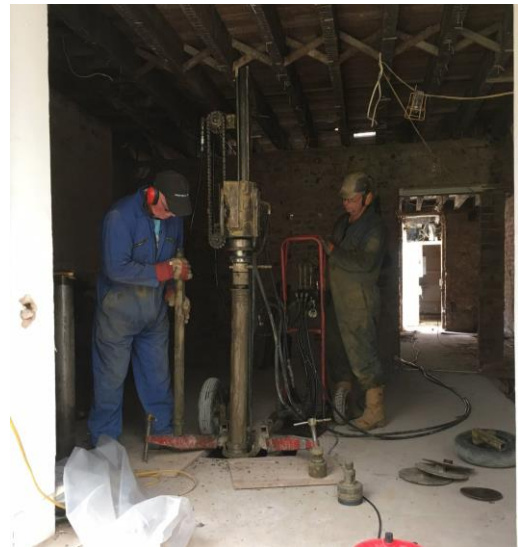
A steady inflow of water was encountered within this borehole at 4.00m, with the water level rising to 2.00m after 5 minutes and was found to stand at 1.00m on completion of all site works.
