Our Ref: 1308651  
Your Ref: 251998/HSA/2016

**REPORT 1 - PRELIMINARY REPORT FOLLOWING COMPLETION OF INITIAL VISIT**

**POLICY NUMBER** B16/0107586  
**NAME & ADDRESS OF INSURED** MF William & Mrs Laura Oddie  
31 Heath Hurst Road, London, NW3 2RU  
**SITUATION OF LOSS/DAMAGE** 31 Heath Hurst Road, London, NW3 2RU  
**TRADE/OCCUPATION** Householders  
**VAT STATUS OF INSURED** Not Registered  
**DISCOVERY** 18 August 2016  
**AREA OF DAMAGE** Front Bay  
**CAUSE** Subsidence  
**THIRD PARTY ASPECT/CONTRIBUTION** Local Authority  
**ADEQUACY OF SUM INSURED** Adequate  
**RESERVE FOR INSURERS** [REDACTED]

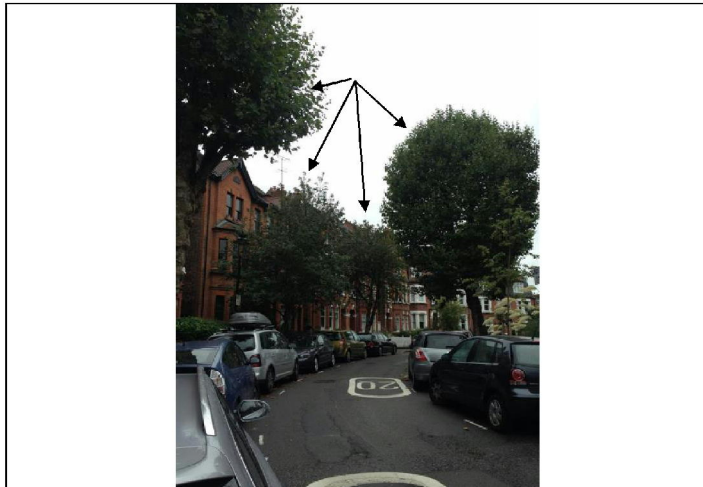
The timing of the event, the presence of shrinkable clay beneath the foundations and the proximity of vegetation where there is damage indicates the shrinkage to be root induced. This is a commonly encountered problem and probably accounts for around 70% of subsidence claims notified to insurers.

Local Authority vegetation to front

Although the cause of the movement needs to be dealt with, we note the involvement of a Local Authority tree. Unfortunately, they will require certain investigations to be carried out to demonstrate the influence of their vegetation.

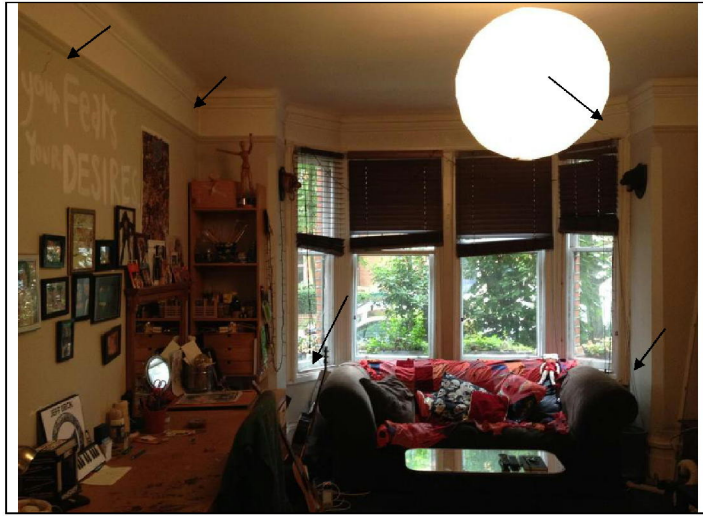
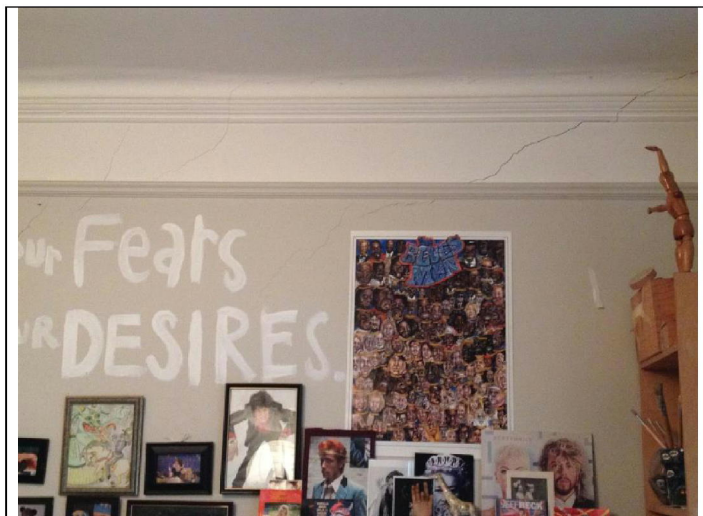
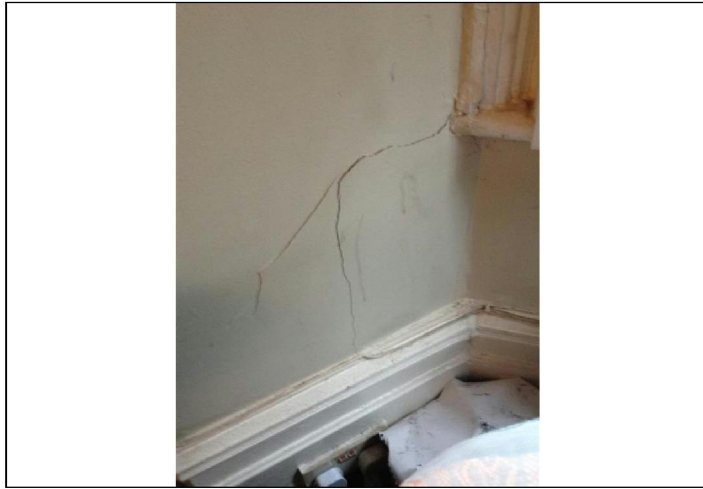
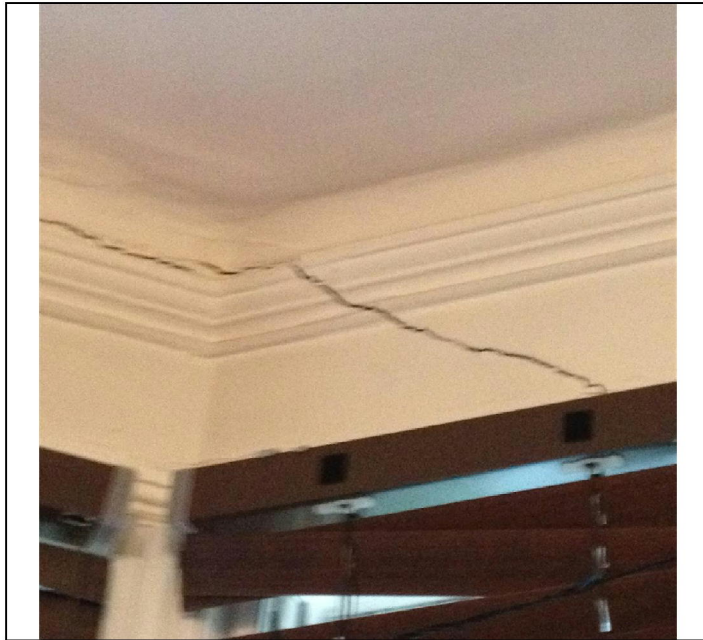
Ground Floor Lounge

Multiple diagonal cracks to internal dividing wall to hall up to 2mm in width.

Diagonal cracking above left hand side of bay window up to 3mm in width.

Diagonal cracking below right hand side of bay window up to 1mm in width.

Separation around bay window frame.

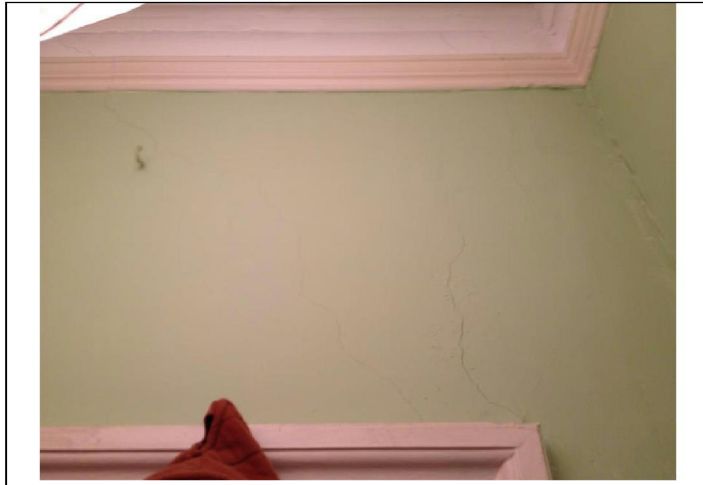
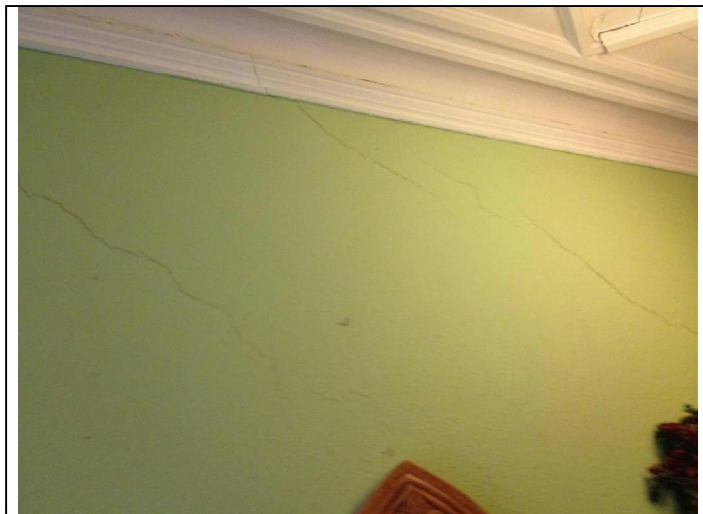
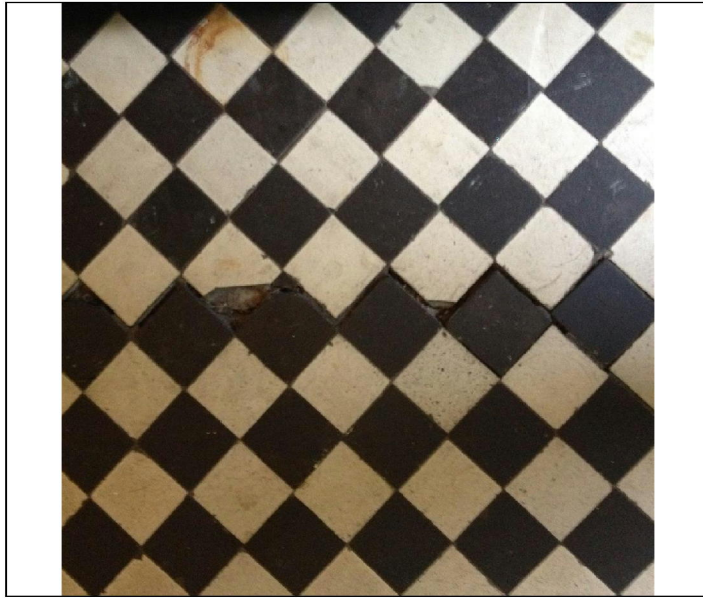
Hall

Cracking to Victorian tiled hallway floor.

Multiple diagonal cracks to internal dividing wall to lounge up to 1mm in width.

Cracking to ceiling.

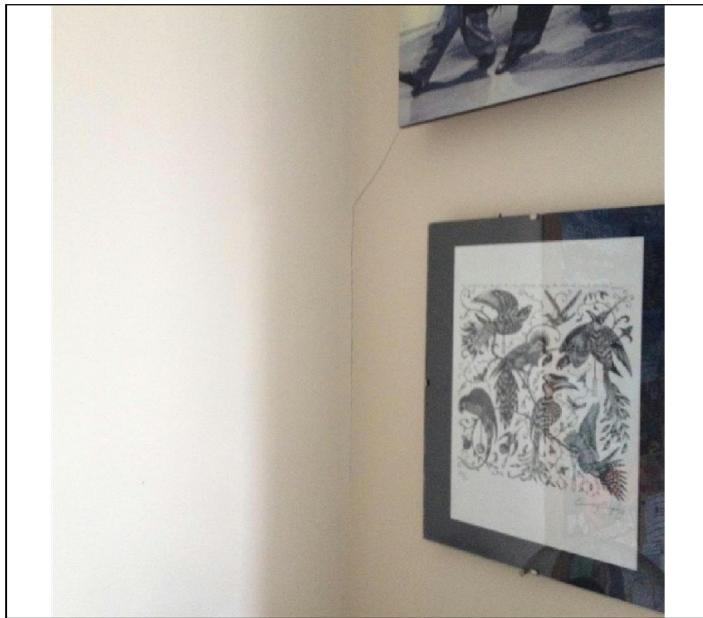
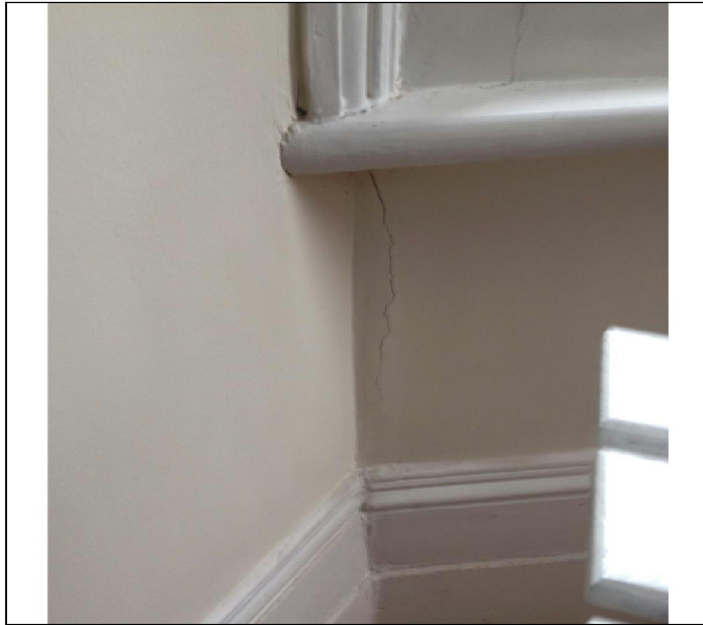
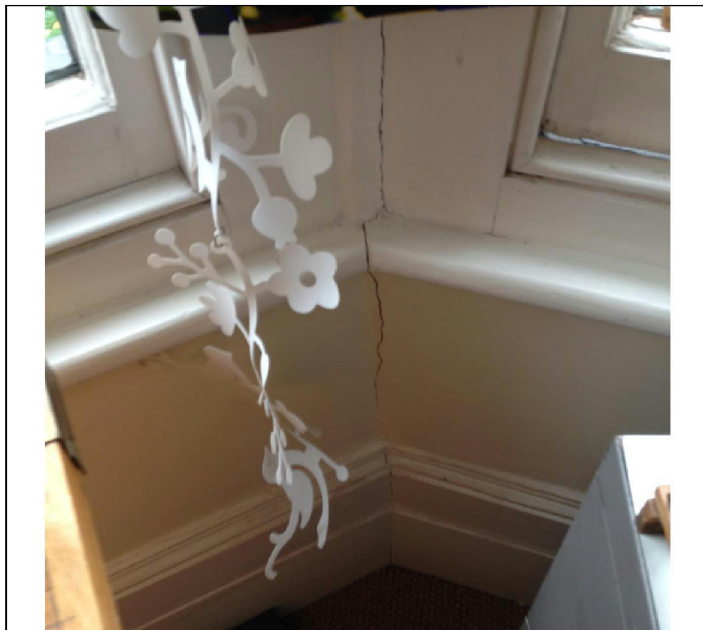
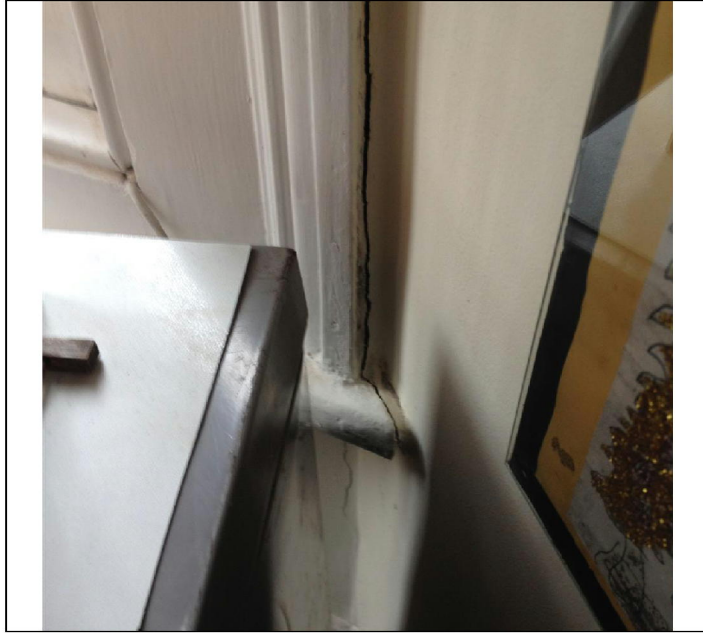
First floor front office

1mm vertical cracking to wall junctions below bay window.

Minor cracking above bay window.

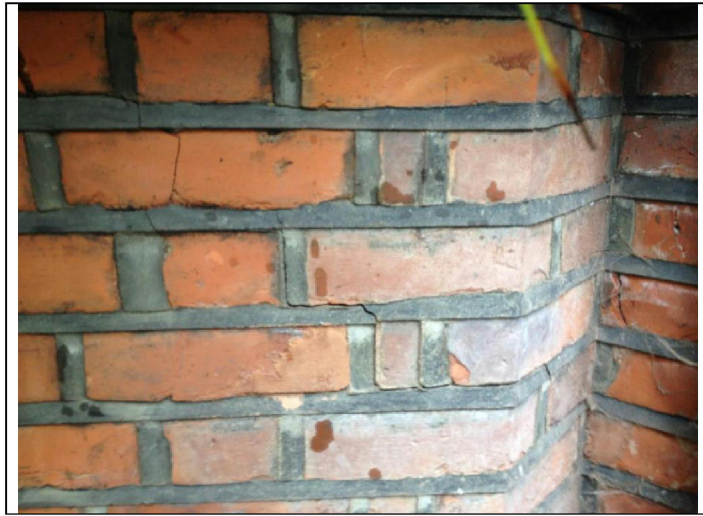
1mm diagonal stepped cracking below right hand side of bay window.

Cracking to bay

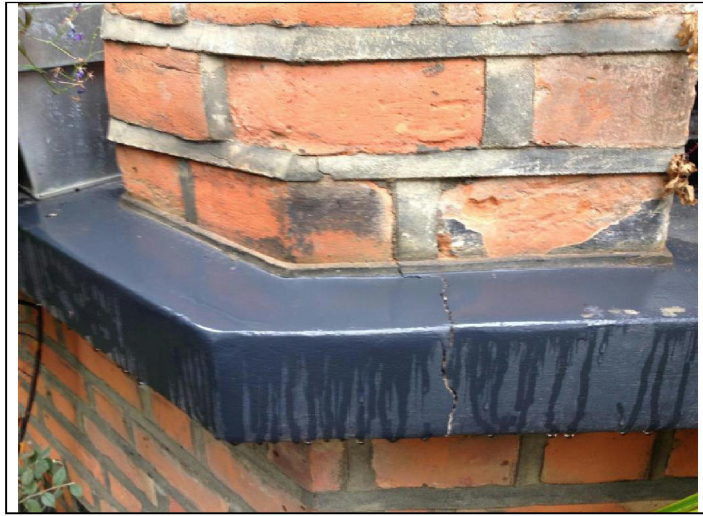
1mm cracking to sill.

Cracking to sill of bay

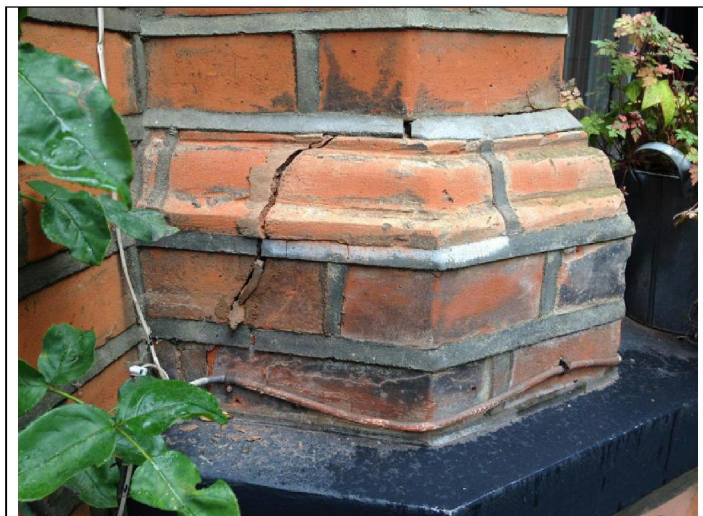
2mm cracking through brickwork to base of left hand window pier.

Cracking to pier of bay

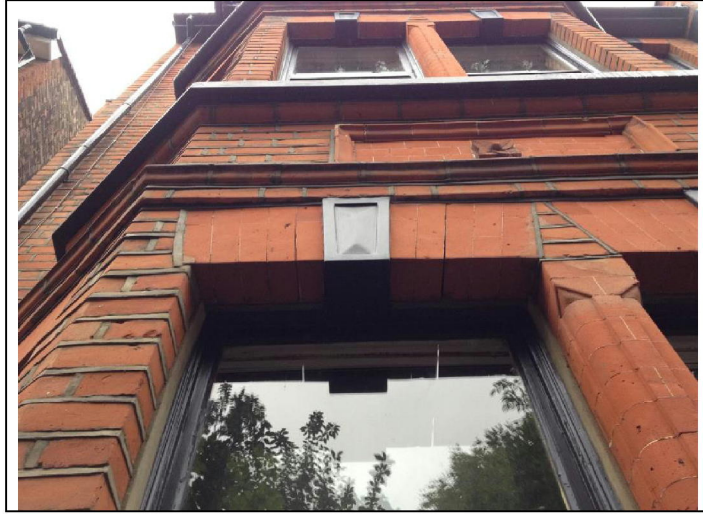
Separation to brick arch.

Separation to brick arch to front bay.

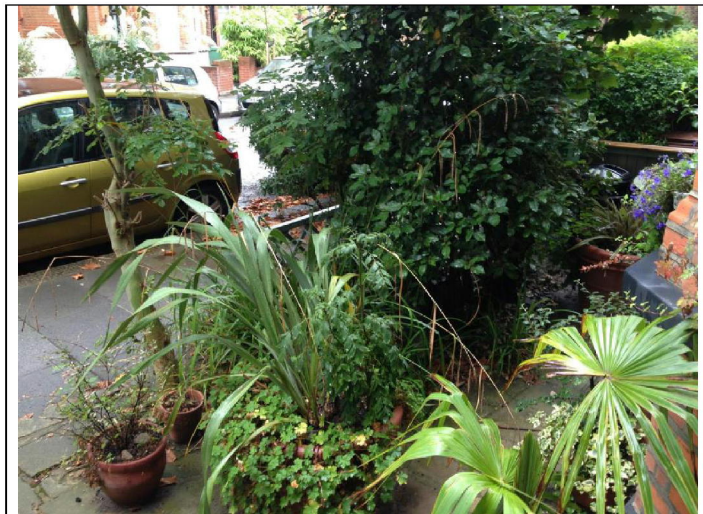
Insureds own vegetation to front 2 x small deciduous trees – may require removal
