STANLEY SIDINGS LIMITED

Condition survey and strength grade assessment of accessible first floor lintel and floor structures at the nos. 26 and 27 Stables Market, Camden Town, London

146.09
October 2016

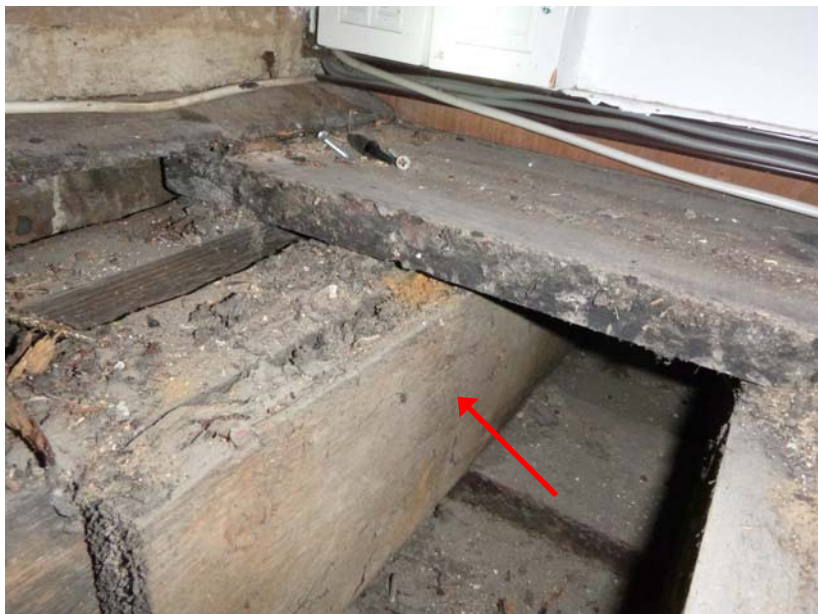
Fig 1:

House 26, south-west corner; showing a joist supported on the west iron beam

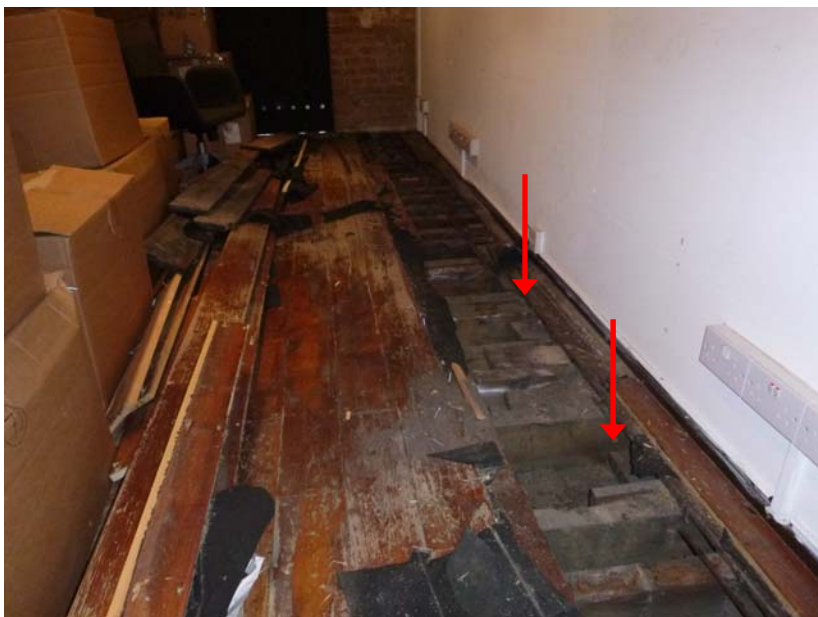
Fig 2:

House 26, west wall; showing the floor structural joists bearing on the west iron beam

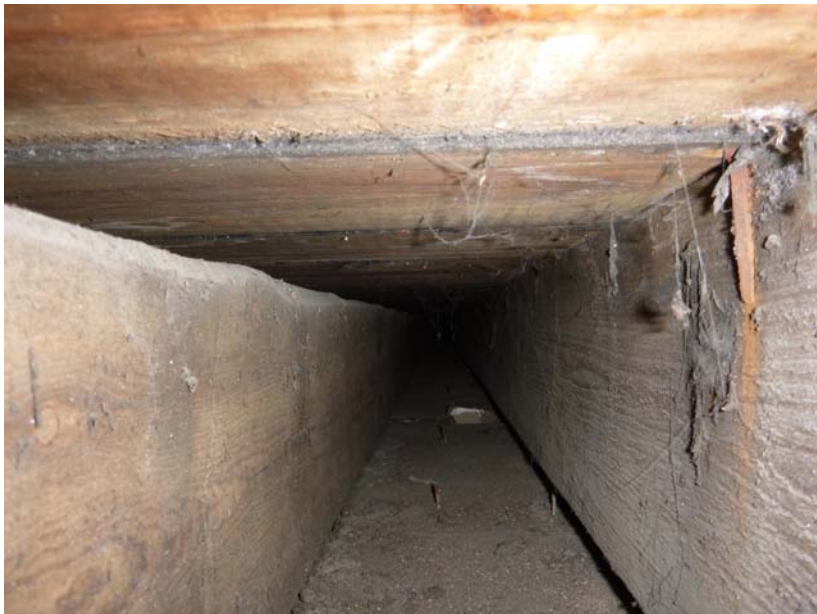
Fig 3:

House 26, floor structure; showing the floor void

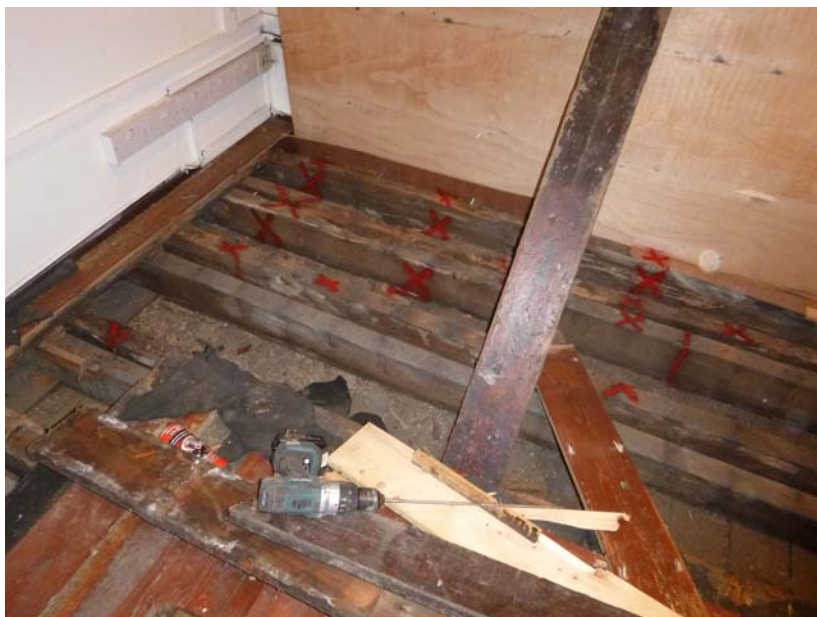
Fig 4:

- 1 General comment: The floor structure comprised of floor joists, approximate dimensions 170 x 60 at 200mm centres supported on an iron beam along the west side of the area. Significant dry rot fungal decay occurs in the north-west corner. The floor had been partially opened up but the opening-up in this area was not extensive. The deep moisture content was taken and found to be 12-14 per cent indicating that the infection may be inactive. There were no signs of active infection

House 26, north-west corner; showing the structurally decayed floor structure

Open up the complete floor to allow detailed inspection of all floor structures in this area. See drawings in Appendix F for the location of opening up work. No chemical timber treatment or wall irrigation is required on refurbishment but extensive repair and isolation will be required

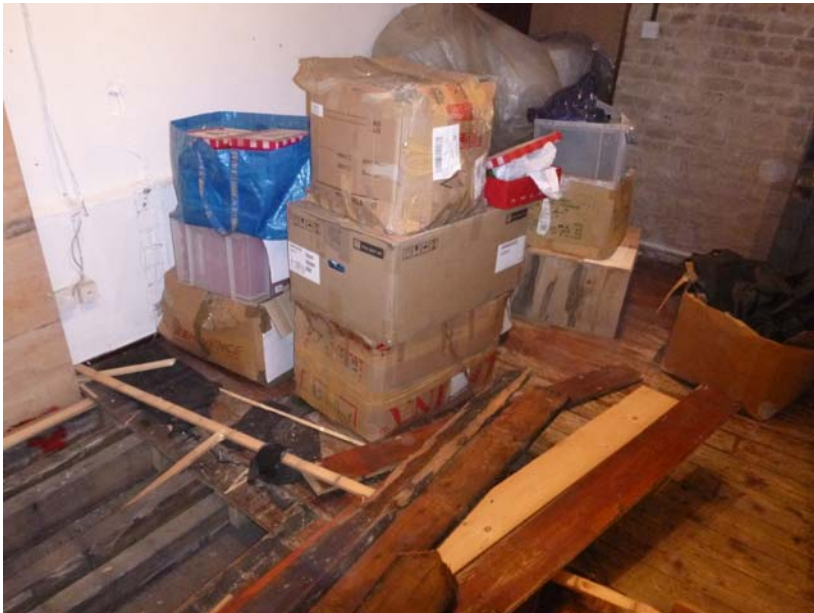
Fig 5:

House 26, east side; showing the inaccessible parts of the floor

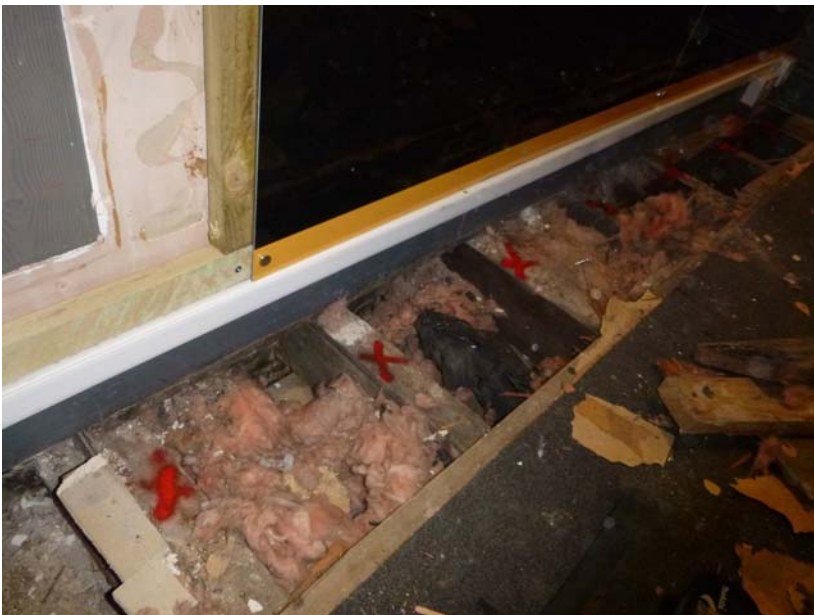
Fig 6:

- 3 Floor joists: Inspection of the first floor joists revealed that 11 no. joists were decayed by wet rot fungal decay at their north bearing ends. There was no access to the south bearing ends where the joists were connected to the primary beam. The deep moisture content at the north bearing ends was found to be 12 to 20 per cent. This is damp enough for the decay to continue. The decayed joists were marked on site with red spray paint. See drawings for the location of the decayed joists. There was no access to the wall plate, if one exists

House 27, north side; showing decayed joists bearing in the north wall

The structurally decayed first floor joists (11 no.) should be repaired at their north bearing ends or replaced entirely. Remove floorboards and wall panelling to gain

access. The repair may be carried out by cutting back to sound timber and partnering with new timber joists coach bolted to the remaining sound timber. Alternatively, it may be more cost effective to replace the decayed joists entirely. The embedded wall plate, if one exists, should be removed and the void bricked-in. Lift all floor coverings to facilitate and allow further inspection of all joists at their connections to the primary beams. Repair estimates should allow for the further inspection and probable repair and strengthening of up to 6 no. joist at the connections to the primary beams

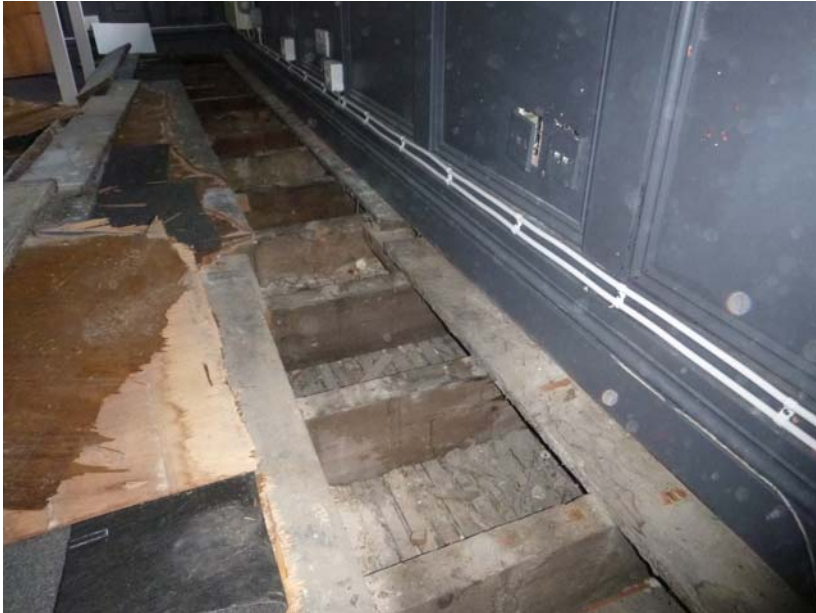
Fig 7:

House 27, south side; showing joists bearing in the south wall

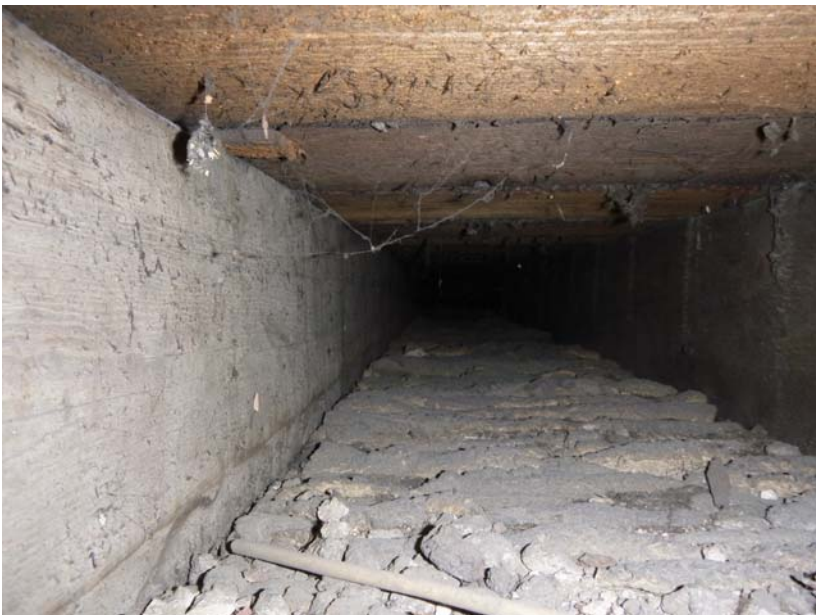
Fig 8:

House 27, south side; showing the floor void

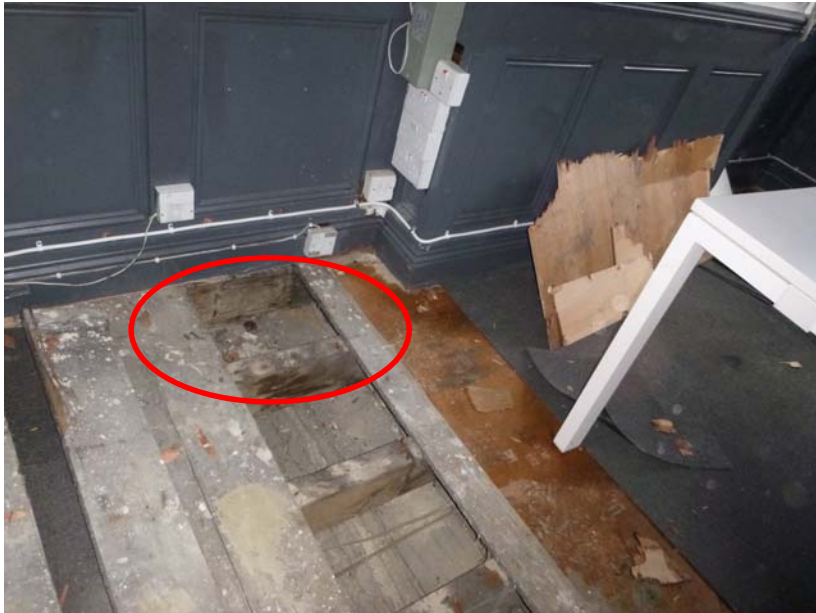
Fig 9:

House 27, east side; showing the east bearing end of the south primary beam. Access to the beam was restricted

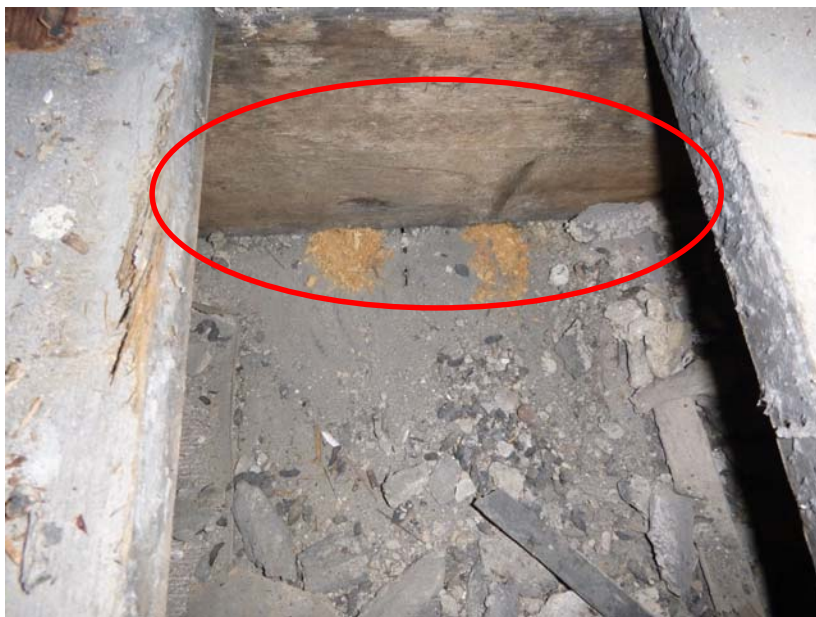
Fig 10:

House 27, east side; showing the east bearing end of the north primary beam

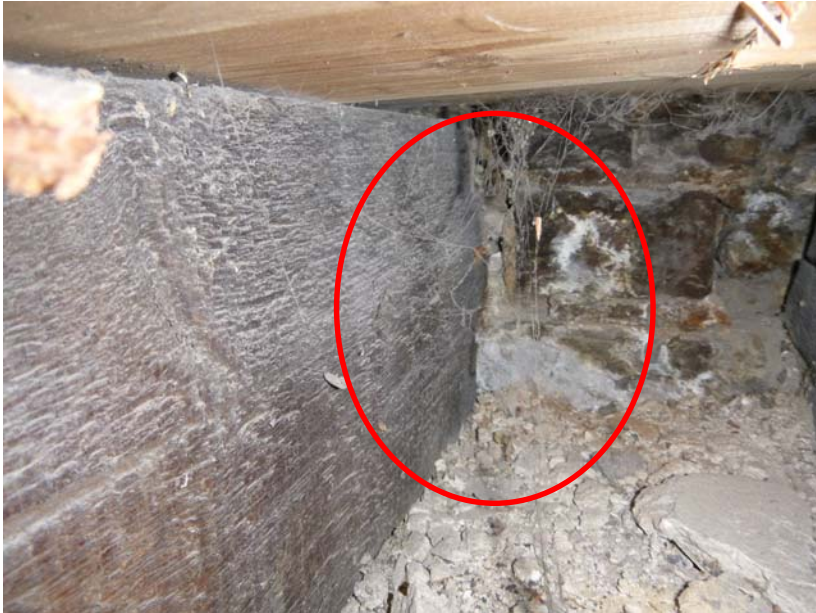
Fig 11:

House 27, north side; showing the minimum bearing end of a joist

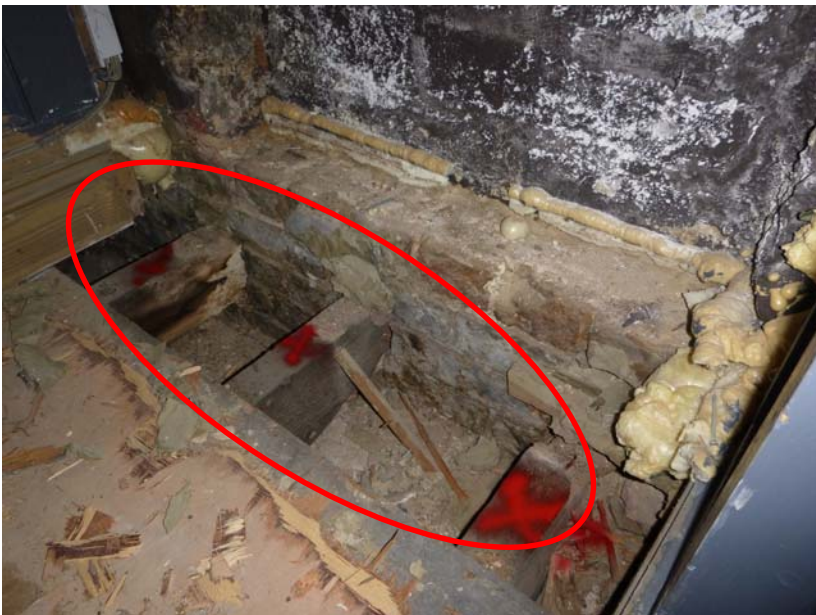
Fig 12:

House 27, north side; showing the structurally decayed north beams

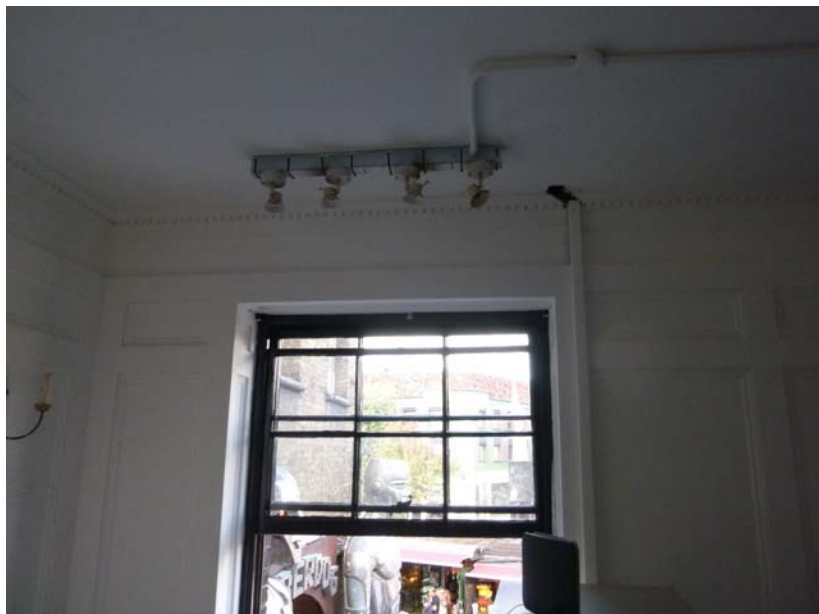
Fig 13:

- 4 Lintels: Lintel nos. 1, 2, 3 and 4 were drilled at their bearing ends. No decay was detected. The deep moisture content was less than 12 per cent

House 27, lintel over window no. 1

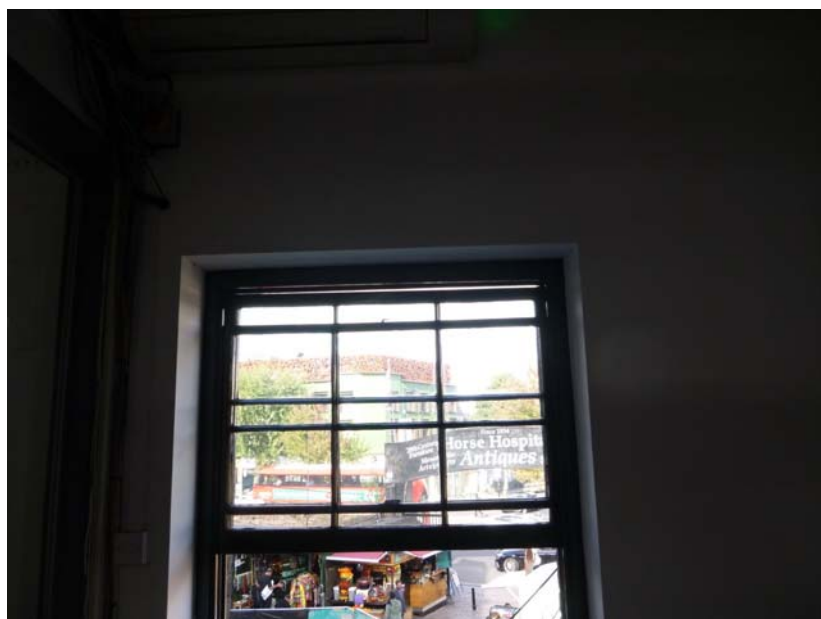
Fig 14:

House 27, lintel over window no. 2

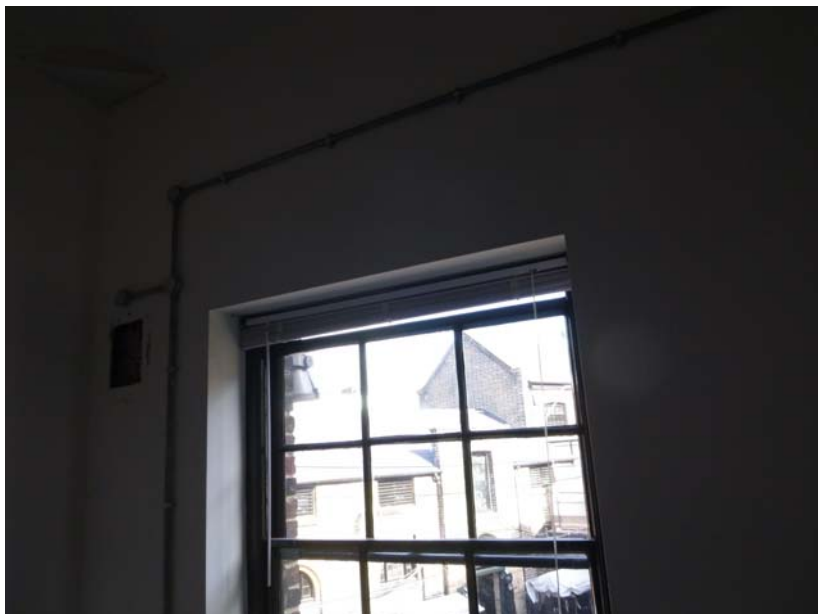
Fig 15:

House 27, lintel over window no. 3

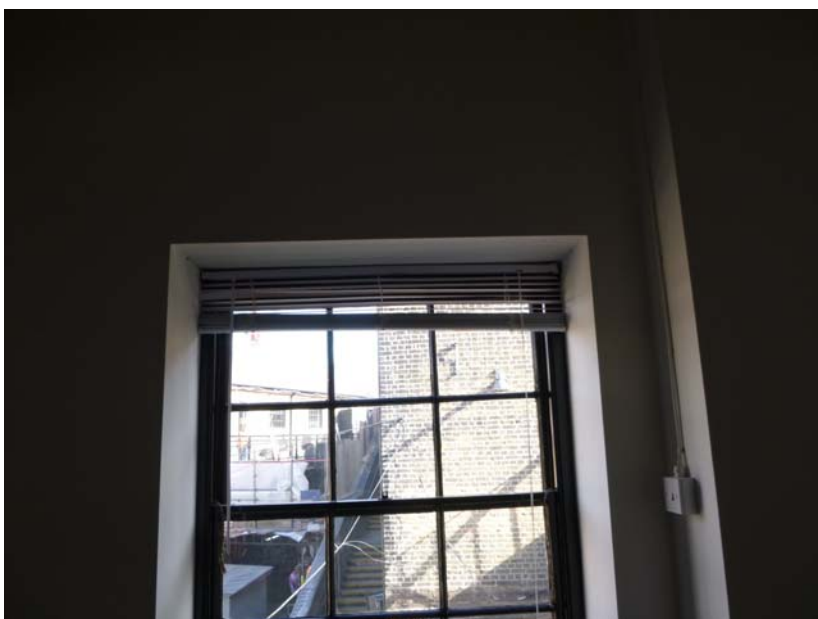
Fig 16:

House 27, lintel over window no. 4

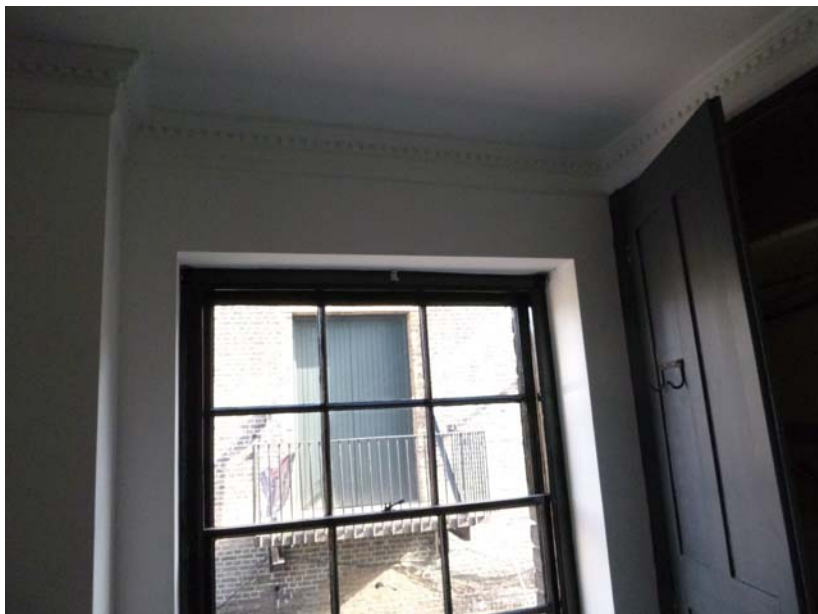
Fig 17:

House 27, lintel over window no. 5

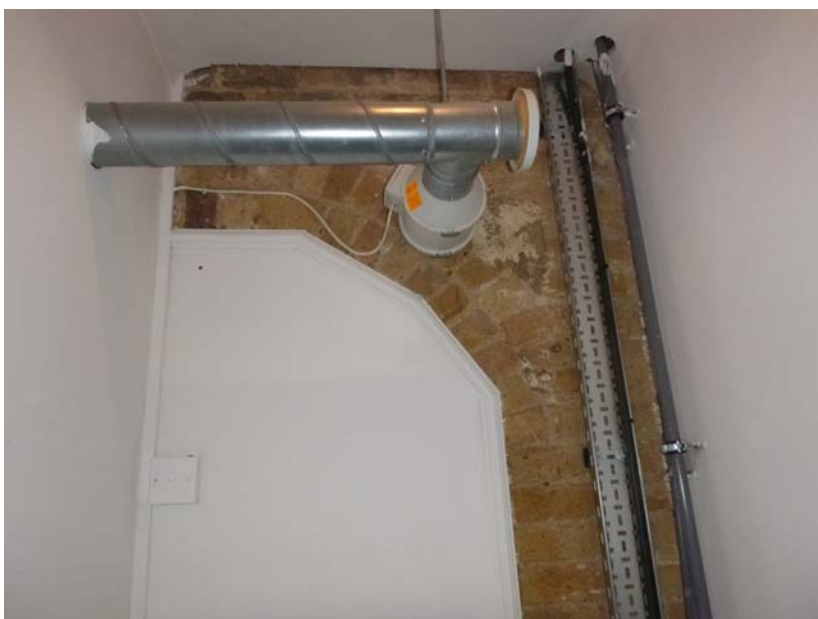
Fig 18:

House 27, brick arch over window no. 6

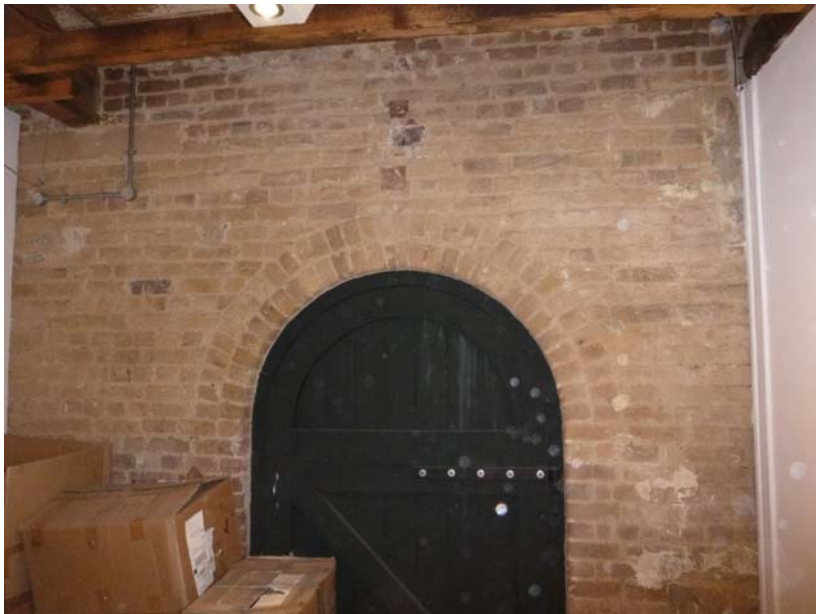
Fig 19:

House 27, brick arch over window no. 7,

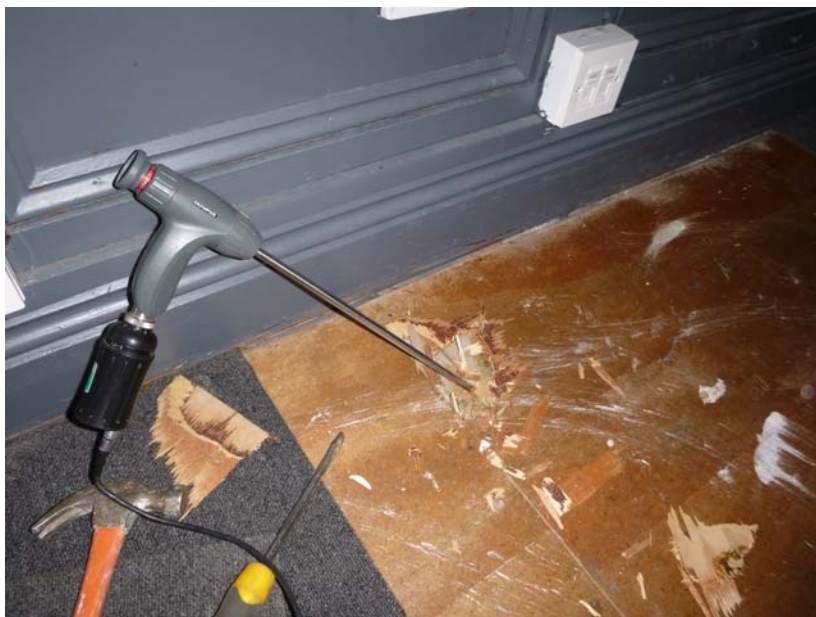
Fig 20:

House 27, west side; showing borescope inspection of the floor void
