**St Katherine's The Danish Church  
Structural Appraisal of Pinnacles**

**Prepared for  
The Danish Church  
November 2015**

This structural engineering appraisal has been prepared by Alan Baxter Limited (ABA) and relates to the two masonry pinnacles on the west elevation of the St Katherine's, The Danish Church in London (see photo 01).

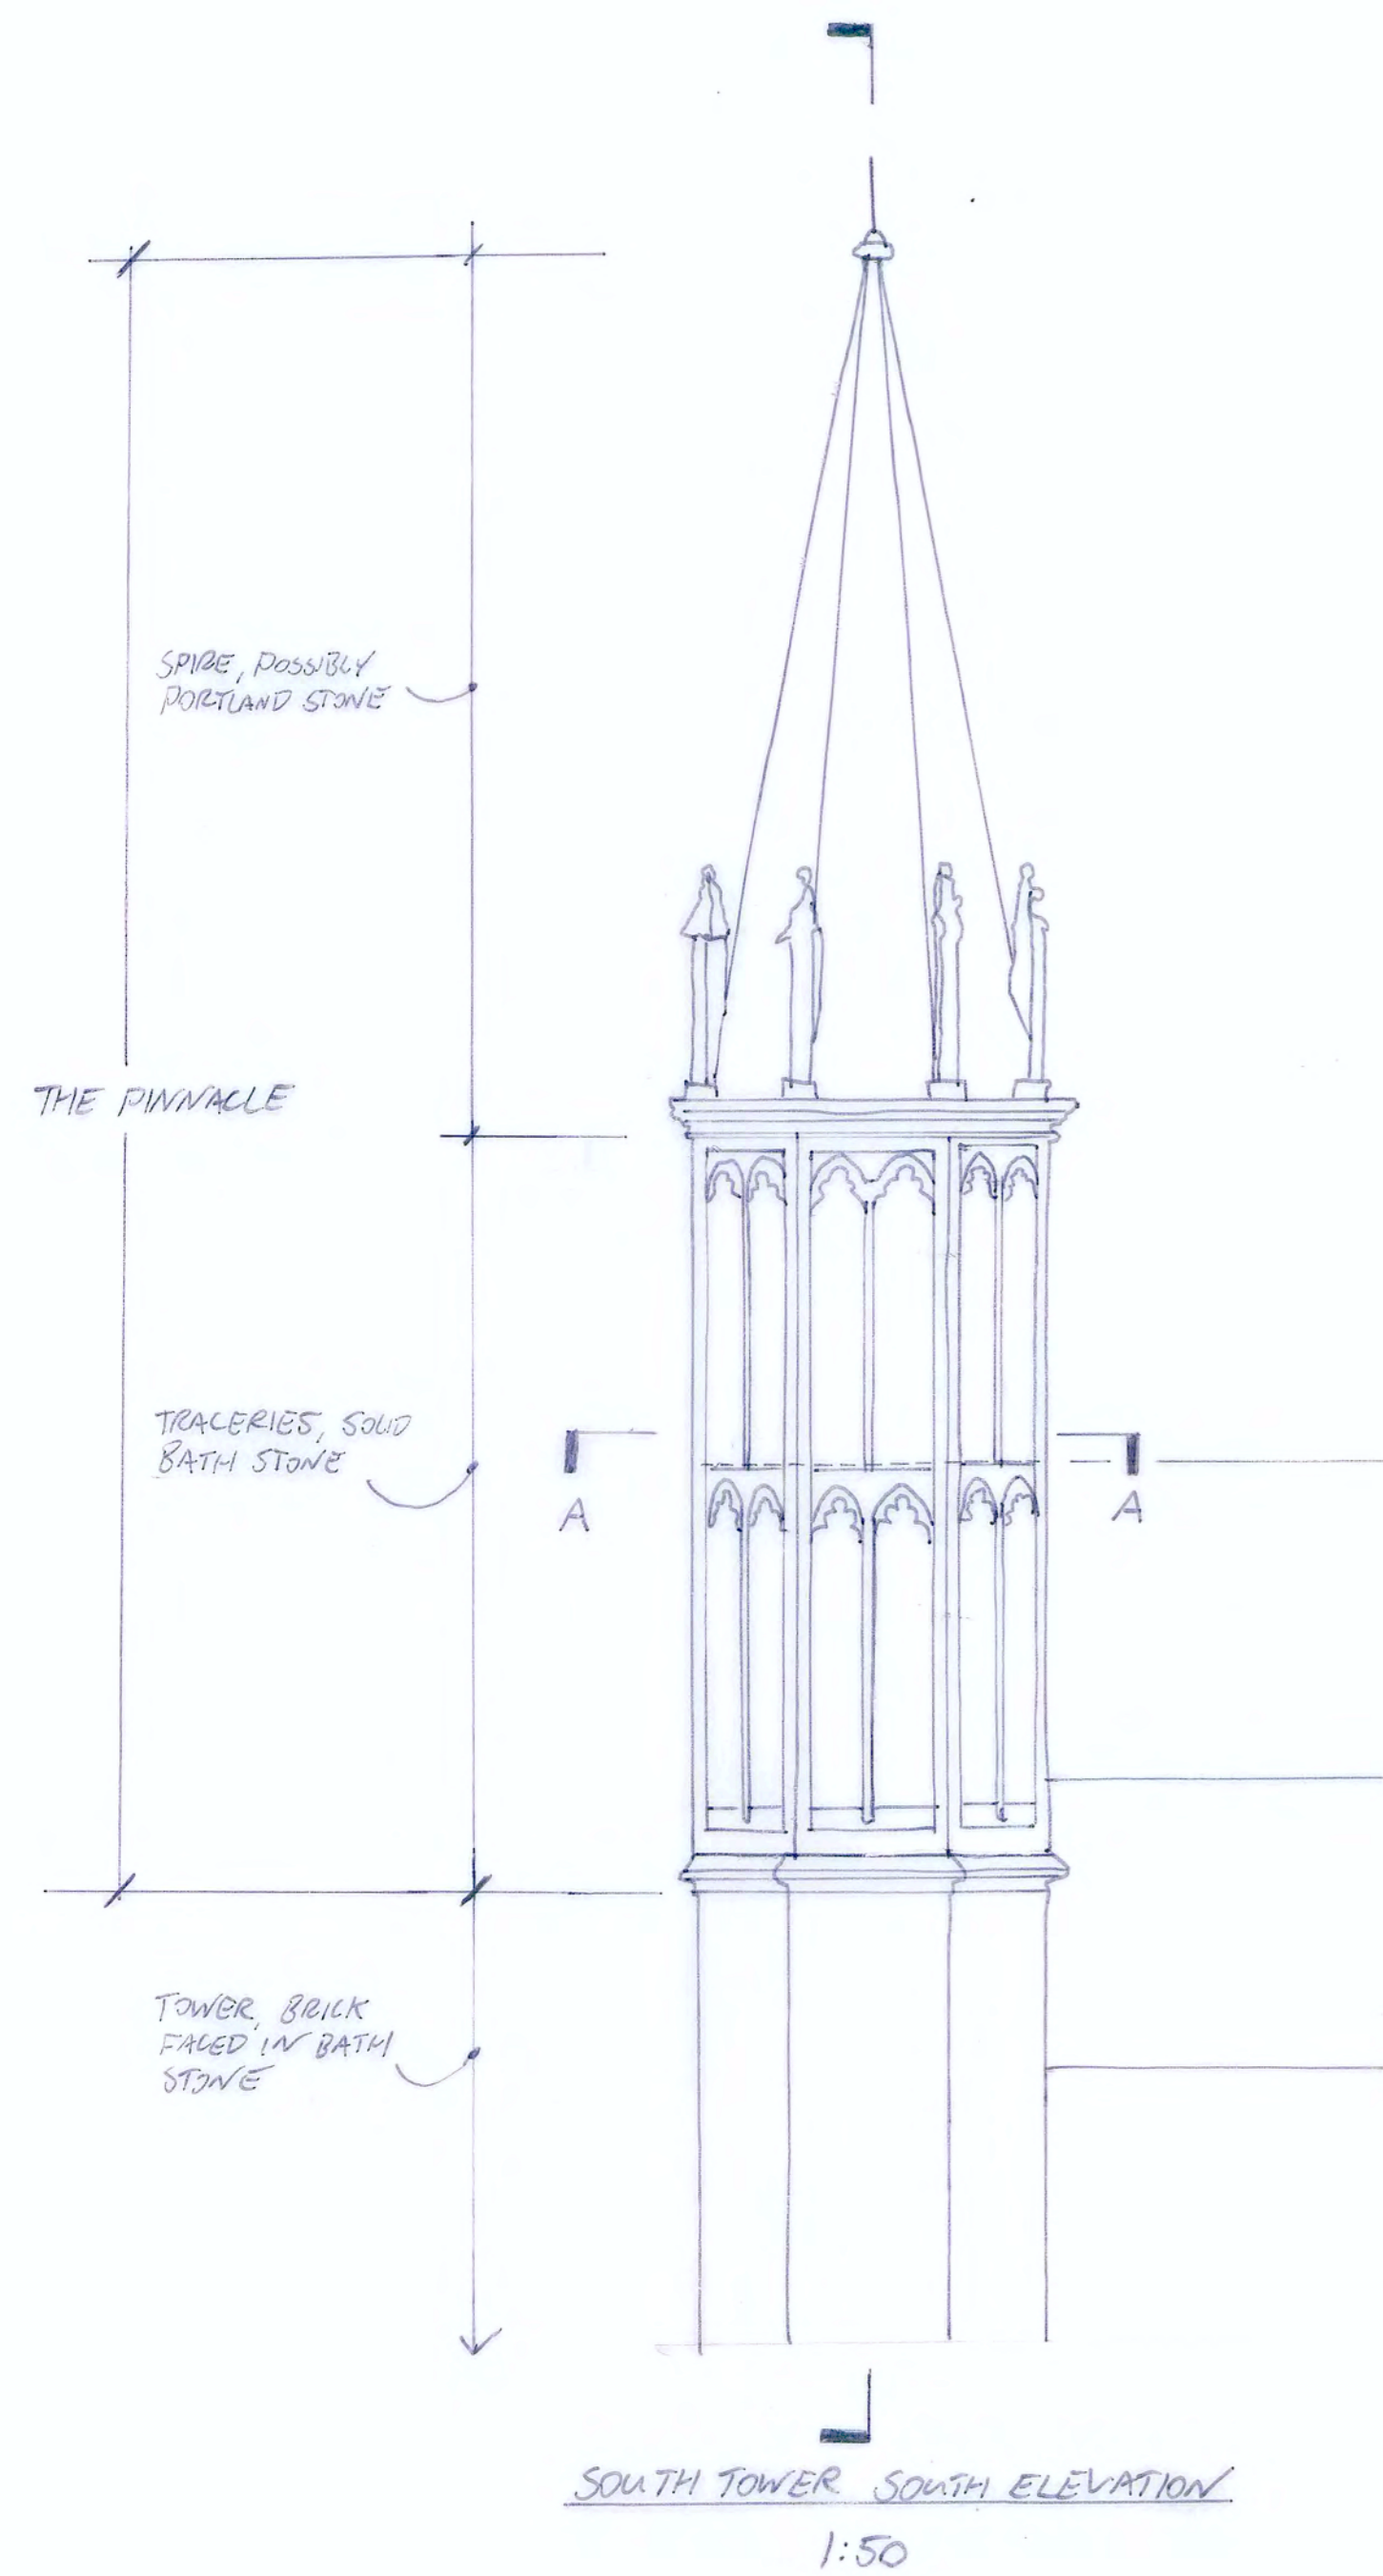
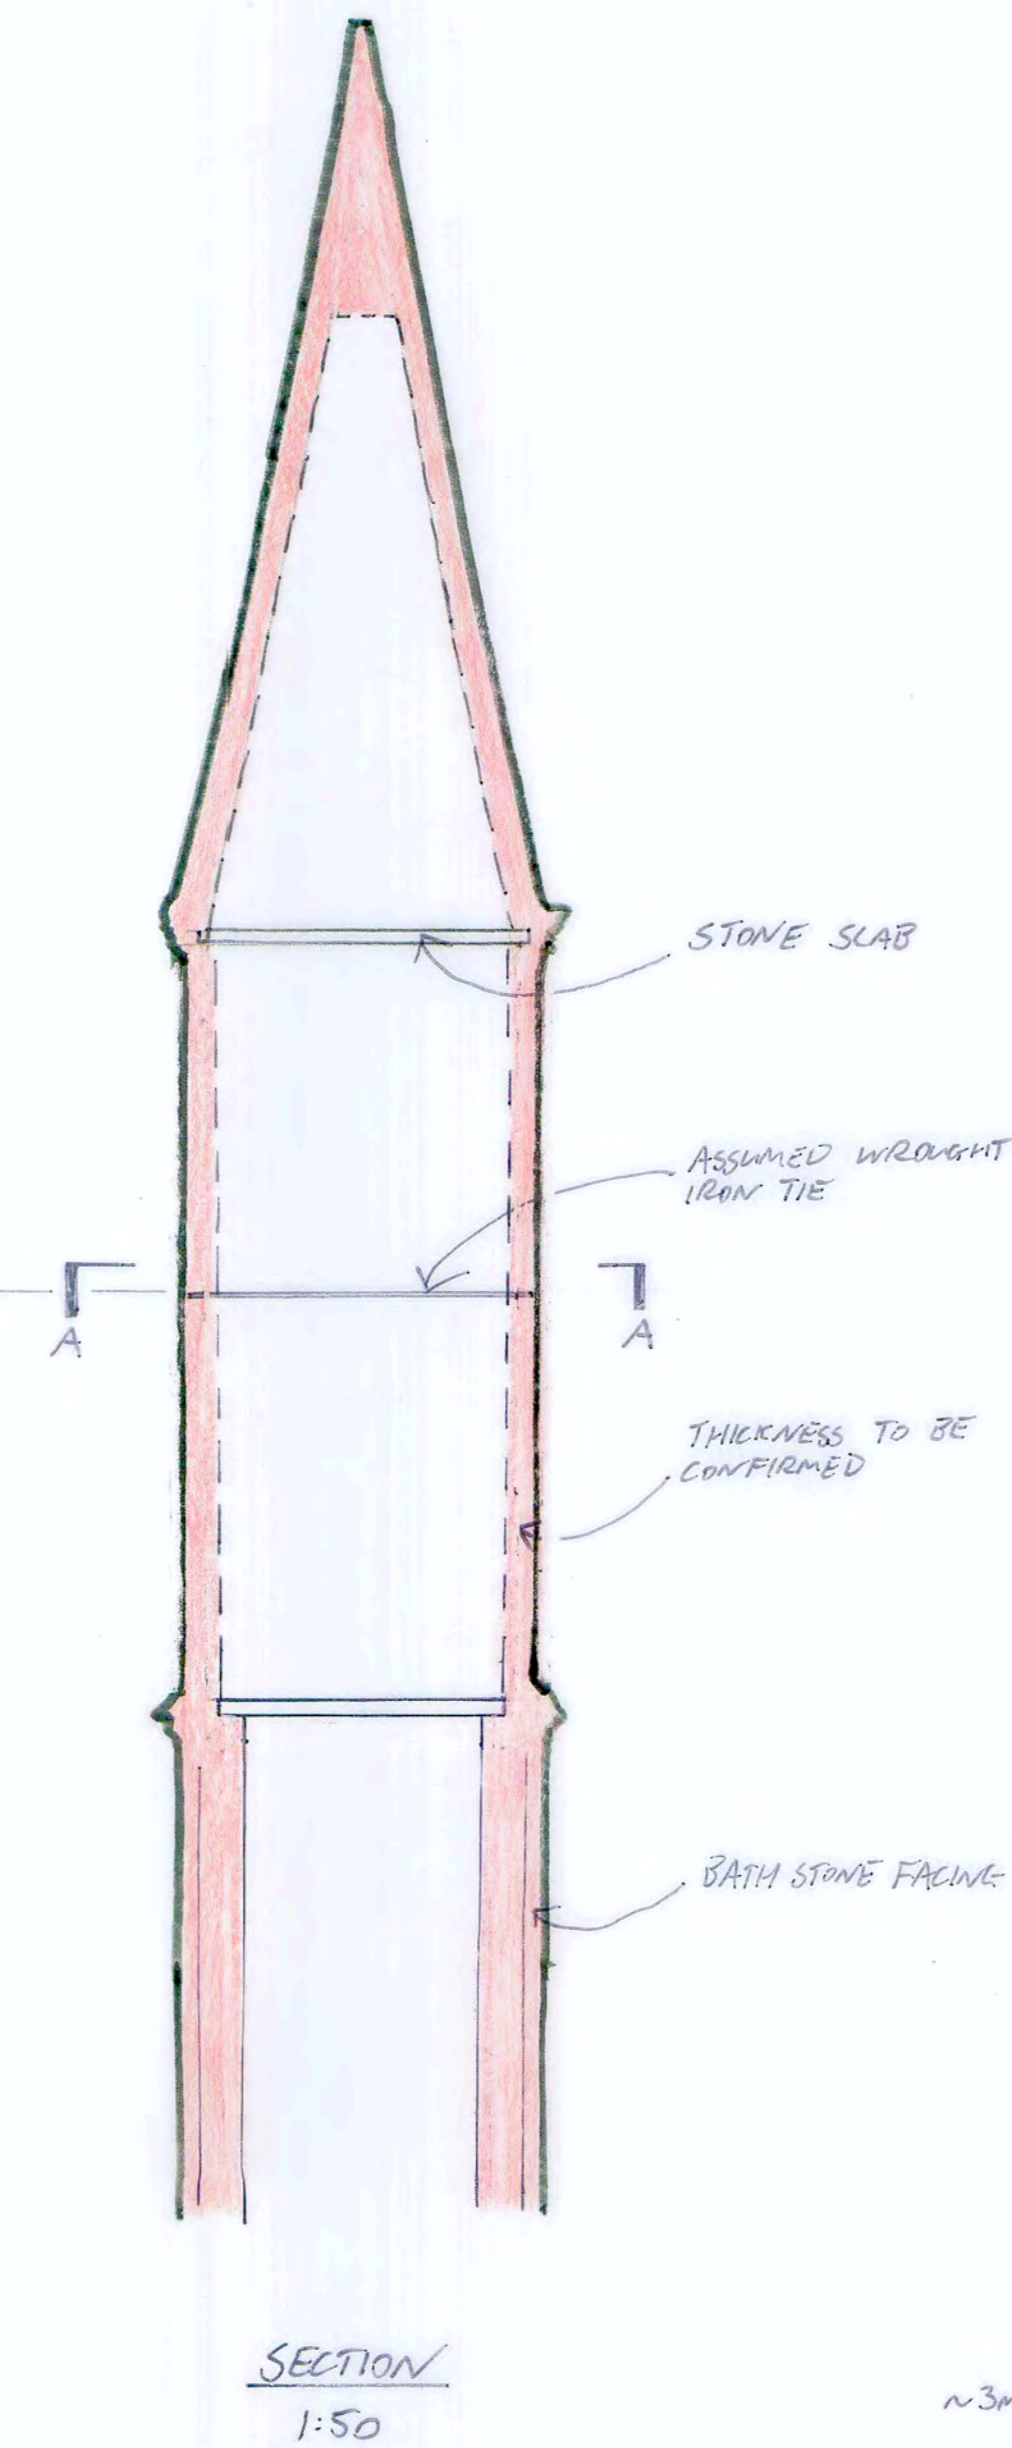
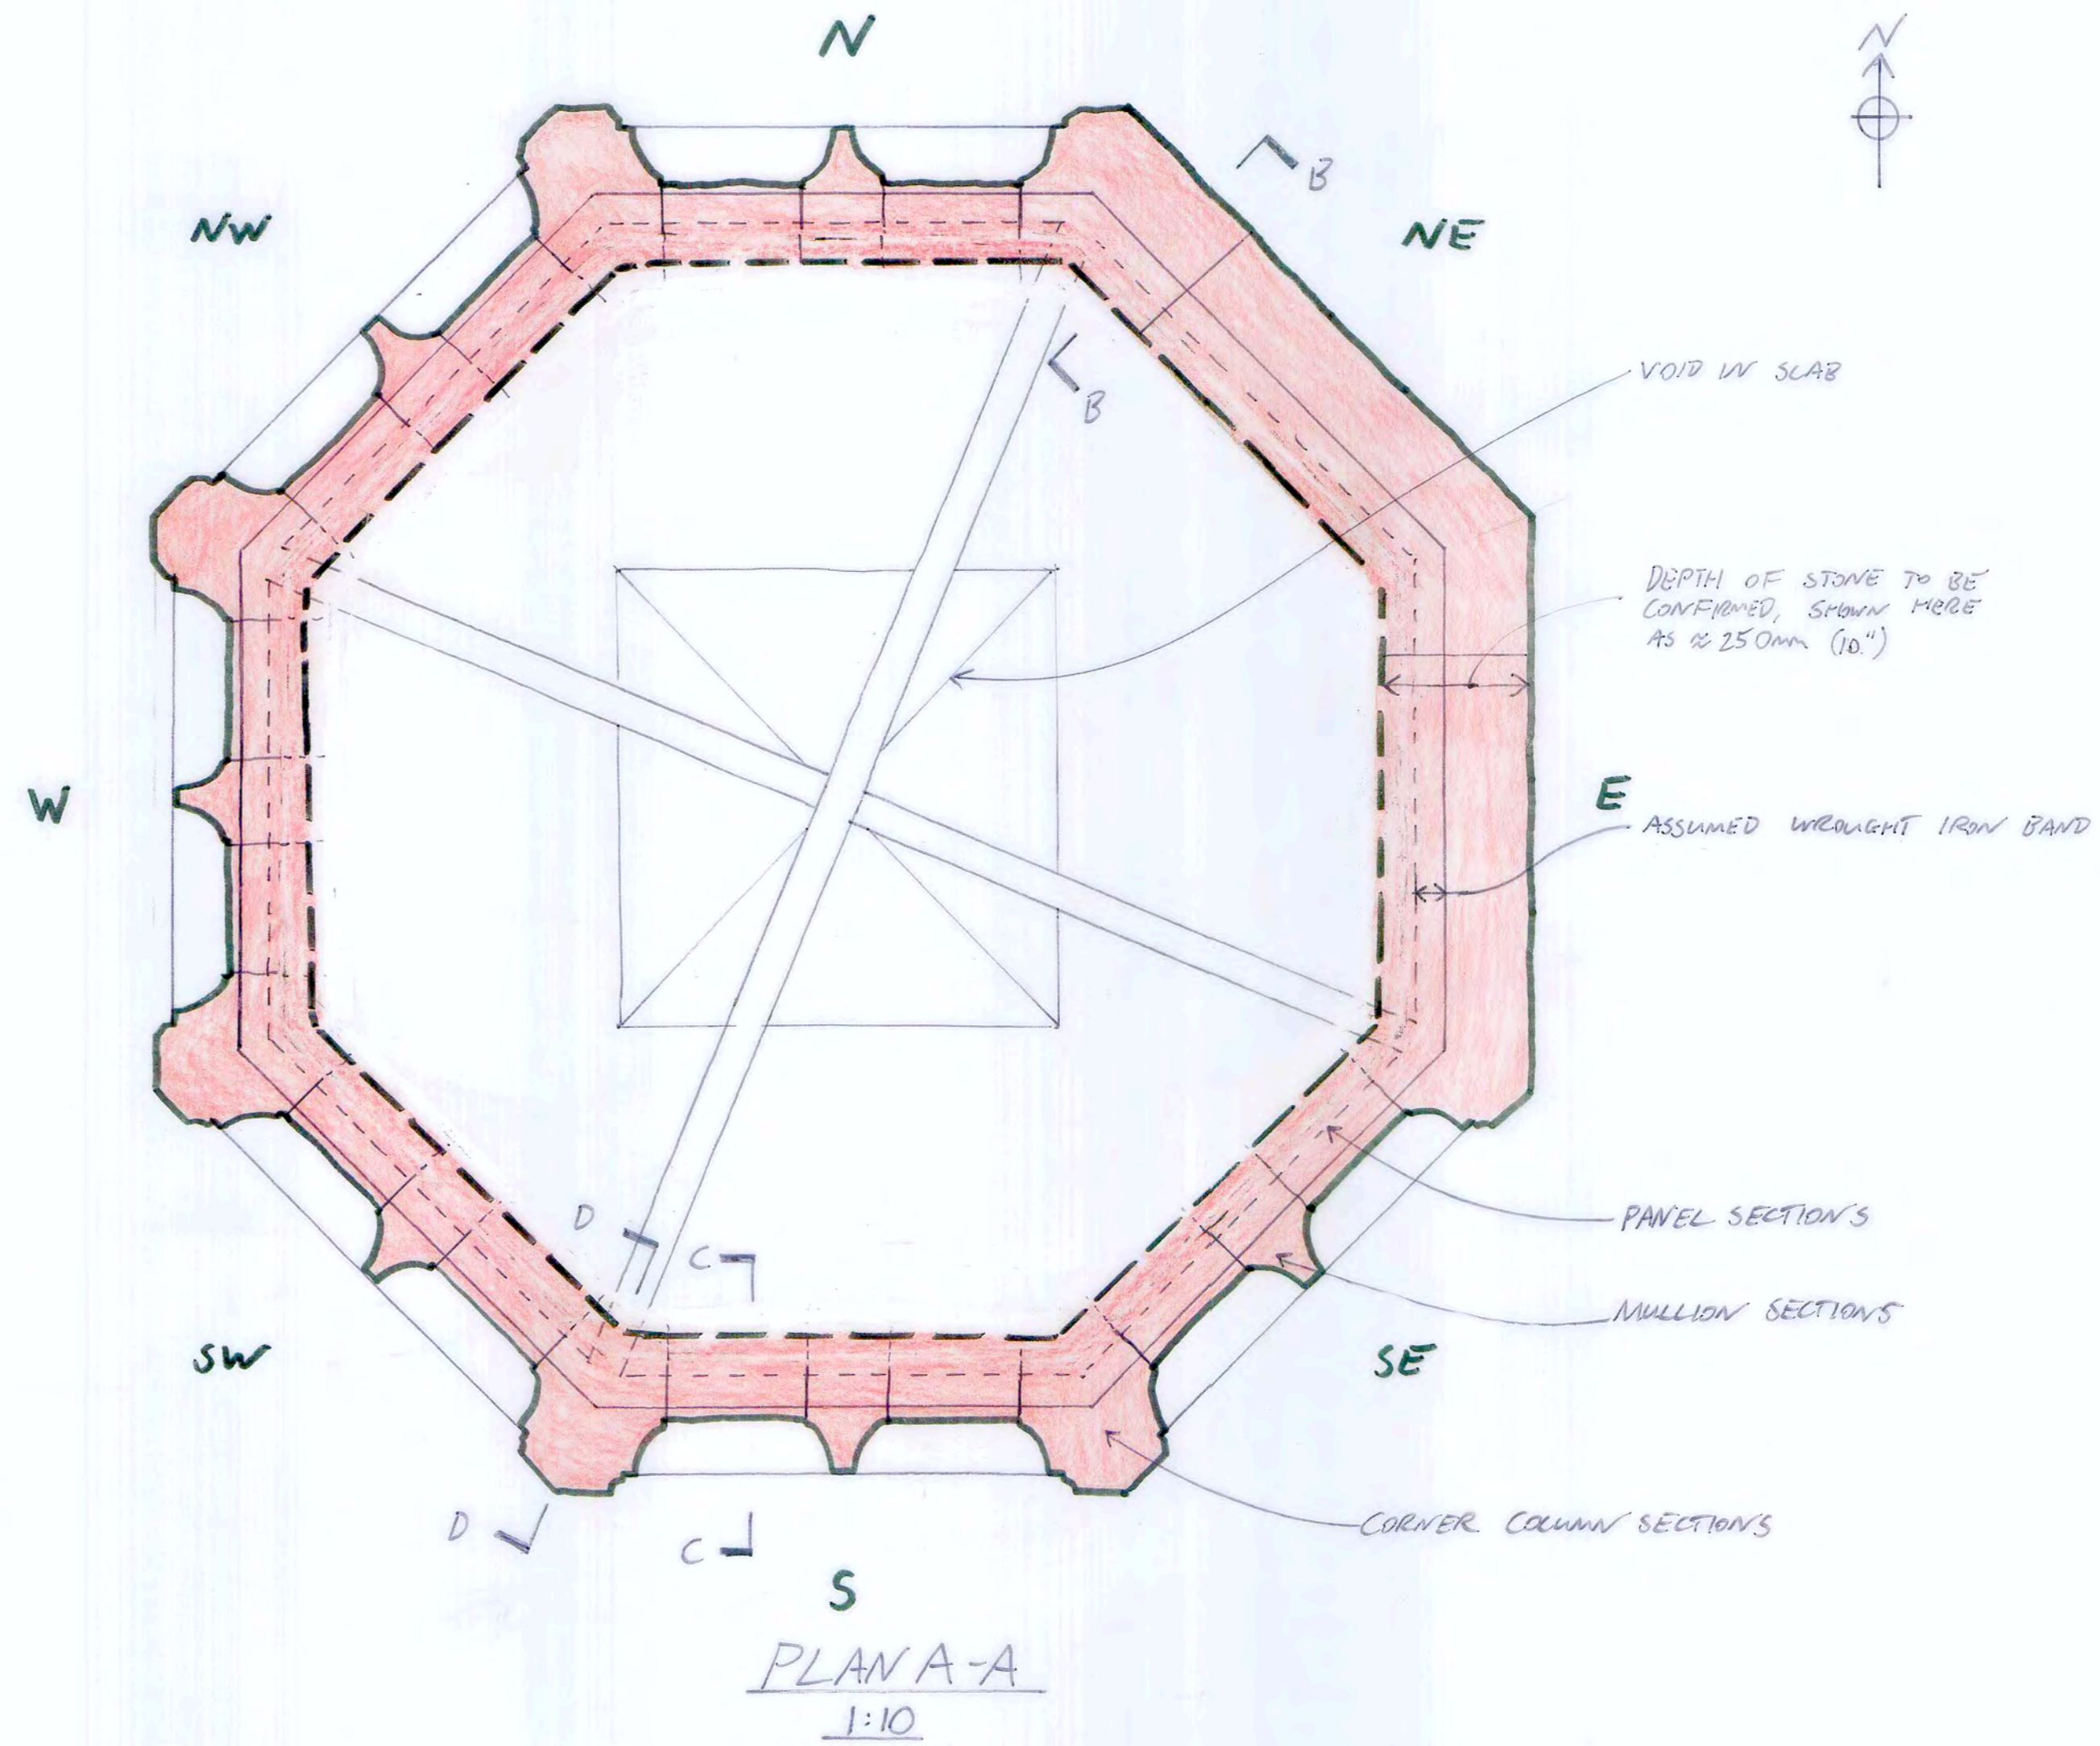
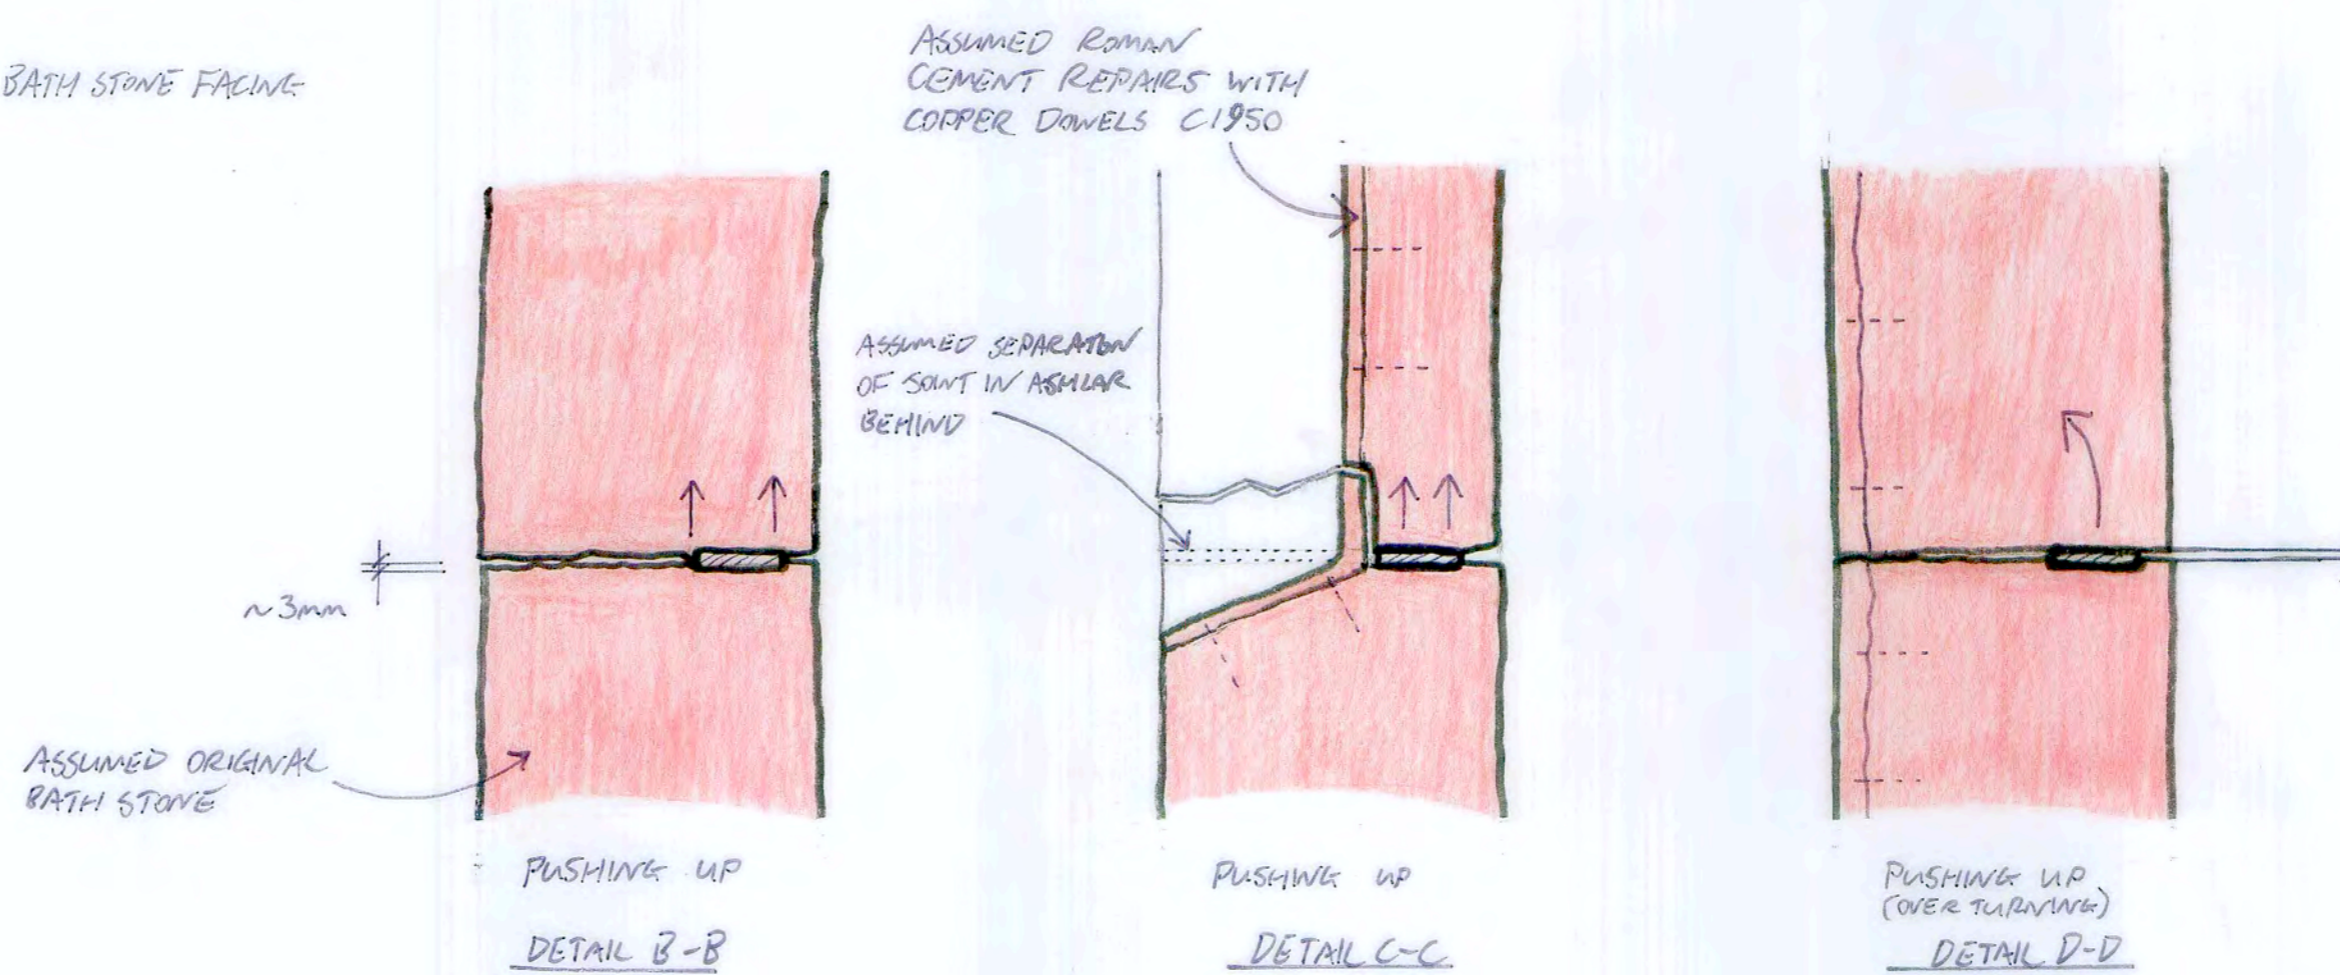
title  
**SOUTH PINNACLE:  
 PLAN AND SECTION**

Locally the jacking has caused some stone elements to move out of plumb, as shown on drawing 1601/212/01.

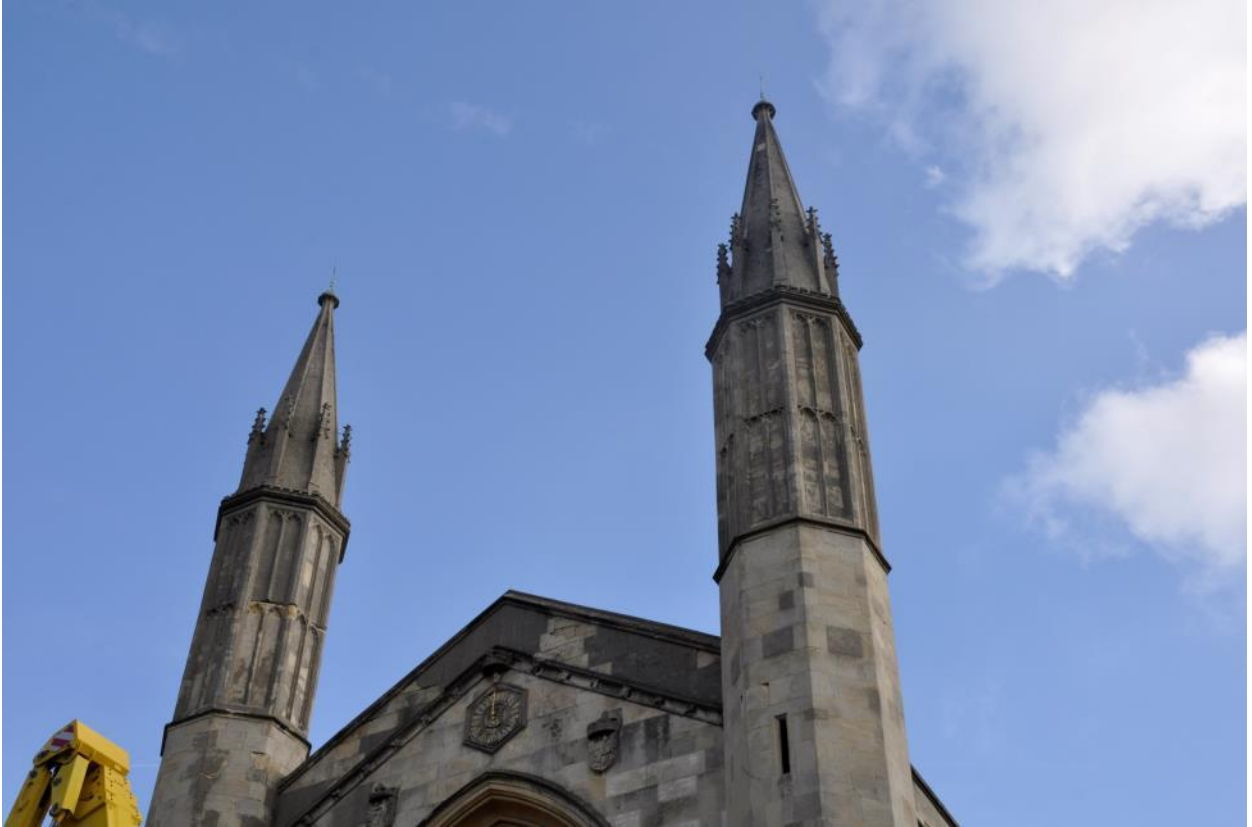
**Photo 01** – west elevation showing the two towers

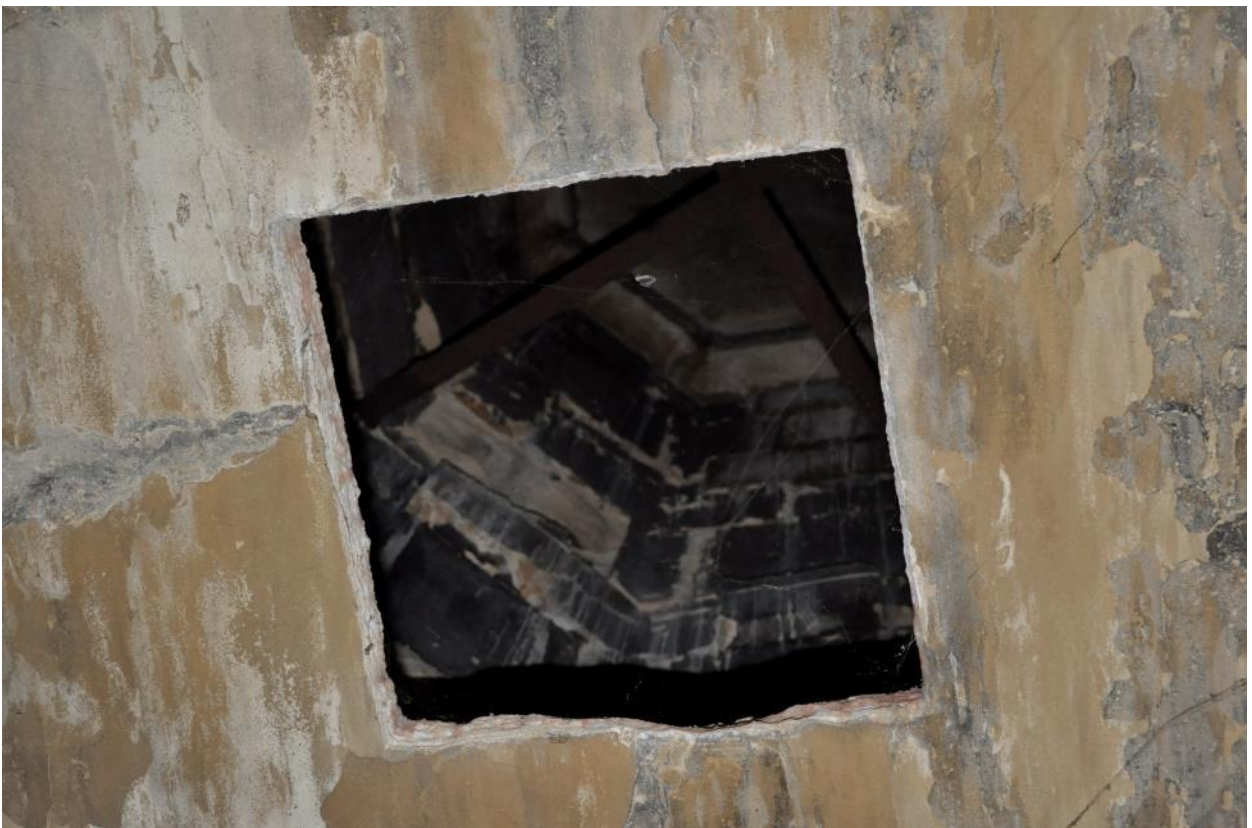
Internally between the traceries, two wrought iron braces can be seen (see photo 02). These are likely to connect to the band and tie the straight bonded stone columns back to the properly bonded rear (undecorated) walls of the pinnacle at the same level as the traceries. The purpose of this strap is to tie the "stack of stones" together. It is therefore an important element of the structure.

**Photo 02** – south tower, looking up inside trceries (note assumed wrought iron brace)

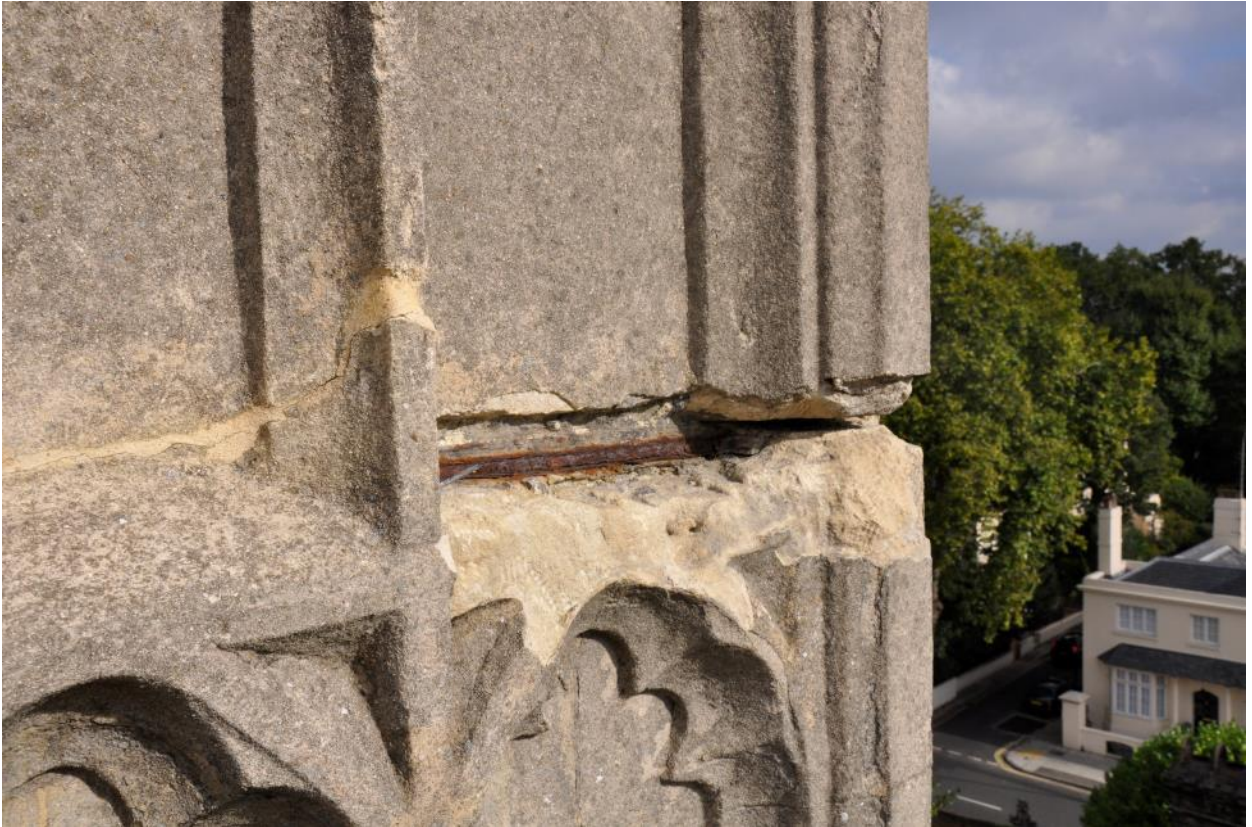
The assumed wrought iron band, between the traceries has corroded, causing the stonework to spall, leaving the ironwork further exposed. This process has jacked the pinnacles up by around 3-4mm (see photos 03-06).

**Photo 03** – north tower, spalled stonework and repairs revealing assumed wrought iron band behind

In light of this, we consider that the iron band needs to be removed and its structural action replaced with a new stainless steel member.

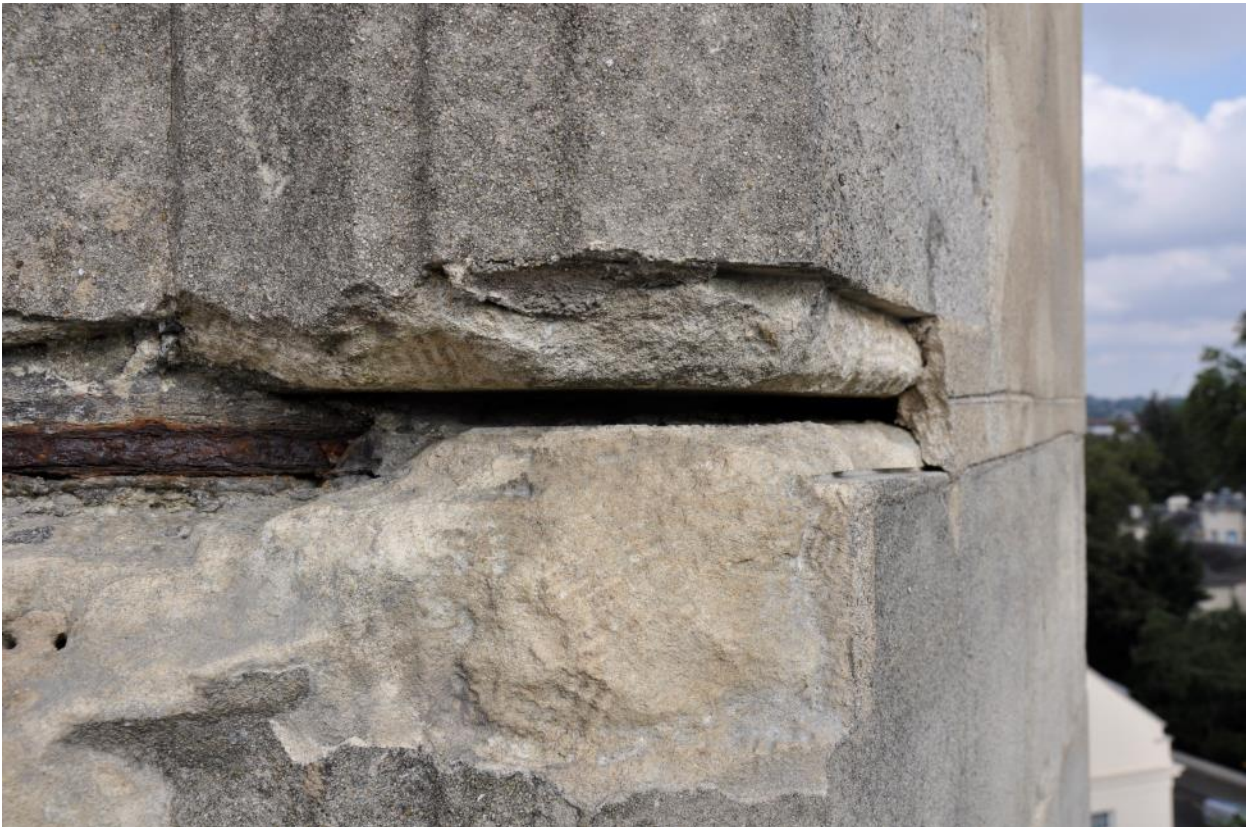
Globally, the jacking appears to be uniform on all faces and has caused the stonework to part along its horizontal bed joint.

**Photo 04** – north tower, parting in bed joint, note later repair to side face masking extent of parting.

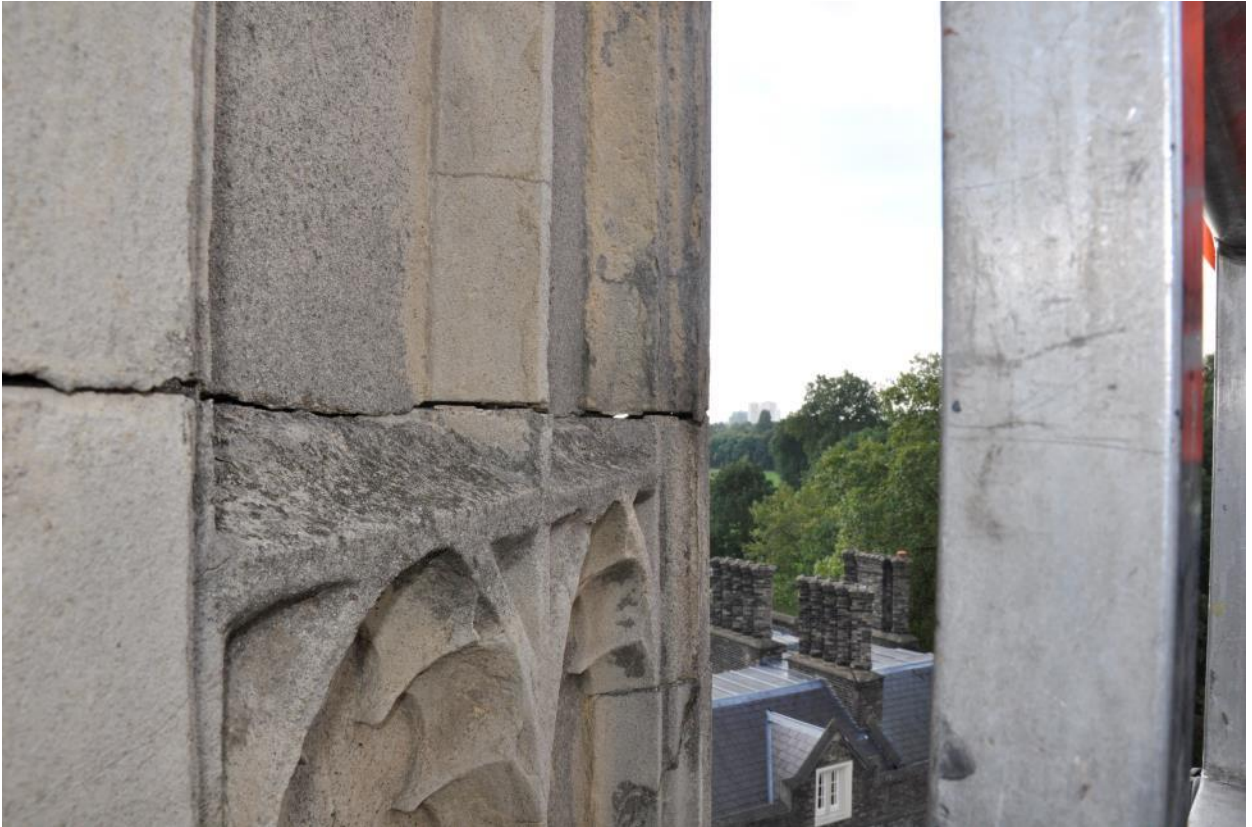
**Photo 05** – south tower, parting in bed joint between traceries (level or wrought iron band)

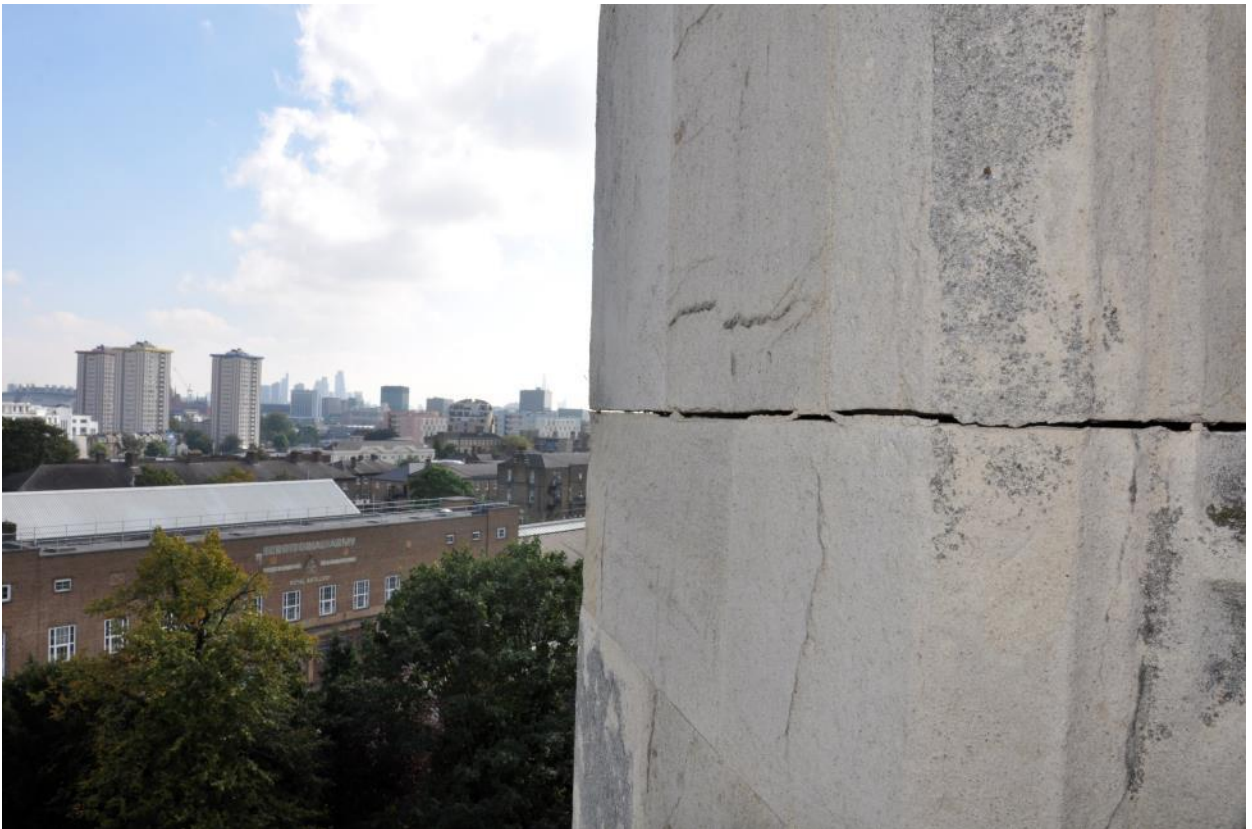
**Photo 06** – south tower, parting in bed joint along non-decorated face (level or wrought iron band)

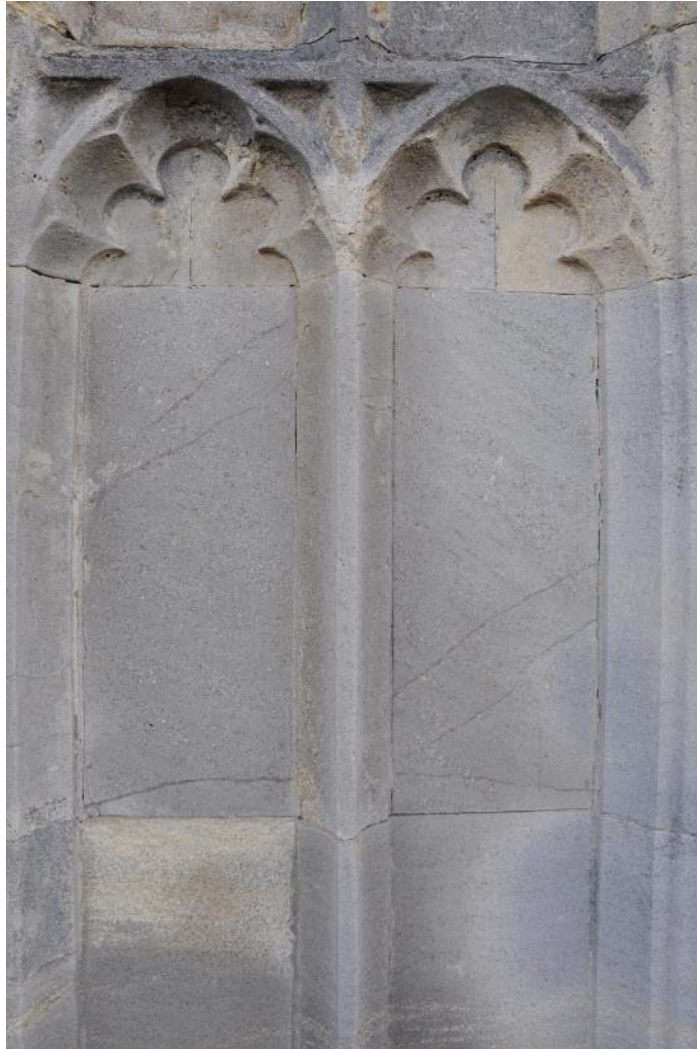
The stonework in the traceries are straight bonded and is understood to be solid Bath stone (see photo 07). The main components of the traceries are corner columns, mullions and panels. The use of straight bonded masonry is very unusual and compromises the pinnacles ability to work as shell. Instead the various components of the pinnacle should be considered as a 'stack of stones' or column, with little or no restraint except at the level of slab and wrought iron band.

**Photo 07** – straight bonded stonework in tracery
