St. Katharine's - The Danish Church in London
Rectified Return Elevations - North Tower

Client:
The Danish Church in London
4 St Katharine's Precinct
London
NW1 4HH

Drawing no. 043-E4-01-01
Issue date Oct 2016
Issue status FOR TENDER
Scale 1:10@ A1

St. Katharine's - The Danish Church in London EXTERNAL MASONRY REPAIR

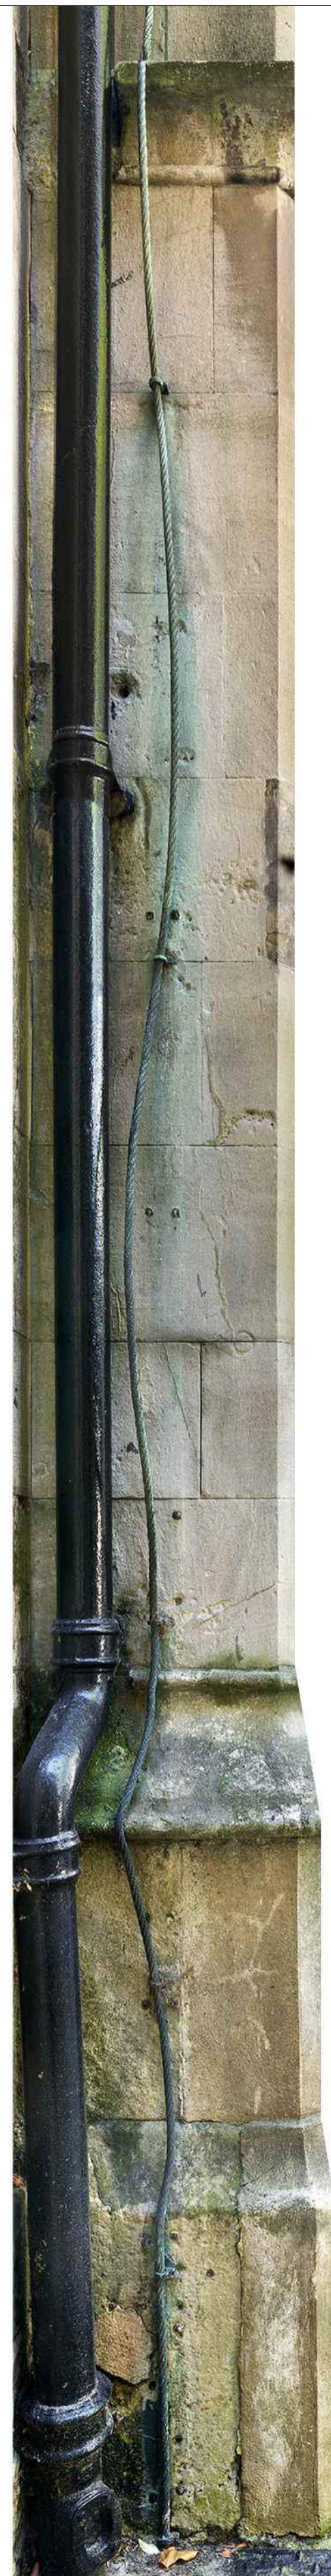
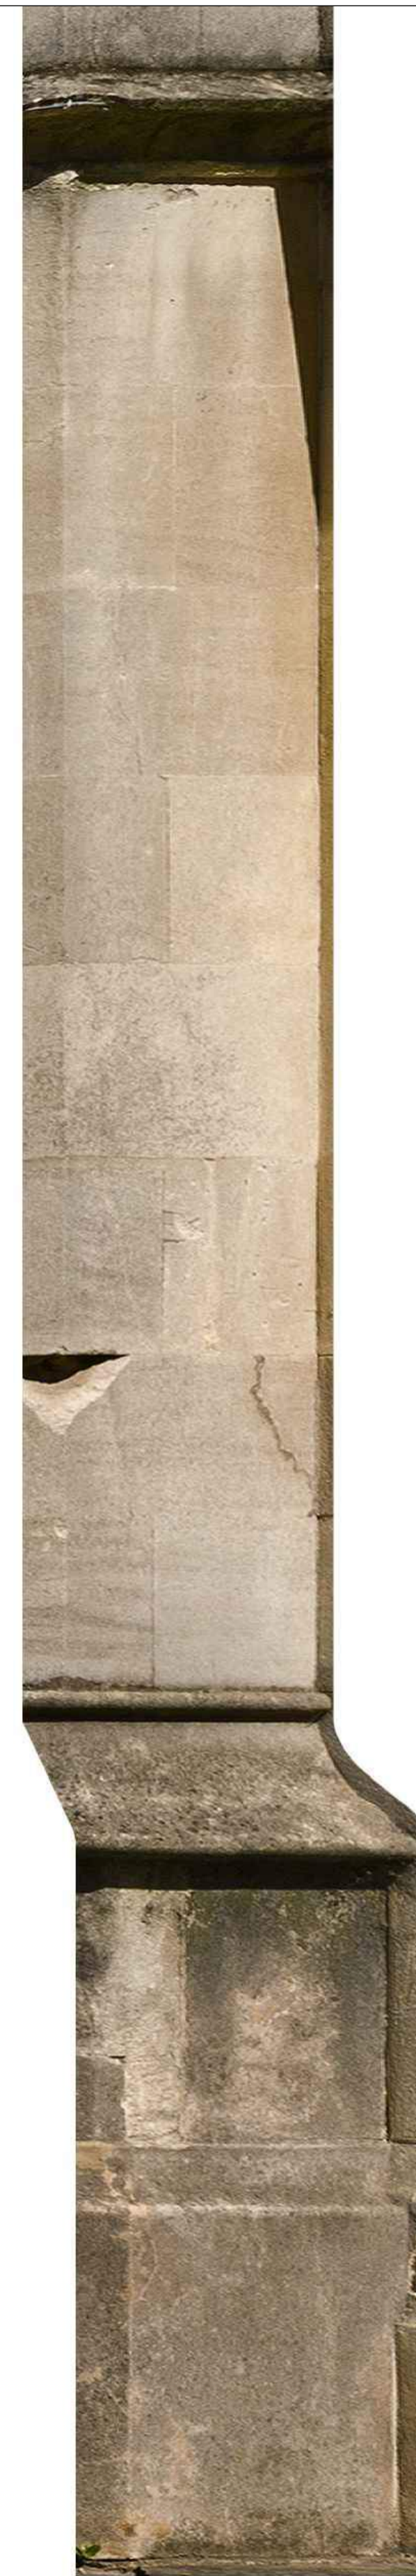
- CA** **Cramp Assumed**
Evidence suggests corrosion of embedded cramp within face stonework. Area to be investigated by specialist stonemason. Allow for careful removal of cramp and cramp replacement as per specification F21r/610, and stone replacement, indent repair or mortar repair as scheduled.

**For Structural Investigation**
Signs of movement or structural concern at time of survey to be investigated by Structural Engineer
-

**Replace Stonework**
Carefully replace stonework as per specification F21r and approved sample.
-

**Mortar Repair**
Repair with lime mortar as per specification F21r/750 and approved sample.

**Stone Indent Repair**
Indented repair as per specification F21r/710 and approved sample.
- C** **Replace Cramp**
Careful removal of existing cramp and cramp replacement as per specification F21r/610. Allow for stone replacement, indent repair or mortar repair as scheduled.

**Shelter Coat**
As per specification F21r/860

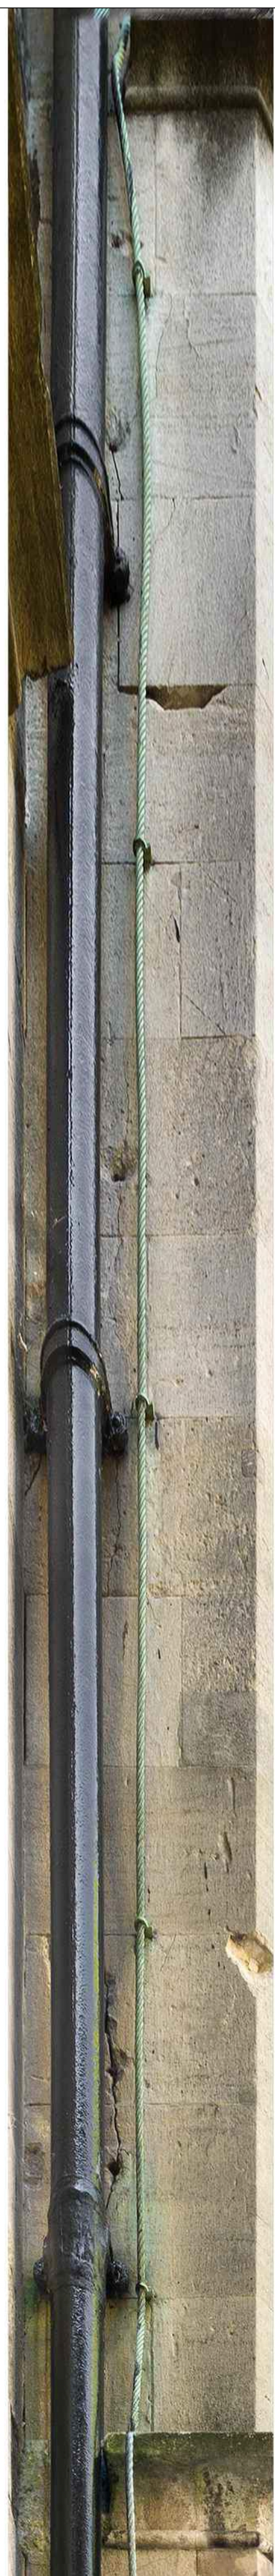
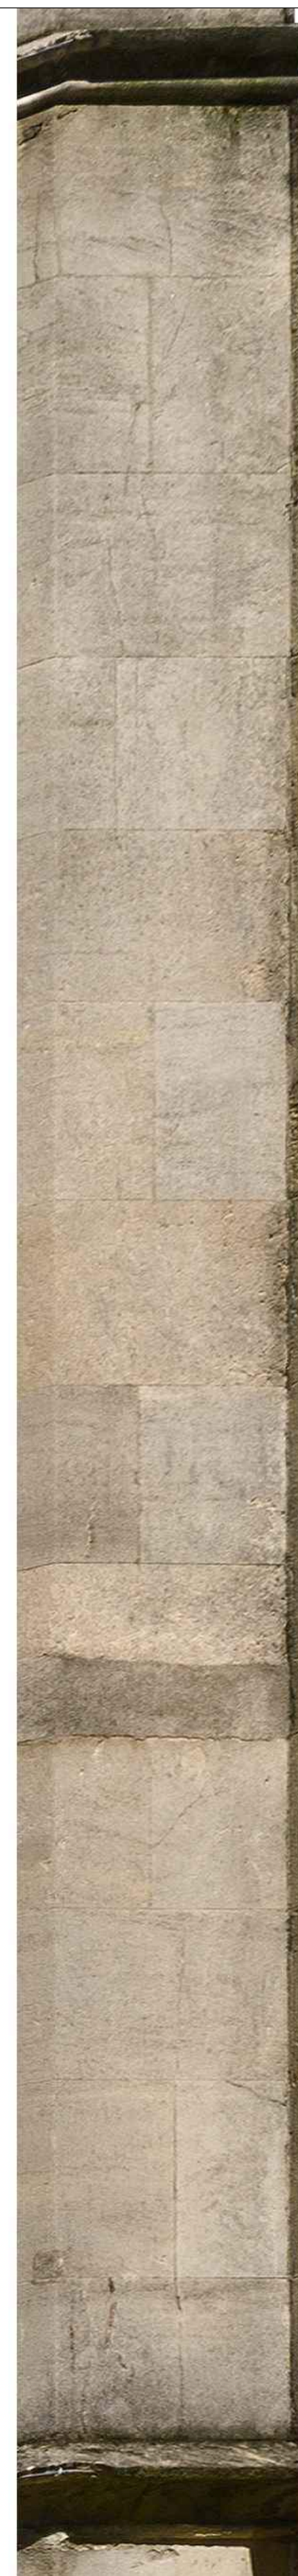
Drawing no.043- E4-02-01
Issue date Oct 2016
Issue status FOR TENDER
Scale **1:10@ A1**

CA **Cramp Assumed**
Evidence suggests corrosion of embedded cramp within face stonework. Area to be investigated by specialist stonemason. Allow for careful removal of cramp and cramp replacement as per specification F21r/610, and stone replacement, indent repair or mortar repair as scheduled.

**For Structural Investigation**
Signs of movement or structural concern at time of survey to be investigated by Structural Engineer

**Replace Stonework**
Carefully replace stonework as per specification F21r and approved sample.

**Mortar Repair**
Repair with lime mortar as per specification F21r/750 and approved sample.

**Stone Indent Repair**
Indented repair as per specification F21r/710 and approved sample.

C **Replace Cramp**
Careful removal of existing cramp and cramp replacement as per specification F21r/610. Allow for stone replacement, indent repair or mortar repair as scheduled.

**Shelter Coat**
As per specification F21r/860
