St. Katharine's - The Danish Church in London
Rectified Elevation

Drawing 043-E2-N01-01
Issue date Sept 2016
FOR TENDER
Scale 1:10@ A1

St. Katharine's - The Danish Church in London
EXTERNAL MASONRY REPAIR

Drawing 043-E2-N01-02
Issue date Oct 2016
FOR TENDER
Scale 1:10@ A1

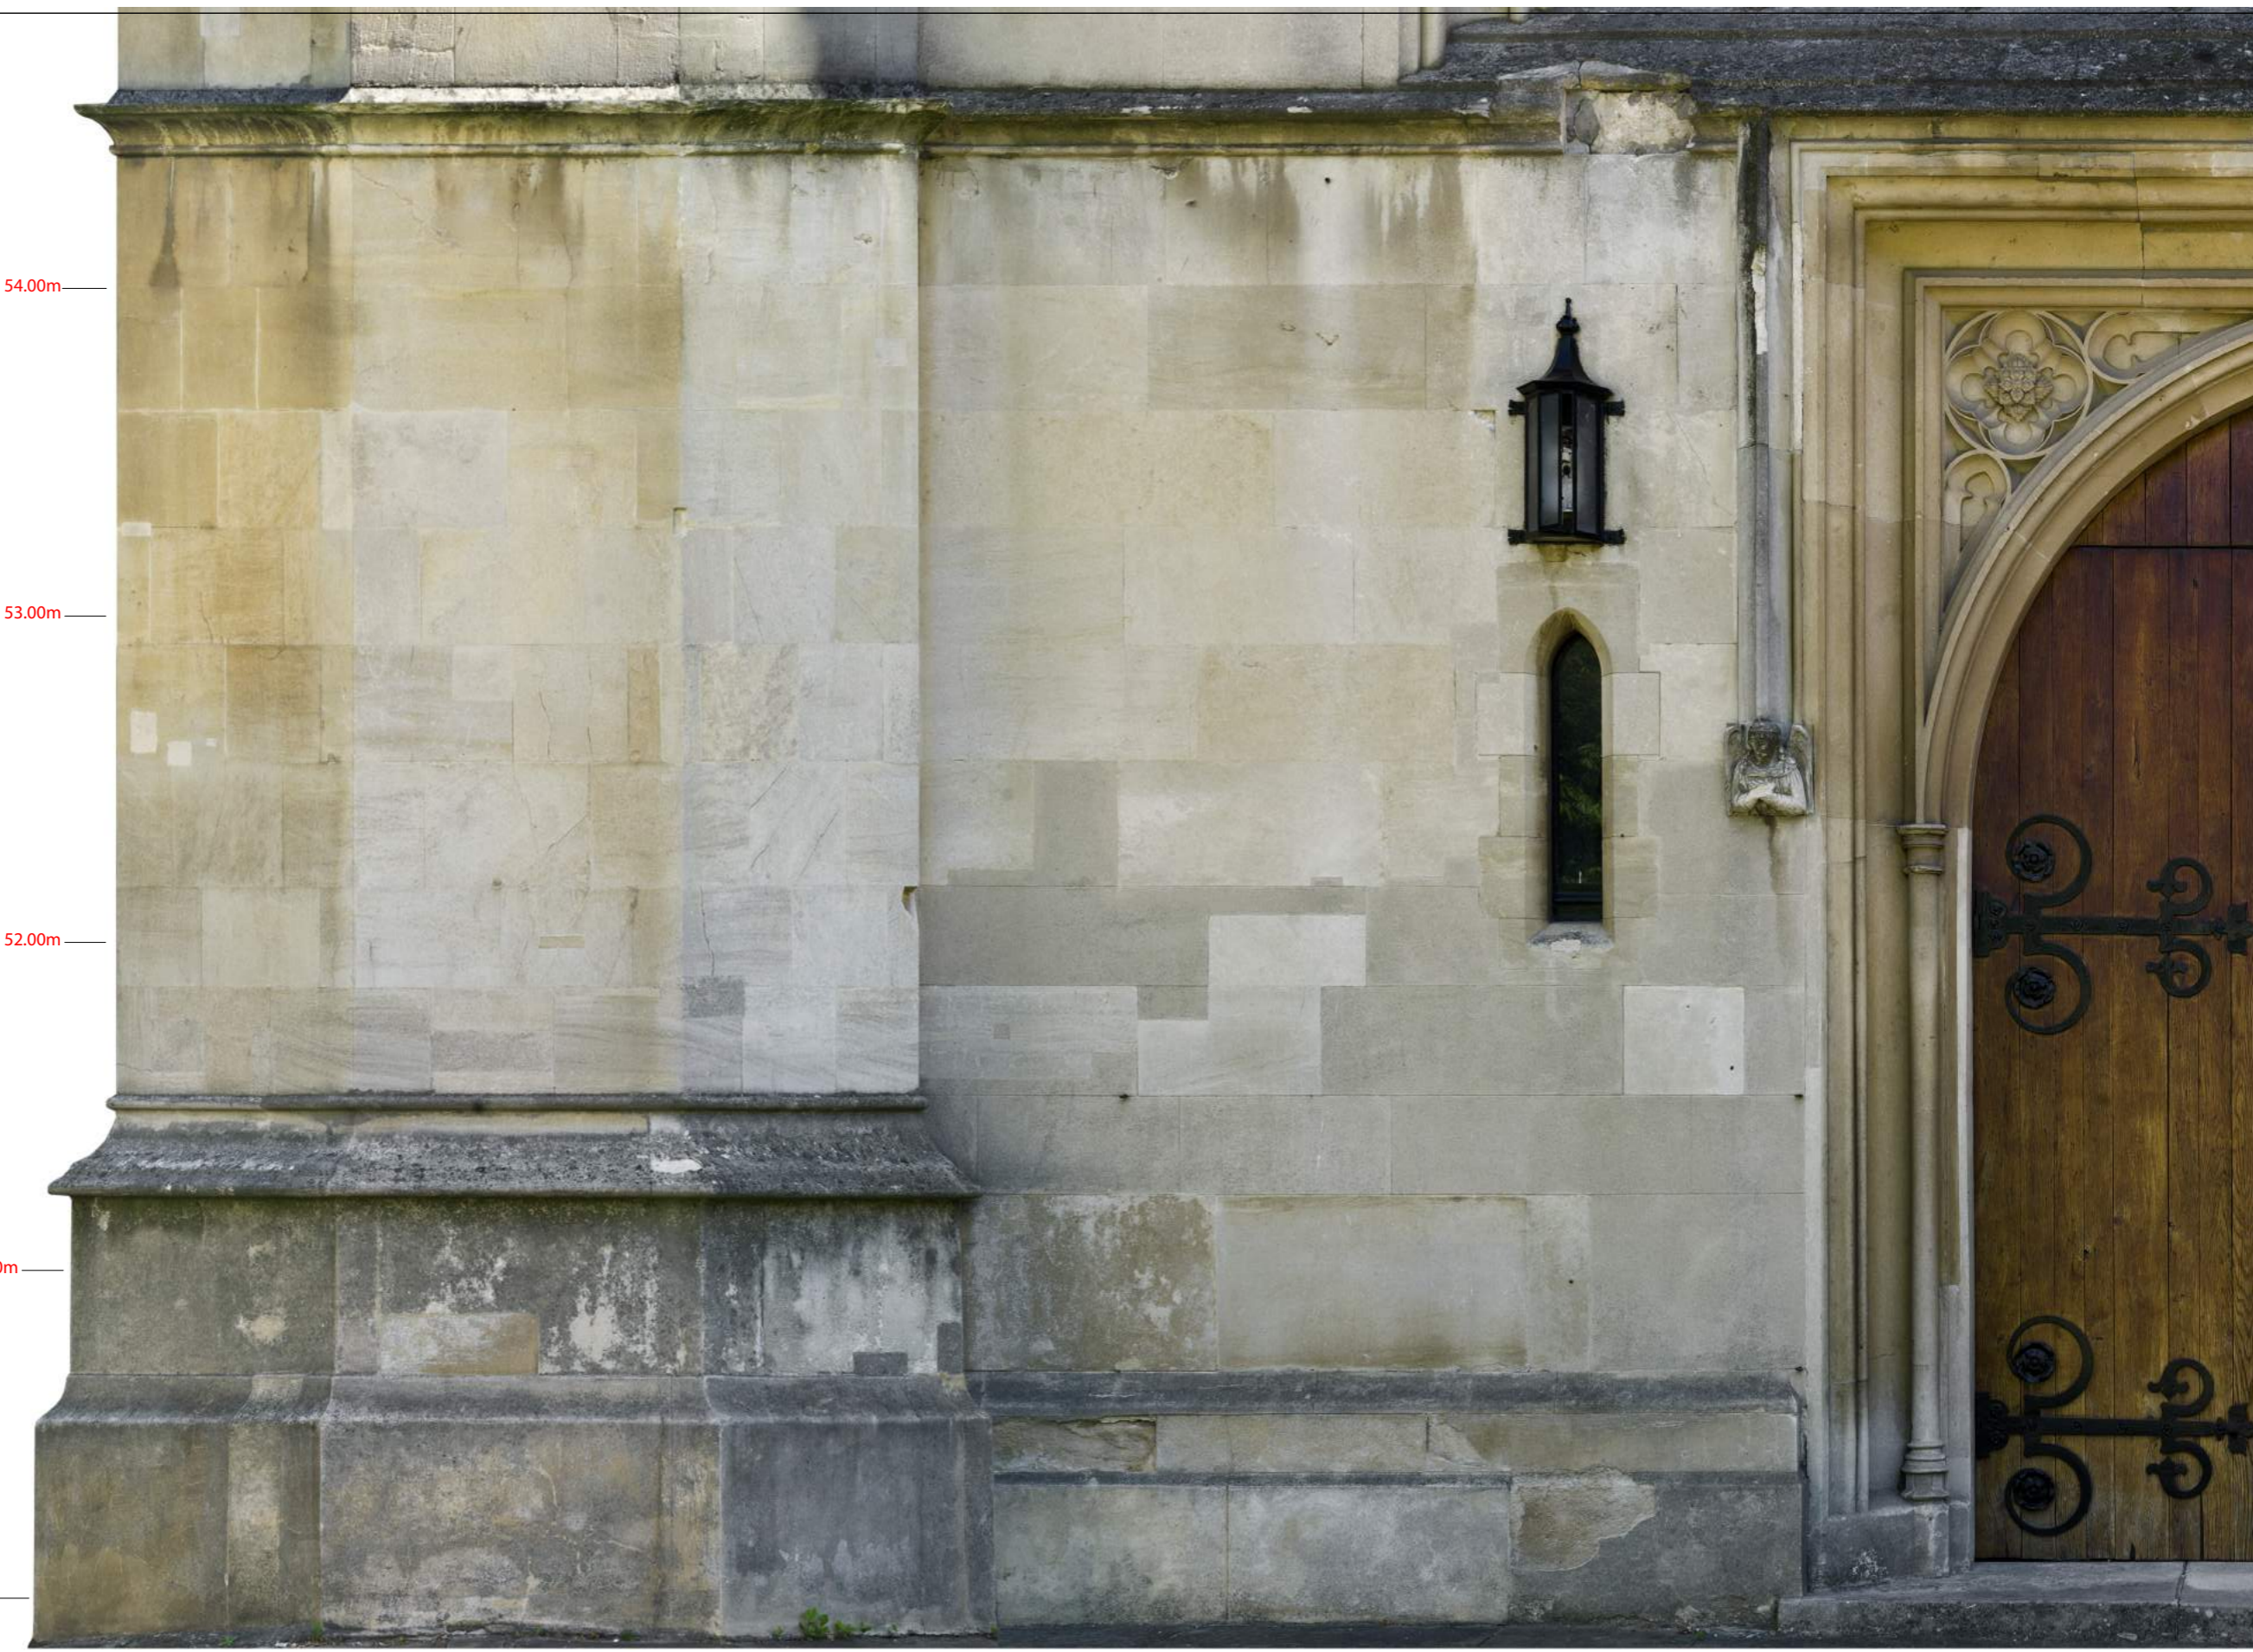
ELEVATION KEY - E2

CA **Cramp Assumed**
Evidence suggests corrosion of embedded cramp within face stonework. Area to be investigated by specialist stonemason. Allow for careful removal of cramp and cramp replacement as per specification F21r/610, and stone replacement, indent repair or mortar repair as scheduled.

**For Structural Investigation**
Signs of movement or structural concern at time of survey to be investigated by Structural Engineer

External cleaning to be completed prior to commencement of stonework repairs, following approved external cleaning trials with DOFF steam as per spec A12r/460 in consultation with CA.

Allow for ashlar repointing to open joints only (approximately 50% of total surface area) as per specification Z21r/490. All hairline fissures to ashlar and retained rendered surfaces to be filled where possible, in consultation with CA.

**Replace Stonework**
Carefully replace stonework as per specification F21r and approved sample.

**Mortar Repair**
Repair with lime mortar as per specification F21r/750 and approved sample.

**Stone Indent Repair**
Indented repair as per specification F21r/710 and approved sample.

C **Replace Cramp**
Careful removal of existing cramp and cramp replacement as per specification F21r/610. Allow for stone replacement, indent repair or mortar repair as scheduled.
