APPENDIX E

Foundation Inspection Pits (FIPs) Photo Sheets

Client Fairview Ventures Limited	Project Centric Close, Camden	Job No CG/18804A

Title Foundation Inspection Pits	Appendix E

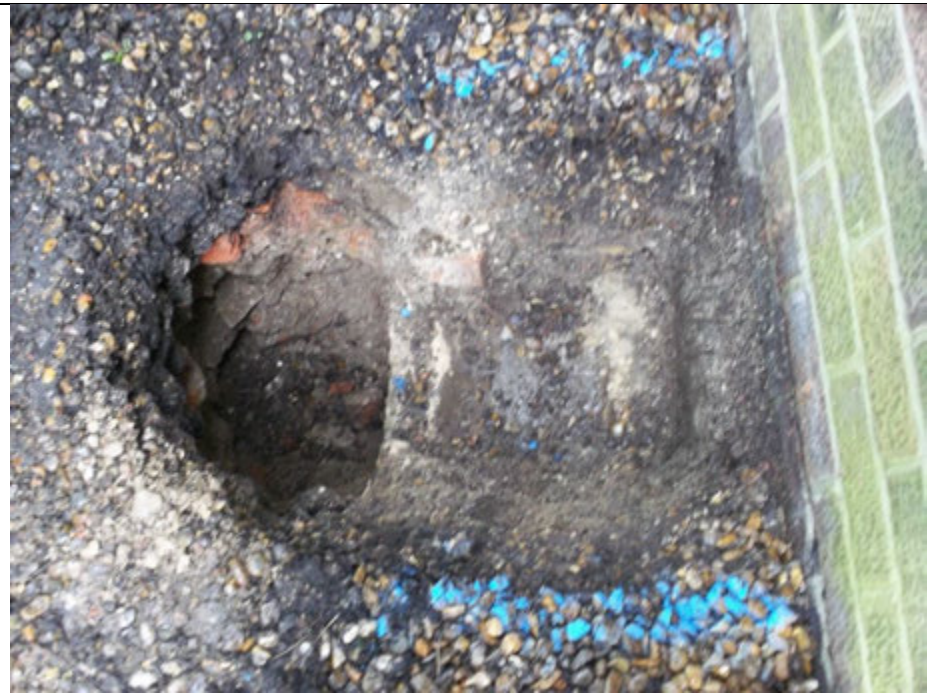
View of concrete foundation encountered in FIP01

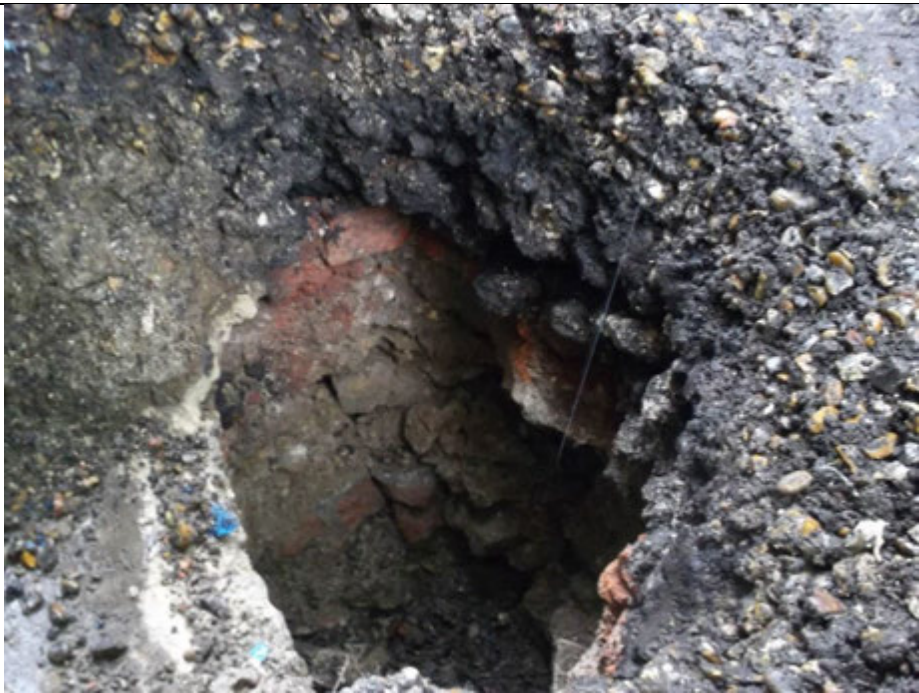
View of Made Ground and concrete footing in FIP01

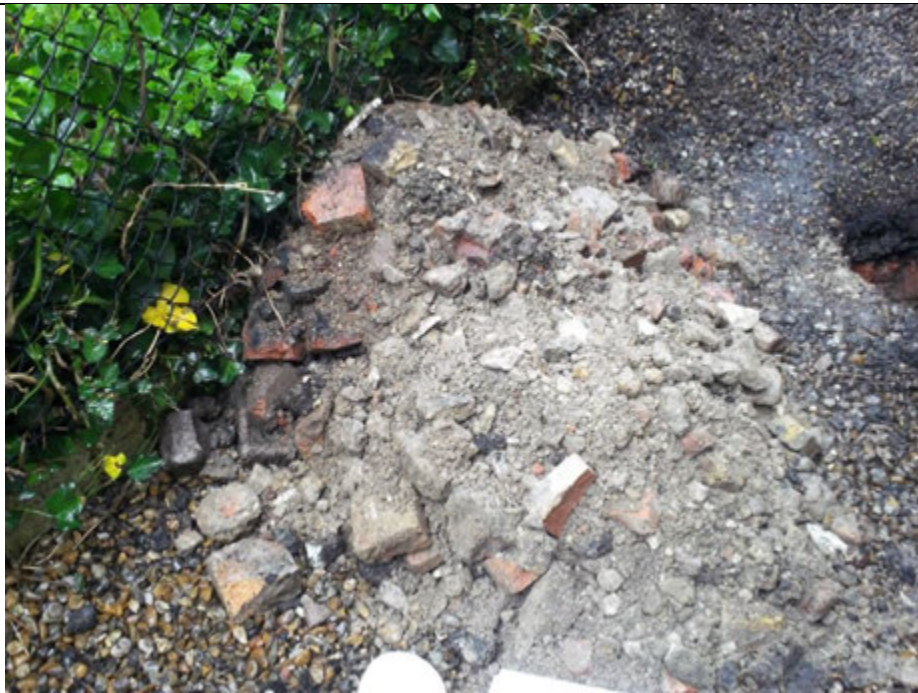
View of arisings excavated from FIP01

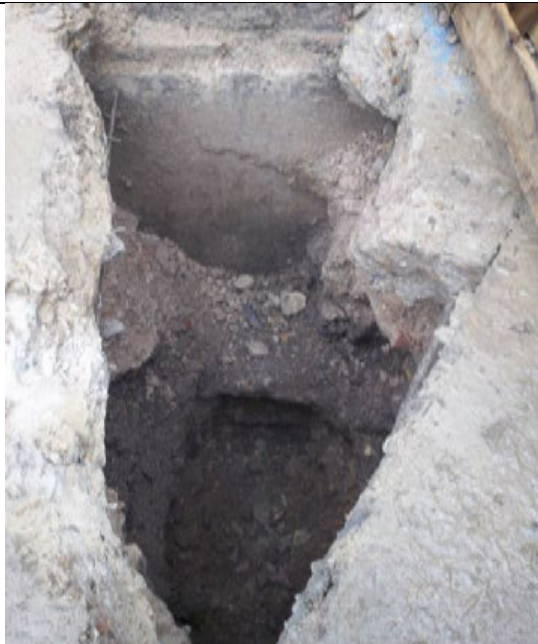
View of FIP02 showing concrete foundation encountered

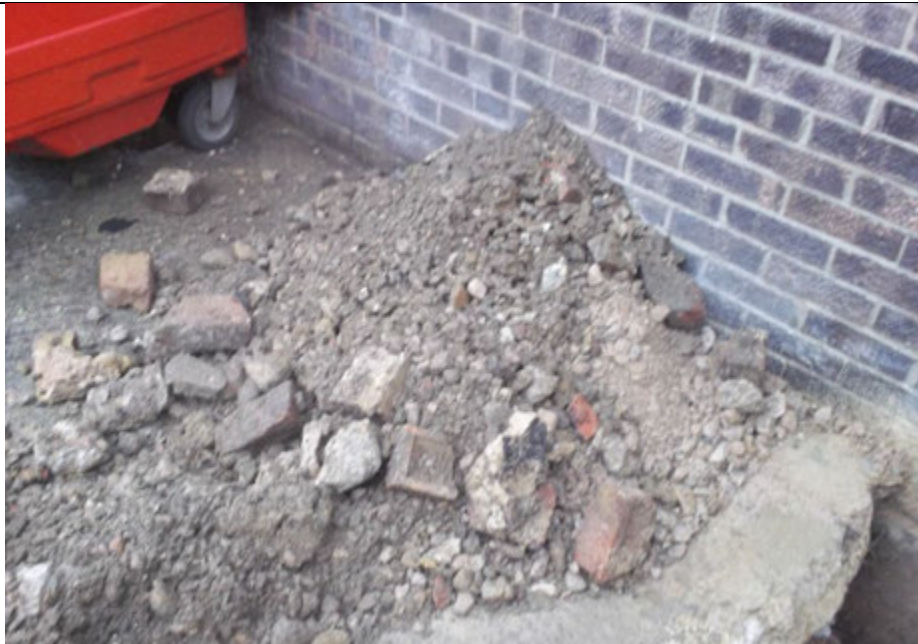
View of arisings from FIP02

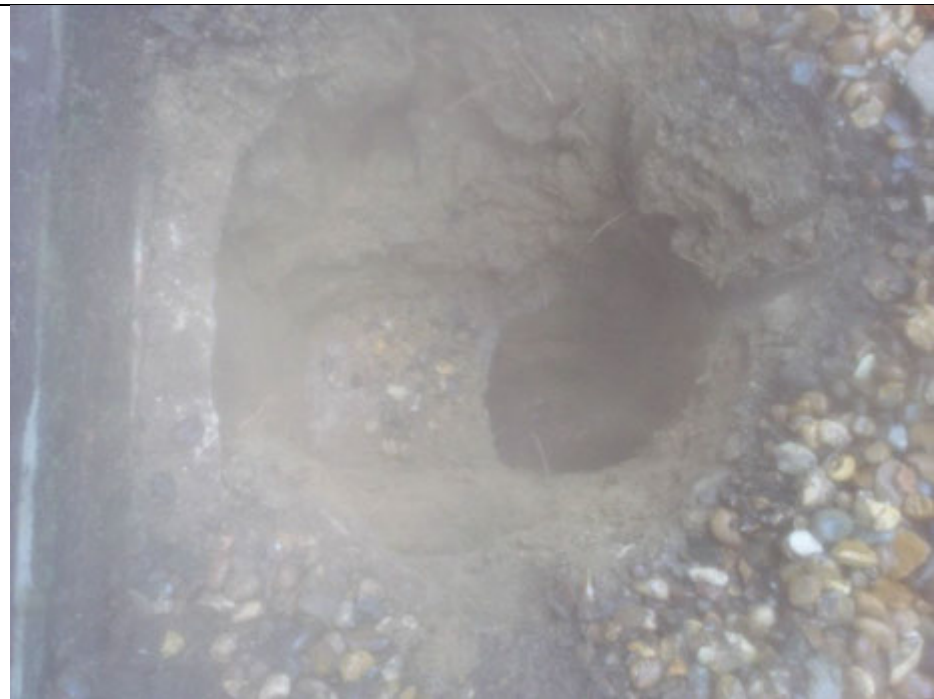
View of concrete foundation in FIP03

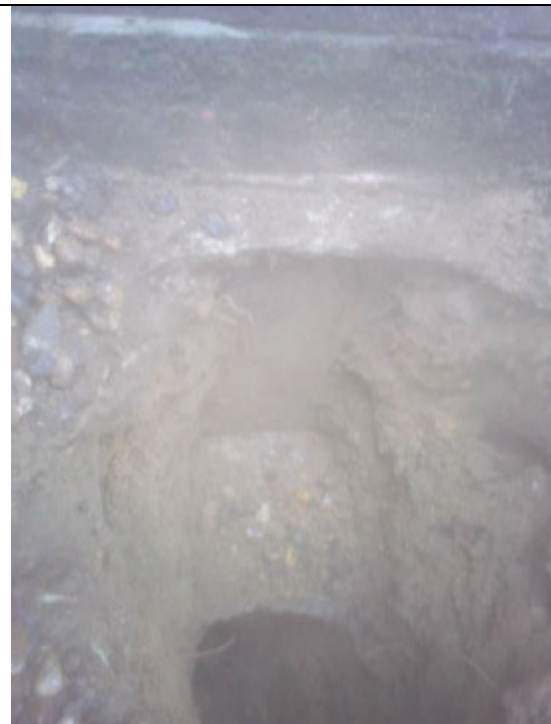
View of concrete foundation in FIP03

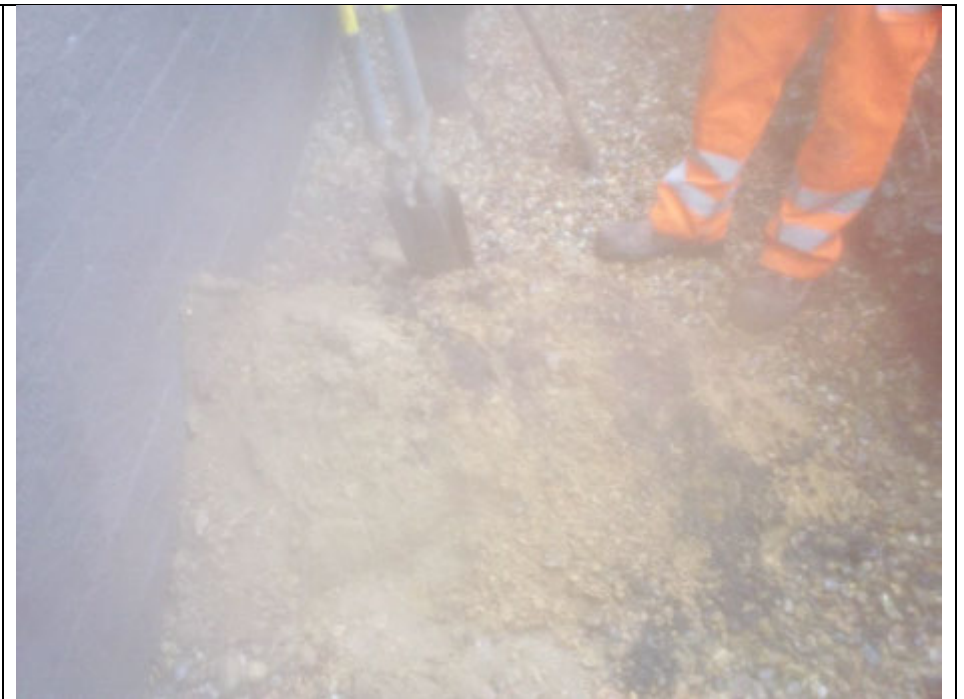
View of arisings from FIP03

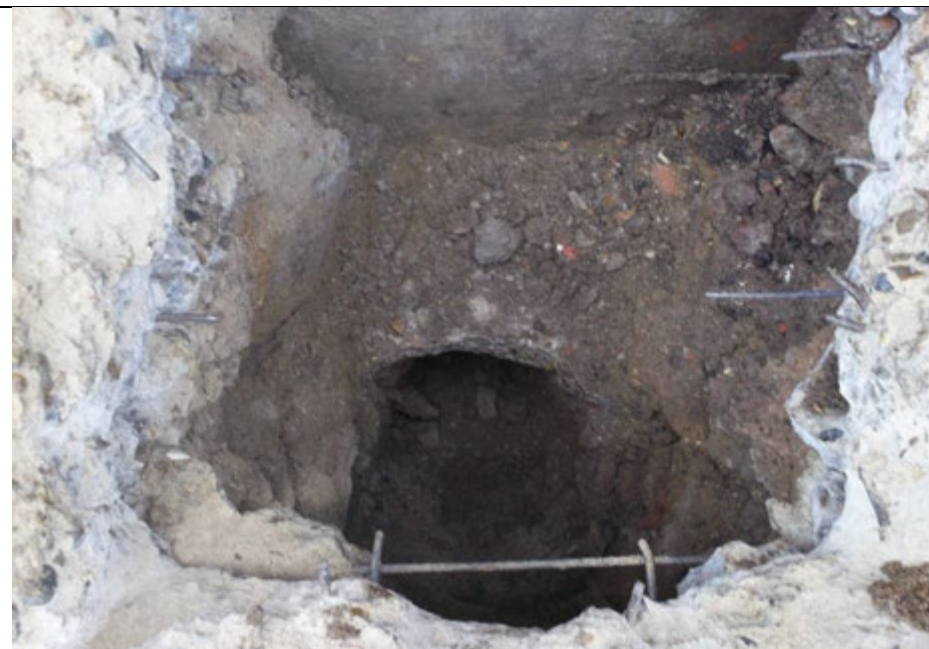
View of concrete foundation in FIP04

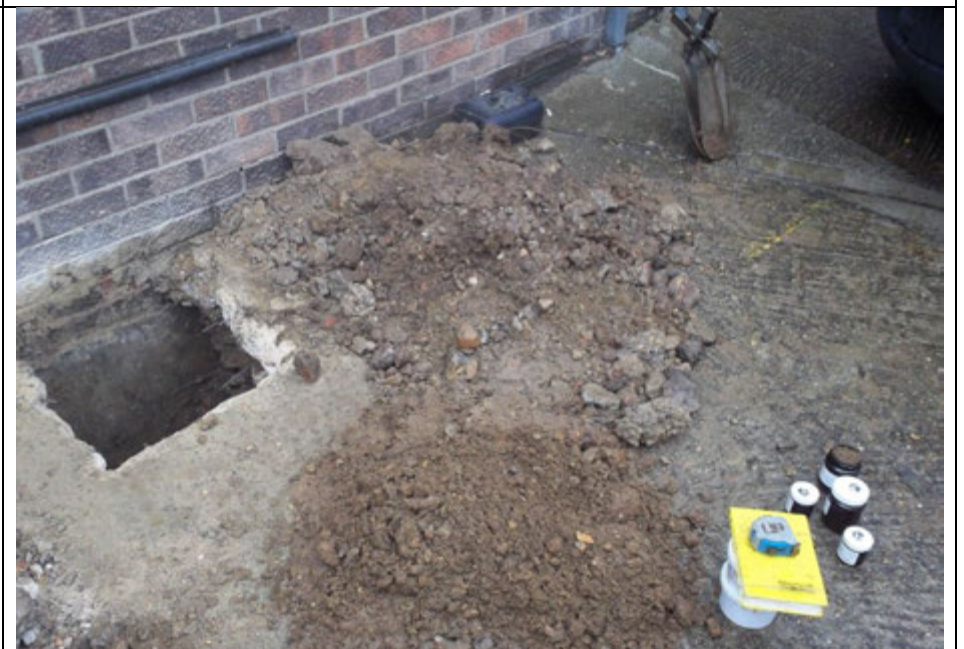
View of arisings from FIP04

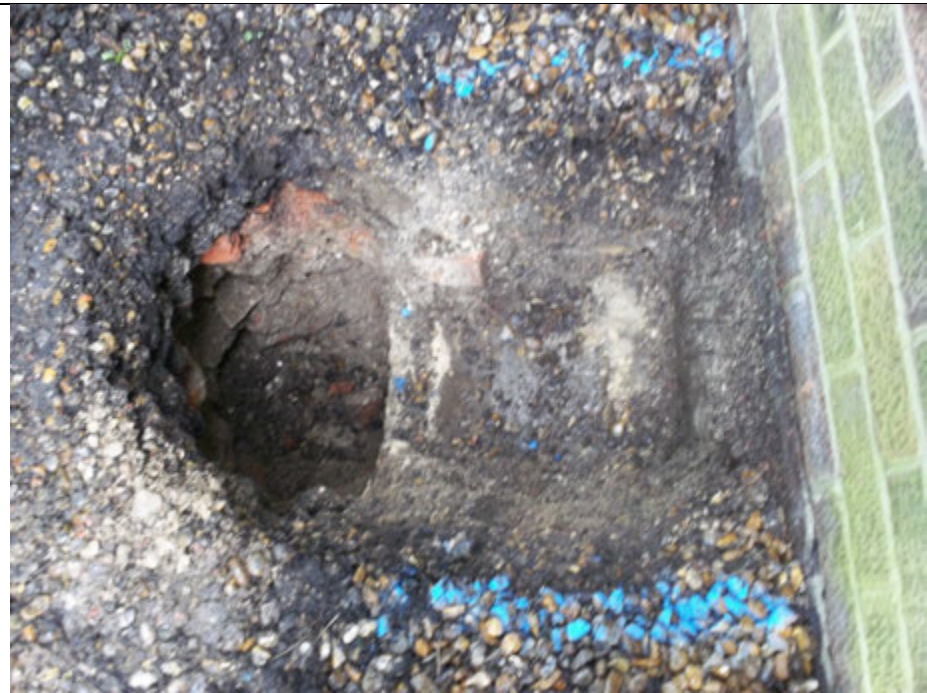
View of concrete foundation encountered in FIP01

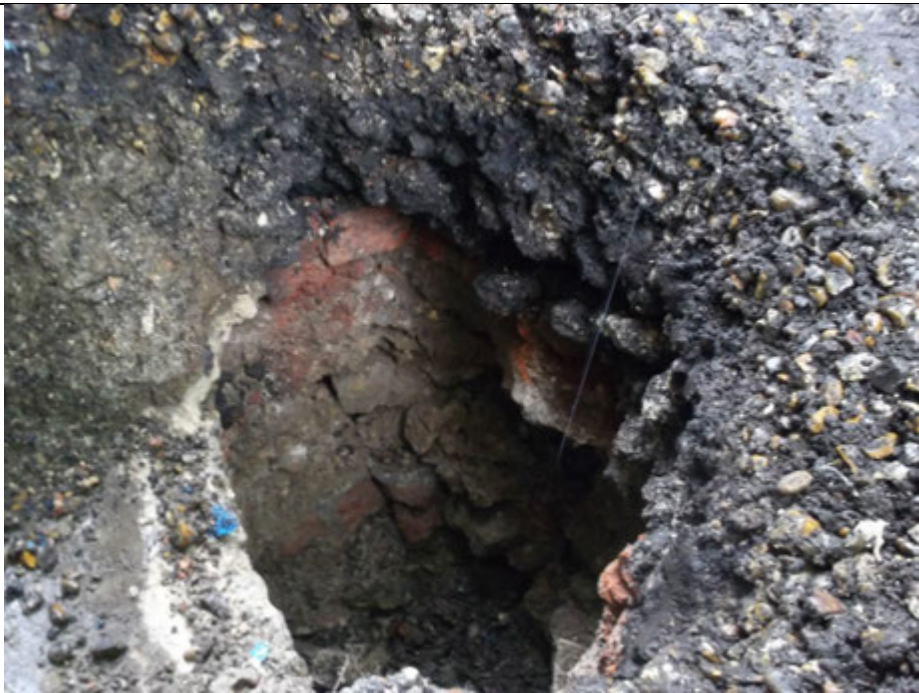
View of Made Ground and concrete footing in FIP01

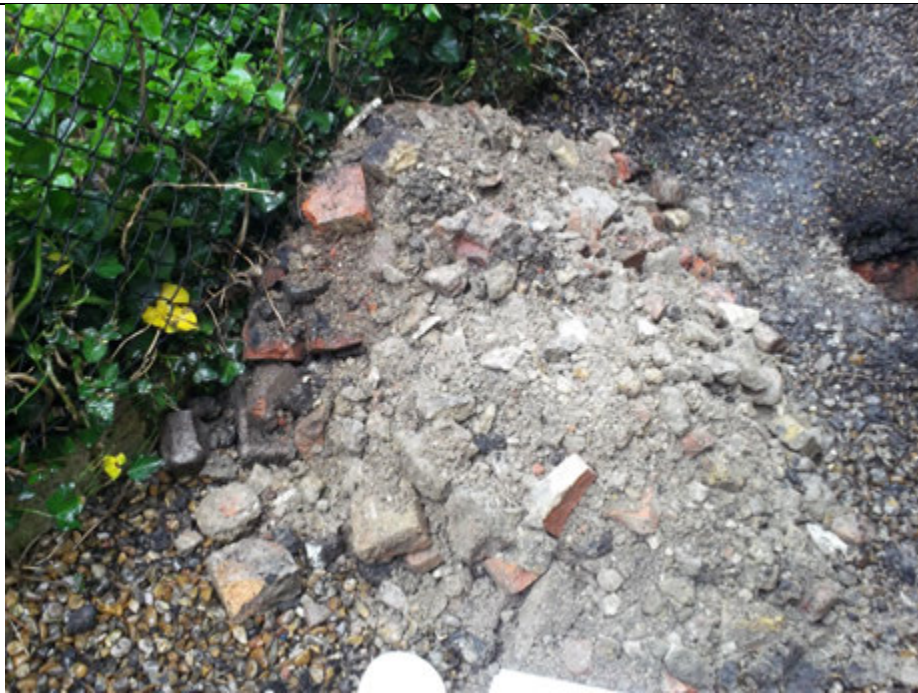
View of arisings excavated from FIP01

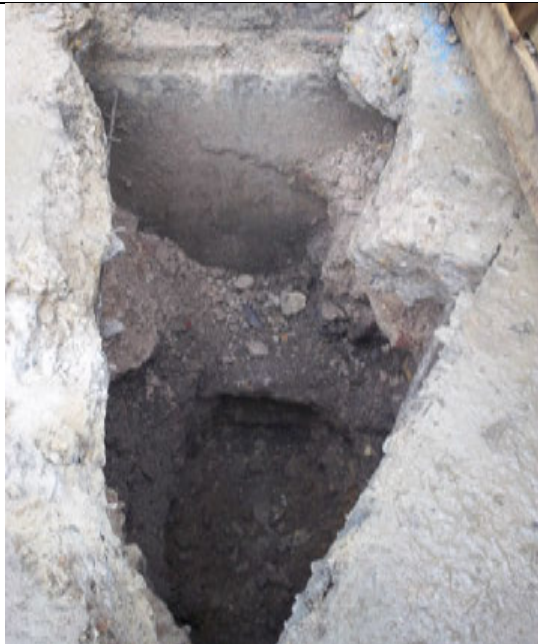
View of FIP02 showing concrete foundation encountered

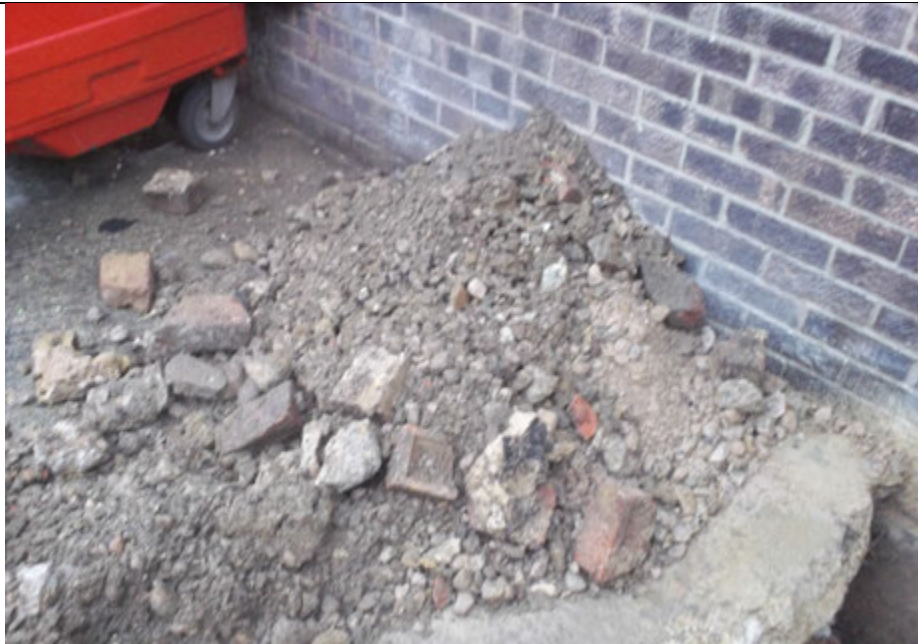
View of arisings from FIP02

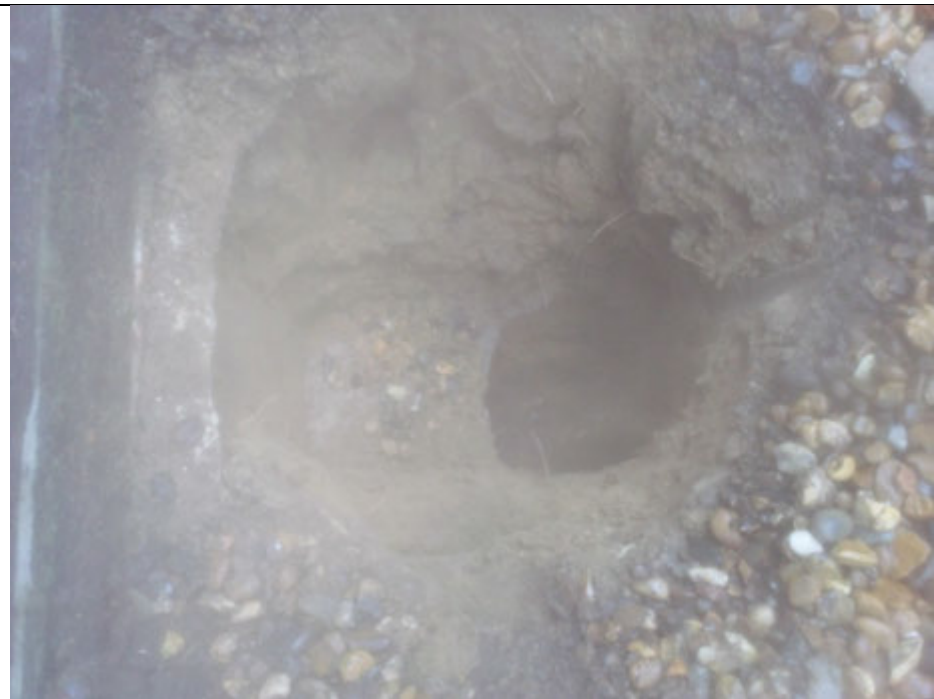
View of concrete foundation in FIP03

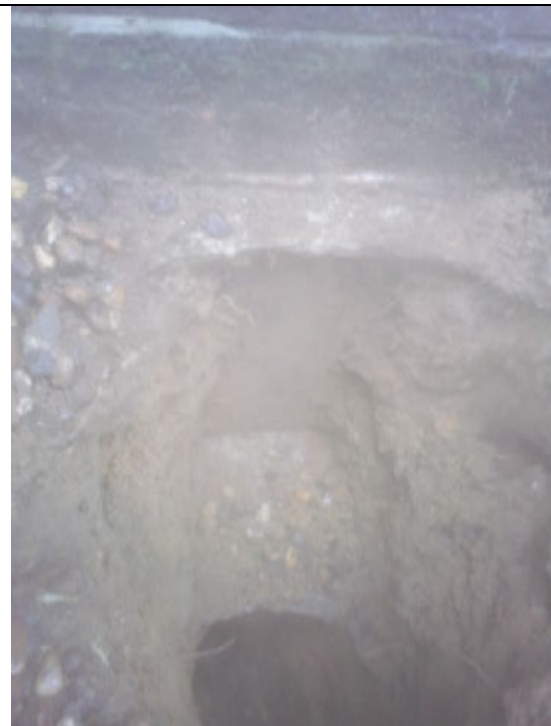
View of concrete foundation in FIP03

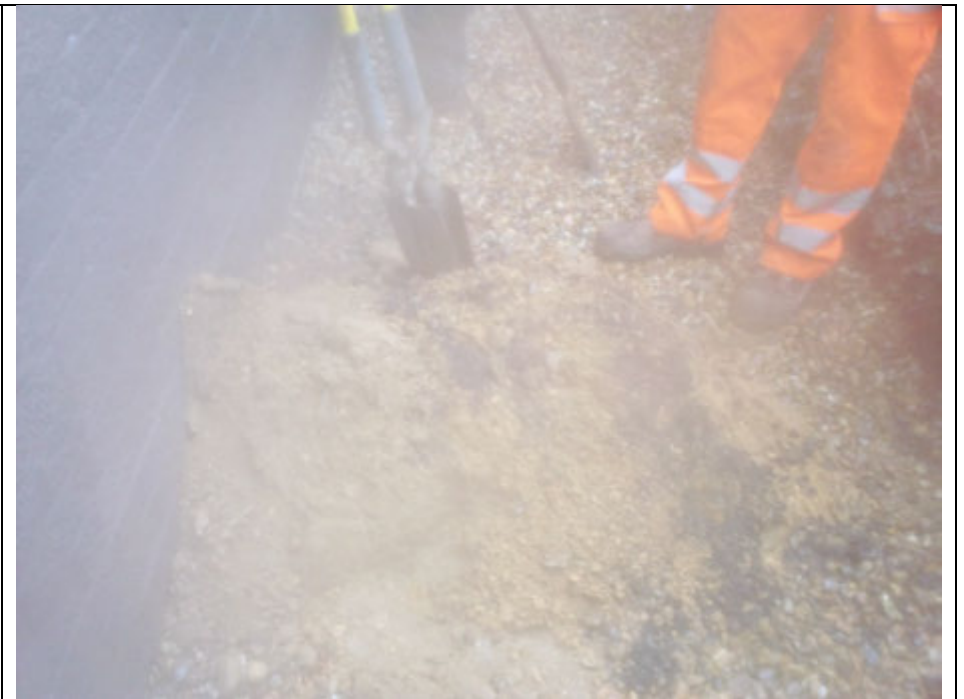
View of arisings from FIP03

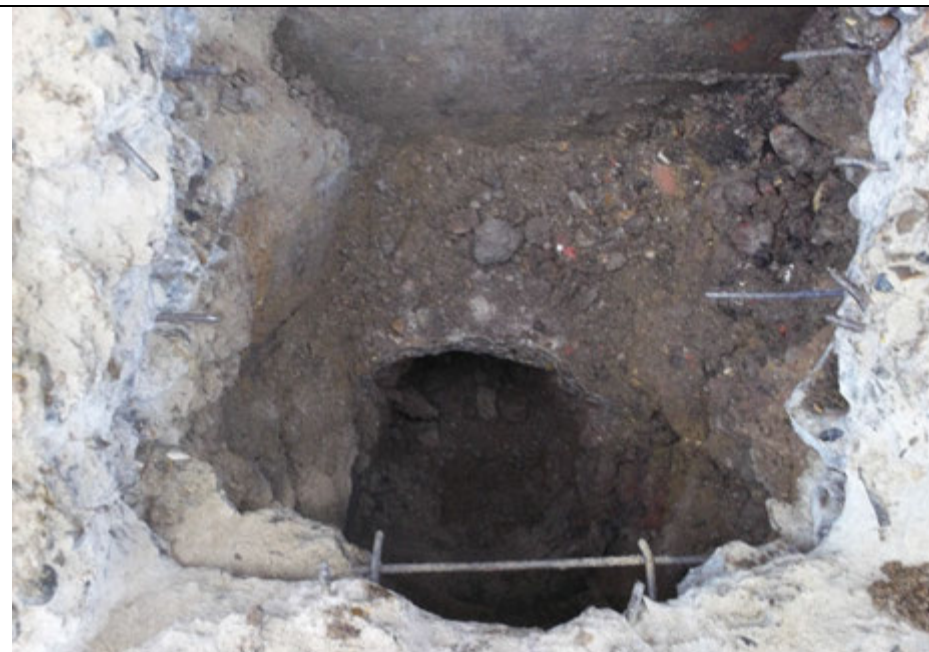
View of concrete foundation in FIP04

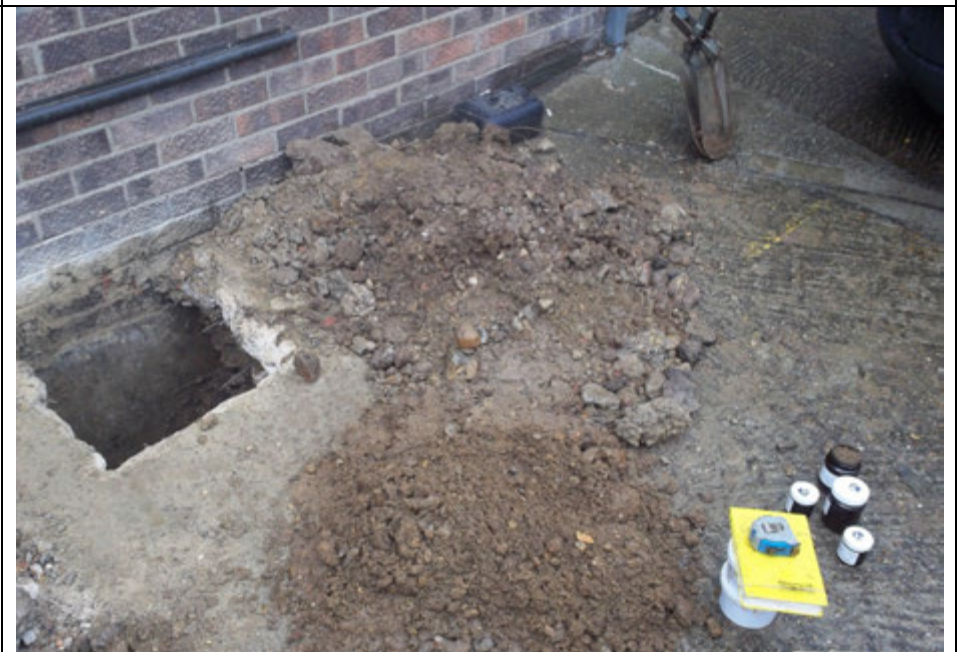
View of arisings from FIP04
