3.0 Design Analysis & Proposal

3.14.0 Structural Analysis

Ref: 68 Huntley Street, London, WC1

Further to your instruction and my visit to the property last Wednesday, I carried out a visual inspection of the structure to comment on the general condition and identify any defects that you should be aware of in relation to your purchase of the building.

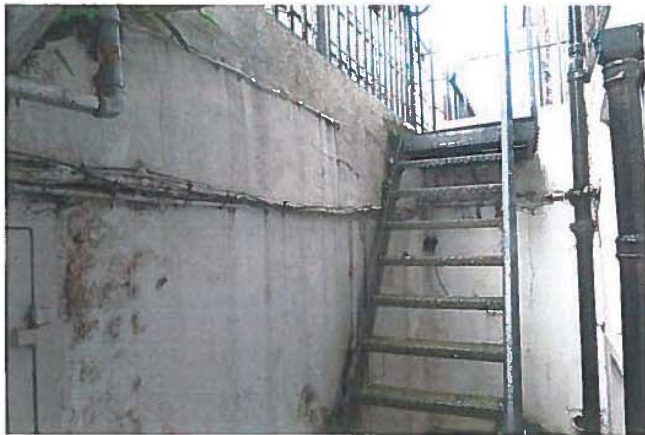
The metal escape staircase and street level railings are both in reasonable structural condition, although there is some rusting in the staircase member connections, which would suggest an overhall and re-painting would be advisable.

Recommendation Item 1
Basement front area metal escape stair & railings

1. The front area metal staircase requires stripping down and all connections mechanically scraped and brushed to remove all friable metal and rust. Repairs should be made and/or replacement parts installed, and the metalwork primed with a 2 pack epoxy paint and redecorated (Photo)
2. The existing steel beams supporting the rear ground floor bridge and porch should be stripped down and the bearings investigated for excessive corrosion to the bearing ends. Depending on the severity of the corrosion, either mechanically scrape and brush the beams to remove all friable metal and rust, and prime with a 2 pack epoxy paint and redecorate, or replace with appropriately designed beams treated against corrosion; repair bearings to masonry(Photo)
3. Investigate the upper floor front room joists and carry out a design check for adequacy. Strengthen with additional joist if necessary.

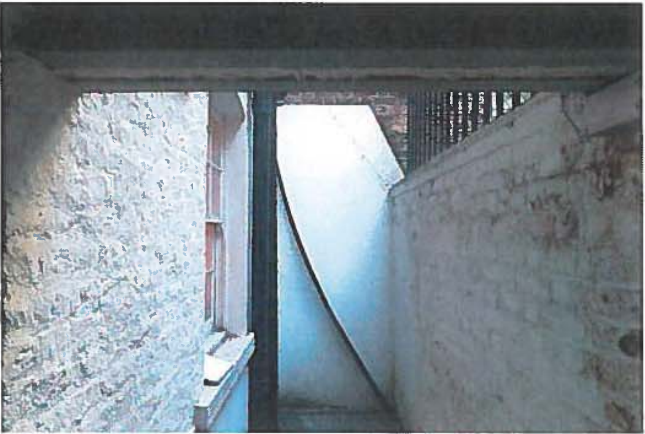
The porch and access bridge above is partially supported on small steel beams that are exposed, although have painted protection. There is clearly some old rusting and lamination of the steelwork that has been painted over, but more importantly there is more severe rusting and de-lamination of the beams where they enter their bearings in the brickwork. The bearings and steels should be physically investigated for condition and the beams may need strengthening or replacing.

Generally the brick construction appears sound and square with no sign of movement. However, as already noted there is a question mark over corroding support steelwork just below ground floor level that should be investigated.

Recommendation Item 2
Support steelwork for rear bridge and porch

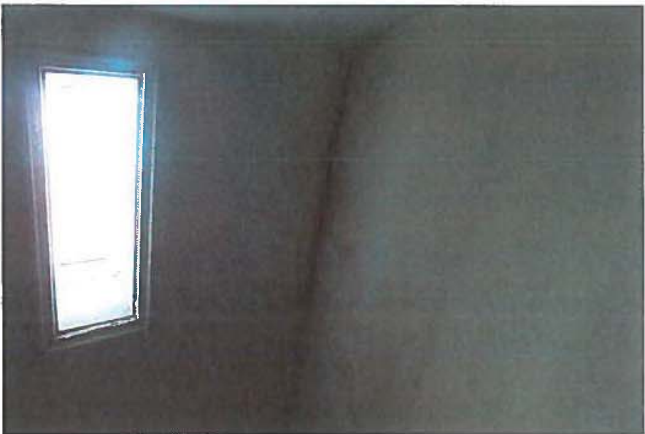
In the rear room there is a damp problem where the mansard slope abuts the party wall, and a separation crack in the plaster between timber mansard structure and party wall. While unlikely to be serious, the flashings and general waterproofing details should be checked for effectiveness and repaired as necessary, to prevent damage to the timber structure and internal finishes.

Recommendation Item 5
Dampness and cracking at 3rd floor of mansard & party wall No. 66

5. Investigate dampness and waterproofing details at the junction of mansard and both party walls at 3rd floor level rear(Photos)
6. Investigate the relationship between the timber floor construction and front elevation brickwork in the vicinity of the outward bulge. If defective, add an internal tie arrangement(Photo)

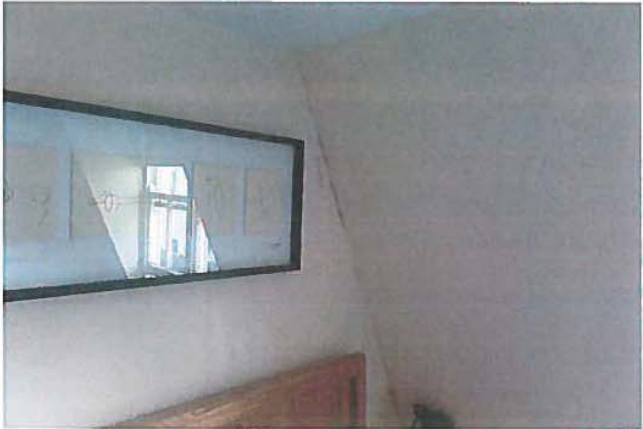
At the top landing there is a damp problem where the mansard slope abuts the party wall, and a separation crack in the plaster between timber mansard structure and party wall. While unlikely to be serious, the flashings and general waterproofing details should be checked for effectiveness and repaired as necessary, to prevent damage to the timber structure and internal finishes.

Recommendation Item 5
Dampness and cracking at 3rd floor of mansard & party wall No. 70

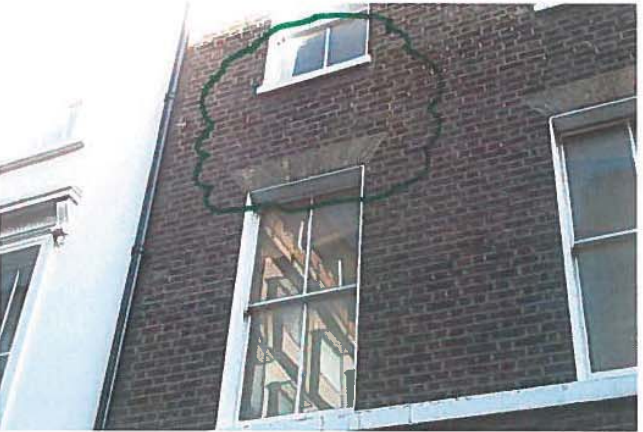
The fair-faced brickwork of the front elevation is in generally very good condition and vertical, with the one exception being some minor outward bulging around the sub sill panel between the 1st & 2nd floors of the LHS window. Otherwise the horizontal lines are good, the pointing appears sound, the windows and doors are square, and the gauged brick arches perfectly sound. The whole elevation is relatively free of any significant cracking or movement.

Recommendation Item 6
Minor outward bulging in front elevation LHS 2nd floor

Internal investigation of the relationship and tying in of the bulging brickwork and timber floor at 2nd floor level would be advisable.

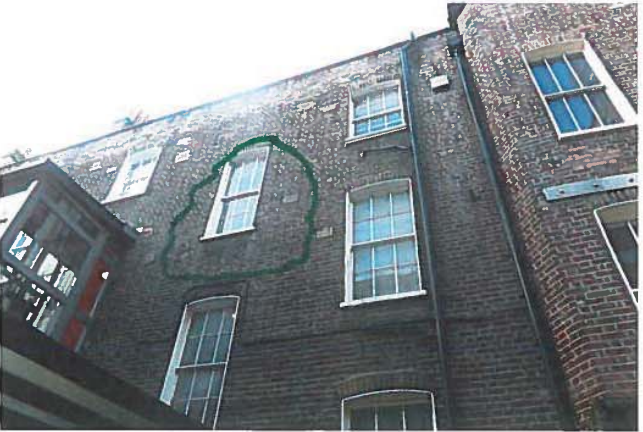
The fair-faced brickwork of the front elevation is in generally good condition and vertical, with the one exception being some outward bulging around the sub sill panel between the 1st & 2nd floors and reveals above of the LHS window. Otherwise the horizontal lines are good, the pointing appears sound, the windows and doors are square, and the gauged brick arches perfectly sound. The whole elevation is relatively free of any significant cracking or movement.

Recommendation Item 7
Outward bulging in rear elevation LHS 2nd - 3rd floor stair landing level.

Internal investigation of the relationship and tying in of the bulging brickwork and timber floor at 2nd and 3rd floor levels would be advisable.

7. Investigate the relationship between the timber floor construction and rear elevation brickwork in the vicinity of the outward bulge. If defective, add an internal tie arrangement(Photo)
