Asbestos Survey Report 10/05/2016
Refurbishment Survey

3404
246 Belsize Road (basement and rear)
246 Belsize Road (basement and rear)
North Maida Vale
London
NW6 4BT

Survey Reference: FS2028
Start Date: 09/05/2016
Completion Date: 10/05/2016
Publish Date: 11/05/2016

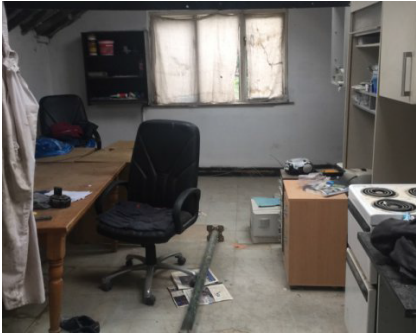
Room/location Reference:	001
Room/location Description:	All areas
Area/floor Reference:	001
Area/floor Description:	First Floor
Accessibility:	Accessible
Total ACMs:	0
Total NoACMs:	0

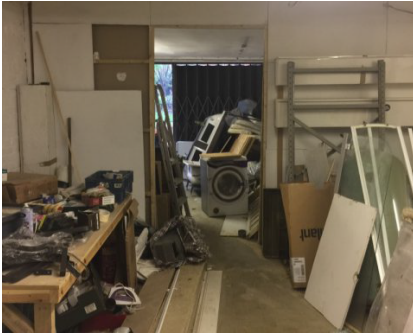
Room/location Reference:	002
Room/location Description:	All areas
Area/floor Reference:	002
Area/floor Description:	Ground Floor
Accessibility:	Accessible
Total ACMs:	0
Total NoACMs:	0

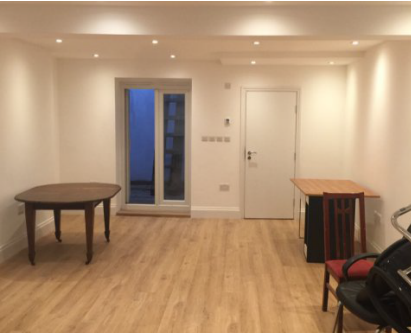
Room/location Reference:	003
Room/location Description:	All areas
Area/floor Reference:	003
Area/floor Description:	Basement
Accessibility:	Accessible
Total ACMs:	0
Total NoACMs:	0
