Astor College - CCTV Survey Report : 25/09/15

Name : KENT DRAINAGE LTD
 Contact : Tom Coe
 Location : Unit 1, 1 Stoney Lane
 Town : Rochester
 Region : Kent
 Postcode : ME1 3QJ
 Tel : 01622 919012
 Mobile :
 Email : info@kentdrainage.co.uk
 Fax :

Name : Galliford Try Construction LTD
 Contact : Lauren Solomon
 Location : Cowley Business Park
 Town : Uxbridge
 Region : Middlesex
 Postcode : UB8 2AL
 Tel :
 Mobile :
 Email :
 Fax :

Name : Astor College
 Contact :
 Location : 99 Charlotte Street
 Town :
 Region : London
 Postcode : W1T 4QB
 Tel :
 Mobile :
 Email :
 Fax :

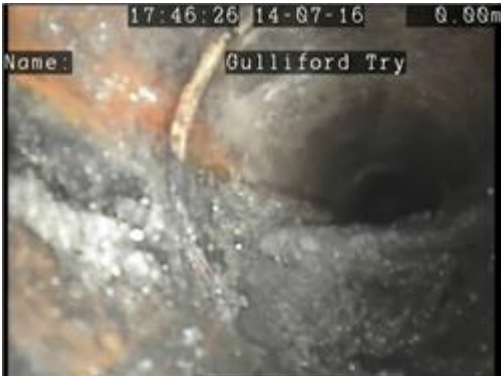
Pos	Code	Description	Image
00.00m	MH	Start node type, manhole S5	
00.00m	WL	Water level: 0% Height/Diameter	
00.00m	DES	Settled deposits fine: 35% Cross sectional area loss - Grade 2 SOLID DEBRIS UNABLE REMOVE WITH STANDARD JET	Image Provided - Ref: 12_2

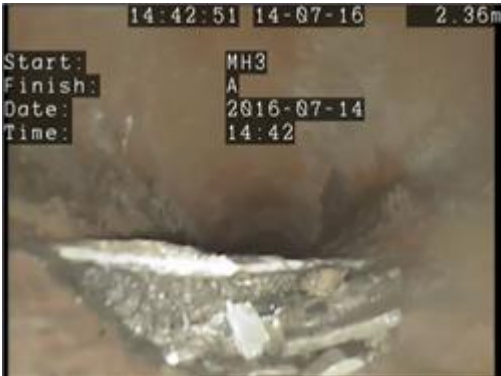
Pos	Code	Description	Image
00.00m	MH	Start node type, manhole MH3	
00.00m	WL	Water level: 0% Height/Diameter	
02.36m	DES	Settled deposits fine: 25% Cross sectional area loss - Grade 2 SOLID DEBRIS POSSIBLE PAINT/CEMENT, UNABLE TO CLEAR USING STANDARD JET	Image Provided - Ref: 16_2

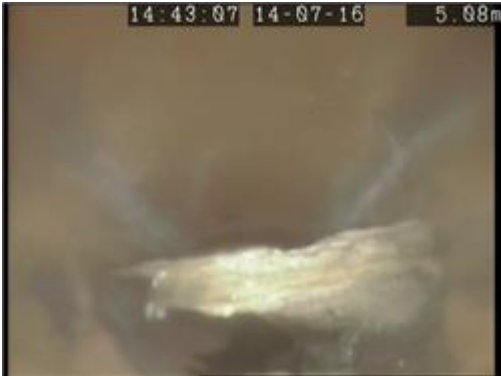
05.08m	DES	Settled deposits fine: 25% Cross sectional area loss - Grade 2 SOLID DEBRIS UNABLE TO CLEAR USING STANDARD JET	Image Provided - Ref: 16_3

05.08m	SA	Survey abandoned UNABLE TO PUSH PAST DEBRIS
