Hutton + Rostron Environmental Investigations Limited

Kidderpore Avenue: Plaster condition investigation at the Chapel

Site note 8 for 28 June 2016, job no. 143.95

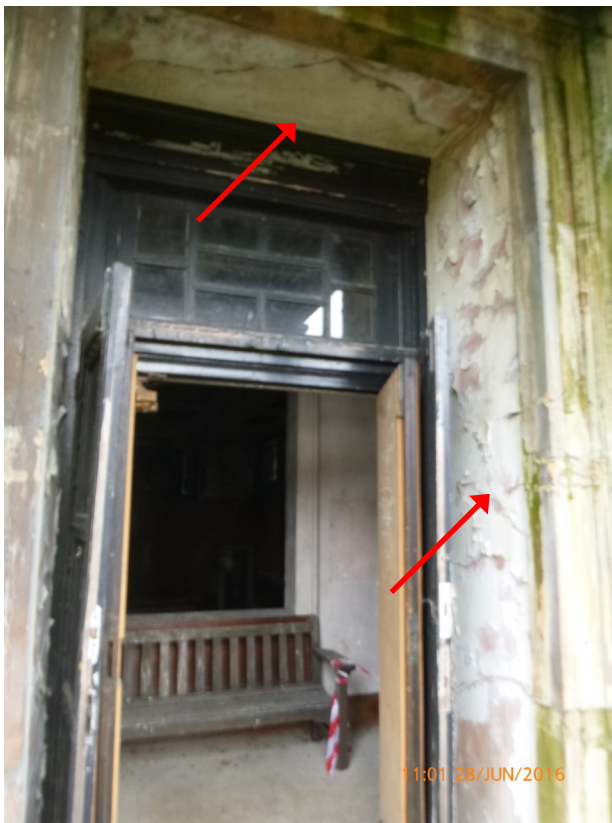
Fig 1:

Entrance; showing doorway reveals of gypsum plaster applied on the hard. Note widespread cracking and water damage

ELEMENT	DESCRIPTION	CONDITION	RECOMMENDATION
Entrance door - reveals	Gypsum plaster, brickwork	Water/salt damage has compromised the plaster and will hinder future repair and re-decoration	Remove plaster using hand tools, taking care not to damage adjacent stonemasonry. Re-finish using render skim on cement board (isolate from the damp brickwork behind using studded plastic membrane to prevent recurrent water/salt damage)
Entrance lobby - walls	Plaster of paris, hessian and timber lath reinforcement, softwood battens, brickwork	Impact damage has heavily damaged over 75 per cent of wall finishes	Allow for dimensional recording the existing decorative plaster scheme prior to removal. Replacement should be made in new materials such as plasterboard
Entrance lobby - ceiling	Plaster of paris, hessian and timber lath reinforcement, softwood ceiling joists, roof structure	Minimal significant damage. General soiling from condensation	Due to the requirement for inspection, repair and re-detailing of the structure above, provisionally allow for replacing the ceiling. Allow for dimensional recording the existing decorative plaster scheme prior to removal

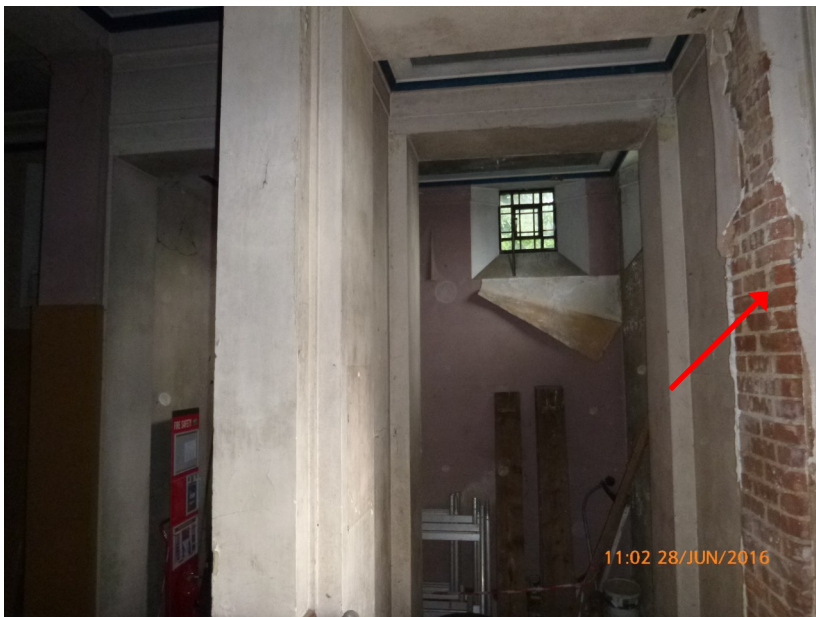
Fig 2:

Entrance lobby; showing plaster of paris linings applied to battens. Note damage and loss of material

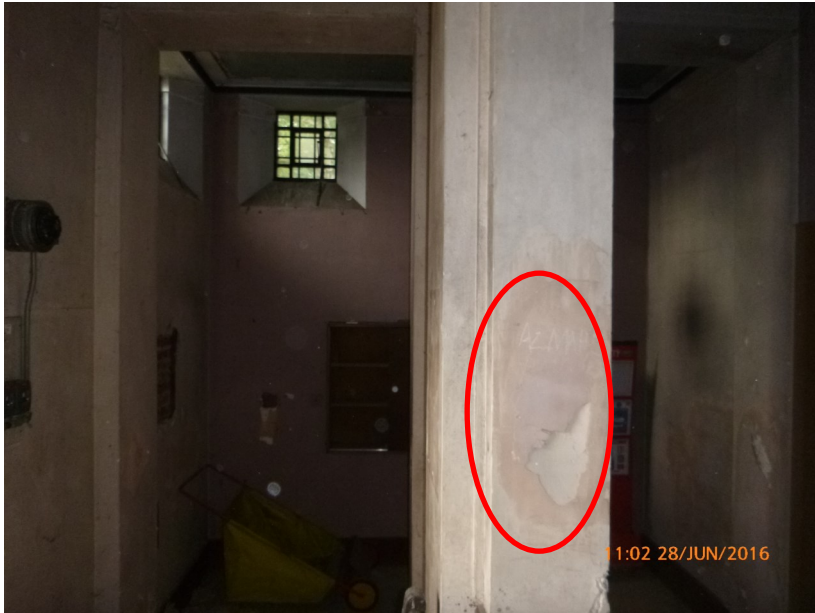
Fig 3:

Entrance lobby; showing plaster of paris linings applied to battens. Note failed gypsum skim repair

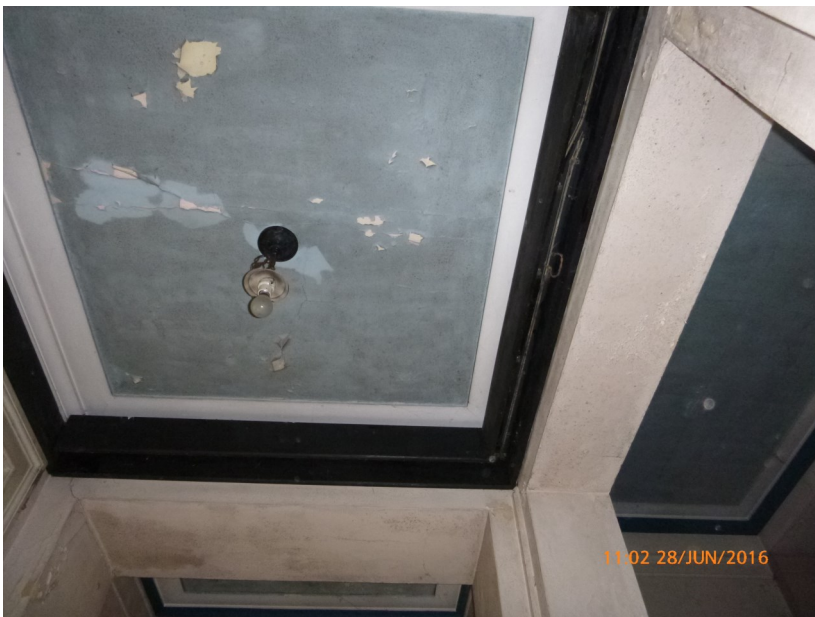
Fig 4:

Entrance lobby; showing plaster of paris ceiling still in-tact

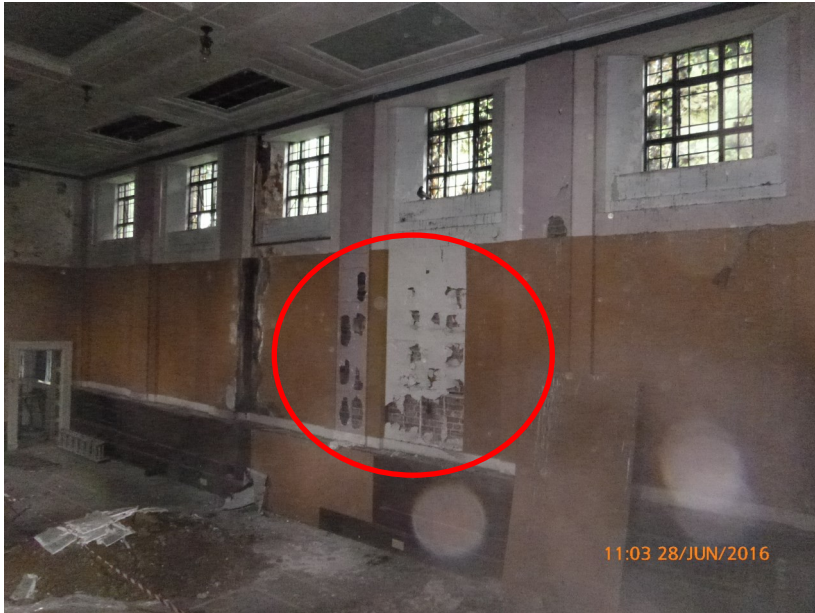
Fig 5:

Nave; showing plaster of paris wall linings applied to battens. Note severe and widespread damage and loss of material (especially where disguised by MDF cladding)

Nave – walls	Plaster of paris, hessian and timber lath reinforcement, softwood battens, brickwork	Impact damage has heavily damaged over 75 per cent of wall finishes	Allow for dimensional recording the existing decorative plaster scheme prior to removal. Replacement should be made in new materials such as plasterboard
Nave - ceiling	Plaster of paris, hessian and timber lath reinforcement, softwood ceiling joists, roof structure	Minimal significant damage but multiple hatches created by others for void access. General soiling from condensation	Due to the requirement for inspection, repair and re-detailing of the structure above, provisionally allow for replacing the ceiling. Allow for dimensional recording the existing decorative plaster scheme prior to removal

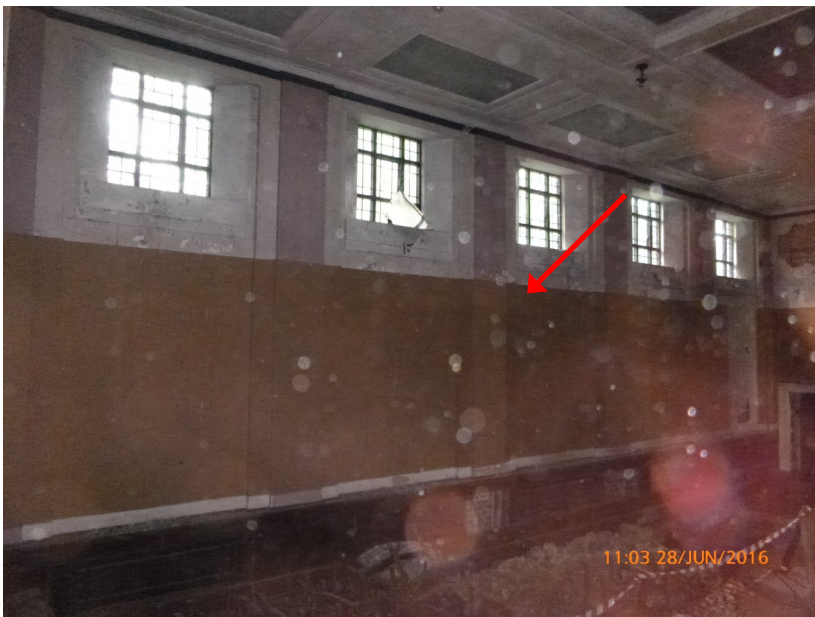
Fig 6:

Nave; showing plaster of paris wall linings applied to battens. Note damage disguised by MDF cladding

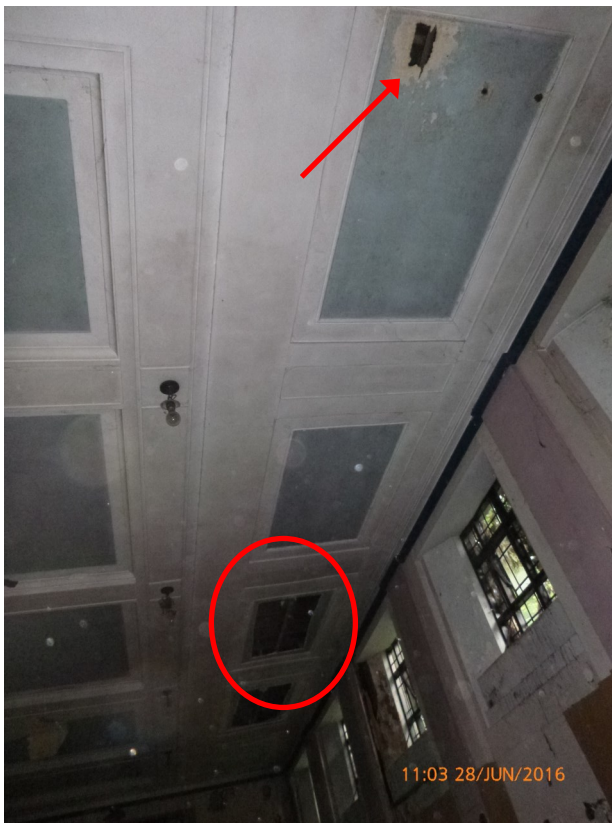
Fig 7:

Nave; showing plaster of paris ceiling mostly in-tact but removed for void access or water damaged locally

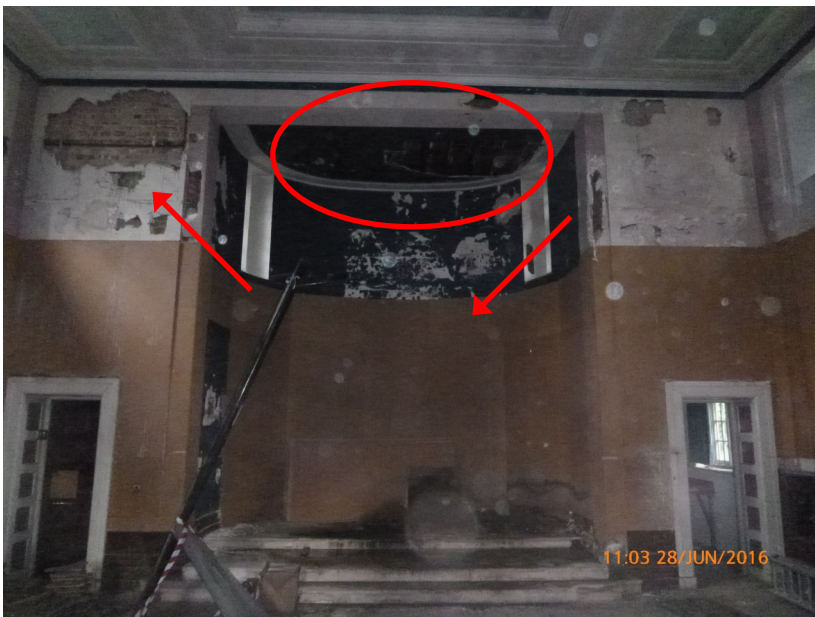
Fig 8:

Chancel; showing plaster of paris linings applied to battens. Note severe and widespread damage and loss of material (especially where disguised by MDF cladding). Also note water damage and collapse affecting ceiling

ELEMENT	DESCRIPTION	CONDITION	RECOMMENDATION
Chancel – walls	Plaster of paris, hessian and timber lath reinforcement, softwood battens, brickwork	Impact damage has heavily damaged over 75 per cent of wall finishes	Allow for dimensional recording the existing decorative plaster scheme prior to removal. Replacement should be made in new materials such as plasterboard
Chancel - ceiling	Plaster of paris, hessian and timber lath reinforcement, softwood ceiling joists, roof structure	Water ingress has heavily damaged over 50 per cent of ceiling finishes	Allow for replacing the ceiling. Allow for dimensional recording the existing decorative plaster scheme prior to removal
Vestry – walls	Gypsum plaster, brickwork	Water damage has affected 25 per cent of wall finishes	Remove plaster. Re-finish using plasterboard (isolate from the damp brickwork behind using studded plastic membrane to prevent recurrent water/salt damage)

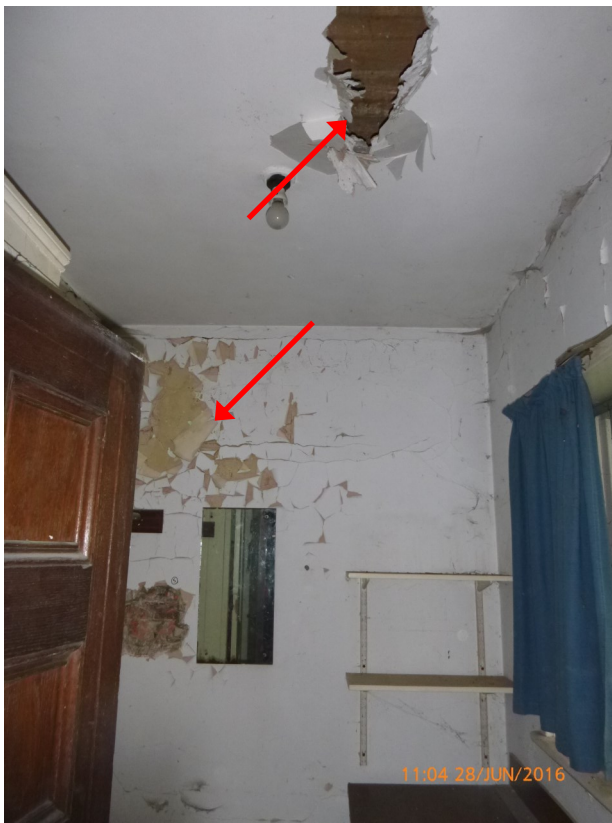
Fig 9:

Vestry; showing plasterboard soffit subject to localised damage. Also note gypsum wall plaster applied on the hard and heavily water damaged

Vestry – ceiling	Plasterboard, softwood roof structure	Localised impact damage	Due to the requirement for inspection, repair and re-detailing of the structure above, allow for replacing the ceiling

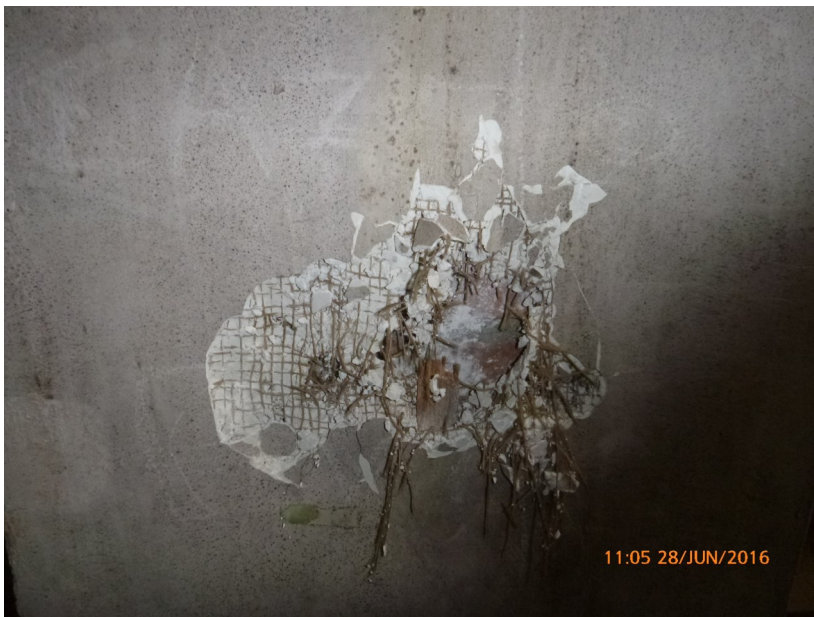
Fig 10:

Plaster of paris; showing fragile material relying upon hessian reinforcement

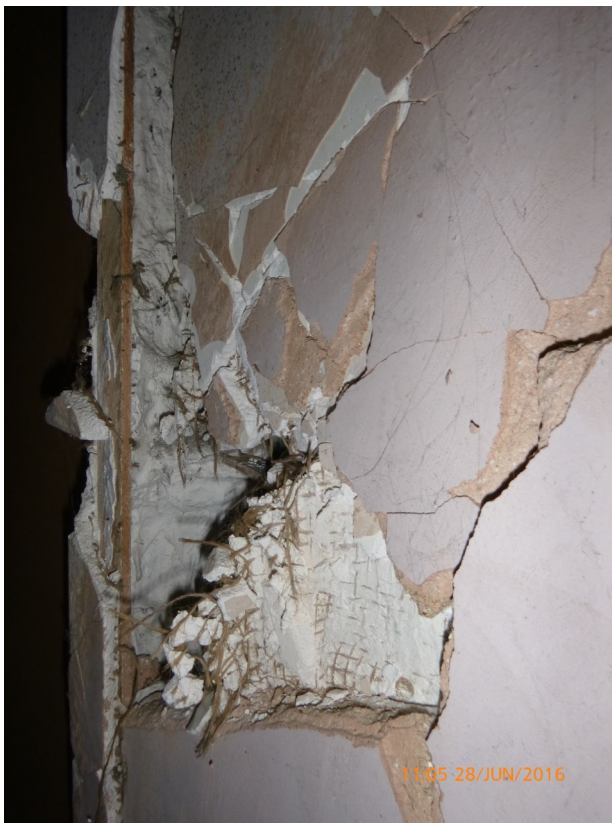
Fig 11:

Plaster of paris; showing failed gypsum skim repair

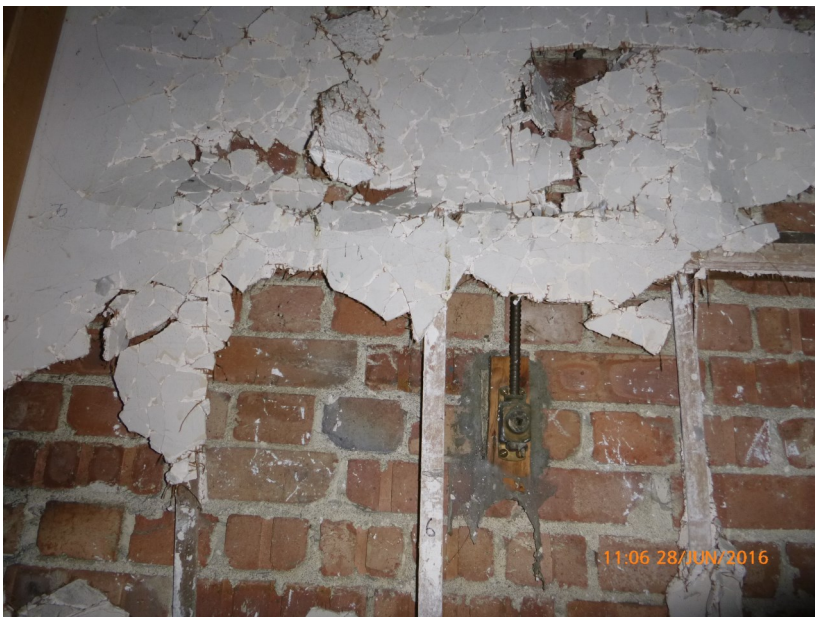
Fig 12:

Plaster of paris; showing typical impact damage sustained by ball games and vandalism

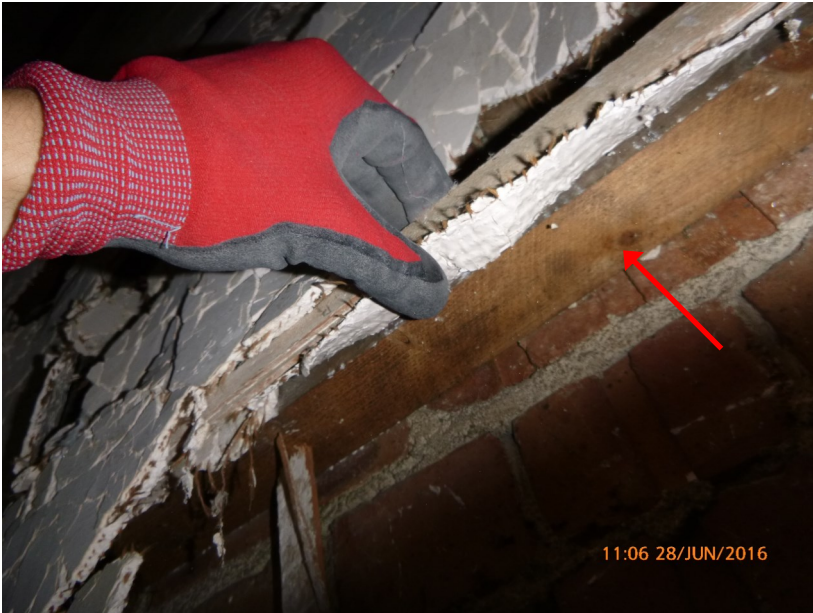
Fig 13:

Plaster of paris; showing wall linings fixed to battens

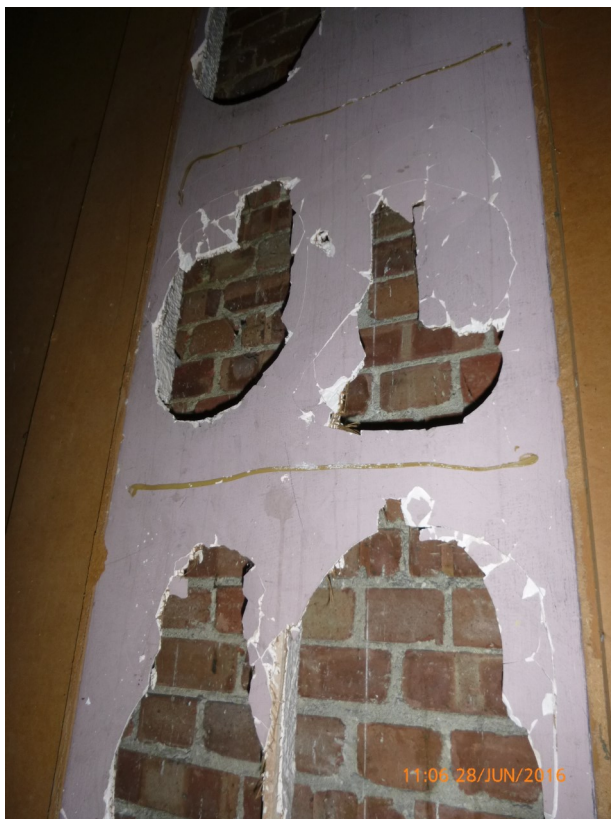
Fig 14:

Plaster of paris; showing typical impact damage sustained by ball games and vandalism

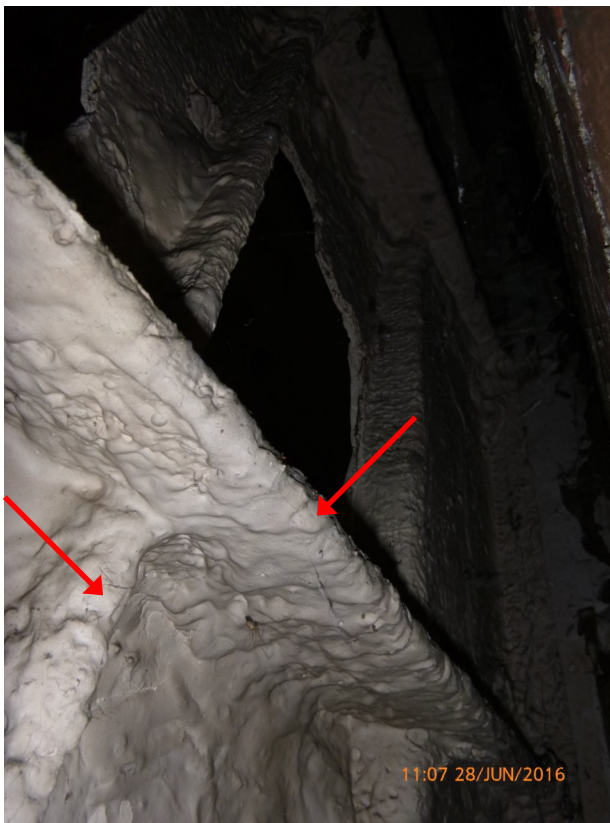
Fig 15:

Plaster of paris; showing laths and spines providing support of wall panels. Note plaster poured over in layers (indicating pre-casting on a workshop bench)

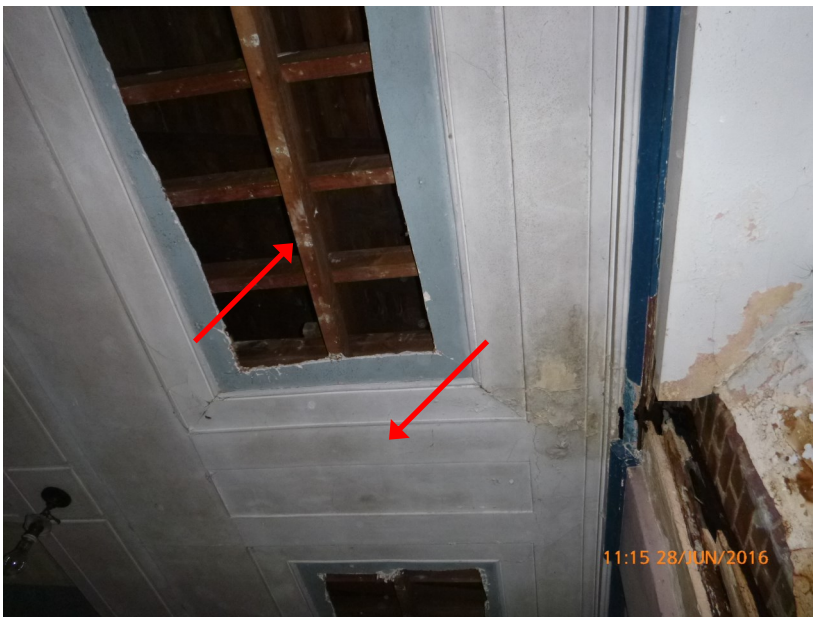
Fig 16:

Plaster of paris; showing large hatch removed for enabling inspection/access by others. Note support from softwood joists. Also note condensation soiling to paint finishes due to inadequate heating/insulation/ventilation

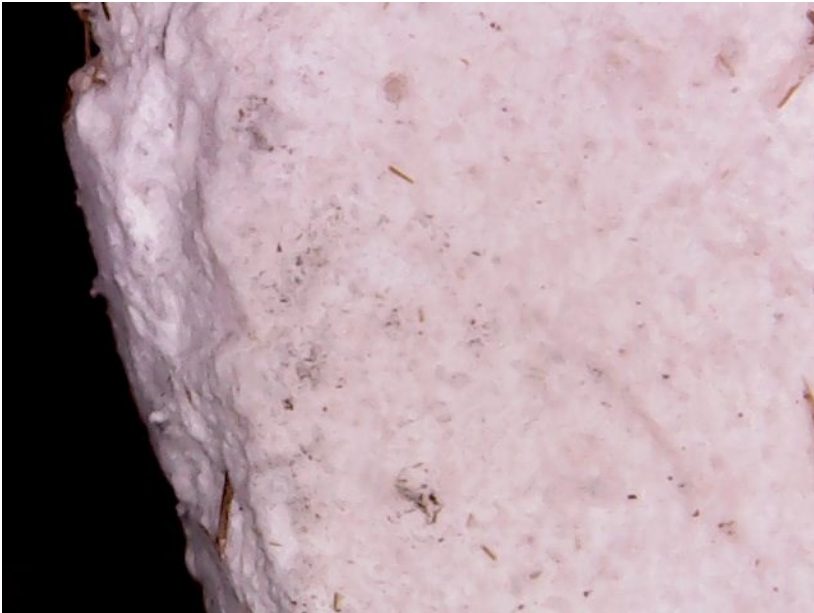
Fig 17:

Plaster of paris; showing microscopic view. Note fine and homogenous mix which was inherently fragile (especially in thin panels)

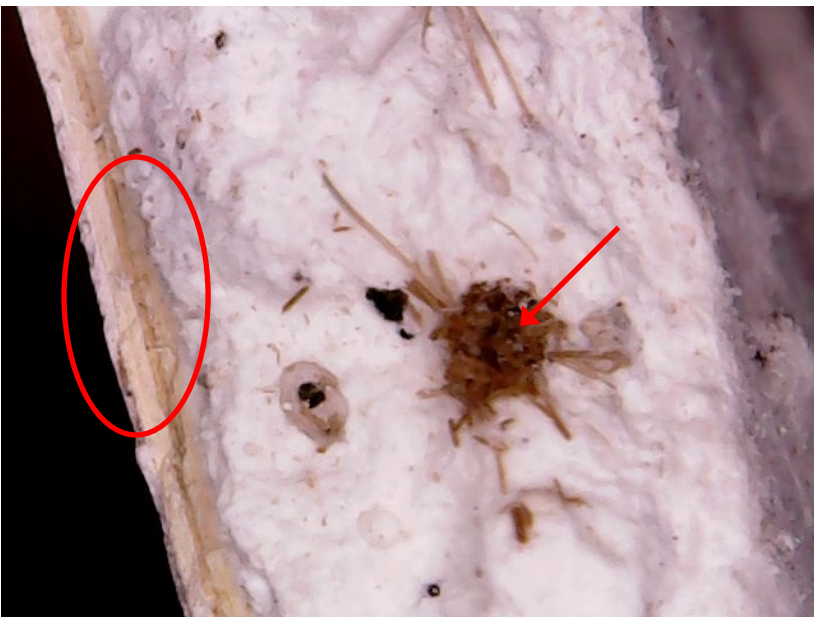
Fig 18:

Plaster of paris; showing microscopic view. Note hessian strand from reinforcement mesh. Also note chronology of paint layers indicating the original colour to have been a cream-brown tone

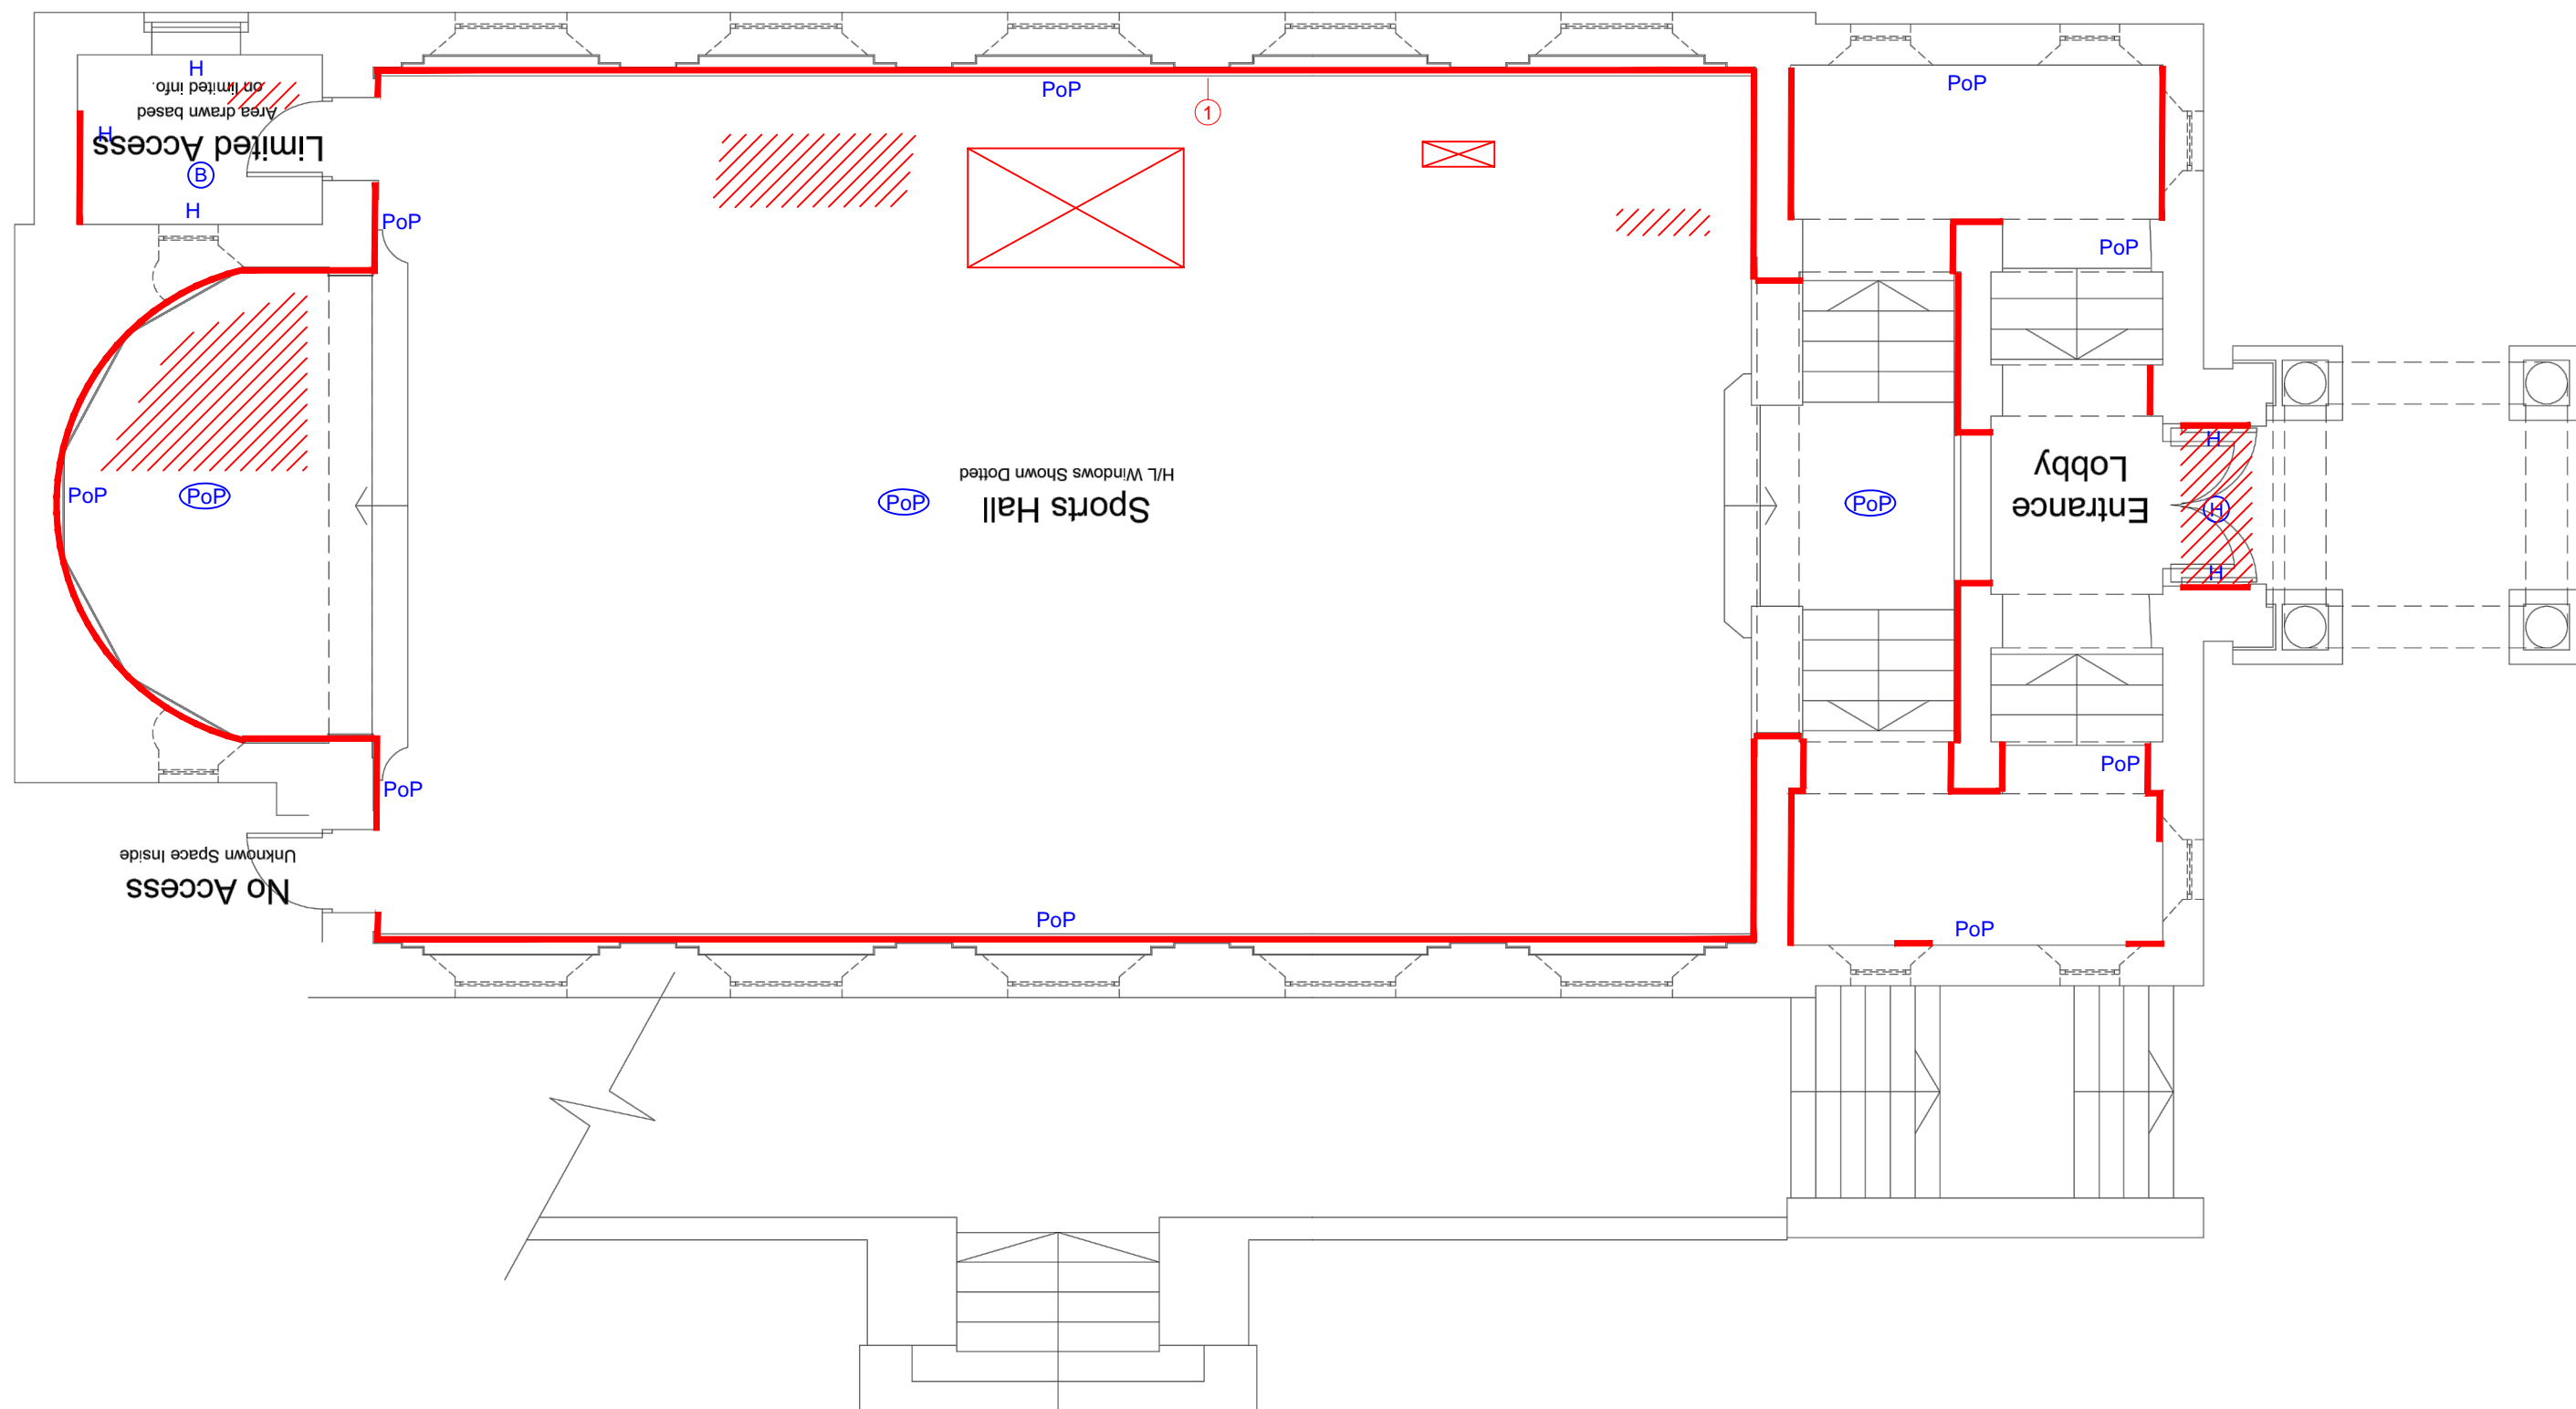
Kidderpore Avenue, Chapel
 Plaster condition investigation
 28 June 2016

Note that the POP construction was inherently fragile. Due to the recent history of use for ball games and general vandalism by occupants, the wall plaster has been comprehensively damaged beyond repair. This related to impact damage. Ceiling plaster had remained in relatively better condition but had collapsed locally due to water penetration from the roof. In general, the ceiling was in a repairable state but it may be justified to remove the finish for the purposes of enabling investigation/repair/re-detailing the roof structure

It was assessed by H+R that it will not be practical to repair the existing plaster finishes in-situ, on refurbishment. This is on the basis of widespread and comprehensive damage in addition to the need for exposing the underlying structures for investigation/repair/re-detailing (so as to ensure the long term sustainability of The Chapel). H+R recommend that the remaining parts of the existing decorative plaster scheme are dimensionally recorded, removed and replicated using new materials. Use of plasterboard would still be in-keeping with the original ethos of using common materials to give a highly decorative appearance and would also be a much more durable finish. However, provisional allowances should be made for reinstating plaster-of-paris finishes like-for-like
