Project No: 3788

29th November 2016

Re: Remedial works for the Cantilever Walkway – Stables Market, Camden

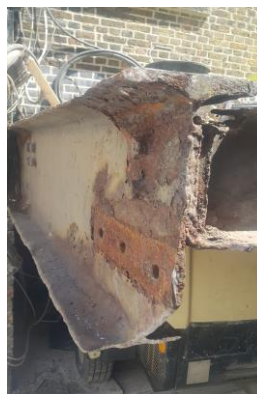
Due to the poor structural condition of beam P1 (high level of corrosion - Figure 1), we recommend a new structural system to substitute the existing primary beam.

Figure 1: Existing condition of primary beam P1

A third option consists of a new truss consisting of a new box section placed on top of the existing beam, supported by a tension plate at the end of the cantilever.

This solution was chosen and is shown in drawing 3788/201. For clarity, the existing beam will remain insitu, but we will not be relying on it for the structure integrity of the Walkway.

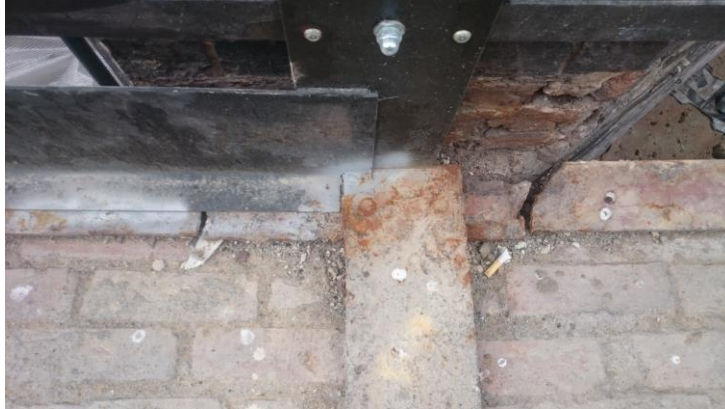
As shown in Figure 2, secondary beams SB3-16 and SB3-17 have the top flanges broken.

Figure 2: Secondary beams SB3-16 and SB3-17 showing poor structural condition

Therefore, we recommend that remedial works are undertaken to reinstate the structural integrity of those beams as soon as possible. We recommend welding an angle, on top of the primary beam in order to support both secondary beams. This repair is shown on detail F on drawing 3788/200.

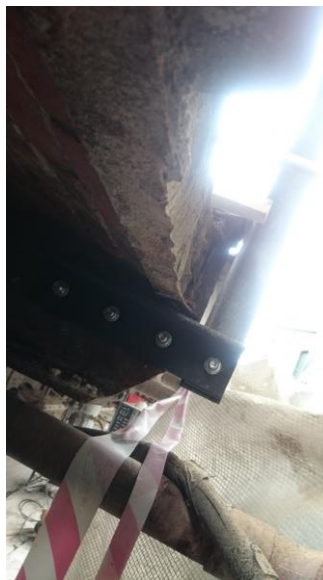
In the Long Stable corner there is a secondary beam (SB3-6) where large sections of the flange are corroded (see Figure 3). Therefore, we recommend placing a new beam underneath the existing secondary beam. This new beam will then be connected to the primary beams (P6 and P7).

Figure 3: Secondary Beam SB3-6

These repairs are shown on detail E on drawing 3788/202.

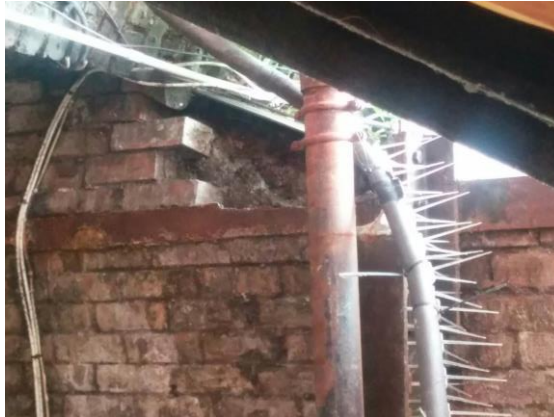
As shown in Figure 4, close to secondary beam SB3-6, there are some bricks missing from the Walkway.

Figure 4: bricks missing from the walkway

Therefore, we recommend placing a new channel beam to fit the brickwork and then connect it to the primary beam (P7) at one end, and to the Long Stable's brick wall at the other end of the beam.
