## SEQUENCE OF DESIGN

Reference: STRUCTURAL REPAIRS TO WALKWAY, CHALK FARM BUILDING  
Stables Market, Chalk Farm Road, London NW1 8AH

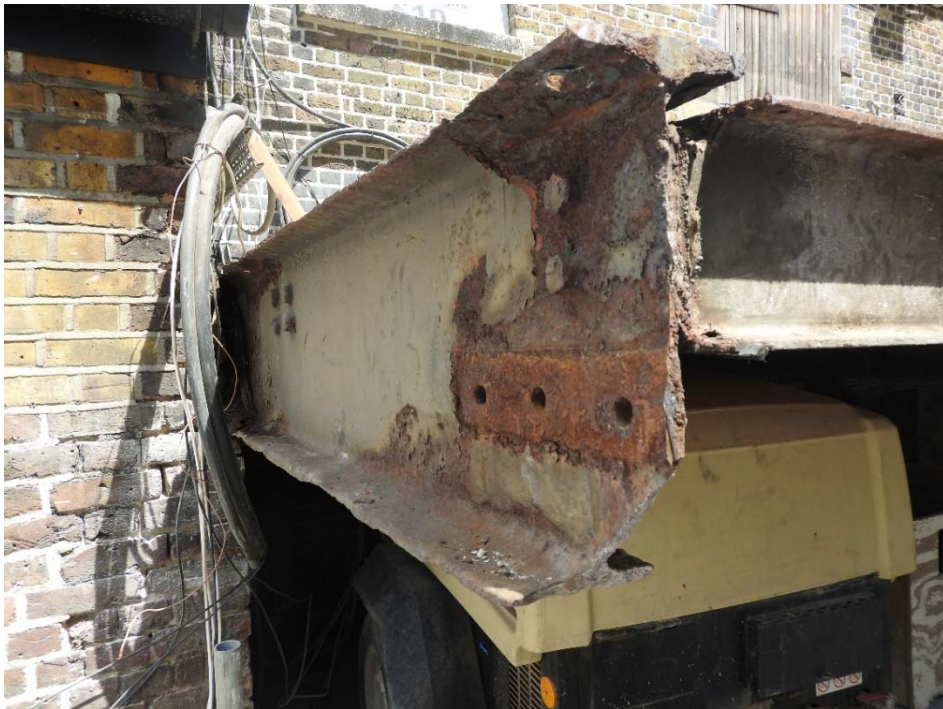
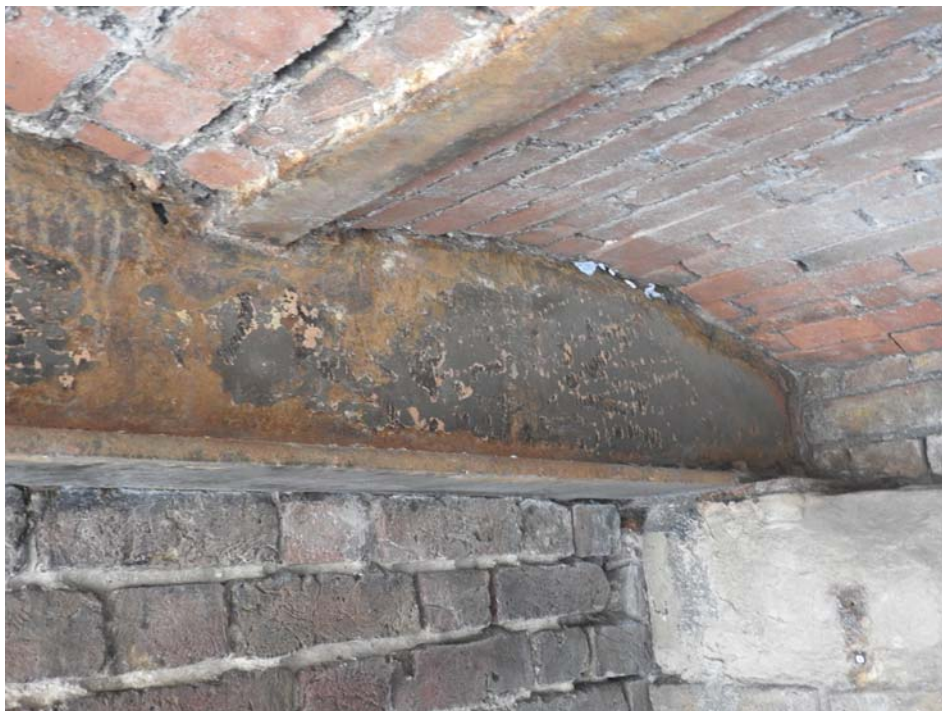
The closer inspection of the walkway underside revealed severe deterioration to the structural steel-work in several locations.

The primary beam at the west elevation of the walkway was found to be in particularly poor condition.

The revised proposal to reinforce the west end beam included a cantilevered square hollow section running along part of the existing beam with additional support provided by tension plates fixed to the brick wall level with the top of the new balustrade. This solution was accepted for inclusion in this application.

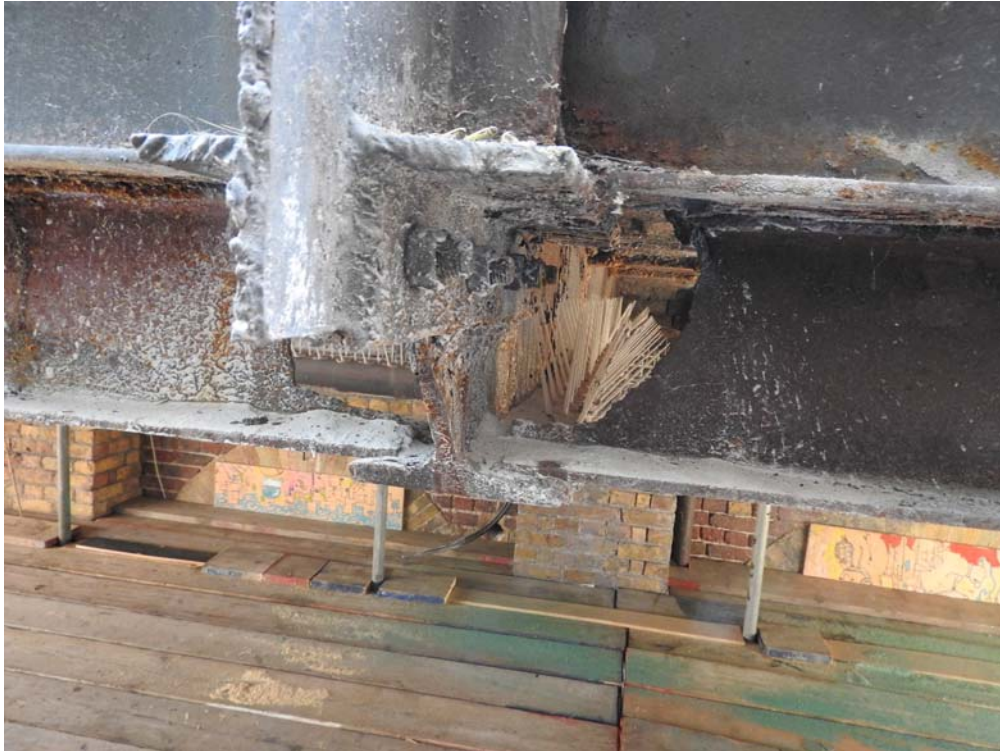
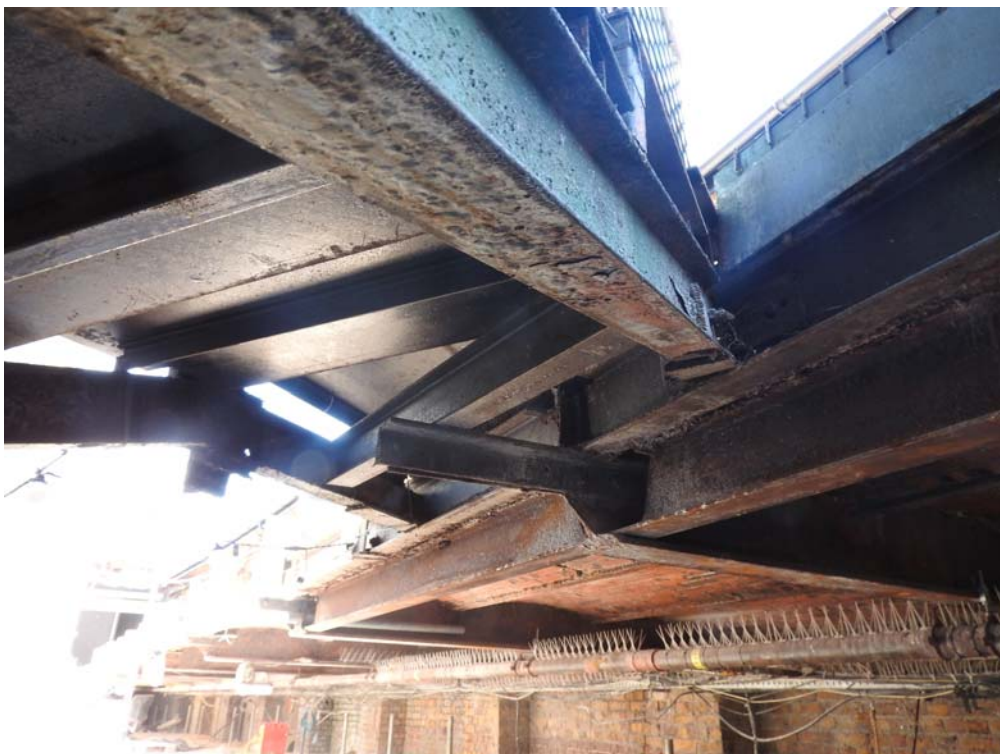
Weaknesses in the existing perimeter secondary beam were observed where the proposed replacement link bridge to the Provender Store is to be supported by the walkway.

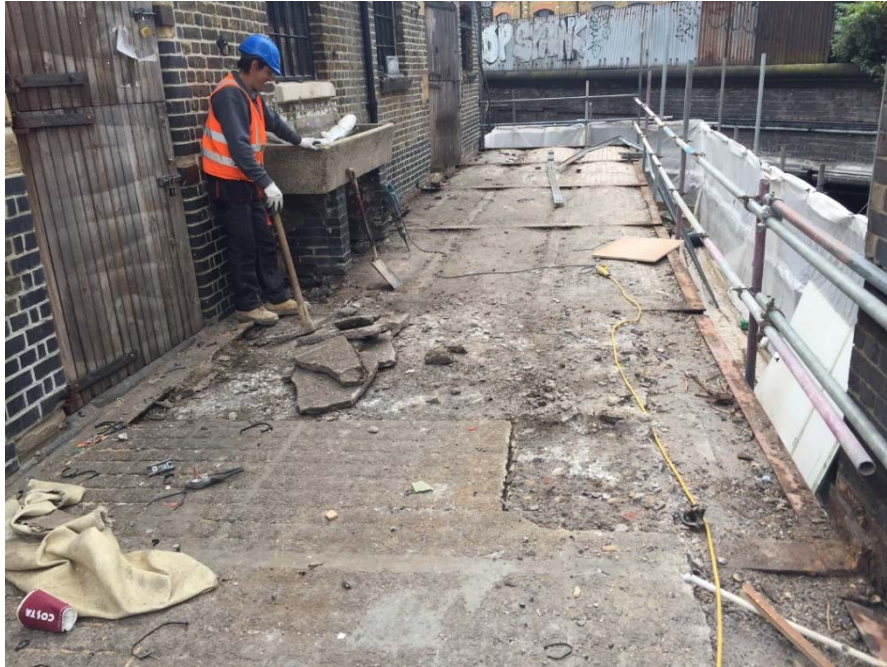
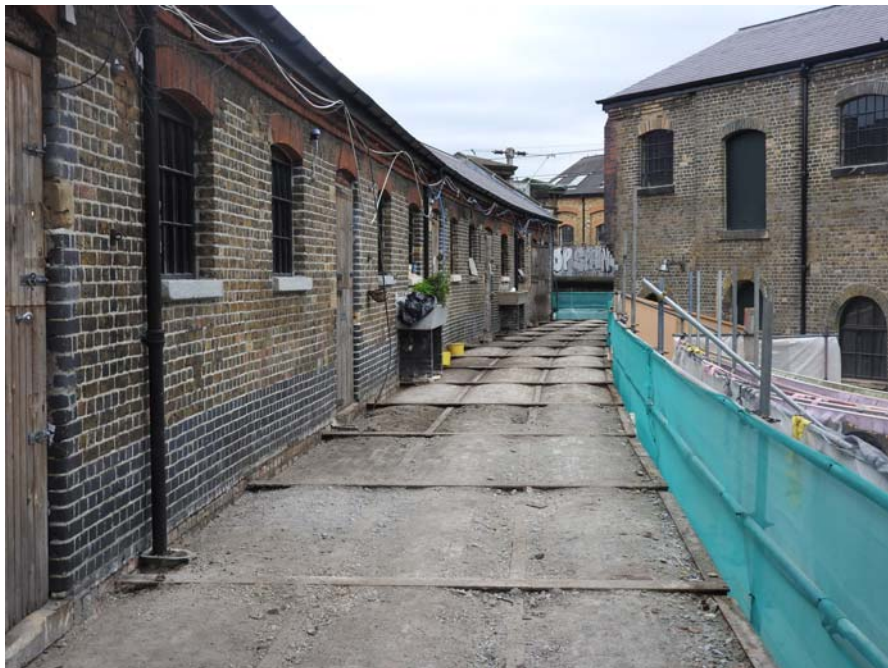
Further investigations into the deterioration of the structural steelwork were carried out following the removal of the concrete deck to the topside of the walkway.

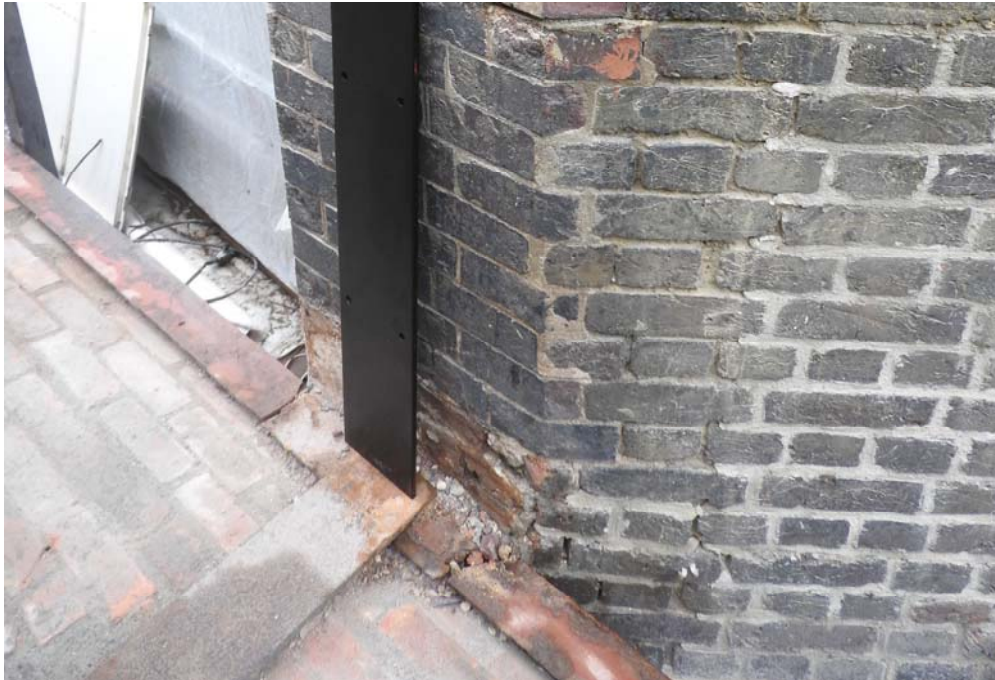
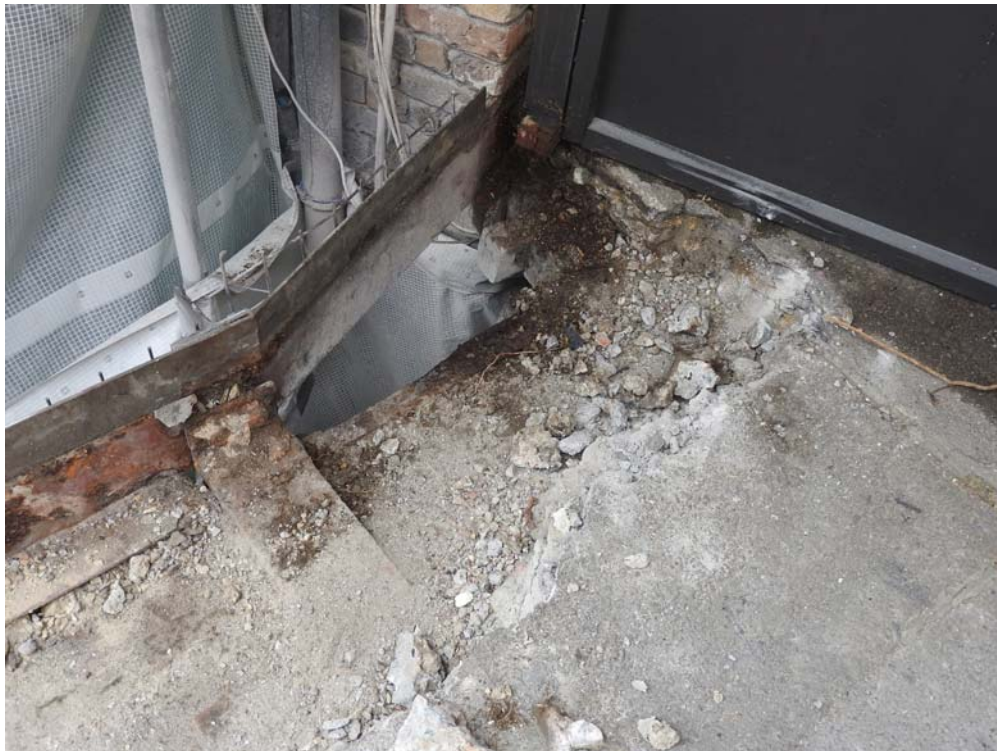
Structural reinforcement was found to be required where the walkway connects directly to the Provender Store and the Long Stable.

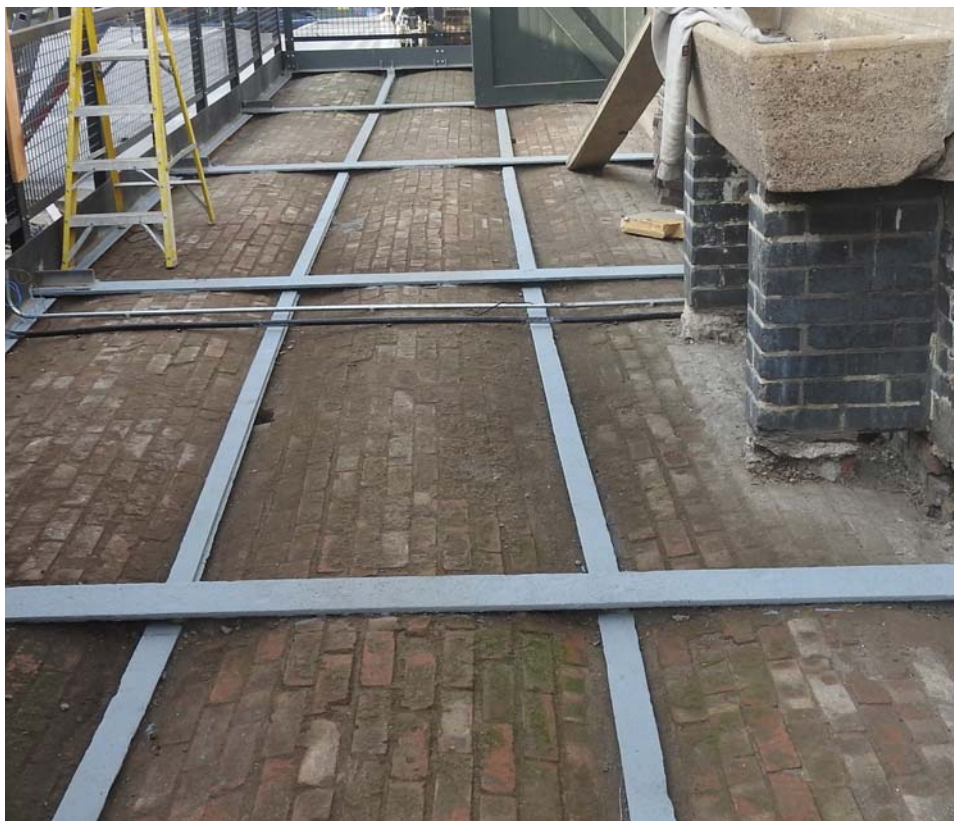
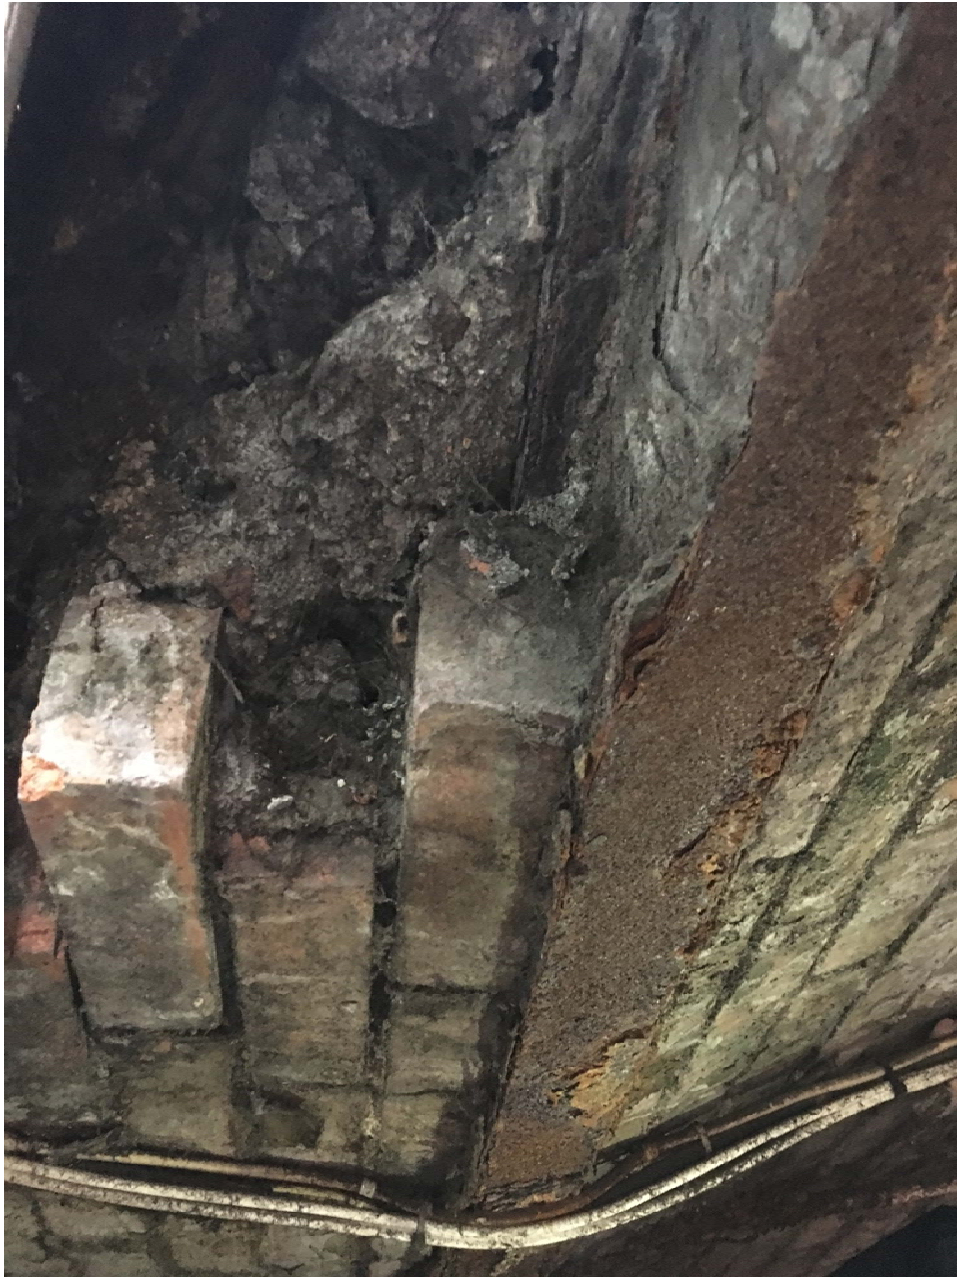
On cleaning the underside of the secondary beams and removing the selected adjacent bricks, it was established that the beams had deteriorated further than anticipated.

1. Plate welded only to topside of secondary beams – rejected due to the insufficient amount of reinforcement this solution would provide to all except four beams.
2. Plates welded to topside and underside of secondary beams - rejected due to impracticality of welding a plate to the deteriorated beam soffits.
3. Standard I-beams without lower flange bolted to primary beams below underside of secondary beams – rejected on the grounds of the required web height causing the reinforcements to project lower than the underside of the primary beams.
4. Unaltered standard I-beams bolted to primary beams below underside of secondary beams – accepted for inclusion in this application. A mock-up of this solution has been prepared.
