THE COCK TAVERN, 23 PHOENIX ROAD, LONDON,
NW1 1HB

REPAIR & RENEW SCHEDULE

OCTOBER 2016, Rev A

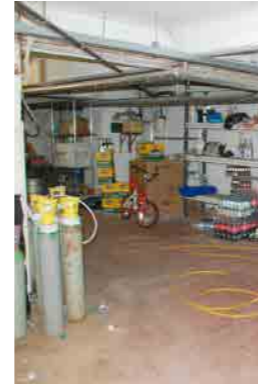
Cellar

Brick piers project into the space support the set-back facades on the two frontage elevations above, retaining walls follow the shop front façade. A down stand steel grid structure supports an insitu concrete slab to the ground floor supported by circular steel columns.

A cold room to the centre of the plan houses the beer barrels constructed from common blockwork. The existing ceiling height is 2 metres below the down stand beams.

Barrel Drop and existing trap door to cellar to be retained and repaired.

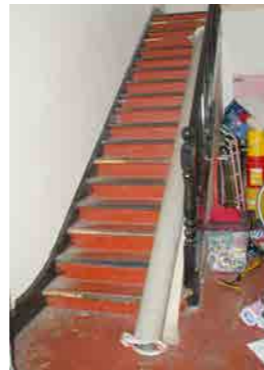
Residential entrance hall

Residential hall with access to yard at the rear and secondary lounge.

New fire rated plasterboard partitions to be installed in current opening to yard and before doorway to lounge. Skirtings and architrave installed to match existing. Refer to plan drawings WD010 and WD110 for further information.

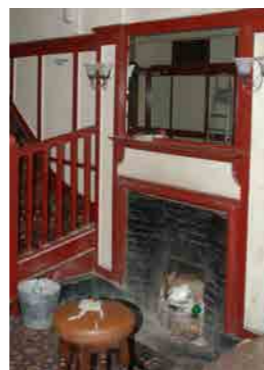
Fireplaces

Fireplace in main bar area along party wall with Walker House and to rear lounge bar.

Original fireplaces retained.

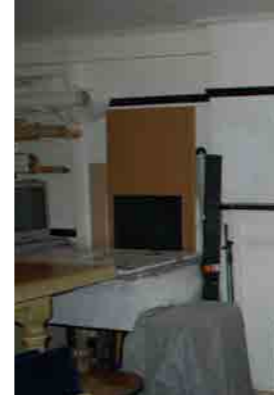
Walls, Architraves and Skirting

Original walls, architraves and skirting in first floor rooms.

Non-original partition walls on first second floor removed to restore original proportions of rooms. Walls between corridor and cupboard and male WC, and first floor bar to be demolished. Existing walls, architraves and skirtings to be retained and restored.

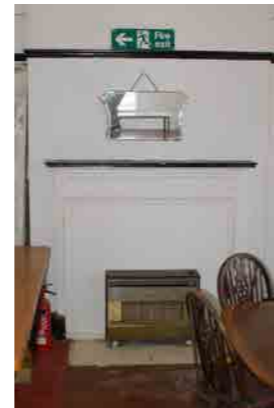
Fireplaces

2 no. fireplaces in function room: one on party wall with Walker House and one on shared wall with bedroom.

Existing fireplaces in function room and bedrooms retained and restored.

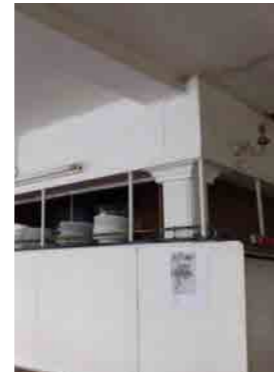
First floor bar

Bar in first floor function room.

Bar location retained with expanded kitchen space behind the bar.
New door to kitchen area beside bar to be installed. Refer to plan drawing WD112.

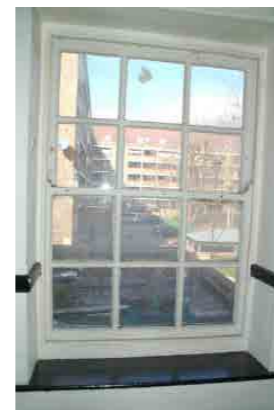
First Floor Sash and Casement windows on rear elevations

First floor sash windows, 6 no., at the rear of building with views into the courtyard. Refer to Window Condition Survey.

Sash windows on first floor North East elevation to be removed and openings bricked up, sash window ref: W1 14 to be restored and retained. Refer to plan drawing WD112 and WD308.

All existing sash boxes to be replaced with new timber boxes to match existing to allow the existing sash windows to be restored and correctly mounted, weighted and preserved. Existing catches and handles to be salvaged and preserved, new brass window pullies, ropes and weights to be installed.

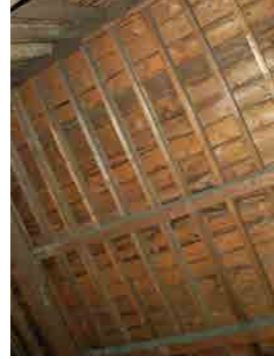
Loft space

Empty loft space punctured by existing chimney stacks. The existing loft is accessed via a hatch and loft ladder in the corridor. The loft has a generous pitched roof form with roof access via a hatch leading to the external parapet and gutter for maintenance.
