# St. Pancras Cruising Club New Clubhouse and Visiting Boaters Facilities

Bat Check Report

December 2016

*St Pancras Cruising Club  
St. Pancras Yacht Basin  
Camley Street  
London N1C 4PN*

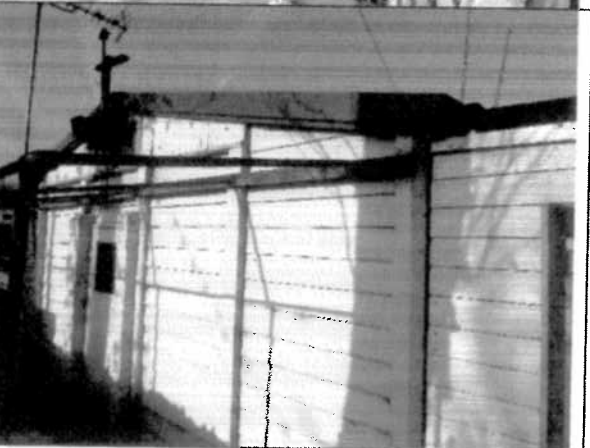
| Building Description | Feature Number | Feature and Location | Feature Details | Evidence | Building Potential |
|--|---|--|---|---|--|
| The building is comprised of two sections, the main clubhouse and the vestibule. The building is constructed of steel uprights with pre-cast concrete panels. The roof on the main clubhouse is corrugated coated steel and the roof on the vestibule is roofing felt. | A | SE, Ground level to 2.5m | Gap between main clubhouse and vestibule. | No | The building is in an urban area where there is a high level of disturbance. On the opposite side of the Regents canal there is extensive building work occurring. There is some light spill but the building is not illuminated at night. Bats are known to forage along the adjacent canal and Camley Street Natural Park is nearby. The building thus has <b>moderate potential</b> to support roosting bats. |

| Feature | Description | Photograph |
|--|--|--|
| A | Gap between main club house and vestibule. | |

The clubhouse should be demolished by the end of February 2017, otherwise a further check for bats will be required. This is because when the weather gets warmer (around March) bats will come out of hibernation and can start moving between roosts sites. This could mean that bats start to utilise the clubhouse.

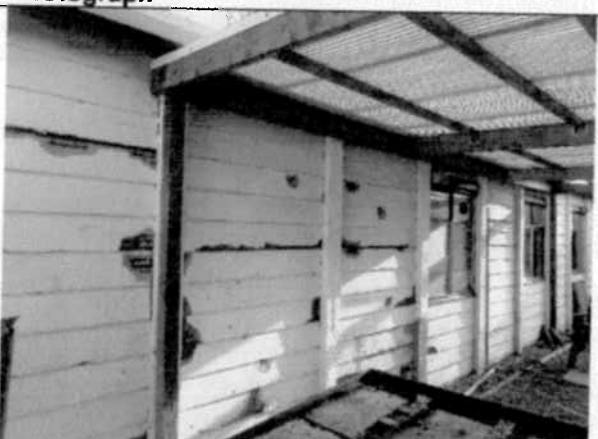
| Building Description | Feature Number | Feature and Location | Feature Details | Evidence | Building Potential |
|--|---|--|---|---|--|
| | B | NW, 2.5m | Gaps under soffit boards. | No | |

| Feature | Description | Photograph |
|---|--|--|
| B | Gap under soffit boards. | |

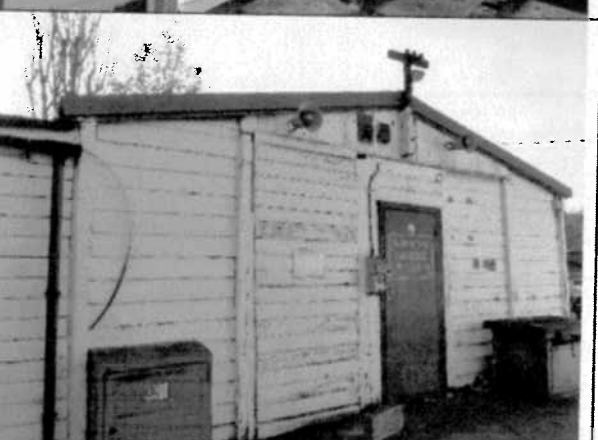
| Building Description | Feature Number | Feature and Location | Feature Details | Evidence | Building Potential |
|--|---|--|---|---|--|
| | C | N, 3m | Hole above northern door. | No | |

| Feature | Description | Photograph |
|---|--|--|
| C | Hole above northern entrance to main clubhouse. | |

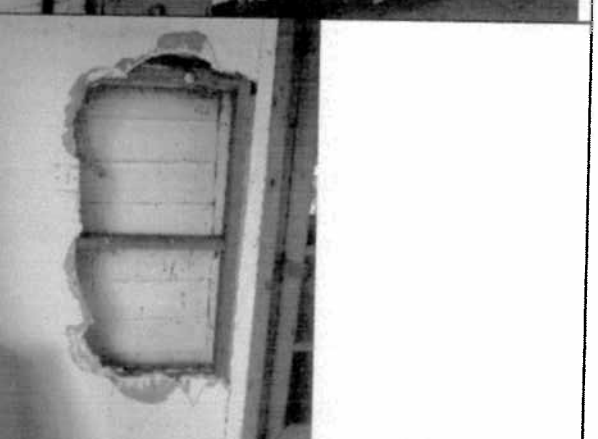
| Building Description | Feature Number | Feature and Location | Feature Details | Evidence | Building Potential |
|--|---|--|---|---|--|
| | D | Inside vestibule where join with main clubhouse is. | Missing plasterboard between vestibule and main clubhouse. Cobwebs present indicating bats are not present. | No | |

| Feature | Description | Photograph |
|---|--|--|
| D | Inside vestibule. Broken plaster board revealing concrete panel of main clubhouse. | |

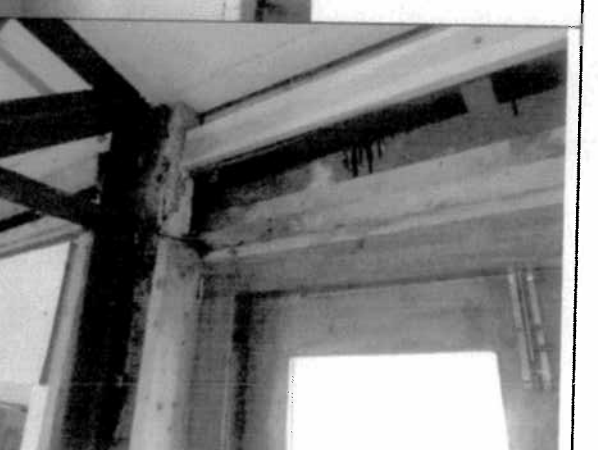
| Building Description | Feature Number | Feature and Location | Feature Details | Evidence | Building Potential |
|--|---|--|---|---|--|
| | E | Inside main clubhouse above internal vestibule door. | Gap between wooden structure. Fully visible with no sign of bats. | No | |

| Feature | Description | Photograph |
|---|--|--|
| E | Gap above door between vestibule and main clubhouse. | |
