Photos 10,11,12

Pls find attached photos which I took today of the retaining wall showing the side of 6 Gladys Rd. There is only very minor bulging. Damaged brickwork can clearly be seen near the top of the wall, mostly where Ivy and Buddleya have been spreading roots for many years.

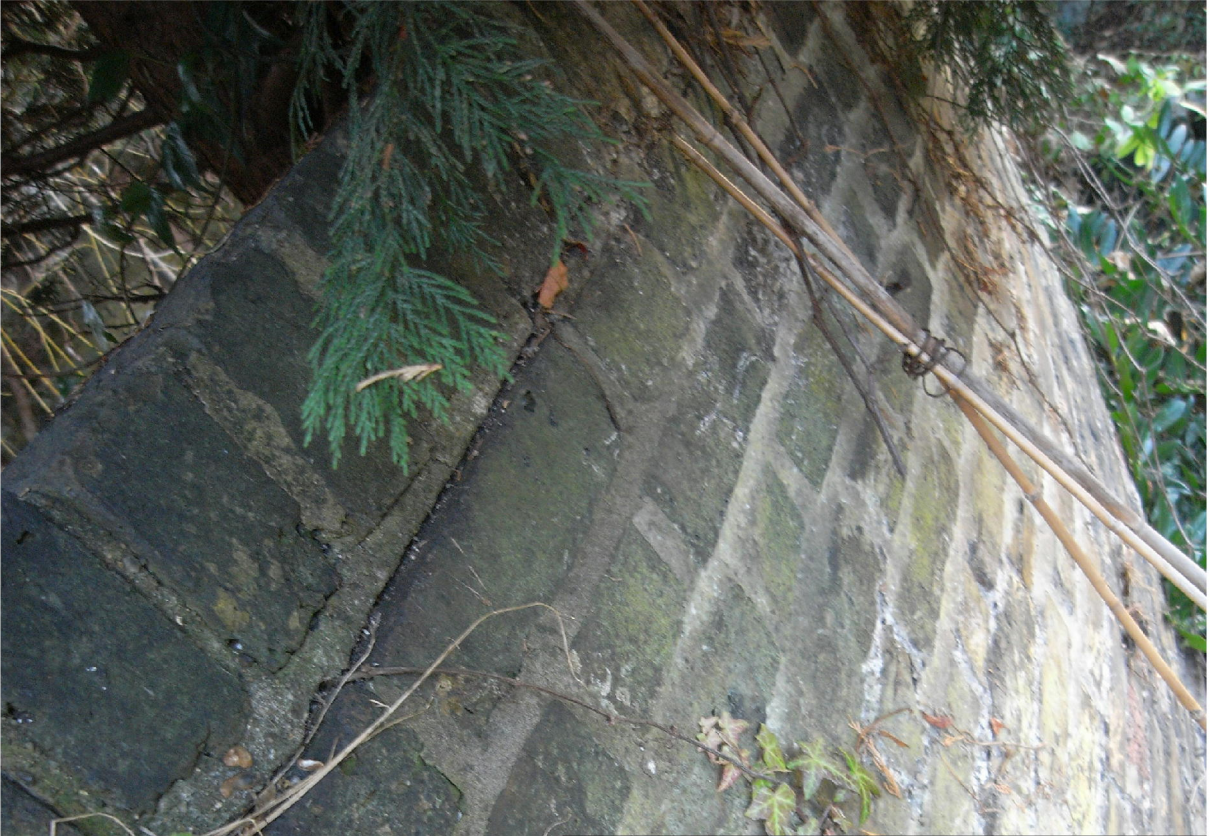
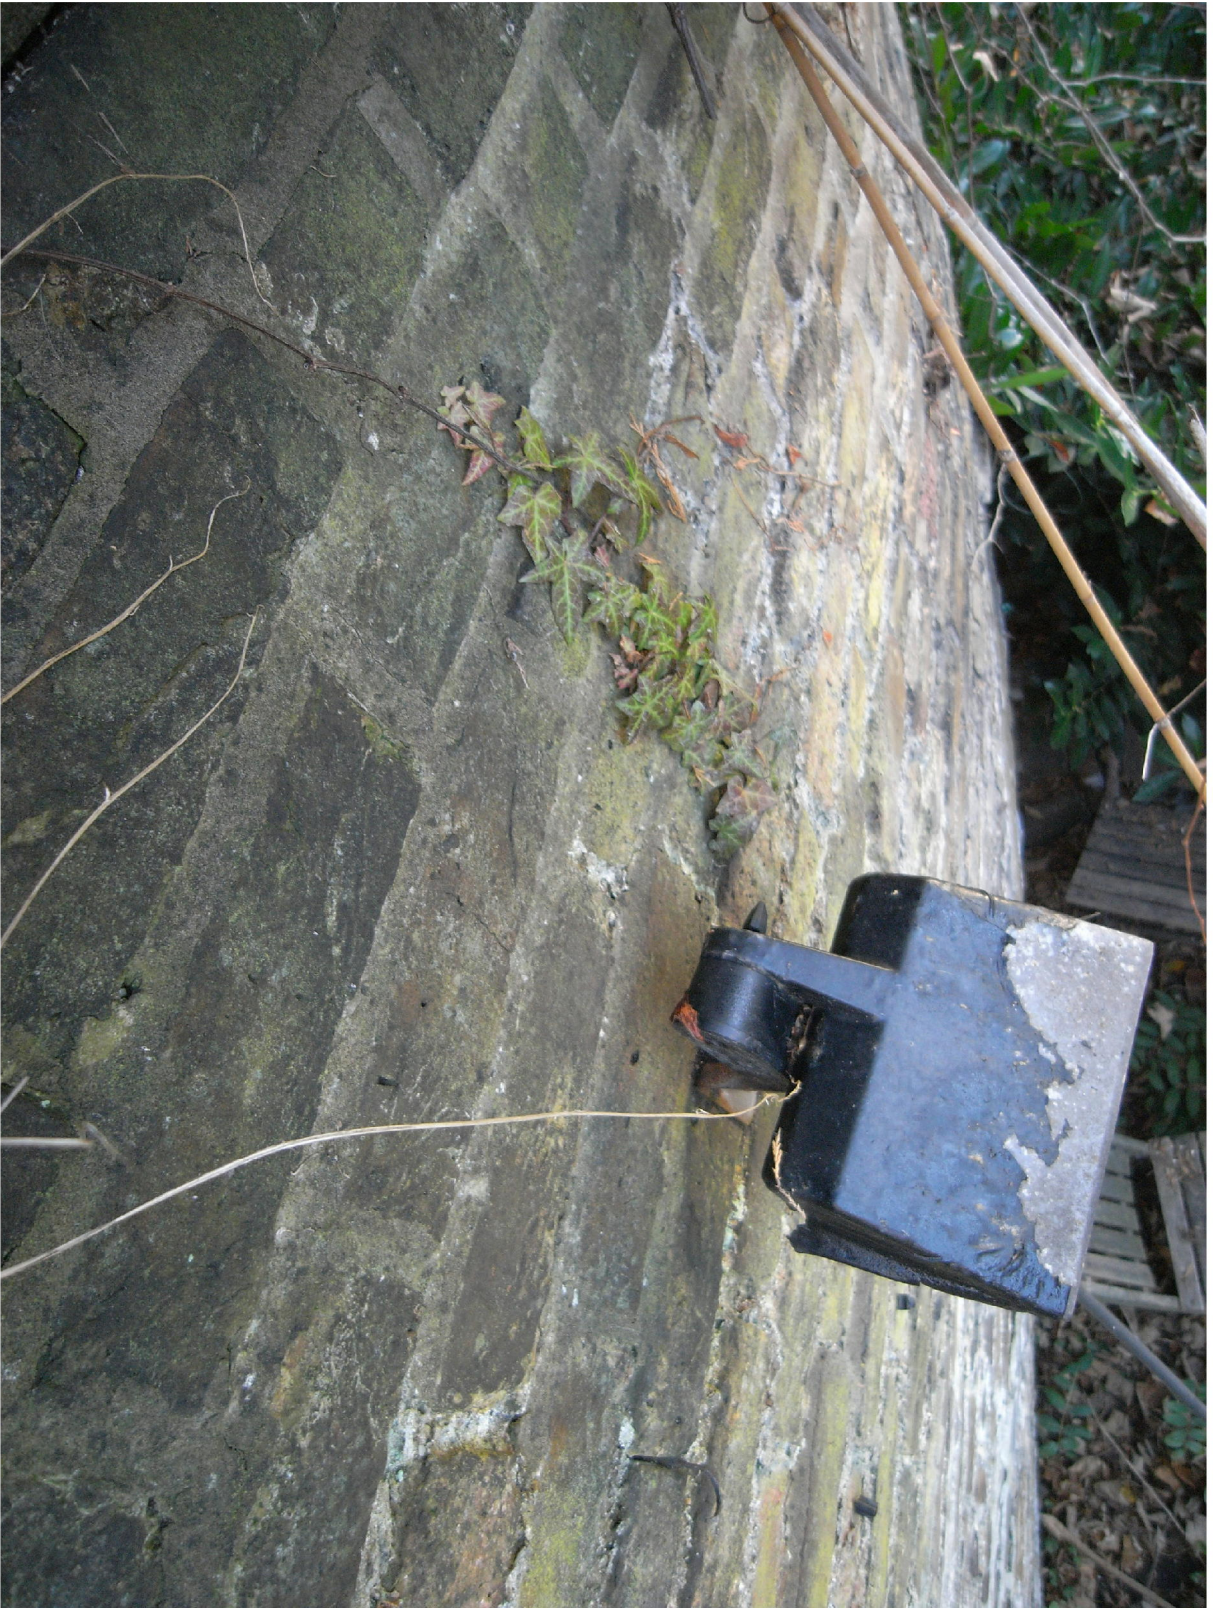
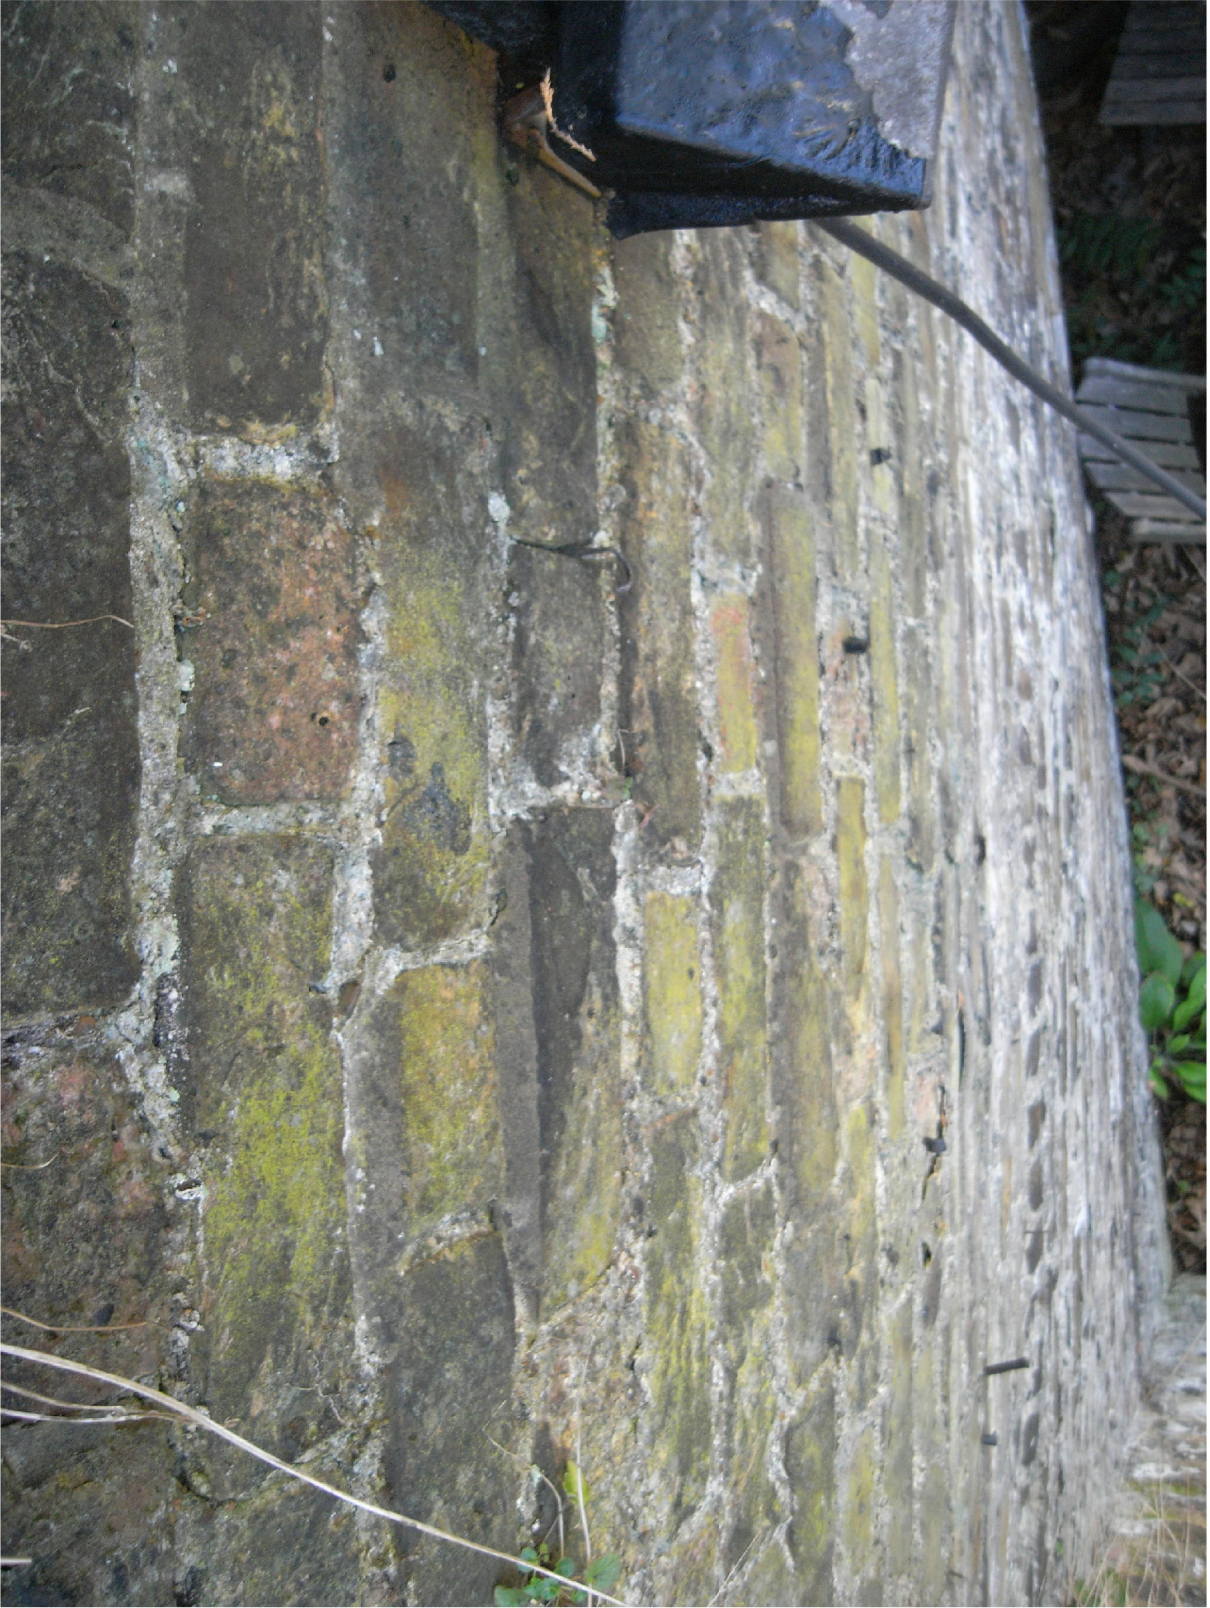
It's unfair to blame tree roots for th. Overall the wall looks relatively sound. The section above the level where it retains soil is obviously leaning towards my shed, which was the main problem at the time Camden Council started writing letters to my landlord. There is obviously some soil movement. However the location of where soil movement is causing the wall to lean towards my shed is so far from the tree it cannot reasonably be attributed to roots interference from the TPO'd Sycamore

Shortly after construction Gladys Rd properties cut a wedge into the uphill slope. This took place several years before Hilltop Road properties were constructed. Land registry data of title No 282530 also includes restrictive covenant for 6 Gladys Rd which mentions a wall height of min 5 ft and max 6 ft. The present wall is almost twice that height.

Owners of Gladys Rd properties owe a duty of care to prevent any such damage, especially since the retaining wall is supporting the higher ground.
