Photos 13,14,15

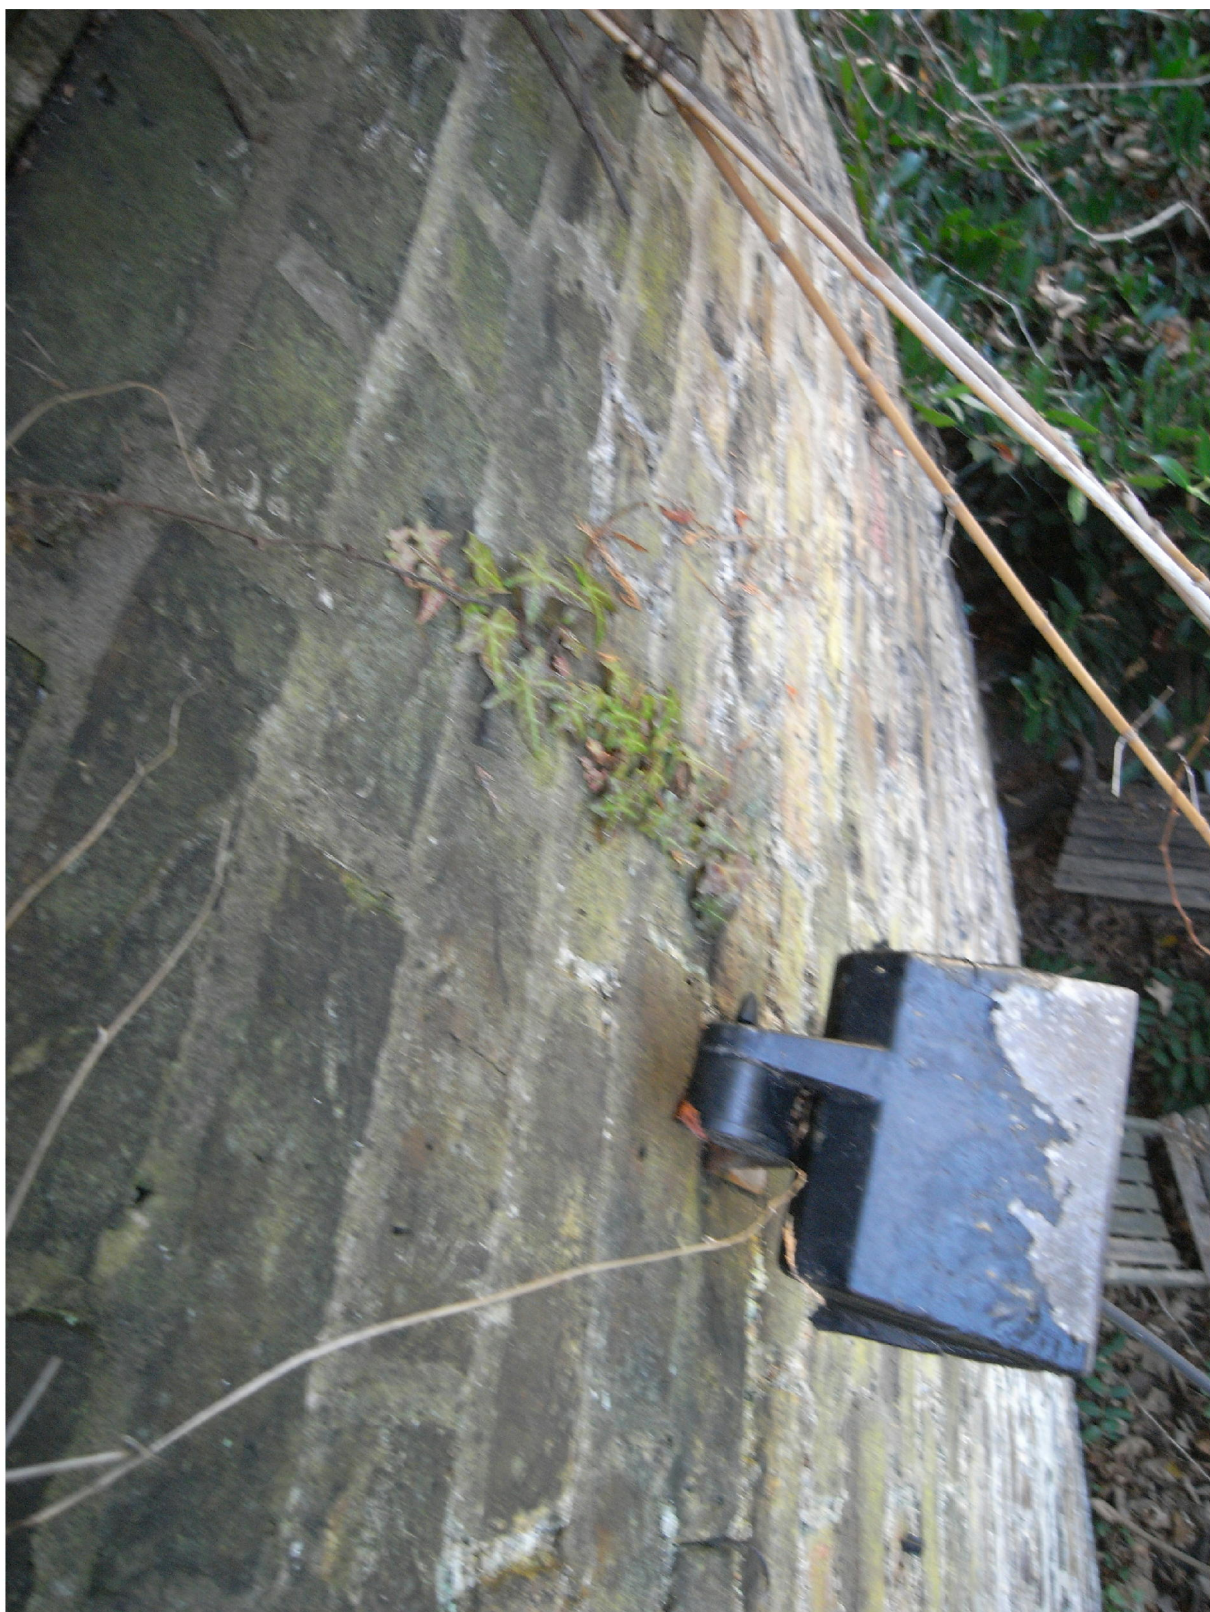
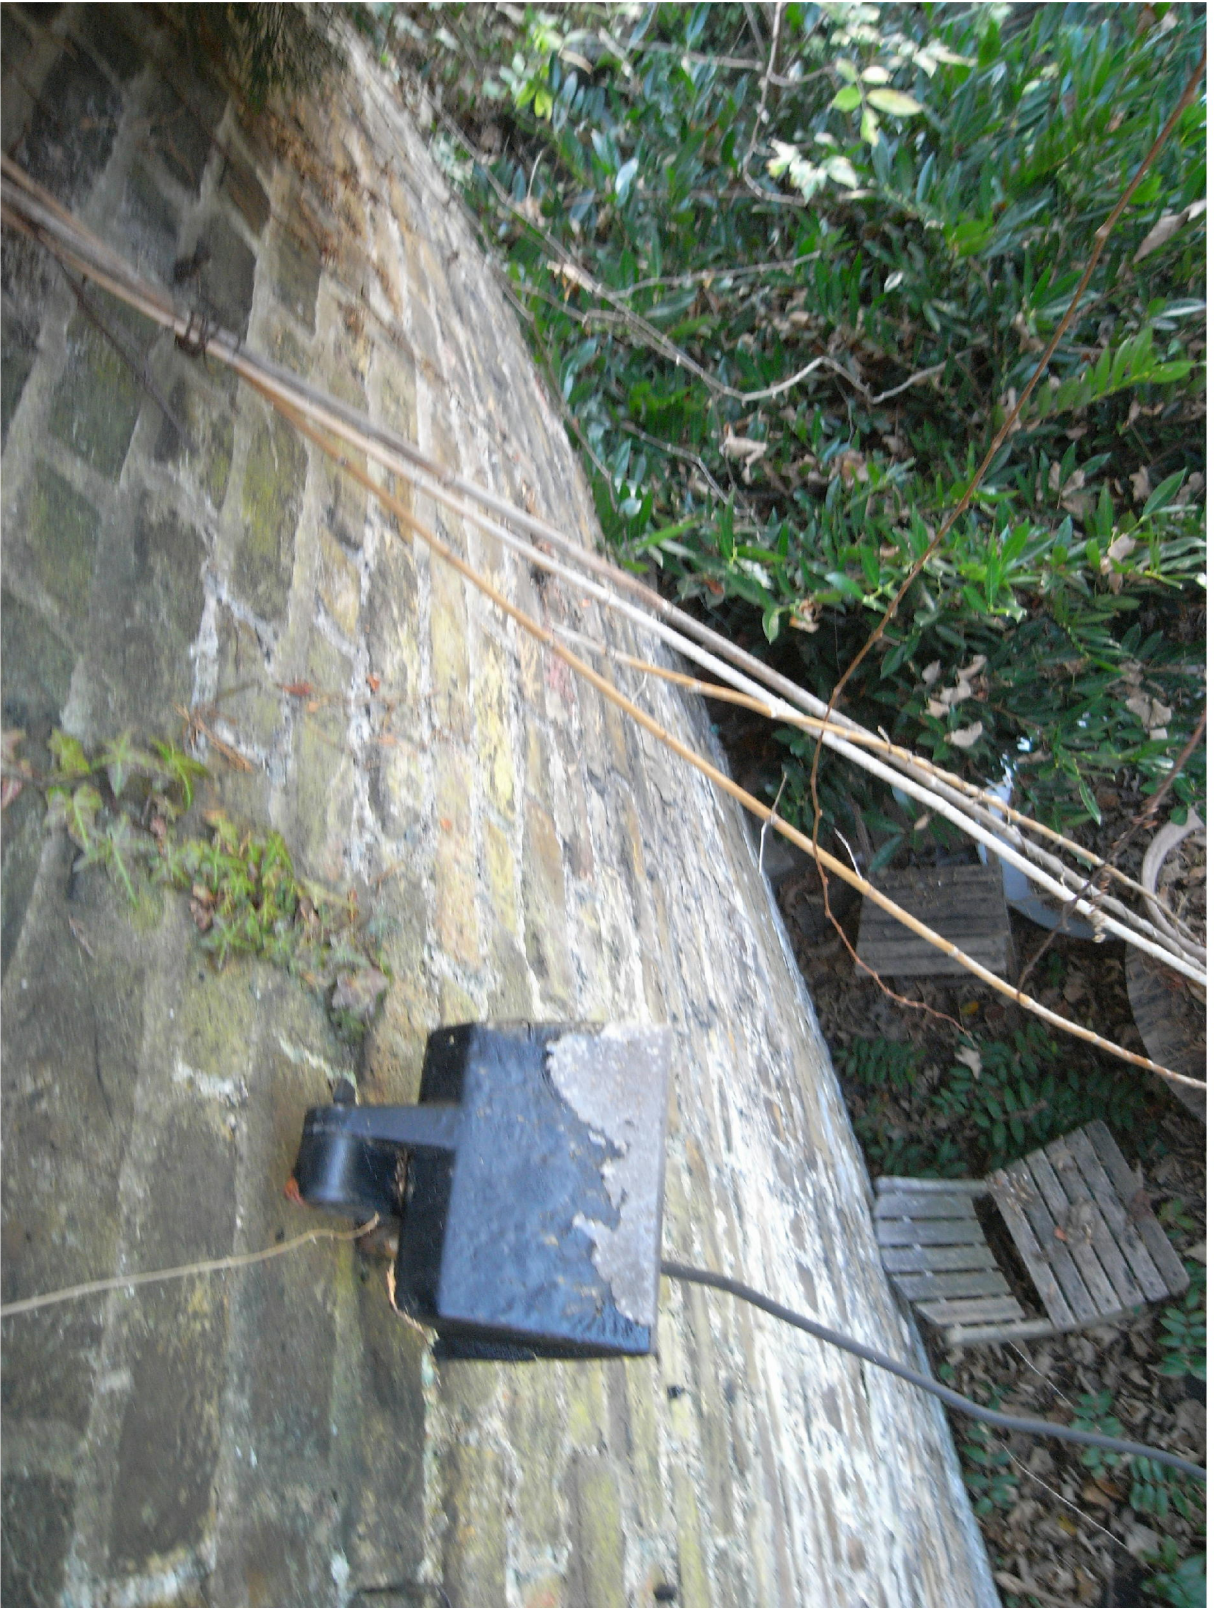
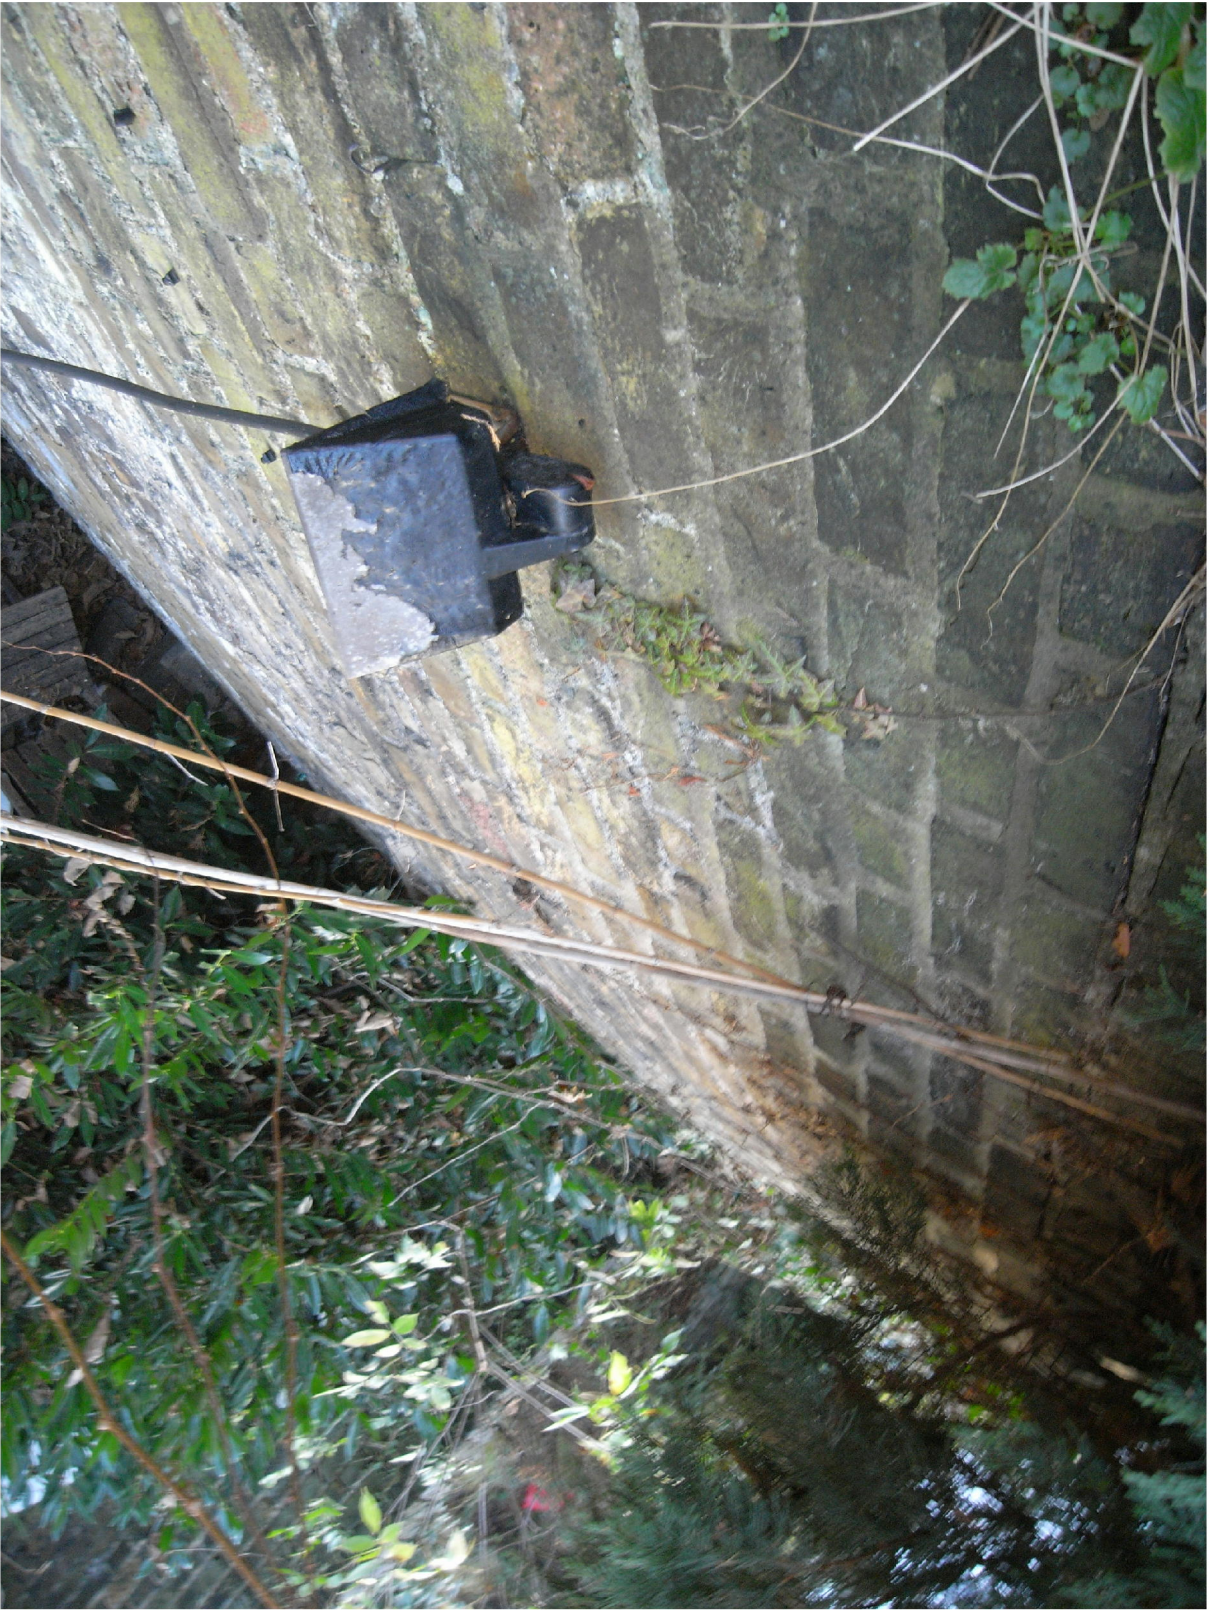
Pls find attached photos which I took today of the retaining wall showing the side of 6 Gladys Rd. There is only very minor bulging. Damaged brickwork can clearly be seen near the top of the wall, mostly where Ivy and Buddleya have been spreading roots for many years.

It's unfair to blame tree roots for th. Overall the wall looks relatively sound. The section above the level where it retains soil is obviously leaning towards my shed, which was the main problem at the time Camden Council started writing letters to my landlord. There is obviously some soil movement. However the location of where soil movement is causing the wall to lean towards my shed is so far from the tree it cannot reasonably be attributed to roots interference from the TPO'd Sycamore
