Photos 16,17,18

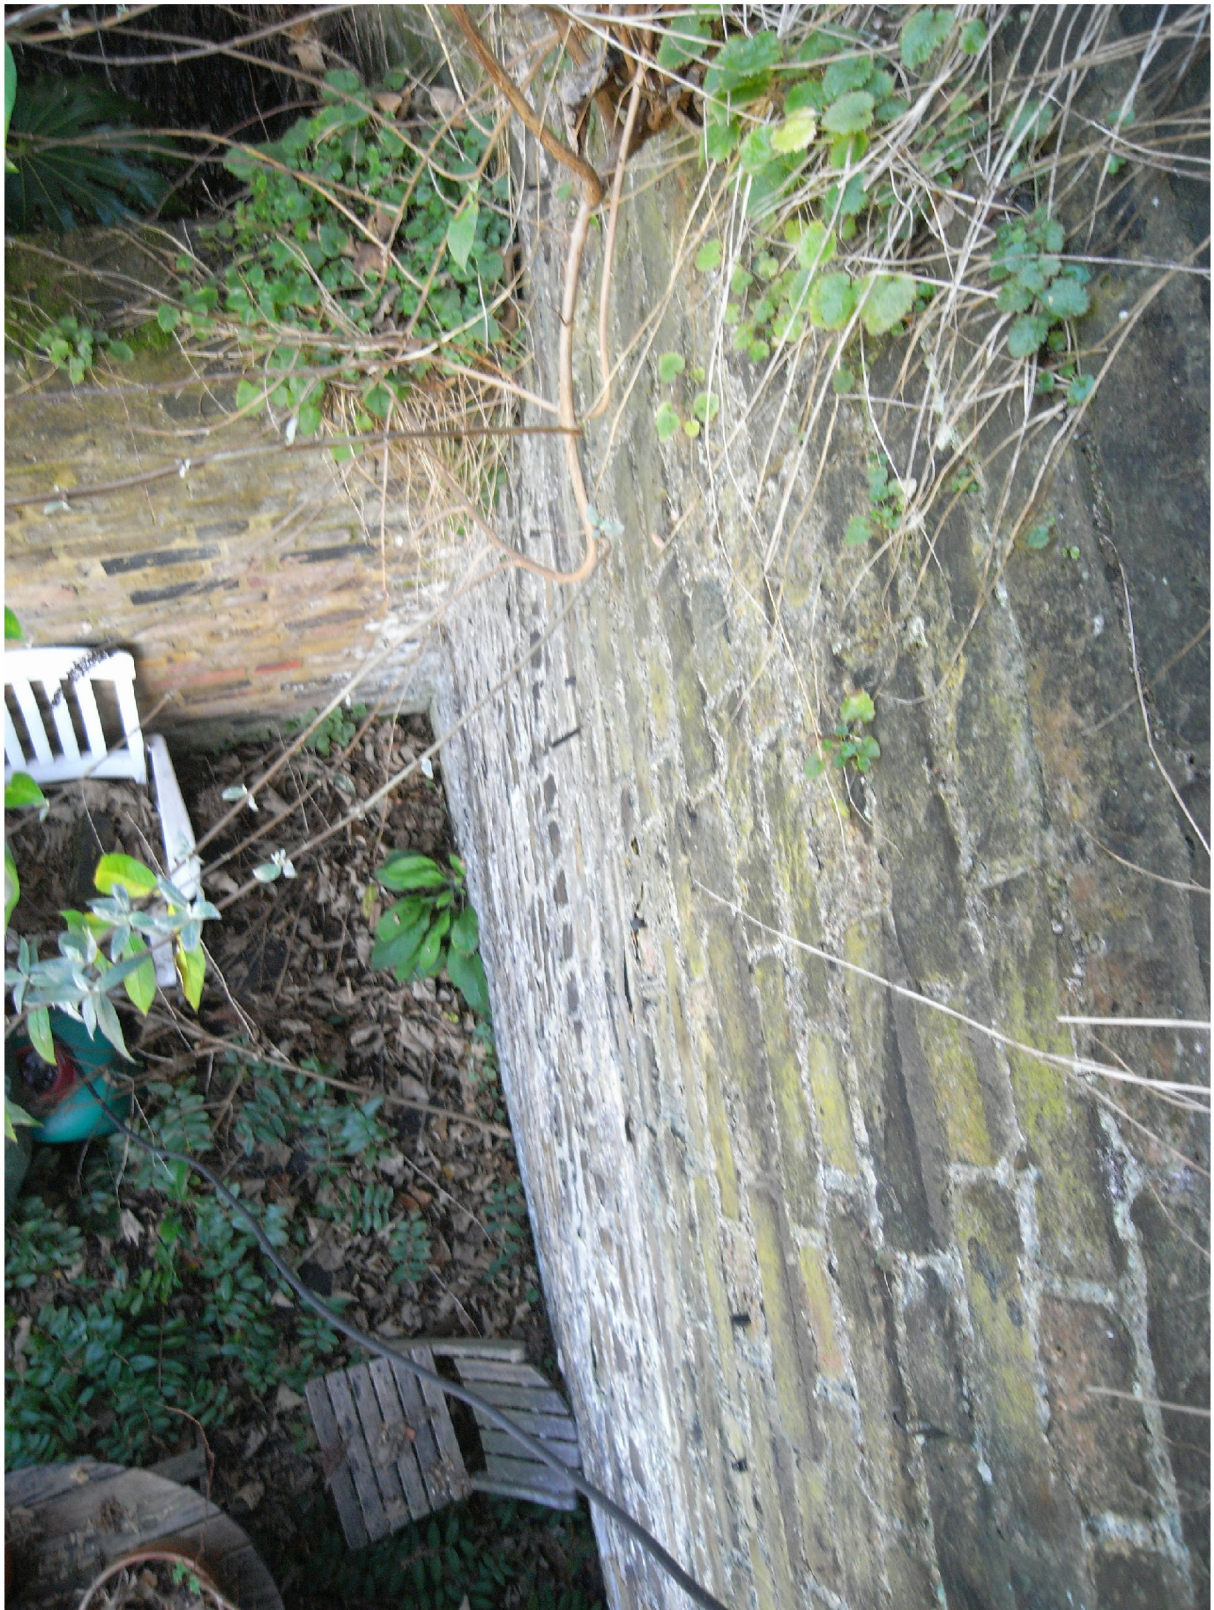
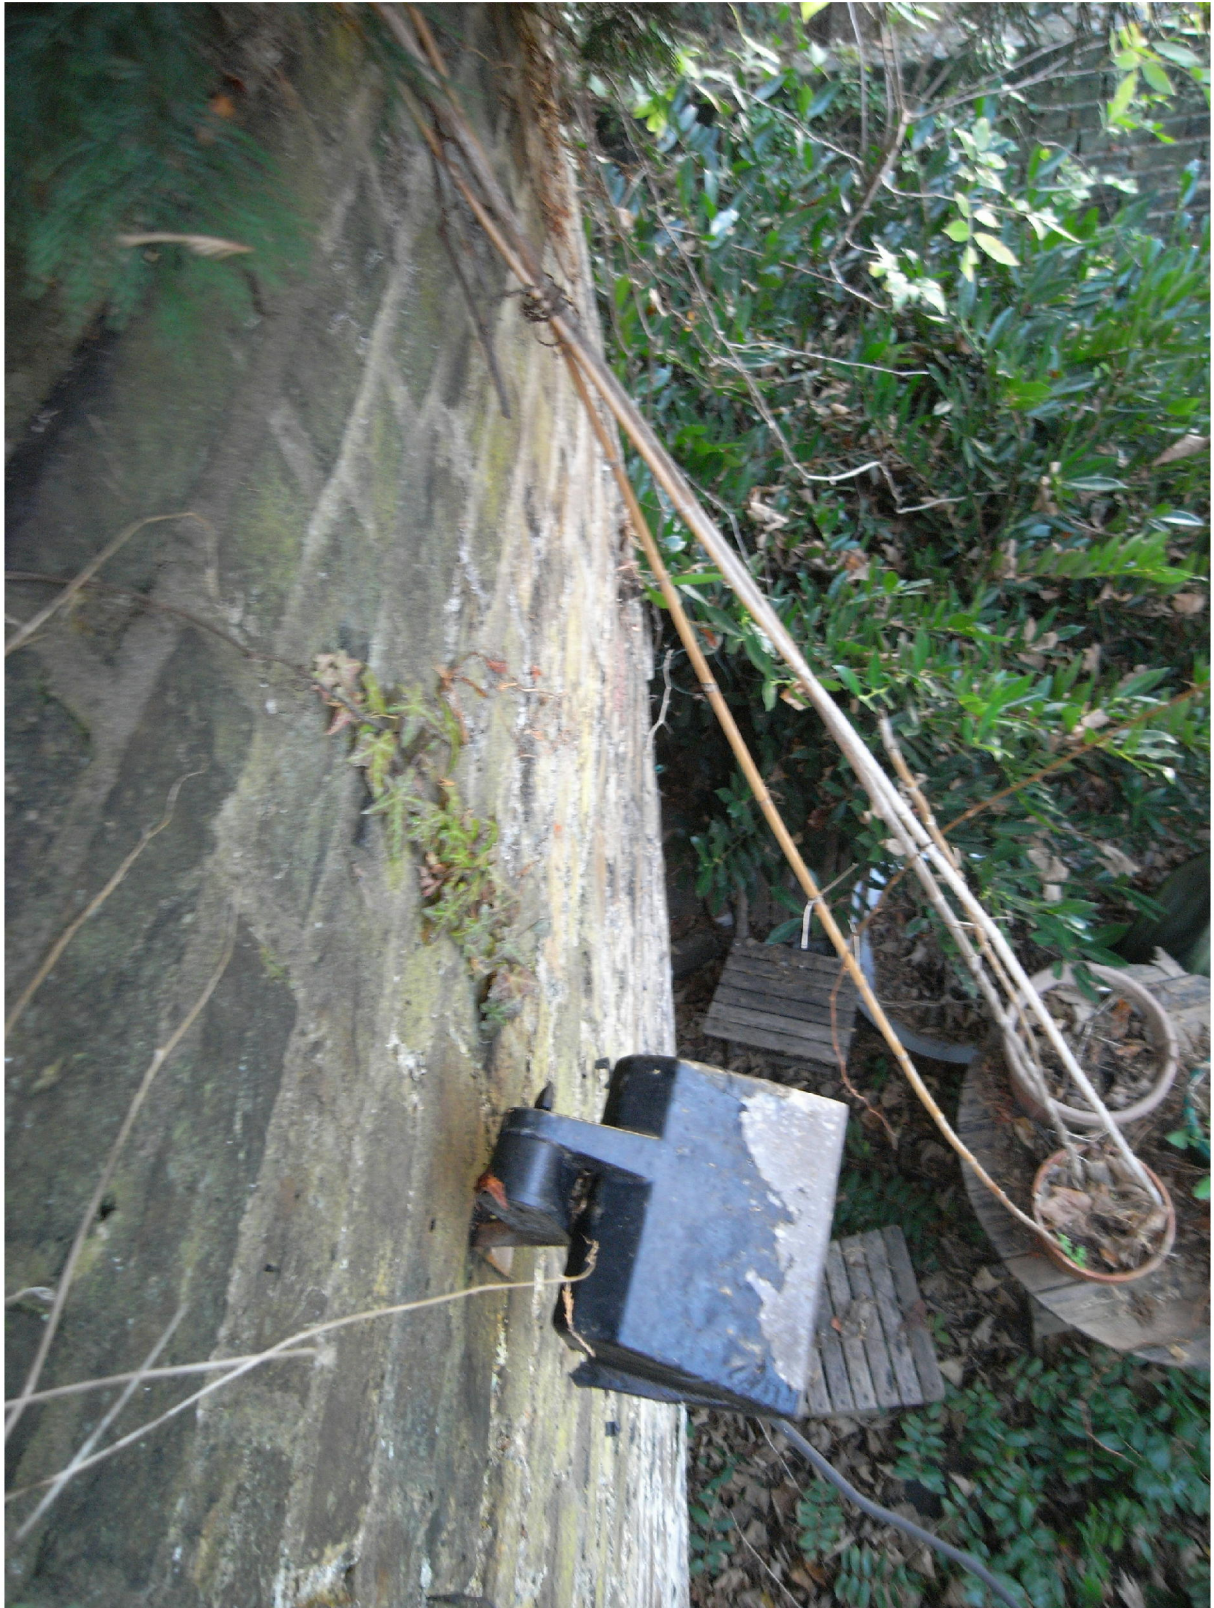
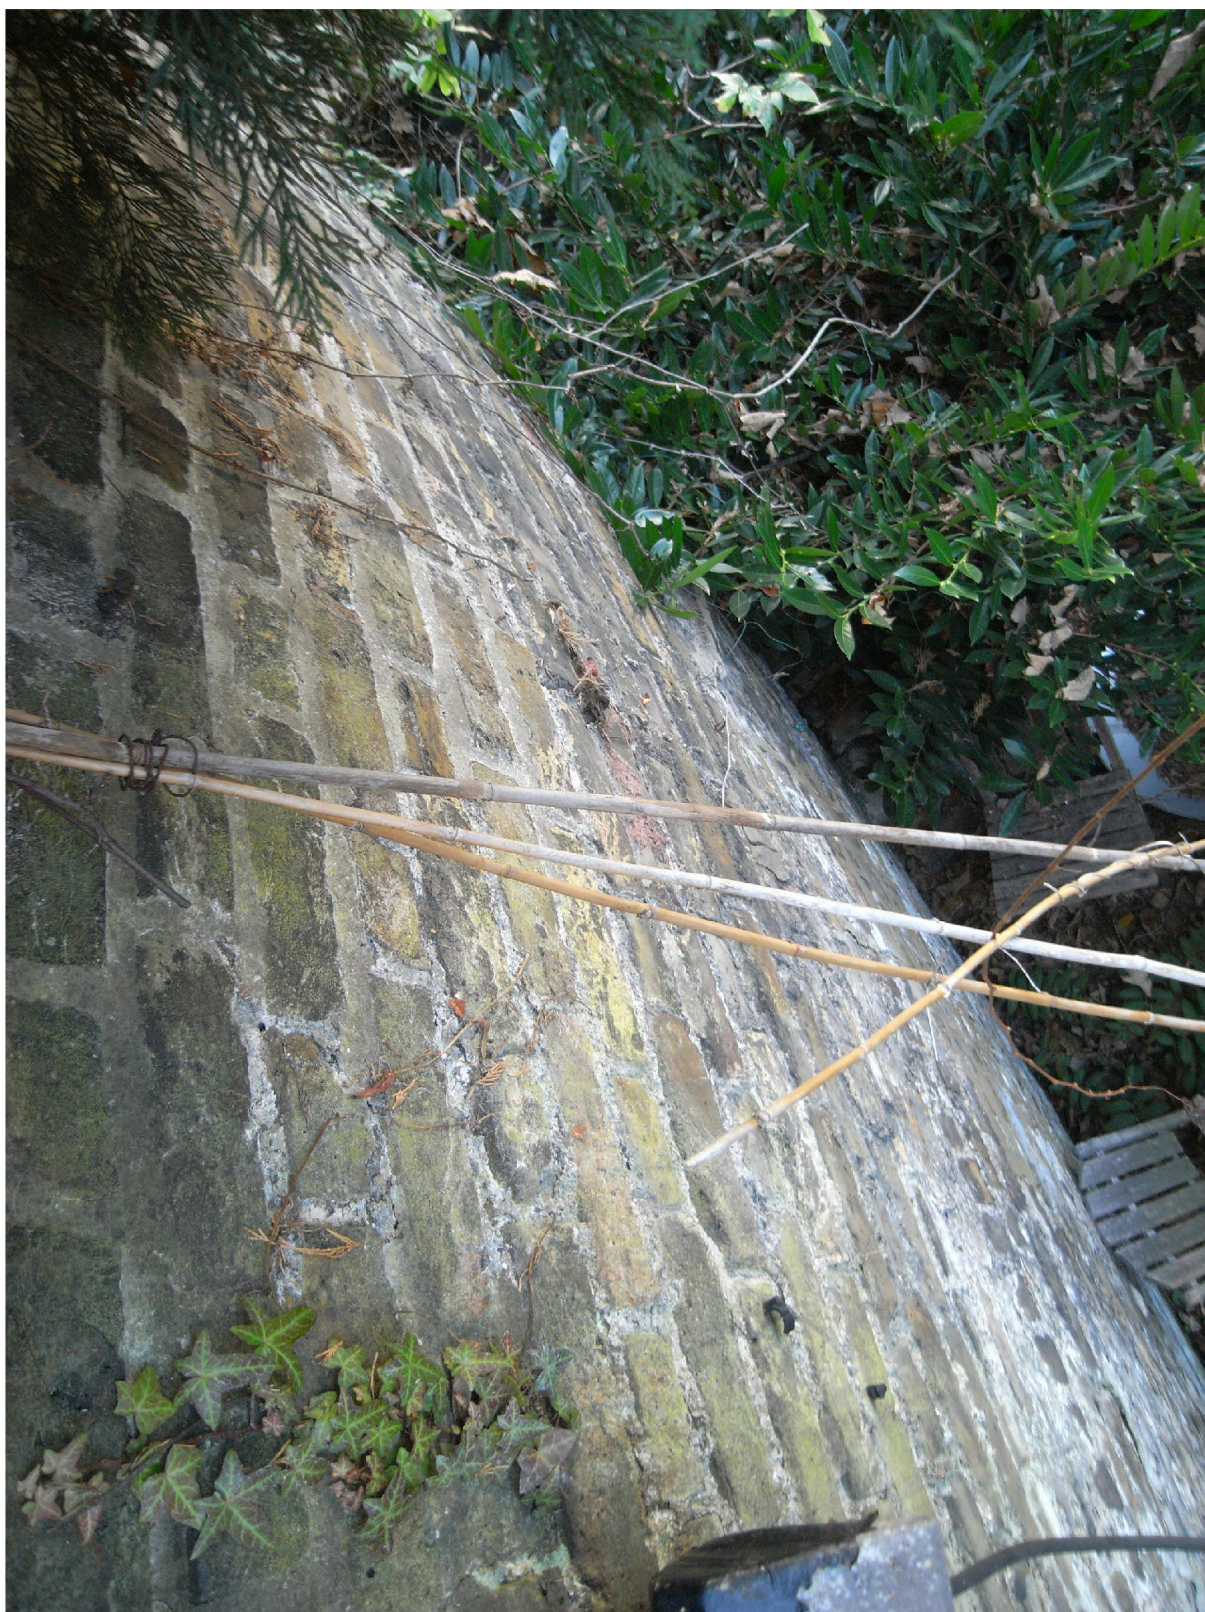
Pls find attached photos which I took today of the retaining wall showing the side of 6 Gladys Rd. There is only very minor bulging. Damaged brickwork can clearly be seen near the top of the wall, mostly where Ivy and Buddleya have been spreading roots for many years.

It's unfair to blame tree roots for th. Overall the wall looks relatively sound. The section above the level where it retains soil is obviously leaning towards my shed, which was the main problem at the time Camden Council started writing letters to my landlord. There is obviously some soil movement. However the location of where soil movement is causing the wall to lean towards my shed is so far from the tree it cannot reasonably be attributed to roots interference from the TPO'd Sycamore

Shortly after construction Gladys Rd properties cut a wedge into the uphill slope. This took place several years before Hilltop Road properties were constructed. Land registry data of title No 282530 also includes restrictive covenant for 6 Gladys Rd which mentions a wall height of min 5 ft and max 6 ft. The present wall is almost twice that height.

Owners of Gladys Rd properties owe a duty of care to prevent any such damage, especially since the retaining wall is supporting the higher ground.
