Photos 4,5,6

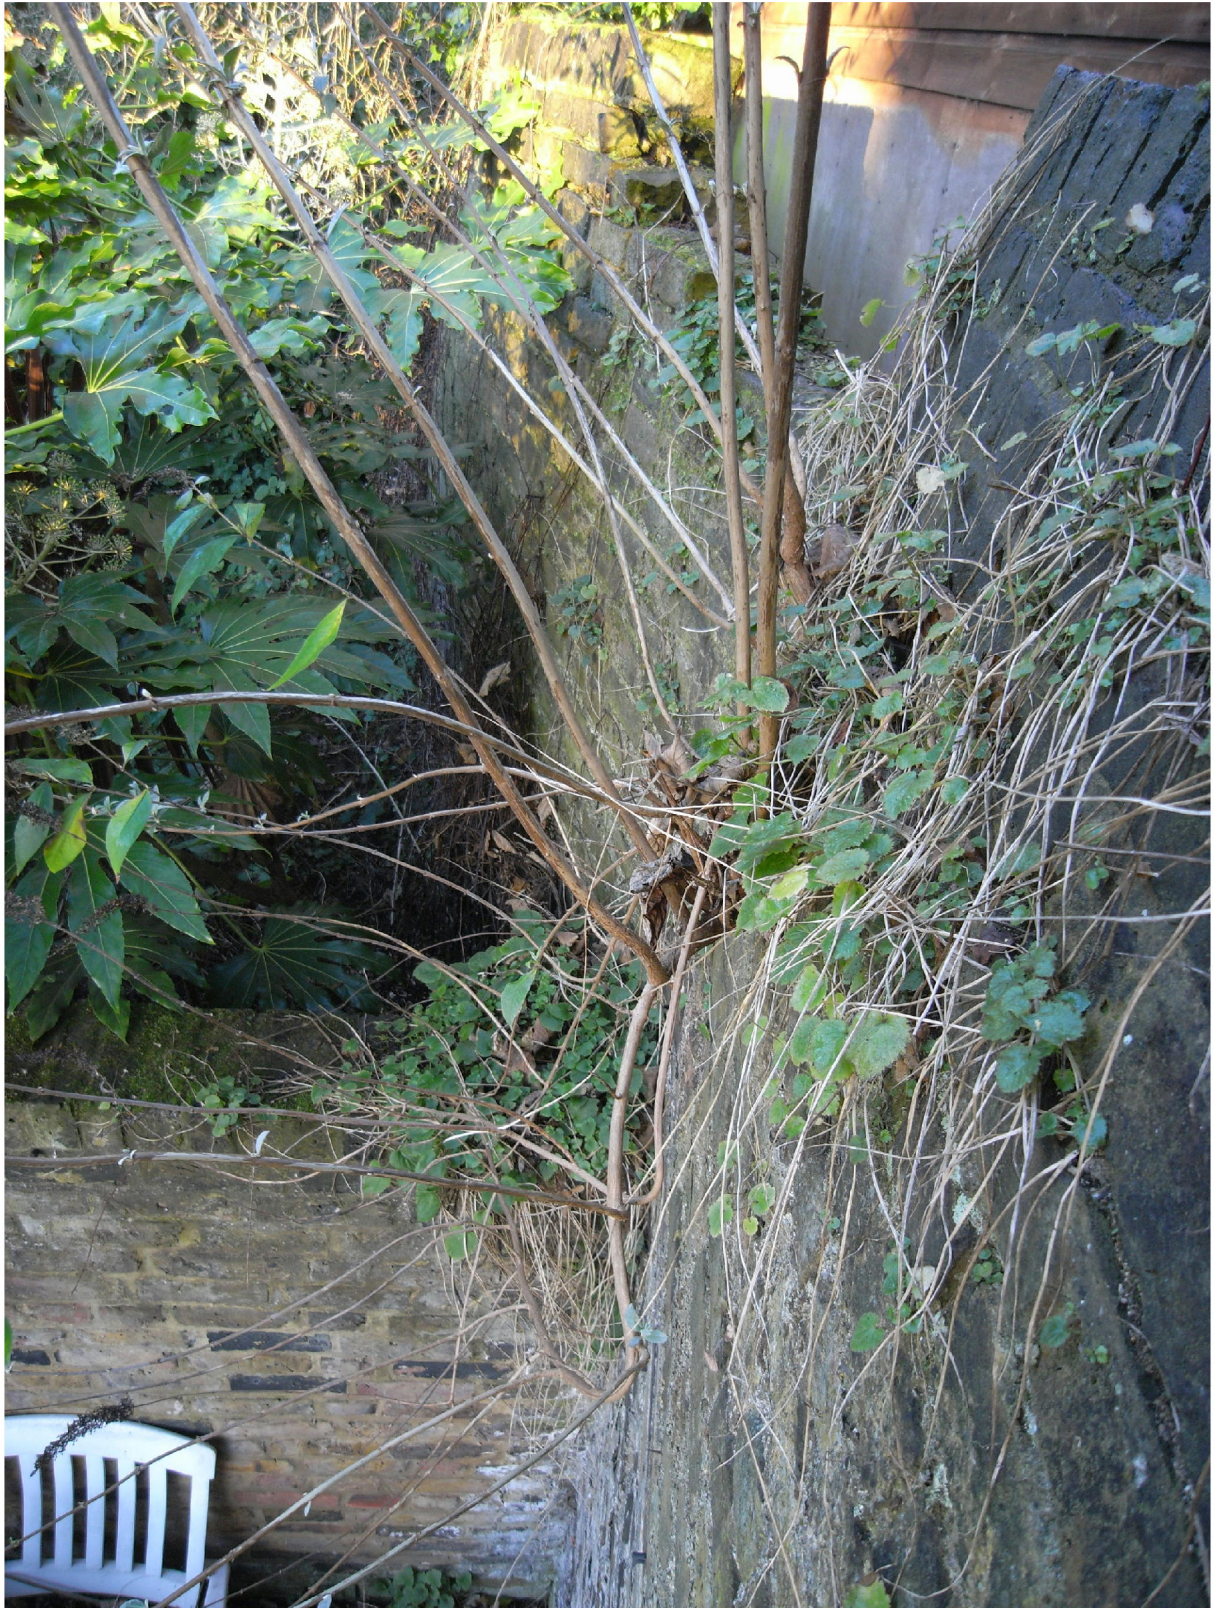
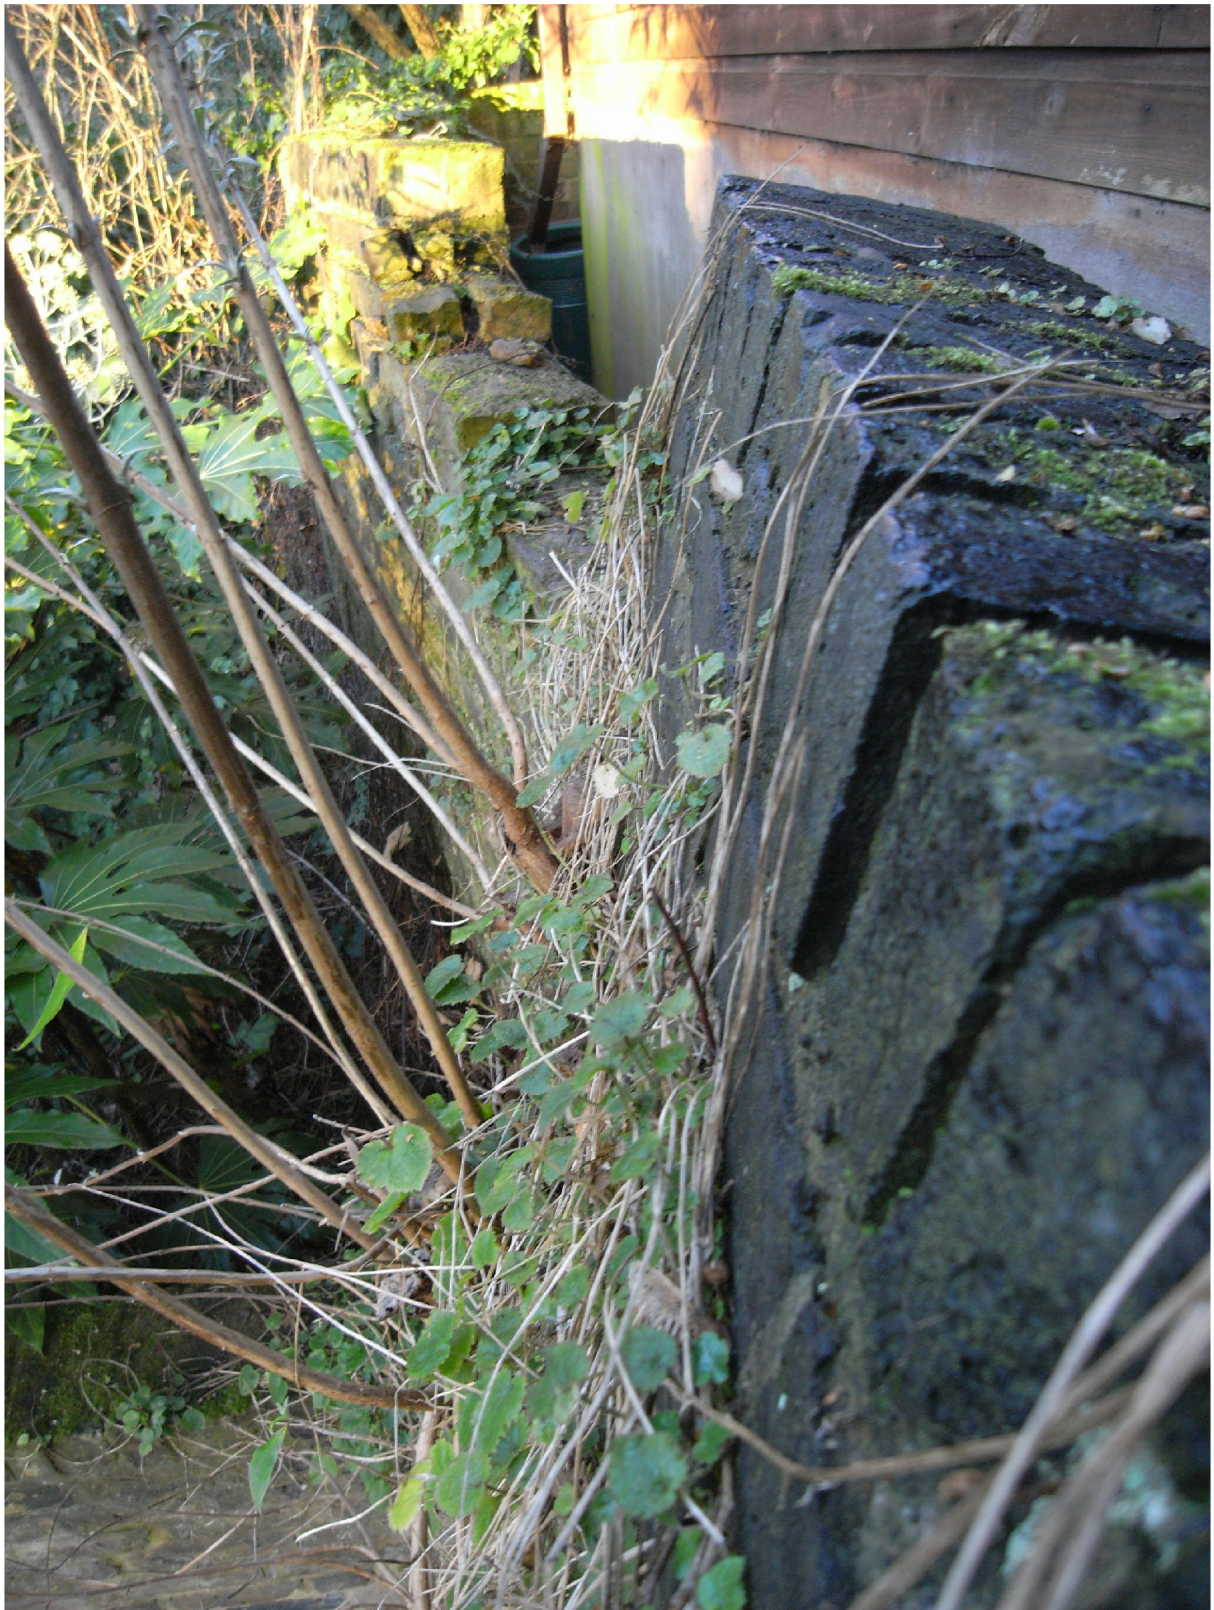
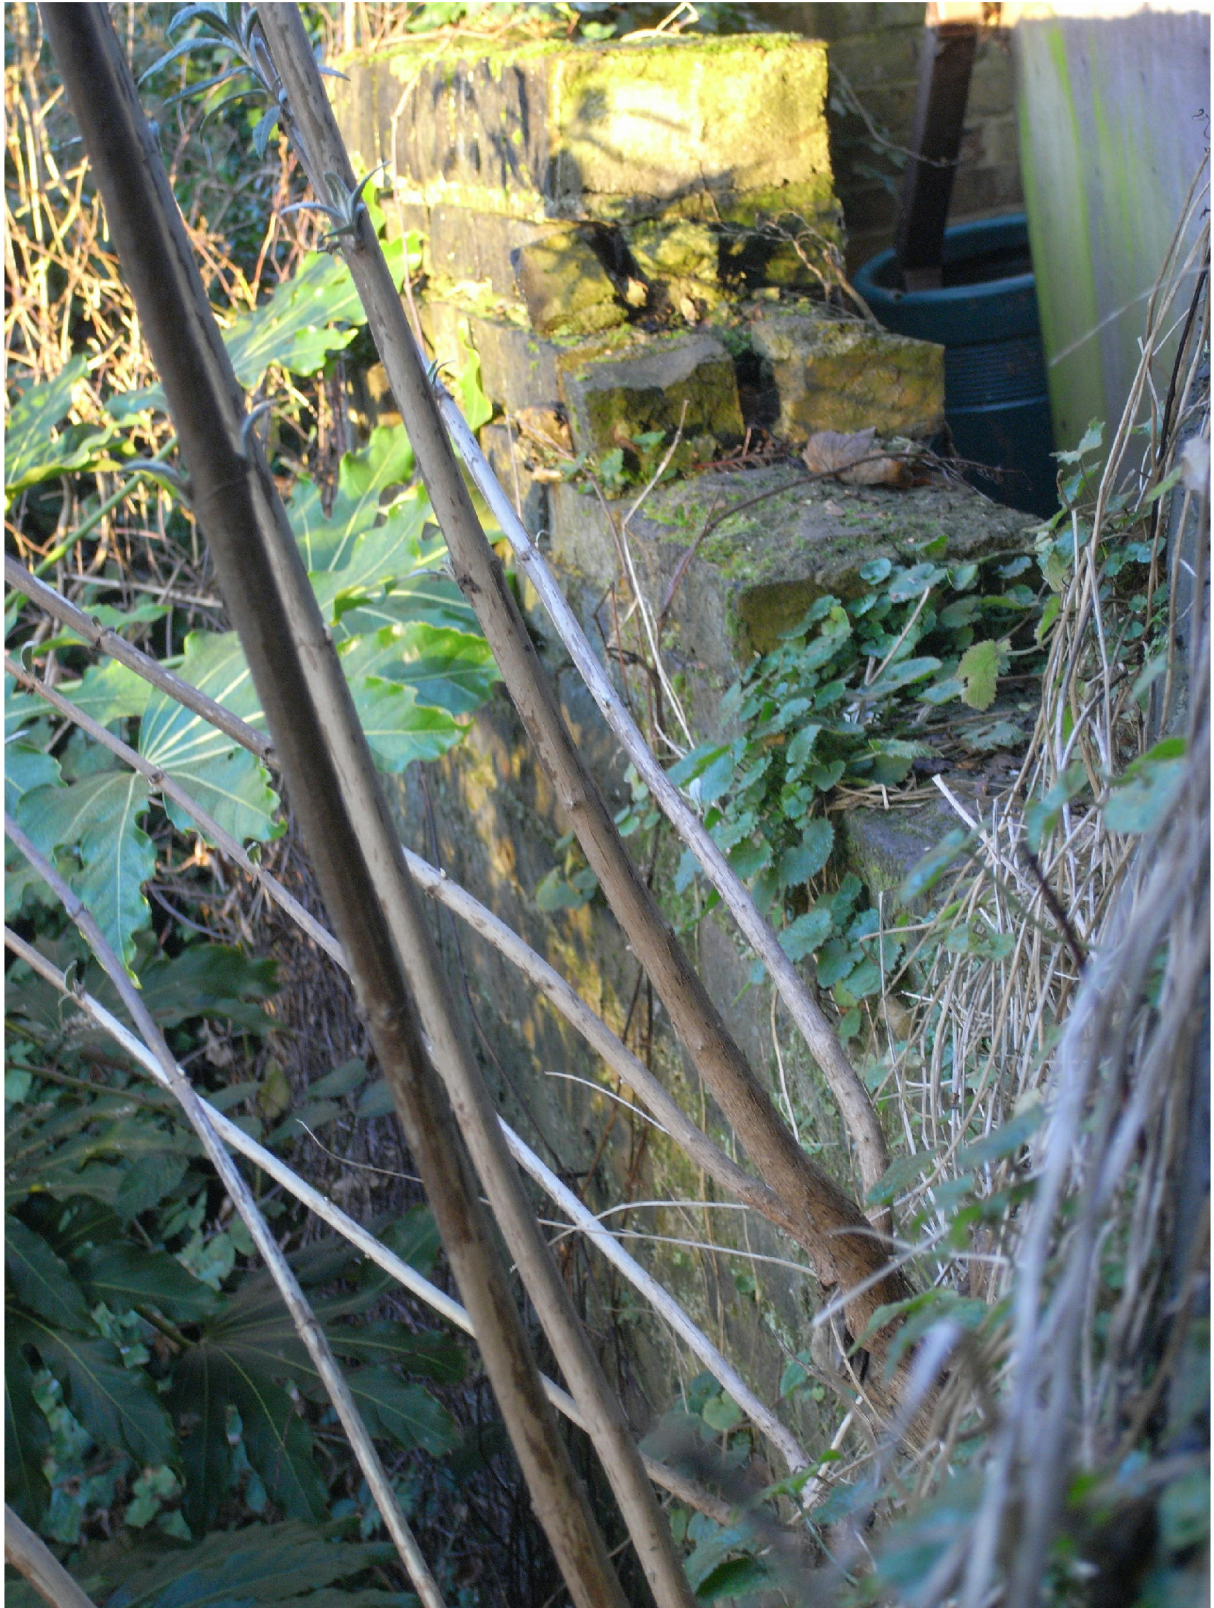
Pls find attached photos which I took today of the retaining wall showing the side of 6 Gladys Rd. There is only very minor bulging. Damaged brickwork can clearly be seen near the top of the wall, mostly where Ivy and Buddleya have been spreading roots for many years.

It's unfair to blame tree roots for th. Overall the wall looks relatively sound. The section above the level where it retains soil is obviously leaning towards my shed, which was the main problem at the time Camden Council started writing letters to my landlord. There is obviously some soil movement. However the location of where soil movement is causing the wall to lean towards my shed is so far from the tree it cannot reasonably be attributed to roots interference from the TPO'd Sycamore

Shortly after construction Gladys Rd properties cut a wedge into the uphill slope. This took place several years before Hilltop Road properties were constructed. Land registry data of title No 282530 also includes restrictive covenant for 6 Gladys Rd which mentions a wall height of min 5 ft and max 6 ft. The present wall is almost twice that height.
