Photos 1-3

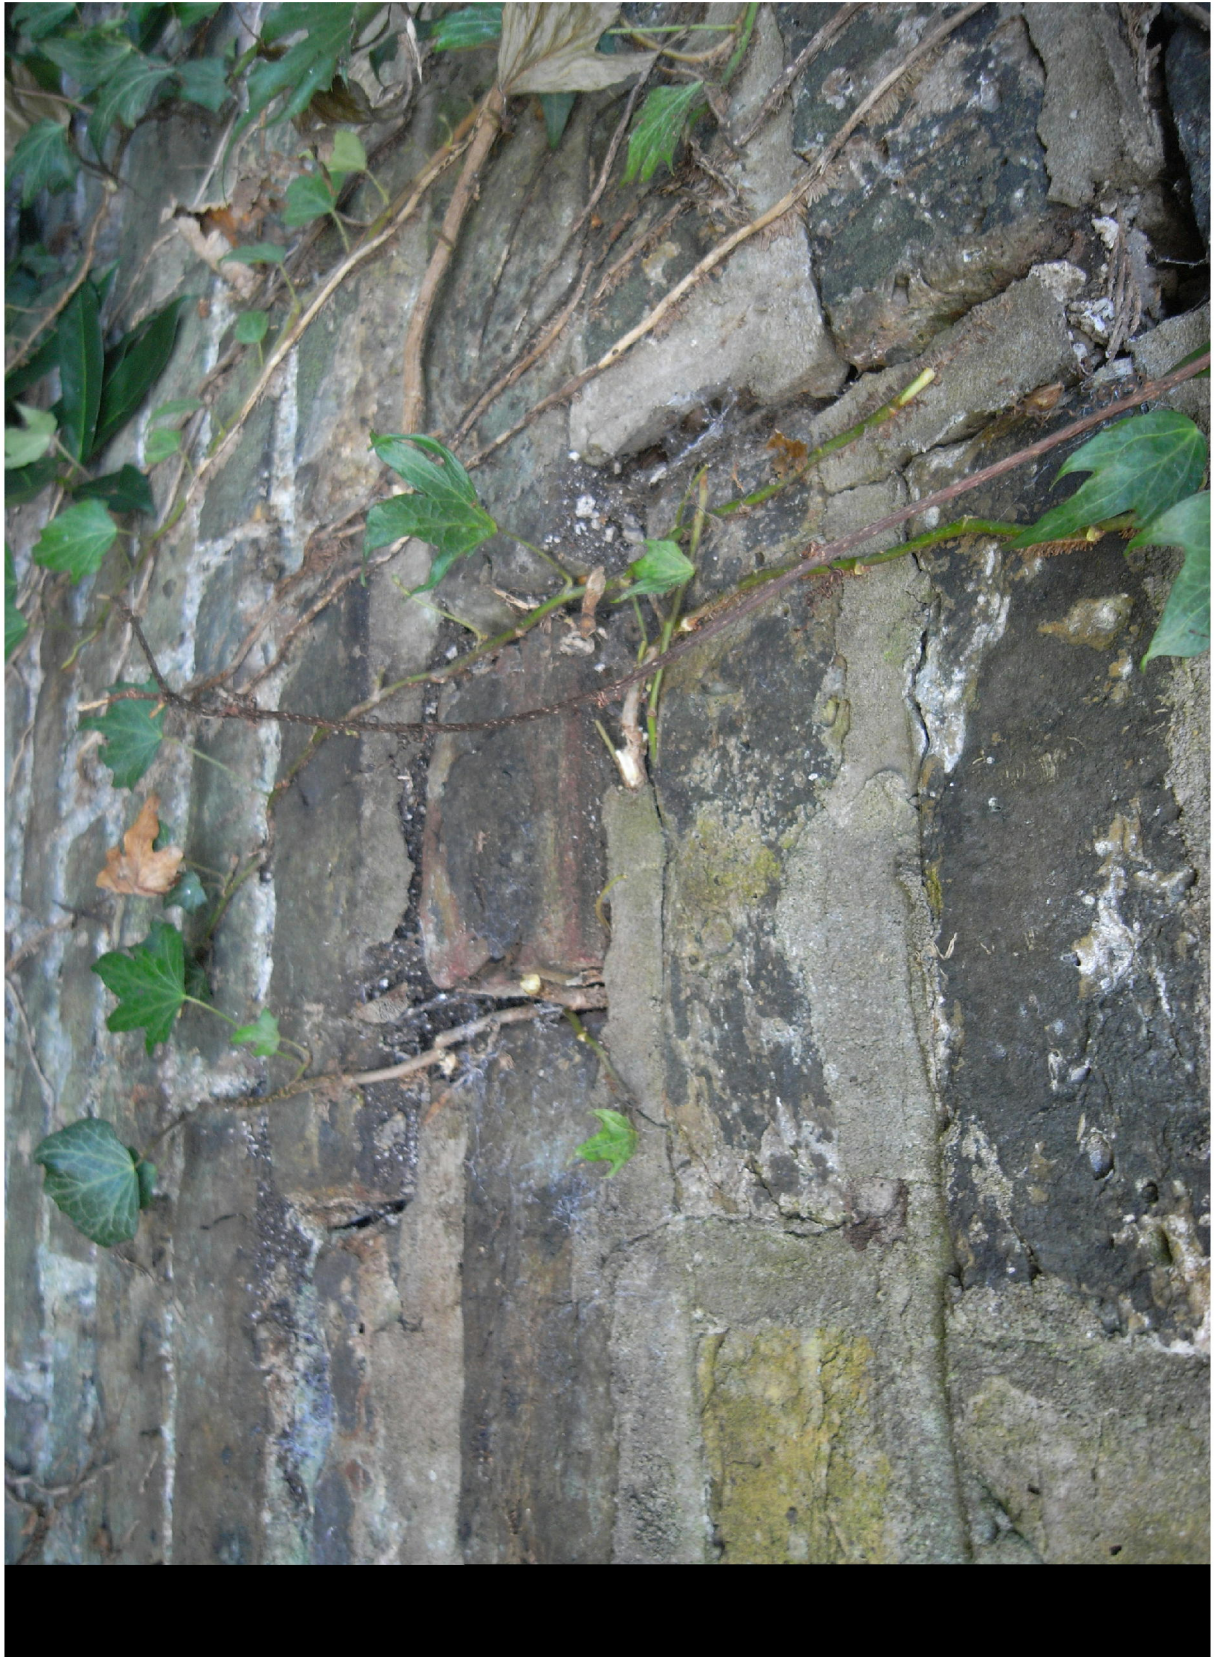
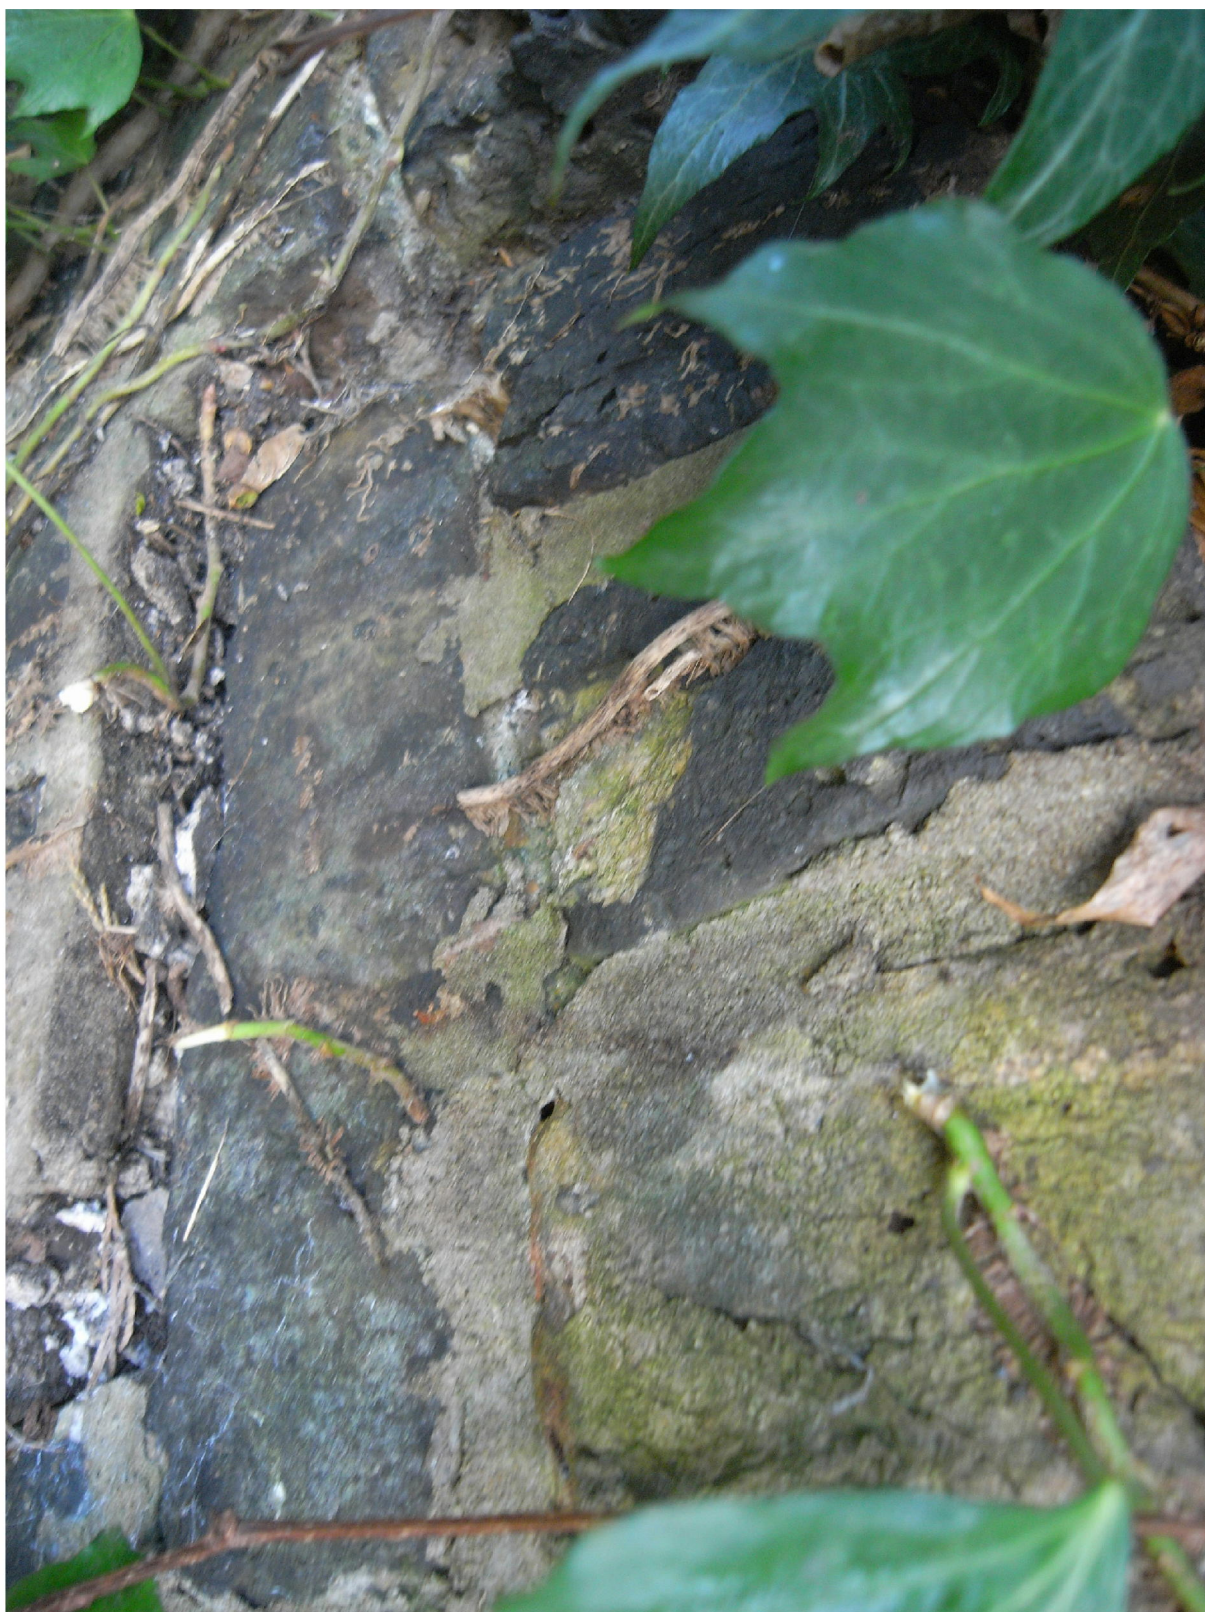
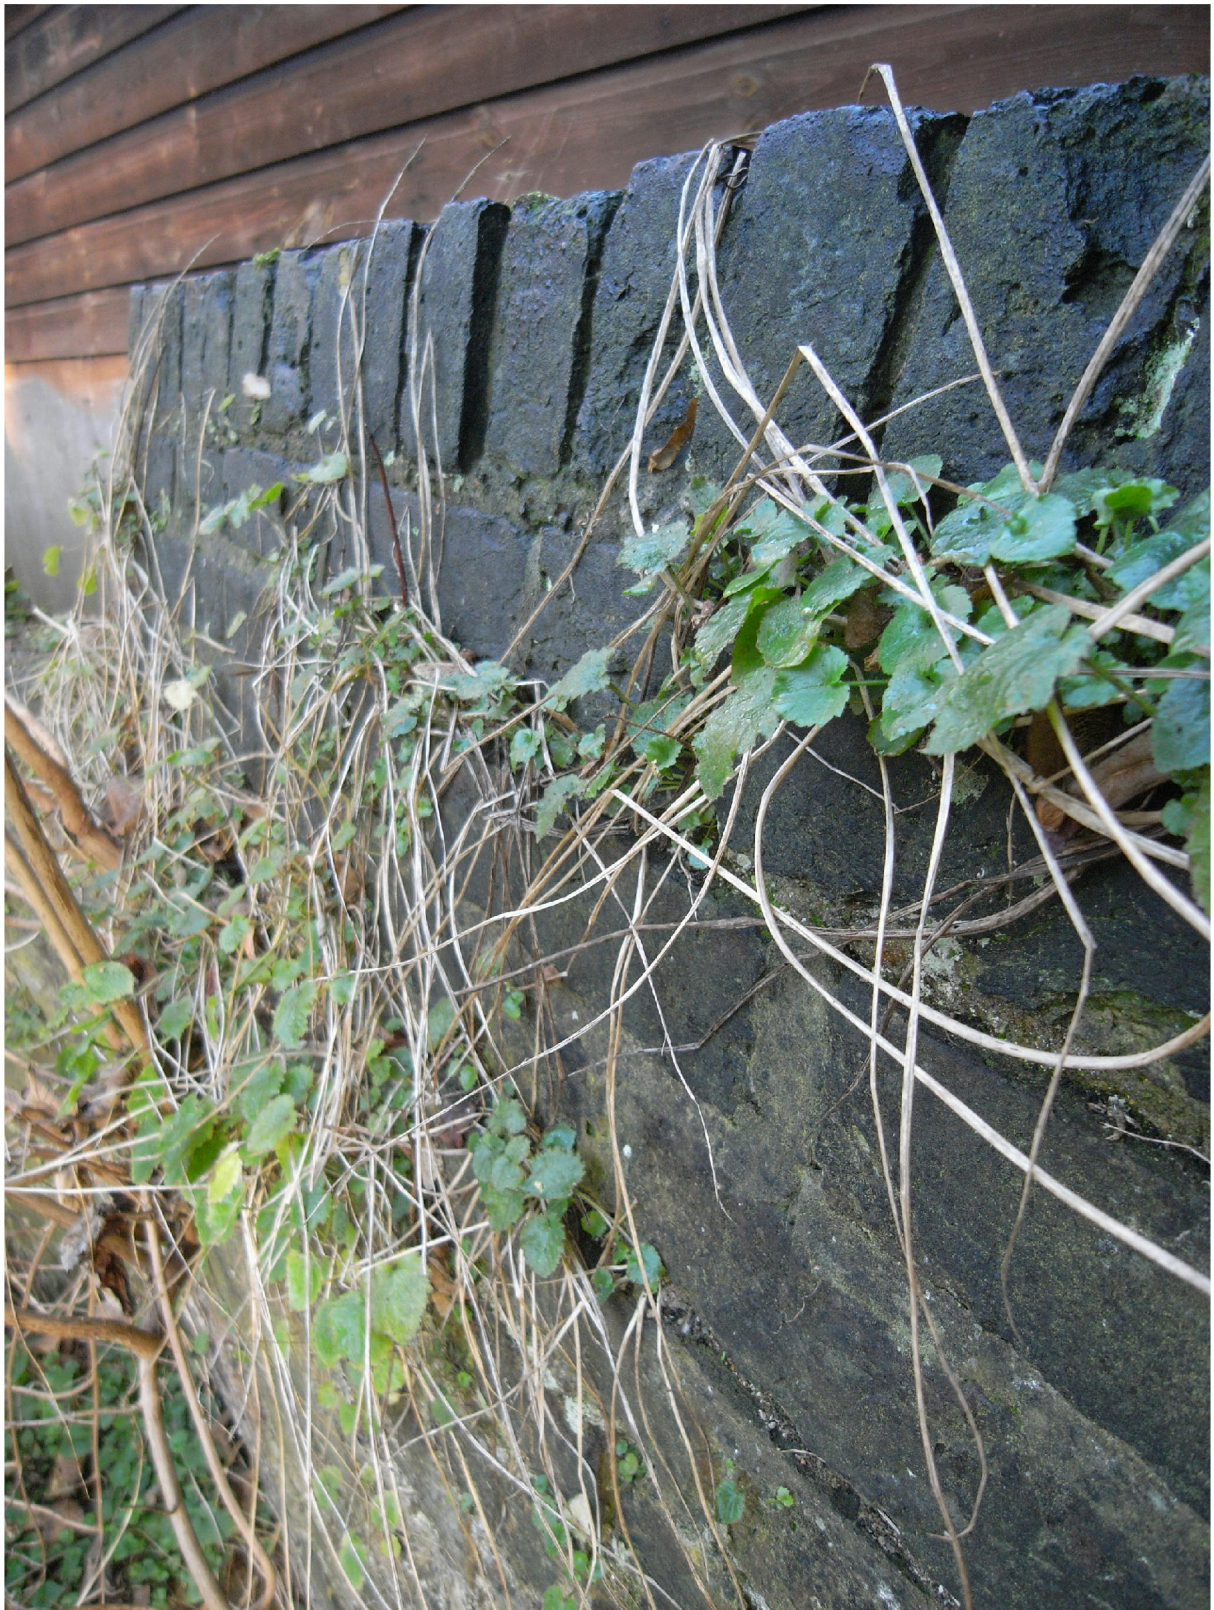
Pls find attached photos which I took today of the retaining wall showing the side of 6 Gladys Rd. There is only very minor bulging. Damaged brickwork can clearly be seen near the top of the wall, mostly where Ivy and Buddleya have been spreading roots for many years.

It's unfair to blame tree roots for th. Overall the wall looks relatively sound. The section above the level where it retains soil is obviously leaning towards my shed, which was the main problem at the time Camden Council started writing letters to my landlord. There is obviously some soil movement. However the location of where soil movement is causing the wall to lean towards my shed is so far from the tree it cannot reasonably be attributed to roots interference from the TPO'd Sycamore

Shortly after construction Gladys Rd properties cut a wedge into the uphill slope. This took place several years before Hilltop Road properties were constructed. Land registry data of title No 282530 also includes restrictive covenant for 6 Gladys Rd which mentions a wall height of min 5 ft and max 6 ft. The present wall is almost twice that height.
