Arboricultural Report

Detailed Tree Inspection

15 Woburn Square
London
WC1H 0NS

15th December 2016

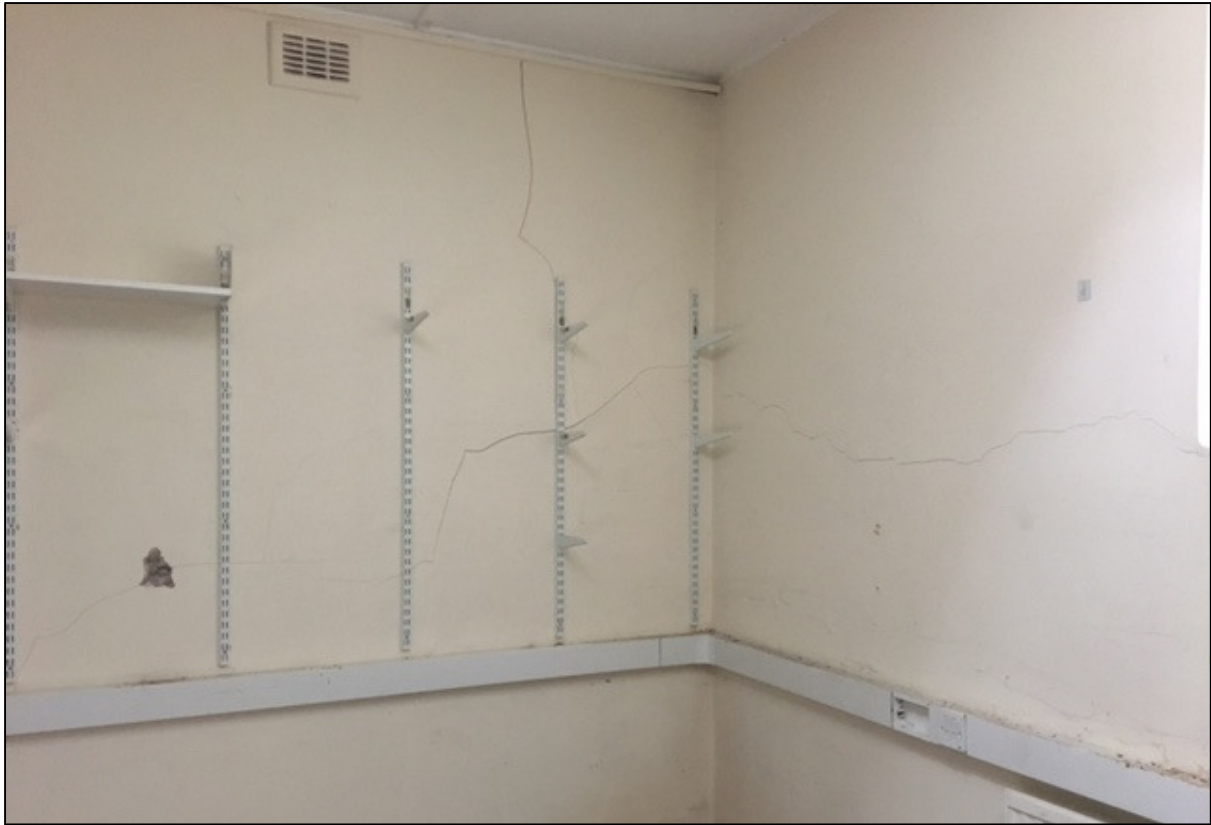
9.1 As stated in the structural report dated the 20th December 2016, the cracks appear to stem from a similar position to that of the external ground level. Associated to this, shown in Figure 1, the cracks on the wall are emanating from the precise location where the tree is located in the courtyard, 610mm from the external wall.

Figure 1: Damage to masonry in close proximity to tree located in court yard

9.2 With regards to the external ground level and the trees proximity of the wall, the cracks are stemming from an area where the tree will have produced its primary support and anchorage roots. These are the larger woody roots within the rooting framework, capable of causing the damage seen in figure 1.

9.3 Shown in figure 2 and 3, roots are growing directly towards the property and causing the soil to heave, indicating the presence of large roots within the immediate area of the damaged wall. Due to this observable root formation, it is likely the damage seen in figure 1 is the result of physical contact between the roots and the wall.

- 10.2** As stated in section 9.4, the tree has 20 to 25 years of growth potential. If the roots are causing the issue as suspected, the damage will continue to worsen. For this reason, it is advisable the tree is removed to ground level and the stump chemically treated.

- 10.4** To alleviate the risk of sudden, unpredictable soil movement, it is advisable the tree is removed in stages to slow the process of forces exerted on the wall. This course of action will additionally facilitate internal structural inspections to assess the condition of the wall.

The tree is to be removed to ground level and the stump chemically treated according to the following stages. All works are to be undertaken whilst the tree is dormant (during winter and autumn months):

Stage 1 – Reduce tree to 10 metres in height, equivalent to a 50% reduction of the overall trees height.

Stage 2 - After 2 growing seasons of completion of stage 1, (2 years) remove the tree to ground level and chemically treat stump to prevent any regrowth.

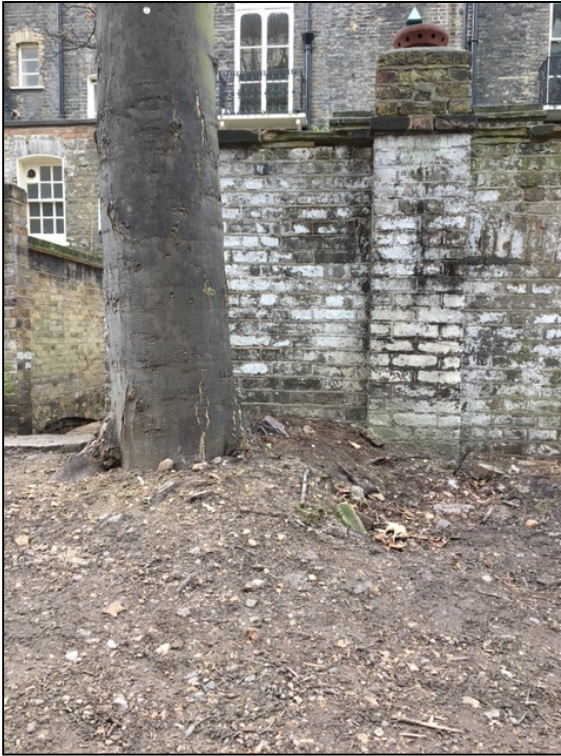
Figure 2: Soil heave indicating presence of large roots

9.6 Noted within the Geotechnical Interpretive Report dated June 2017, elements of shrinkable clay soils were identified within the soil structure in which the tree is situated. Although clay is a significant contributing factor with regards to arboricultural related property damages, the position of the roots (seen in figures 2, 3, A, C and E) are considerably more likely to be the cause of the damages.

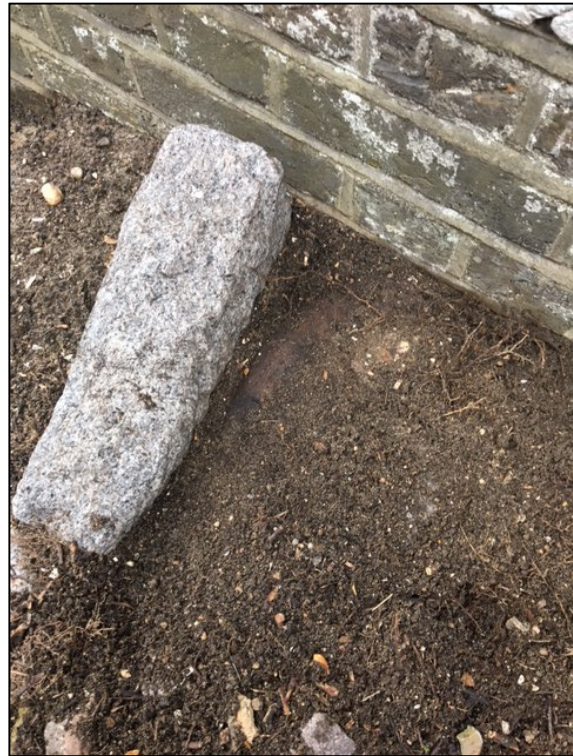
Figure 3: Root growing directly toward damaged area of wall

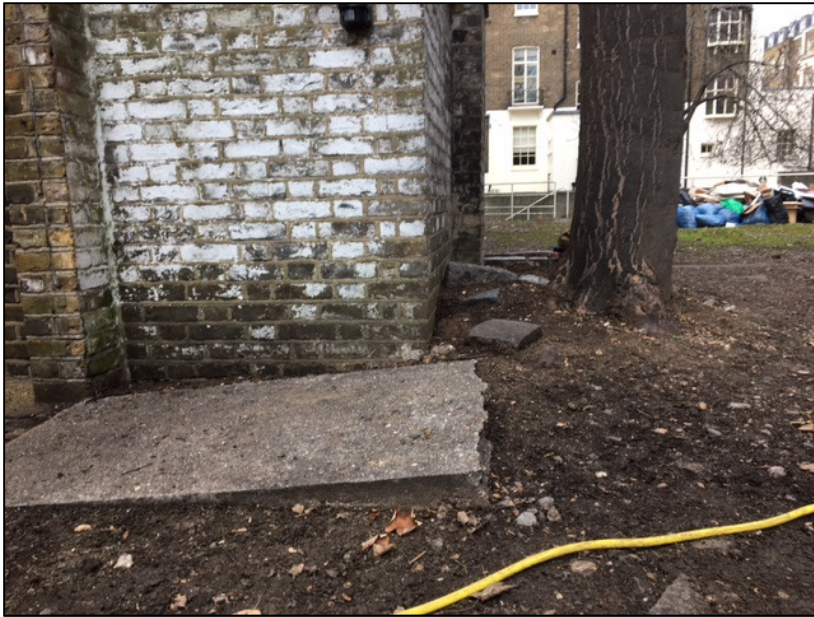
Figure A: Tree in close proximity to property pushing bricks towards wall

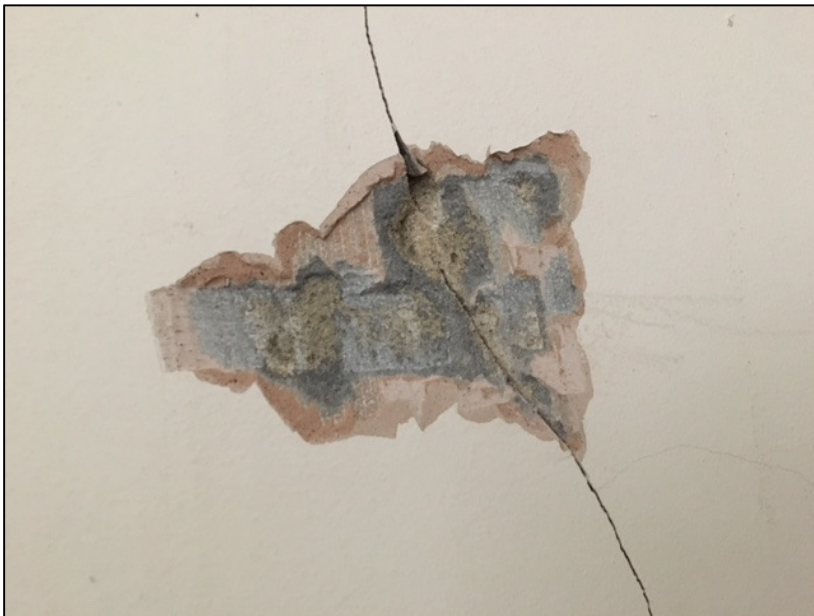
Figure B: Internal damage to wall within property

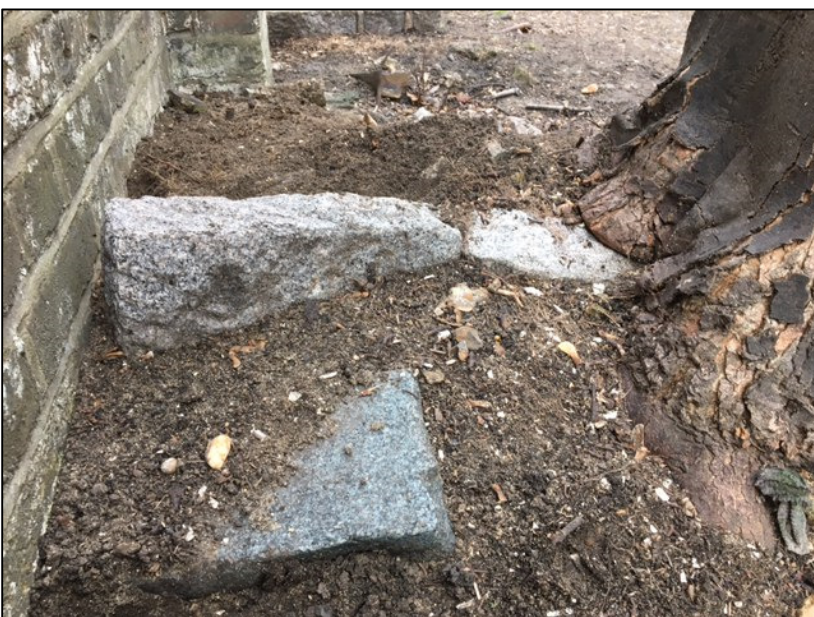
Figure C: Bricks being pushed towards wall

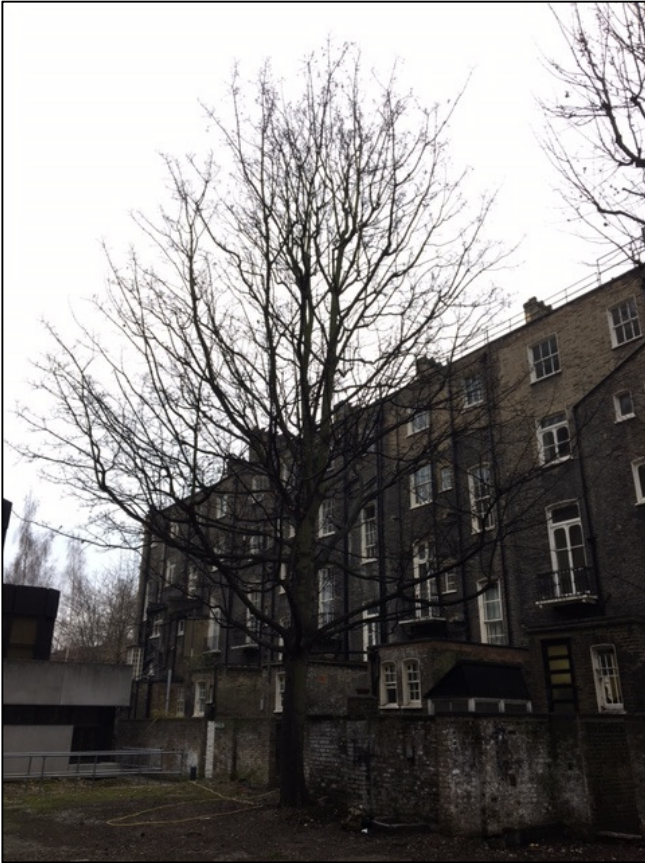
9.5 In addition to interpretations of above ground features, during the time of inspection the tree appeared in good structural condition. Seen in figure D Appendix 3, no physical defects were observed that would result in branch or stem failure to risk causing property damage without significantly strong or prolonged weather conditions.

Figure D: Healthy looking vitality displayed by crown

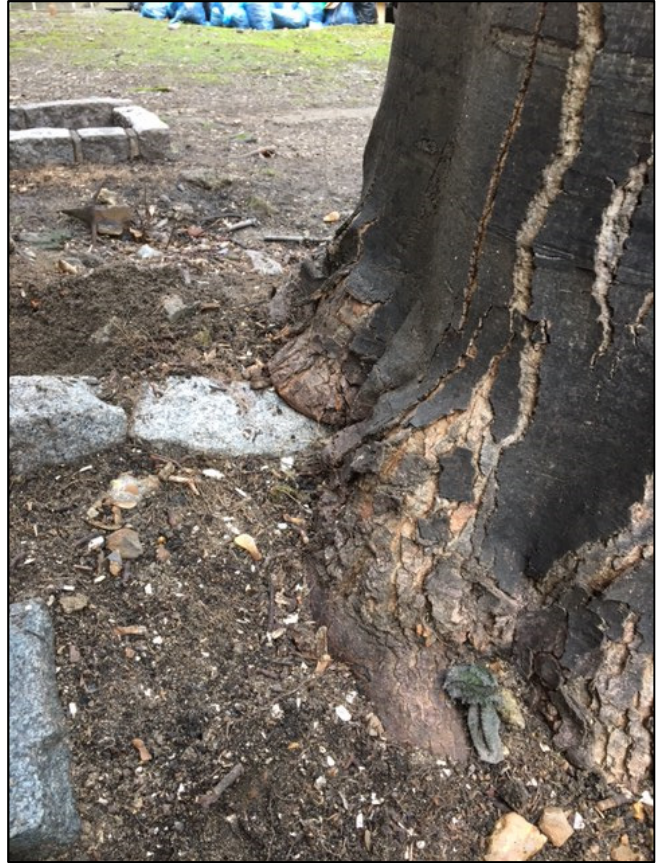
Figure E: Buttress root occluding adjacent brick and pushing towards property
