# Engineer's Report

Our Reference	<b>IFS-AVI-SUB-14-0048840</b>
Claim Reference	<b>14WCI000251</b>
Prepared for	<b>Woolwich</b>

Report Date	<b>23 January 2014</b>
Policyholder	<b>Mr A Dworkin</b>
Address	<b>62 Albert Street, London, NW1 7NR</b>

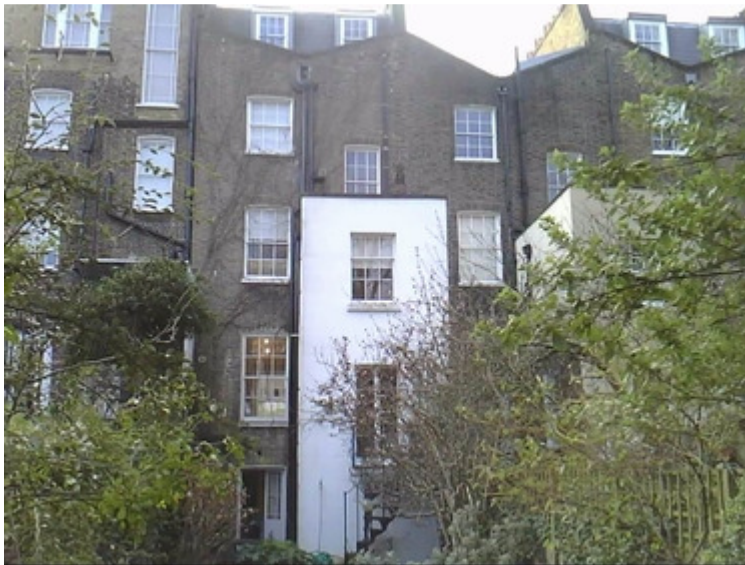
FIGURE 03 Rear Elevation

There is approximately 15mm separation between the main property and the parapet wall to the roof of the 3 storey rear addition.

No other damage was noted externally, although the right-hand junction of the property with the rear addition is obscured by the SVP and the left-hand junction is only accessible via the rear garden of the neighbouring property.

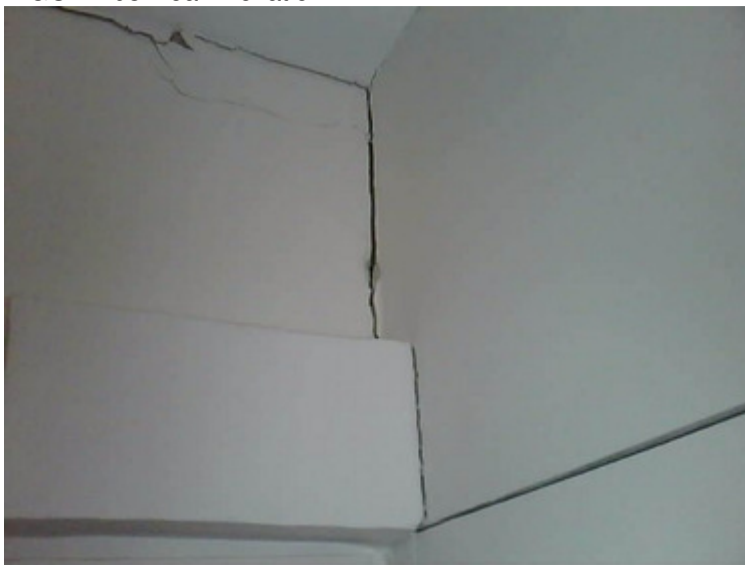
FIGURE 04 Lower ground floor rear bedroom

Finally, there is a full-height vertical tapering crack (3mm) to the right-hand wall at the junction of the main property/rear addition in the rear bedroom in lower ground floor flat.

The diagonal aspect of the cracks, together with the fact that they increase in width with height is indicative of subsidence as a result of shrinkage of the clay subsoil due to the moisture extracting influence of the large tree in the left-hand neighbour's rear garden.

Generally cracks 3mm wide or less will be filled (internal) or re-pointed (external). Internally, where the cracks are wider than 3mm, but less than 5mm the underlying brickwork or blockwork will be exposed and prior to making good the plaster finishes the cracking will be covered with expanded metal lath. Where cracks are 5mm across or wider, some form of bed joint reinforcement will be introduced.

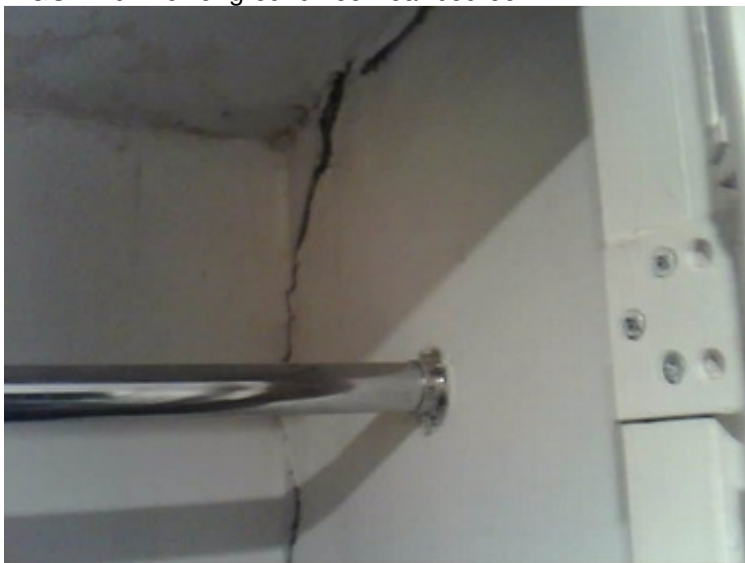
FIGURE 05 Ground floor study lobby

On the ground floor, there is a full-height vertical tapering crack (3mm) to the left-hand wall of the rear study lobby and a further full-height vertical tapering crack (4mm) on the right-hand wall in the same area. Both cracks are at the junction of the main property/rear addition and the crack traverses across the lobby ceiling in a similar manner to the first floor study directly above.

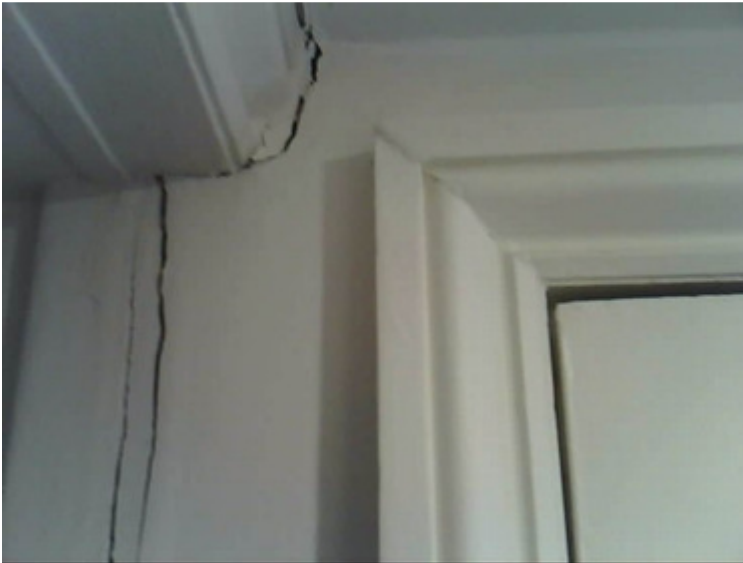
FIGURE 06 1st floor study

There is a 5-10mm separation crack at the rear wall/ceiling junction in the first floor study together with a full-height 15mm crack to the left-hand wall junction with the main property.

It is common practice to categorise the structural significance of the damage in accordance with the classification given in Table 1 of Digest 251 produced by the Building Research Establishment. In this instance, the damage falls into Category 3 (Moderate).
