Arboricultural Consultancy for Aviva

1. Case Details

Insured	Mr Anthony Dworkin	Address	62 Albert Street, London, NW1 7NR		
Client	Infront Innovation	Contact	Arif Khalifa	Claim No.	IFS-AVI-SUB-14-0048840
MT Ref	NL/2301141643/TP-REV1	Consultant	Thomas Peppiatt	Contact No.	08702 416 180
Report Date	13/02/2014 <i>Revised 13/07/2016</i>

3. Technical Reports (Revised)

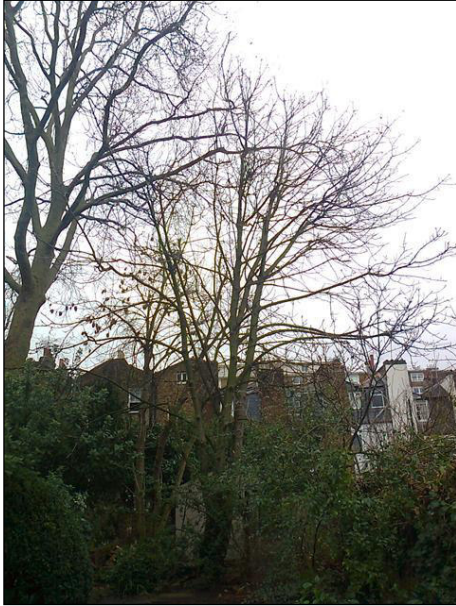
T8 - Horse Chestnut

T4	Acer	1	20	18*	A - Third Party 54 Albert Street London NW1 7NR	Action to avoid future risk	Crown reduce by 2m-3m all around and maintain at reduced dimensions by way of regular pruning (3-year max).
T6	Apple	1	4	7.6	A - Third Party 64 Albert Street London NW1 7NR	Action to avoid future risk	Do not allow to exceed 5m height.
T8	Horse Chestnut	1	11	17	C - Insured	Action to avoid future risk	Do not allow to exceed 14m height.

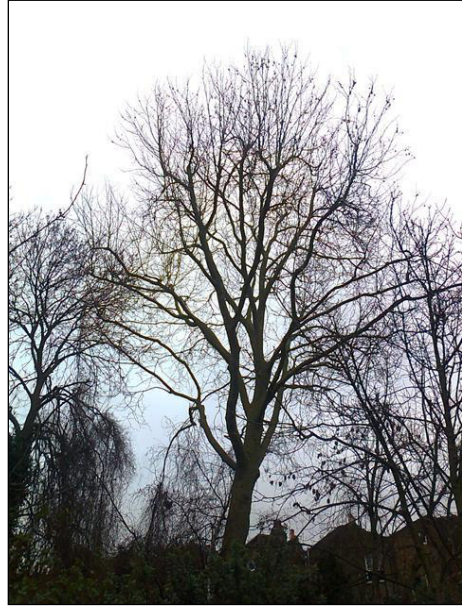
T11 - Plane (London)

T9	Ash	1	10	19*	A – Third Party 67 Arlington RD London NW1 7ES	Action to avoid future risk	Do not allow to exceed 16m height.
T10	Ash	1	17	21.4	A – Third Party 71 Arlington RD London NW1 7ES	Action to avoid future risk	Do not allow to exceed 18m height.
T11	Plane (London)	1	26	25.2	A - Third Party 70 Albert Street London NW1 7NR	Action to avoid future risk	Crown reduce by 2m-3m all around and maintain at reduced dimensions by way of regular pruning (3-year max).
TG1	Lime x2	1	14	11*	A - Third Party 58 Albert Street London NW1 7NR	Action to avoid future risk	Crown reduce by 3m-4m all around and maintain at reduced dimensions by way of regular pruning (3-year max).
Age Cat: 1 = Younger than property; 2 = Similar age to the property; 3 = Significantly older than property

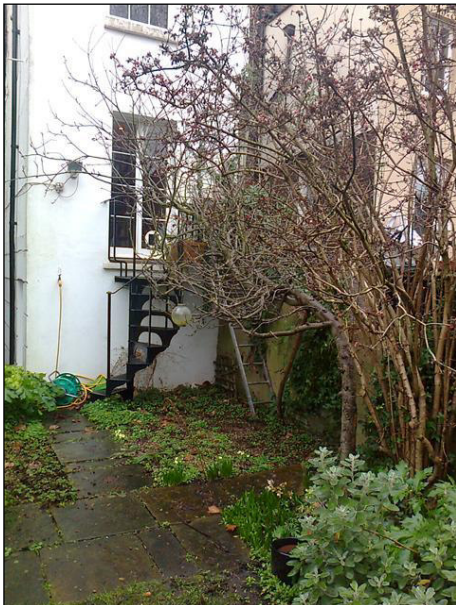
T5 - Apple

However, whilst not directly implicated by positive root analysis, based on our site investigations, and taking account of vegetation location, relative to the focal area of movement/damage, it is our opinion that T5 (Apple) also retains the capacity to be extending roots below the focal areas of movement and accordingly we have also identified it as a secondary contributory factor in the current subsidence damage.

T5 (Apple) and CG1 (Mixed Species Group) are also considered to retain a contributory influence, albeit in a limited/secondary capacity when compared to T7 (Plane (London)).

Tree No.	Species	Age Cat	Approx. Height (m)	Distance to Building (m)	Ownership	Action	Requirement
T5	Apple	1	4	3.7	C - Insured	Remove	Remove and treat stump to inhibit regrowth.
T7	Plane (London)	1	18.5	17.6	A - Third Party 64 Albert Street London NW1 7NR	Remove	Remove and treat stump to inhibit regrowth.
CG1	Mixed species climbers	1	3	2.7	C - Insured	Remove	Remove and treat stump to inhibit regrowth.

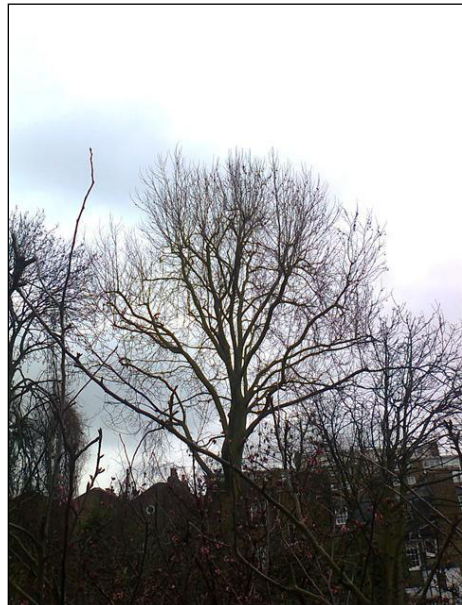
T7 - Plane (London)

Samples of these roots were recovered from underside of foundations and throughout the borehole, these roots were identified (using anatomical analysis) as having emanated from the genus *Platanus spp.*

Our survey of the site identified T7 (Plane (London)), which, given its position relative to the damage it is our opinion that the roots identified emanate from this tree.

In assessing the extent of damage and the potential drying influence of the vegetation on site, T7 (Plane (London)) is judged to be the dominant feature and accordingly we have identified it as the principal cause of the subsidence.

Removal of T5 (Apple), CG1 (Mixed Species Group) and T7 (Plane (London)), will offer the most certain and reliable arboricultural solution likely to restore long-term stability.
